ASBESTOS SURVEY REPORT FOR TOWN END ACADEMY, TOWN END FARM, SUNDERLAND, SR5 4NX

Town End Academy, Town End Farm, Sunderland

Date: 20 August 2024

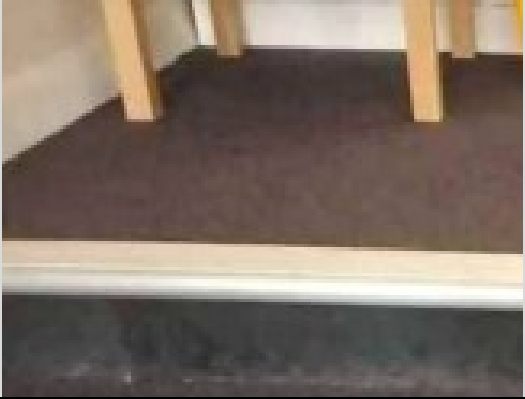
| 1 | AW005974 | Floor lining to steps | Lobby and Corridor G/002 | No Risk |

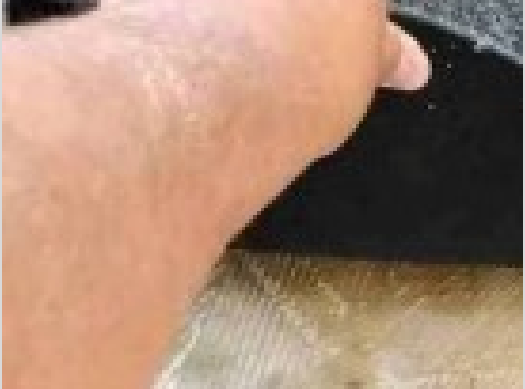
| 3 | AW005976 | Floor adhesive below latex screed | Office G/003 | No Risk |

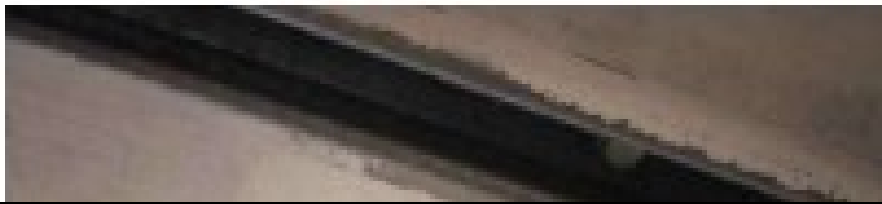
| Photo 1: Wide Angle | | | | |

| 25 | AW006022 | Ceiling Debris | Boiler Room G/083 | Low Risk – 6 monthly |

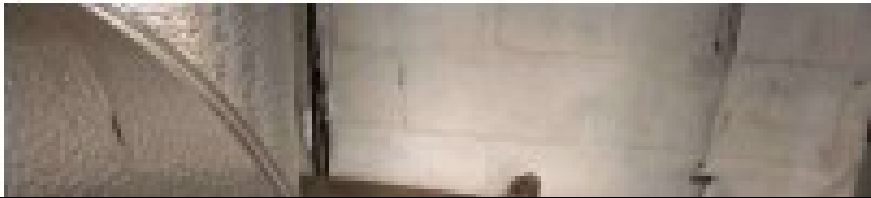
| Photo 1: Wide Angle | | | | |

| 26 | AW006023 | Debris to electrical conduits | Boiler Room G/083 | Low Risk – 6 monthly |

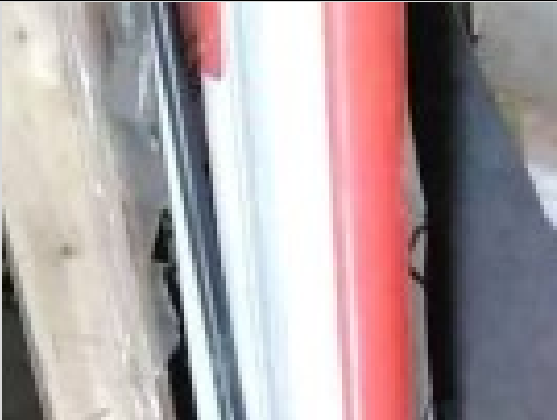
| 27 | AW006024 | Floor Debris | Boiler Room G/083 | No Risk |

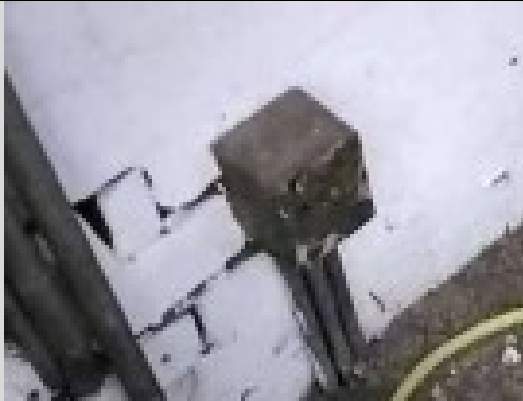
| 28 | AW006025 | Floor Debris | Boiler Room G/083 | No Risk |

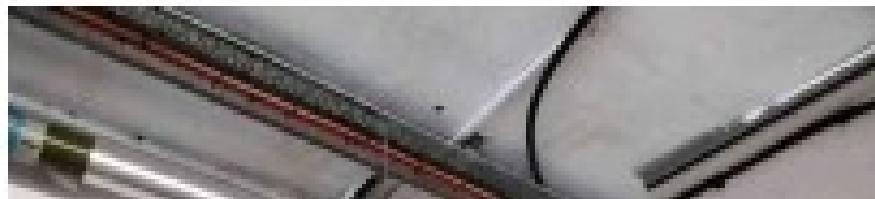
Photo 1: Wide Angle

| 29 | AW006026 | Pipework Gaskets | Boiler Room G/083 | Very Low Risk – 12 monthly |

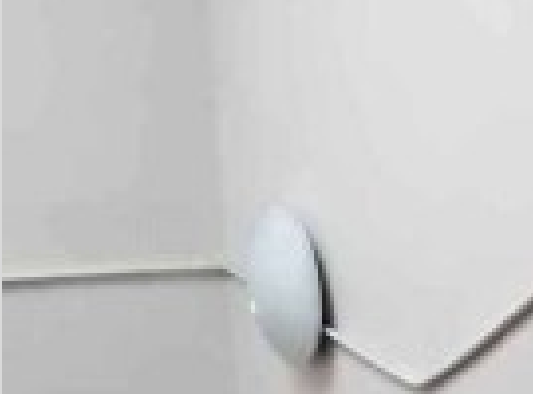
| 35 | As AW006013 | Wall tile | Stairwell 1/004 | No Risk |

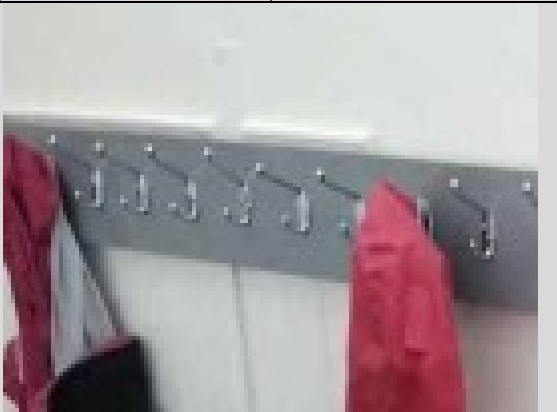
| 38 | As AW006013 | Wall tile | Lobby 1/007 | No Risk |
