ASBESTOS SURVEY REPORT FOR HALTWHISTLE PRIMARY ACADEMY,
PARK AVENUE, HALTWHISTLE, NORTHUMBERLAND, NE49 9BA

Asbestos Register for

**Haltwhistle Primary Academy, Park Avenue, Haltwhistle,
Northumberland, NE49 9BA**

Date: 14 January 2025

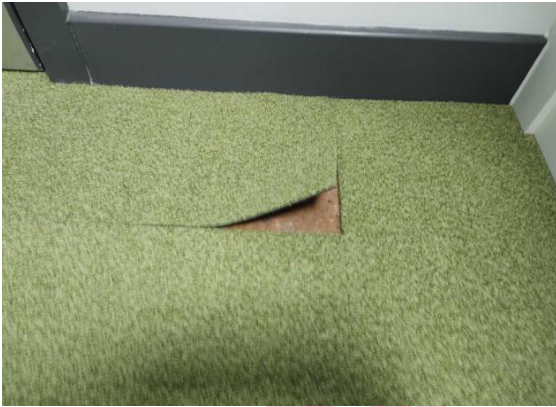
Item 8 Ref: 21-39567-5

The floor screed (Area 16/Classroom 3 and Cupboard) does not contain asbestos.

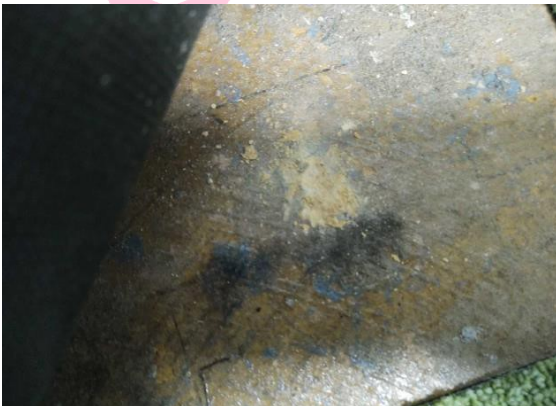
Item 9 Ref: 21-39567-5

The floor screed (Area 17/Classroom 4 and Cupboard) does not contain asbestos.

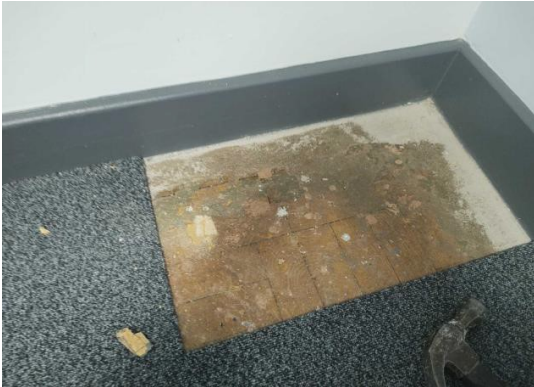
Item 10 Ref: 21-39567-6

The floor screed (Area 32/Classroom 7 and Cupboard) does not contain asbestos.

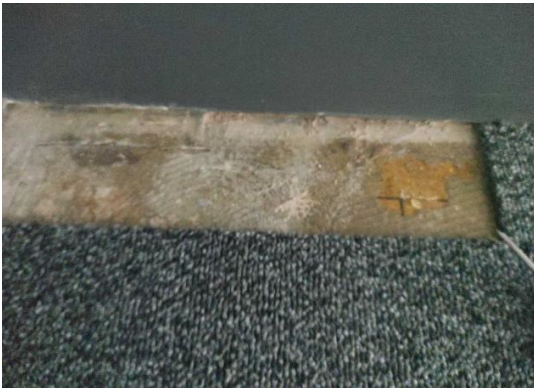
Item 11 Ref: 21-39567-6

The floor screed (Area 33/Classroom 8 and Cupboard) does not contain asbestos.

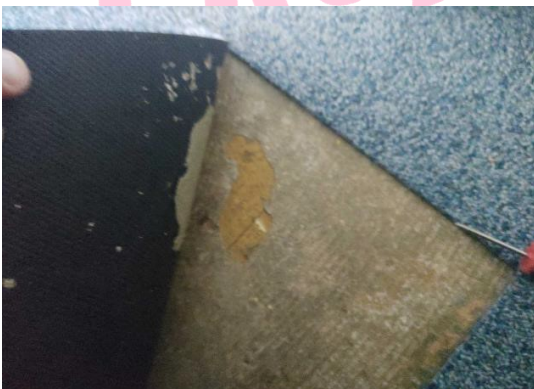
Item 12 Ref: 21-39567-6

The floor screed (Area 34/Library 2 and Cupboard) does not contain asbestos.

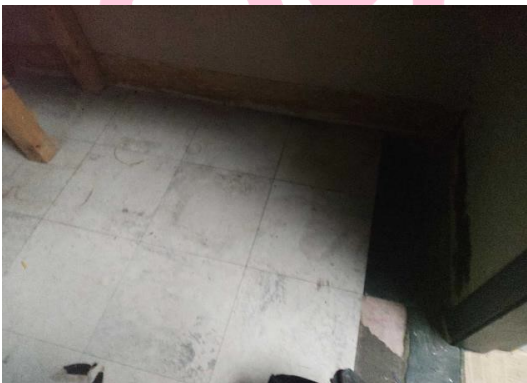
Item 18 Ref: 21-39567-12

The floor tiles and adhesive (Area 84/Store) contain asbestos.

Any change in its appearance should be recorded and passed to Property Services.

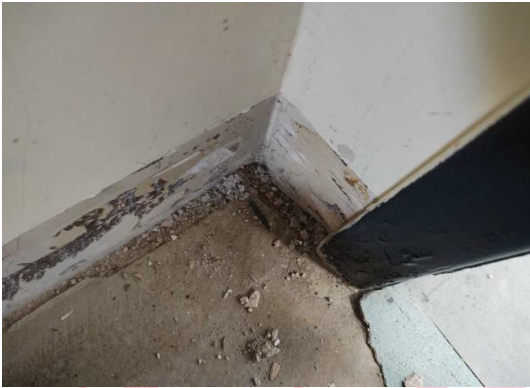
Item 23 Ref: 21-39567-17

The floor tiles and adhesive (Area 96/Drying Store) does not contain asbestos.

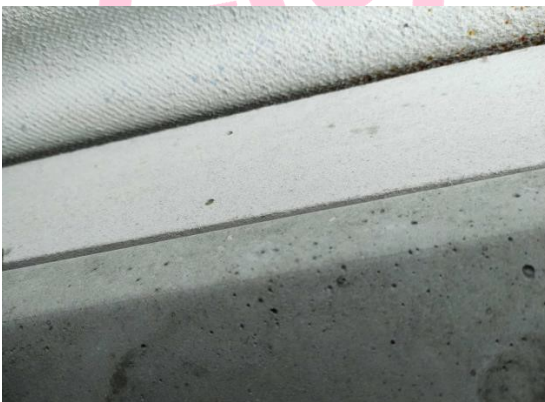
Item 24 Ref: 21-39567-18

The infill panels to top of wall (Area 104/Garage 1) do not contain asbestos.

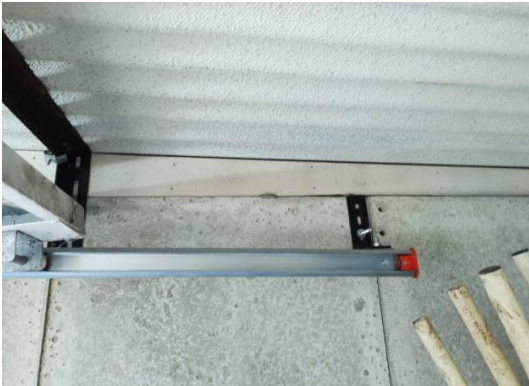
Item 26 Ref: 21-39567-18

The infill panels to top of wall (Area 106/Garage 3) do not contain asbestos.

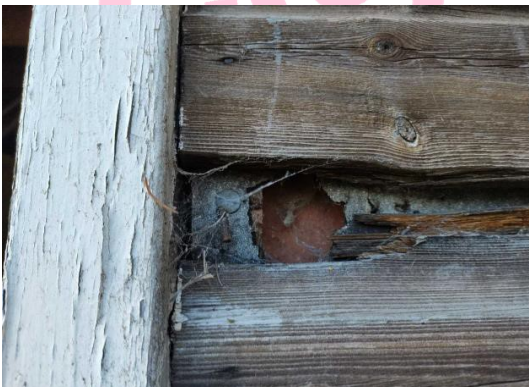
Item 27 Ref: 21-39567-19

The damp proof sheeting behind wood cladding to walls (Area 107/External Store) does not contain asbestos.

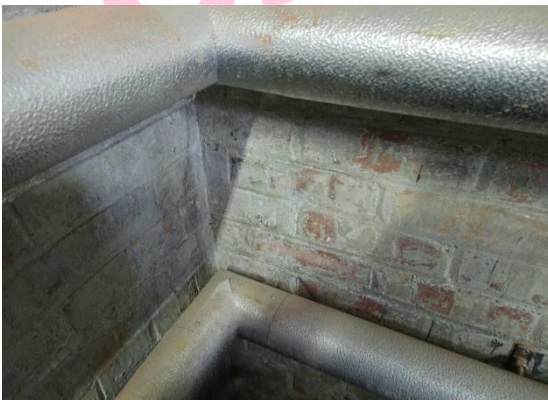
Item 33 Ref: 21-39567-21

The residue to wall 2 (Area 110/Boiler Room) does not contain asbestos.

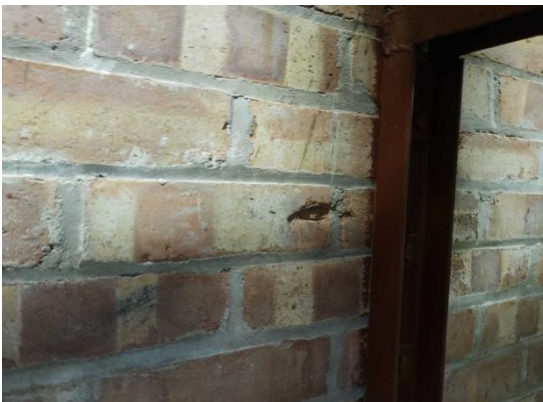
Item 36 Ref: 21-39567-24

The residue to wall 3 (Area 110/Boiler Room) does not contain asbestos.

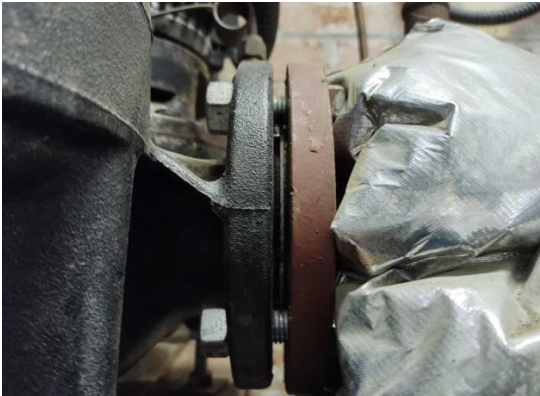
Item 38 Ref: 21-39567-26

The gasket to flanges (Area 110/Boiler Room) do not contain asbestos.

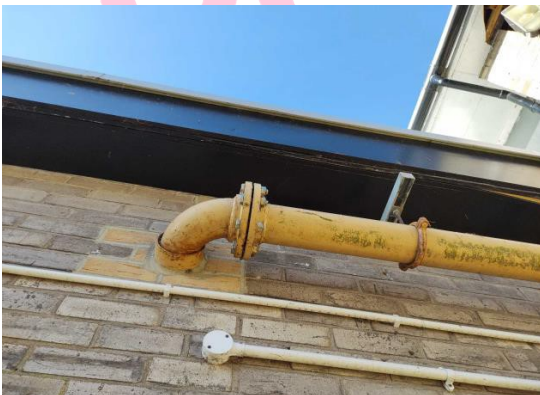
Item 39 Ref: 21-39567-20

The gasket to flange of gas mains pipe (Area 129/ External) does not contain asbestos.

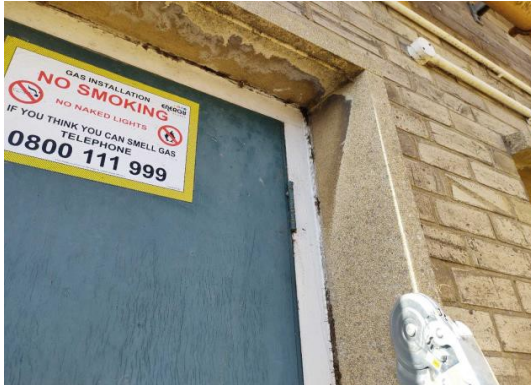
Item 40 Ref: 21-39567-27

The mastic to outside door of gas inlet cupboard (Area 129/External) contains asbestos.

Any change in its appearance should be recorded and passed to Property Services.

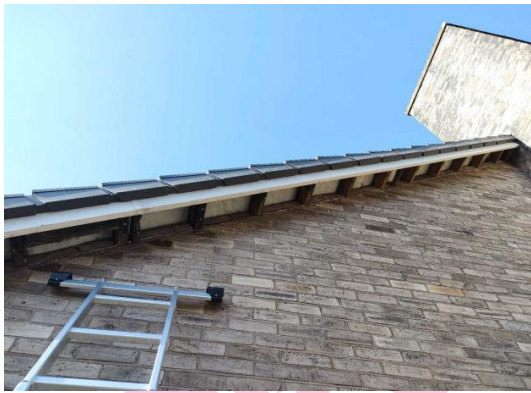
Item 41 Ref: 21-39567-29

The residue to nails to former gable end soffits of Children's centre (Area 129/External) does not contain asbestos.

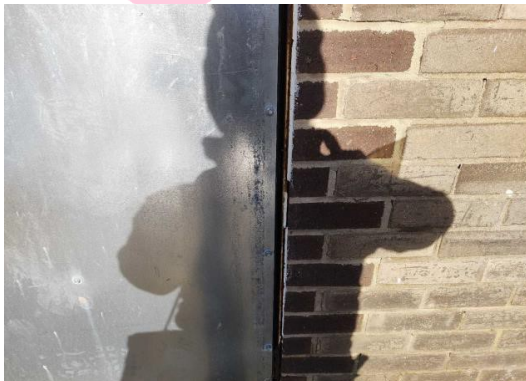
Item 42 Ref: 21-39567-30

The mastic to quad bike store doors (Area 129/External) does not contain asbestos.

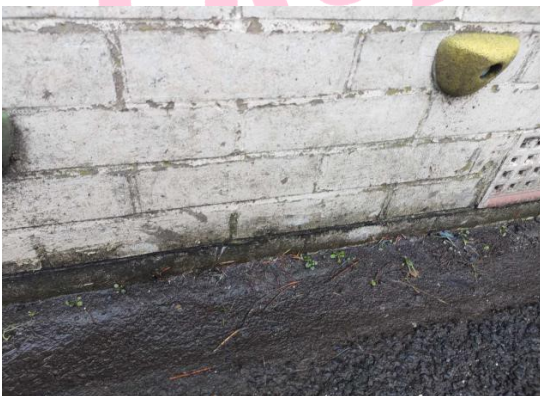
Item 45 Ref: 21-39567-33

The damp proof course to walls (Area 129/External) does not contain asbestos.
