ASBESTOS SURVEY REPORT FOR WELBECK ACADEMY, FLODDEN STREET, WALKER, NEWCASTLE, NE6 2QP

Asbestos Register for

Welbeck Academy

Date: 11 February 2025

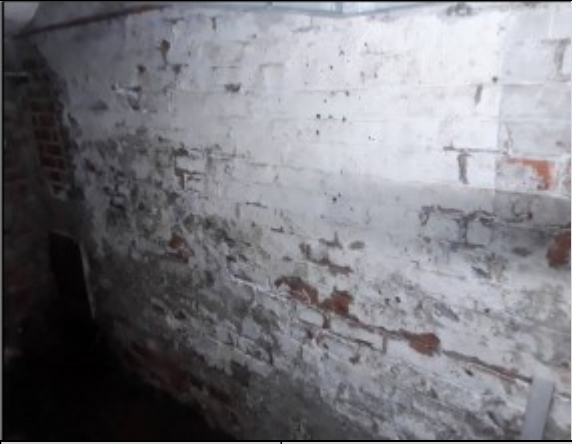
1	NZ001807	Debris to entrance wall	Boiler room north Z1/001	No Risk

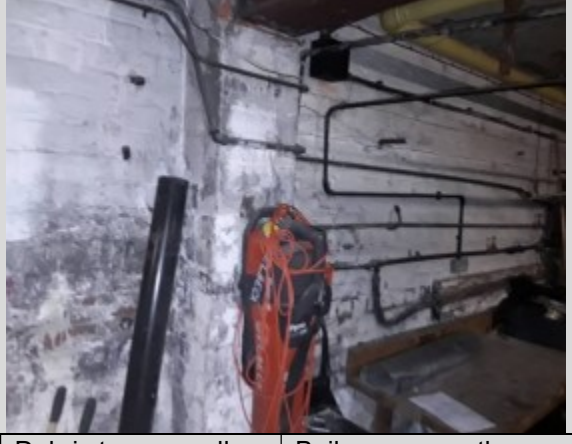
2	NZ001808	Debris to left hand wall	Boiler room north Z1/001	No Risk

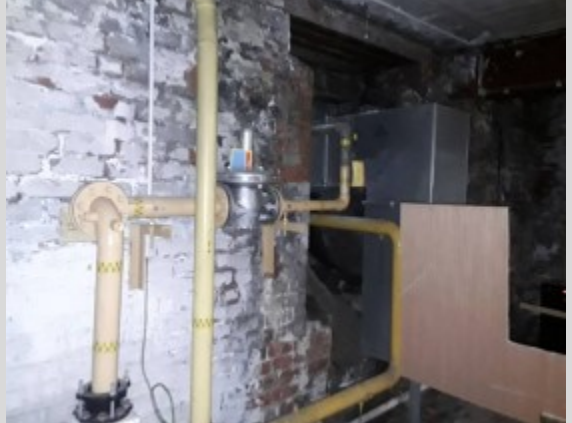
3	NZ001809	Debris to rear wall	Boiler room north Z1/001	No Risk

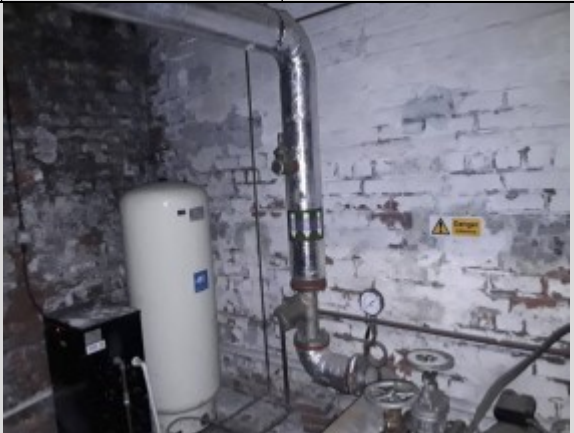
4	NZ001810	Debris to right wall	Boiler room north Z1/001	No Risk

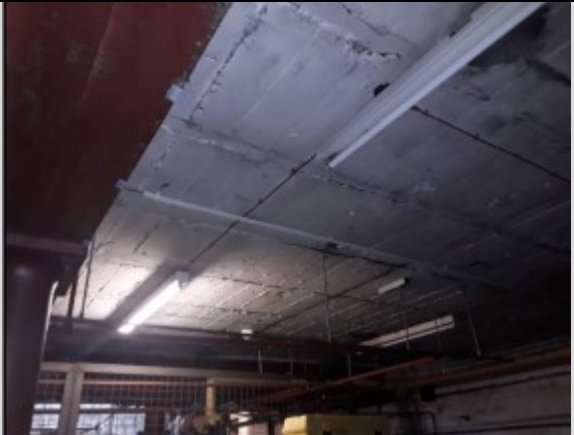
5	NZ001811	Debris to ceiling	Boiler room north Z1/001	No Risk

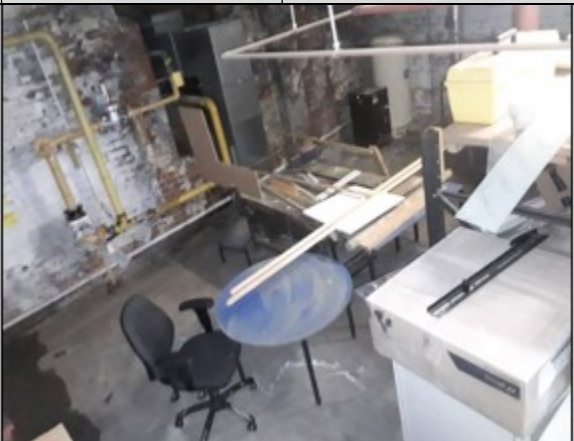
6	NZ001812	Debris to floor	Boiler room north Z1/001	No Risk

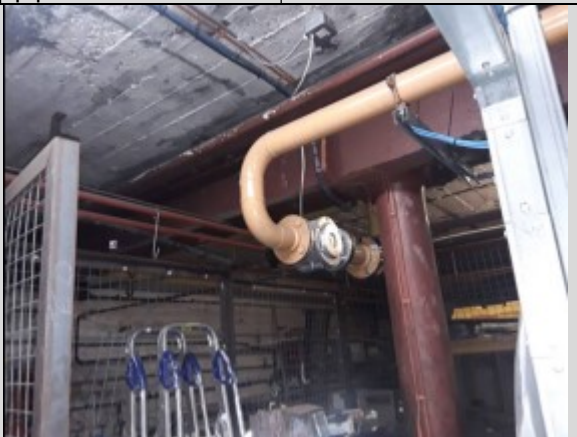
7	NZ001813	Pipework gaskets to new boilers and gas pipes	Boiler room north Z1/001	No Risk

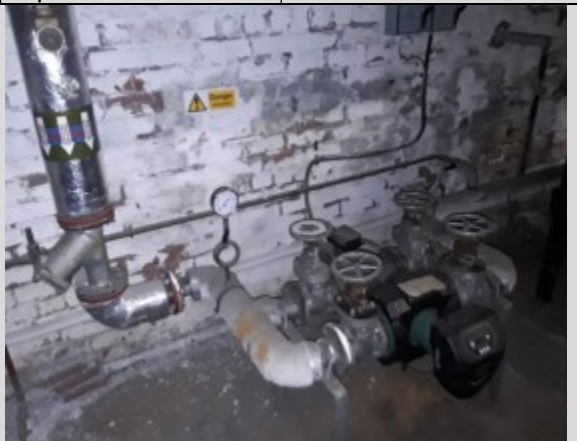
9	NZ001815	Pipework gaskets redundant gasket on top of old valves	Boiler room north Z1/001	No Risk

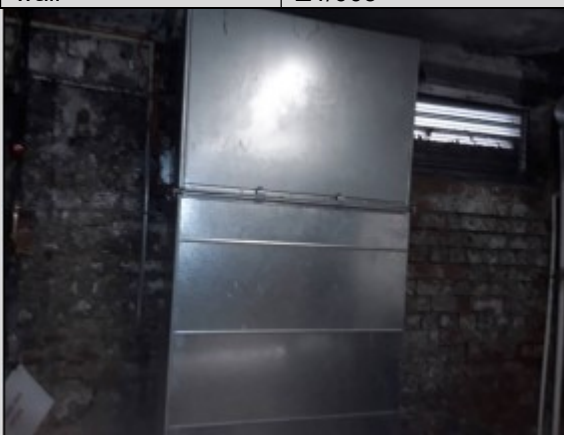
12	NZ001817	Debris to left hand wall	Boiler room South Z1/003	No Risk

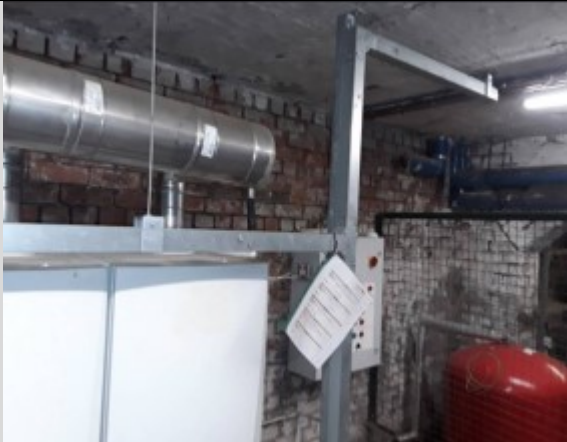
13	NZ001818	Debris to rear wall	Boiler room South Z1/003	No Risk

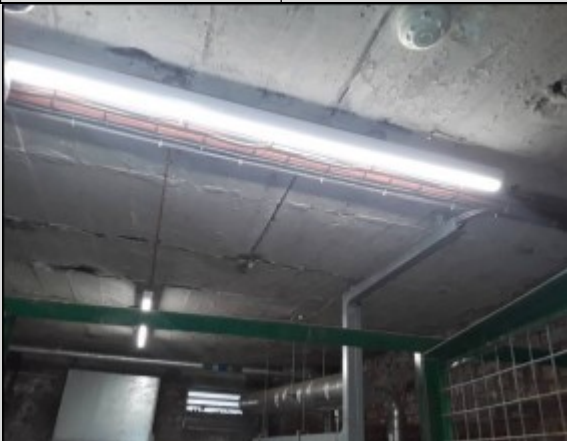
15	NZ001820	Debris to ceiling	Boiler room South Z1/003	No Risk

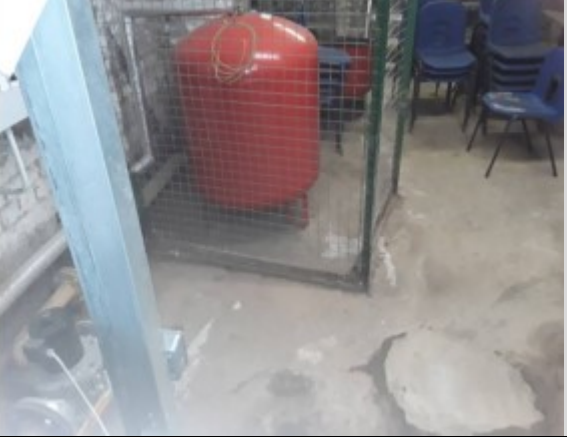
16	NZ001821	Debris to floor	Boiler room South Z1/003	No Risk

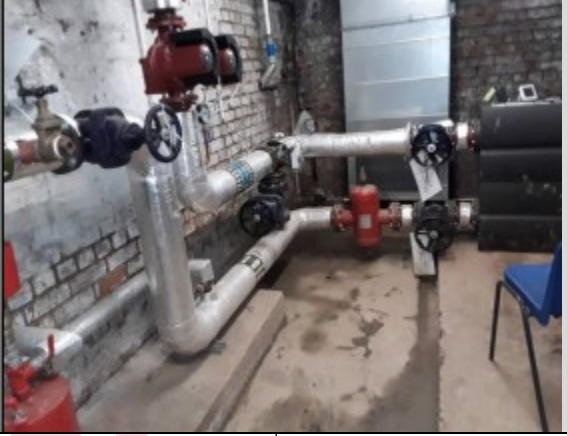
17	NZ001822	Pipework gaskets to new boilers and gas pipes	Boiler room South Z1/003	No Risk

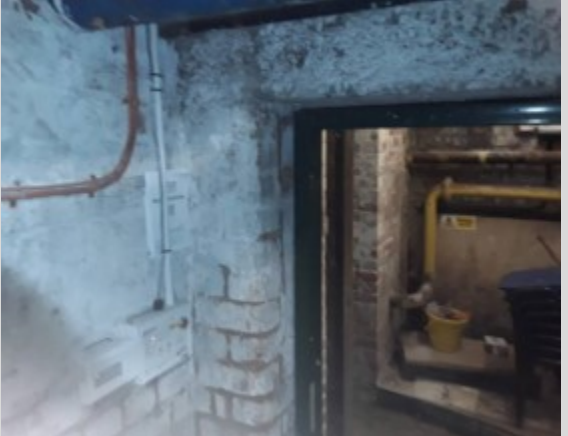
19	NZ001823	Door seal gasket remnants from removed door frame	Boiler room South Z1/003	No Risk

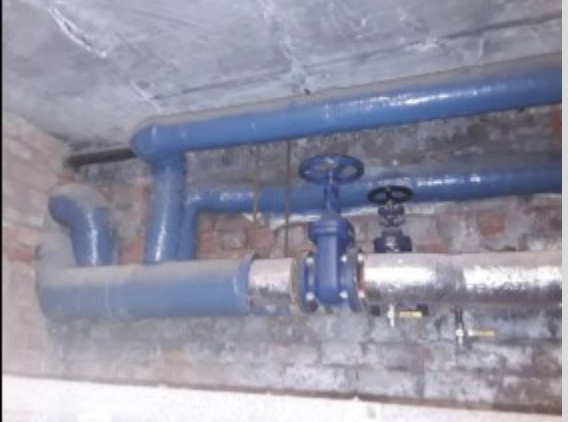
20	NZ001824	Pipework Gaskets	Gas inlet room Z1/004	No Risk

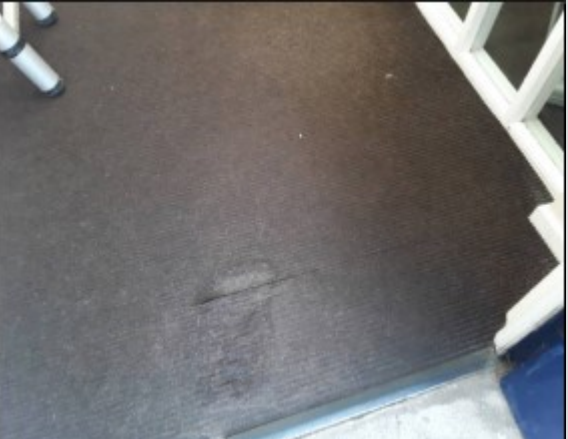
21	NZ001784	Floor adhesive under modern screed	Entrance Hall/Foyer/Lobby G/001	No Risk

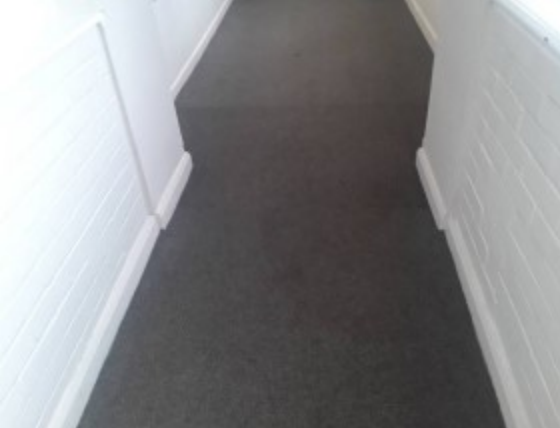
</div> </div>				
42	NZ001790	Floor adhesive under carpet and modern screed	Corridor G/037	No Risk

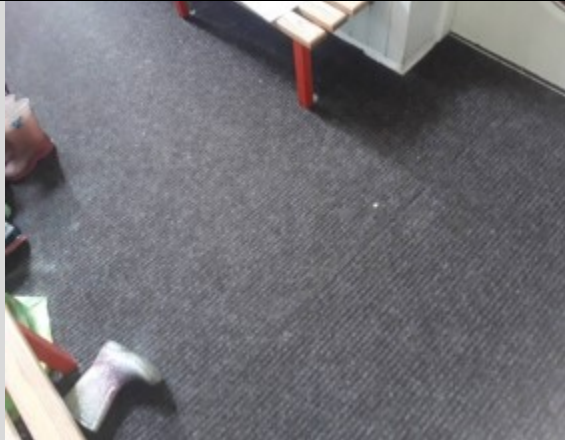
56	As NZ001794	Floor adhesive under carpet and modern screed	Corridor G/068	No Risk

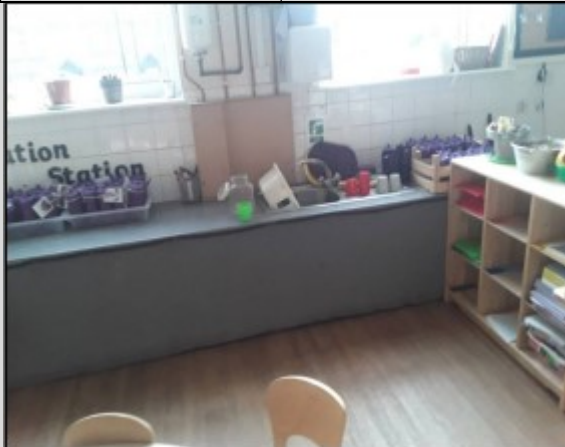
57	As NZ001793	Under sink mat	Classroom G/070	No Risk

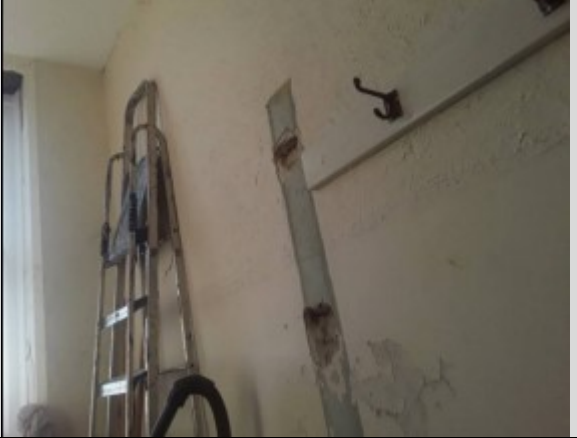
73	NZ001805	Wall coating	Store Room 1/040	No Risk

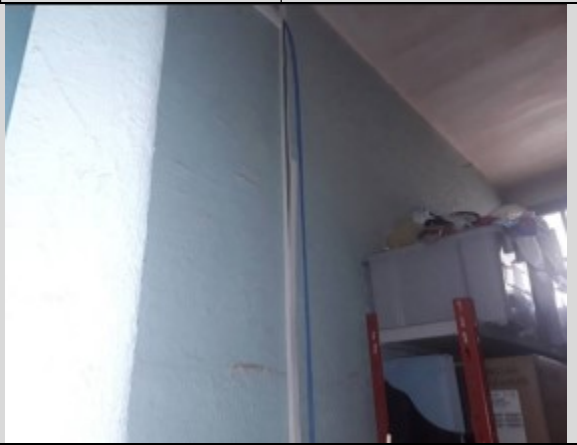
74	As NZ001805	Wall coating	Store Room restricted due to stored items 1/041	No Risk

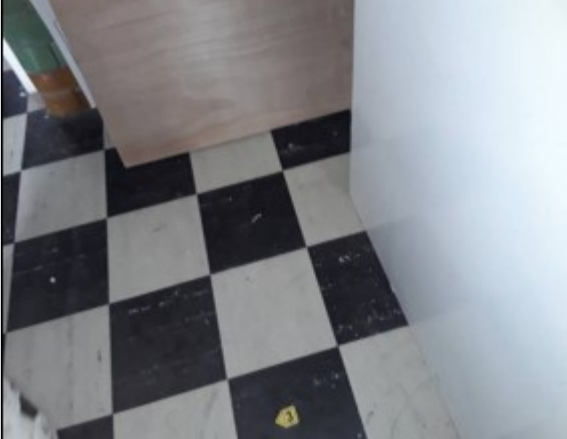
77	NZ001799	Floor – tile with adhesive under	Hallway MZ/002	No Risk

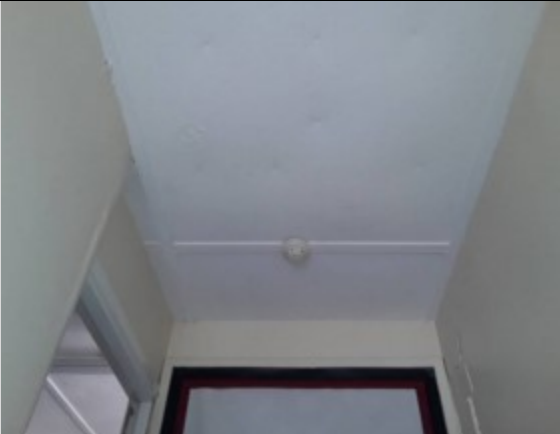
84	As NZ001797	Ceiling	Landing MZ/010	No Risk

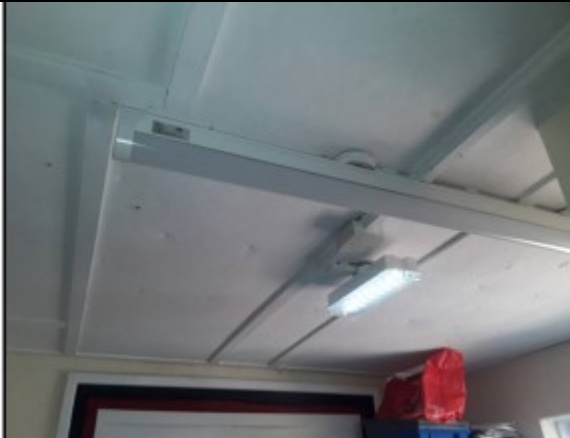
85	NZ001801	Floor tile with adhesive under carpet and modern screed	Hallway/Passageway MZ/011	Very Low Risk 12 monthly		
<table border="1" style="width: 100%; border-collapse: collapse;"> <tr> <td style="width: 50%; text-align: center; vertical-align: top;"> <p>Photo 1: Wide Angle</p>   </td> <td style="width: 50%; text-align: center; vertical-align: top;"> <p>Photo 2: Close-up</p>   </td> </tr> </table>					<p>Photo 1: Wide Angle</p>  	<p>Photo 2: Close-up</p>  
<p>Photo 1: Wide Angle</p>  	<p>Photo 2: Close-up</p>  					
86	As NZ001797	Ceiling	Hallway/Passageway MZ/011	No Risk

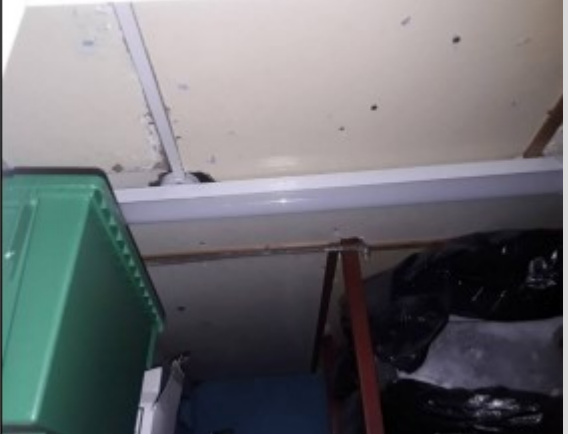
88	As NZ001797	Ceiling	Tank Room MZ/012	No Risk

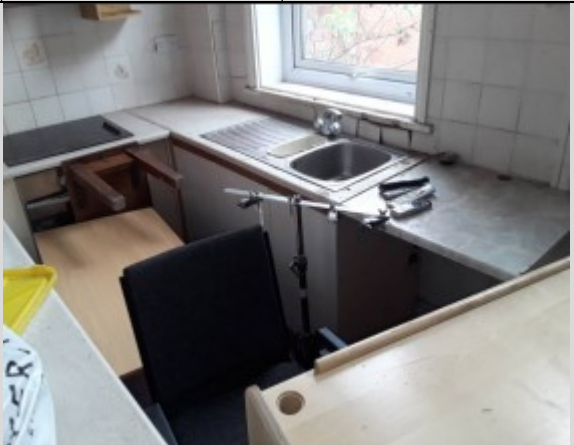
103	NZ001832	Under sink mat	Caretakers House Kitchen G/005	No Risk

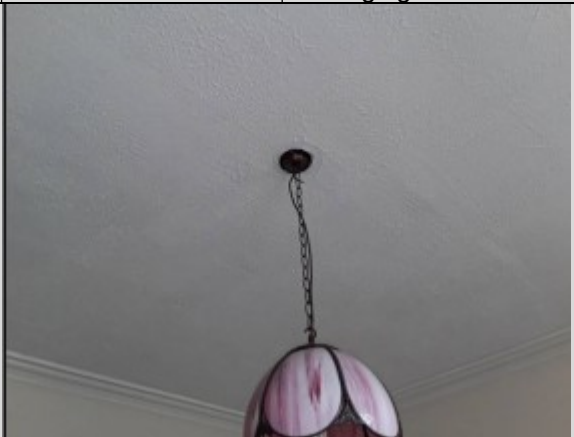
104	NZ001833	Ceiling coating	Caretakers House Living room/lounge limited inspection within due to tenants belongings G/007	No Risk

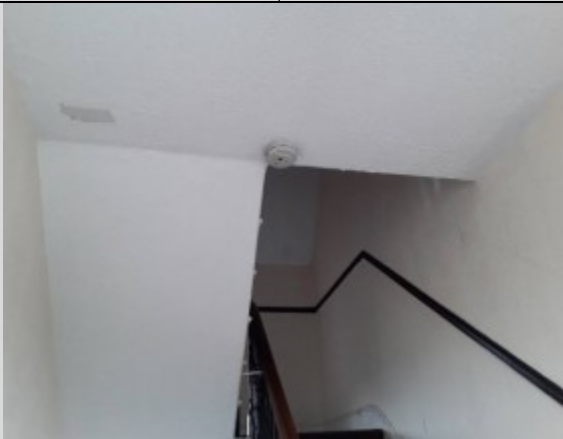
106	NZ001834	Ceiling coating	Caretakers House Landing including staircase 1/001	No Risk

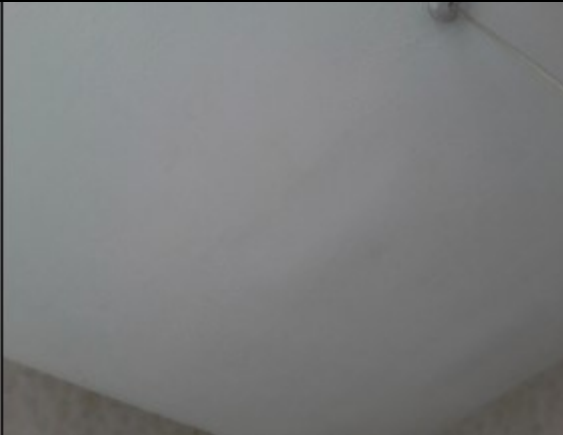
107	As NZ001834	Ceiling coating	Caretakers House Bedroom 1 1/002	No Risk

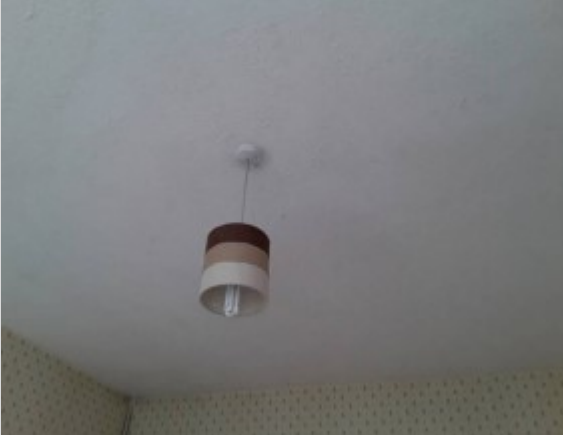
108	NZ001835	Ceiling coating	Caretakers House Bedroom 2 1/003	No Risk
