ASBESTOS SURVEY REPORT FOR FARRINGDON ACADEMY SCHOOL, SUNDERLAND

**FARRINGDON ACADEMY SCHOOL,
SUNDERLAND**

Date: 06 December 2024

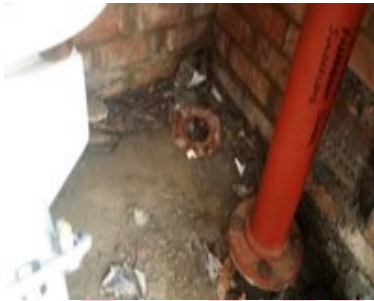
Item 16 Ref: 101894-8

The flange gasket to the pipework in the gas meter house does not contain asbestos.

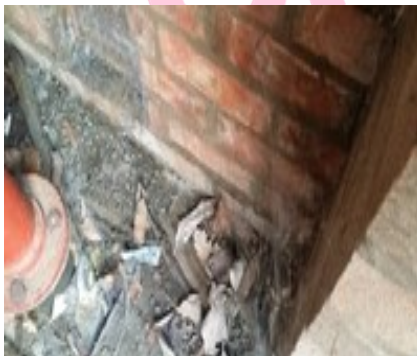
Item 17 Ref: 101894-9

The loose lying gasket to the gas meter house contains asbestos.

Any change in its appearance should be recorded and passed to Property Services.

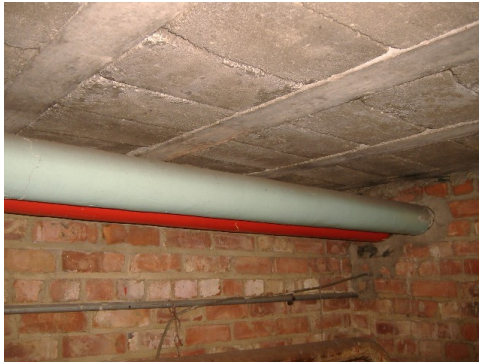
Item 39 - Ref: Presumed

The pipework insulation to the tank room (Rm 0/110) is presumed to contain asbestos.

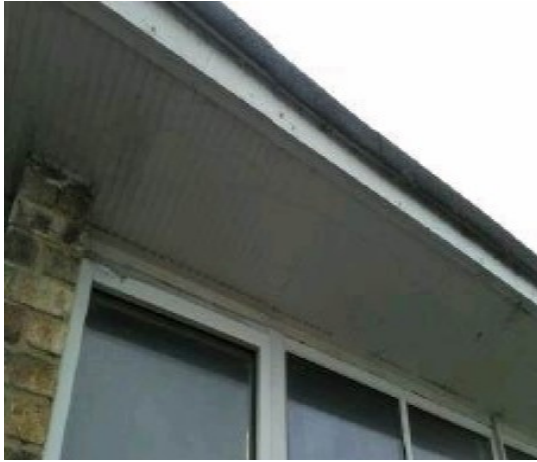
Item 47 - Ref: WC0483/08

The soffits to the exterior of the building contain asbestos.

Any change in its appearance should be recorded and passed to Property Services.

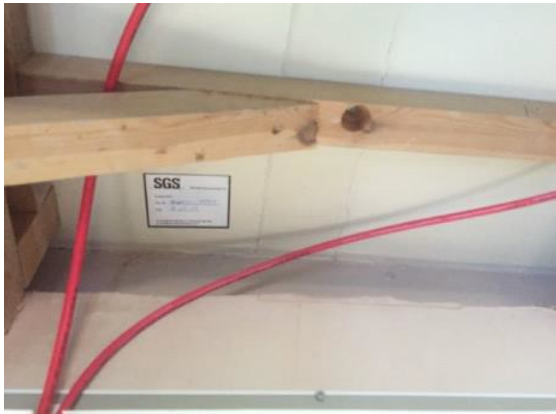
Item 48 – Ref: 741266-1

The ceiling void in the Staff Room does not contain asbestos.

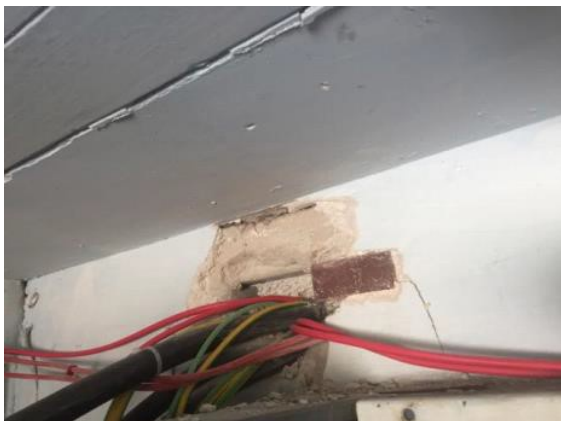
Item 49 – Ref: 741267-2

The ceiling in the Switch Room does not contain asbestos.

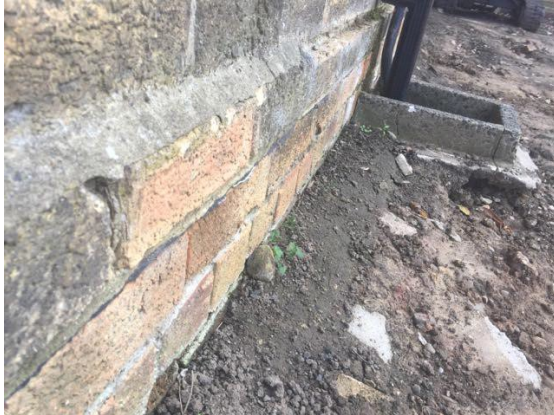
Item 53 - Ref: 741271-7

The damp proof course to the Lower Wall (External) contains asbestos.

Any change in its appearance should be recorded and passed to Property Services.

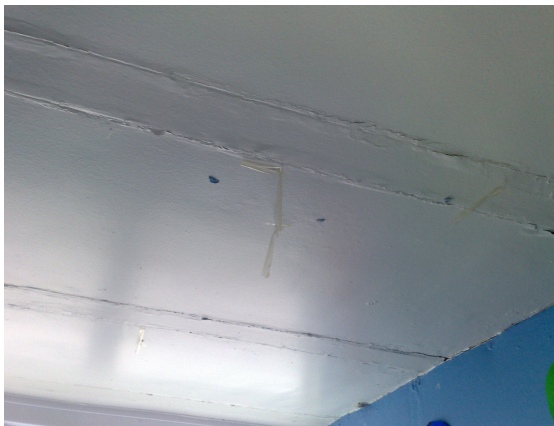
Item 54 - Ref: KR09/47

The ceiling in cloakroom 1 (Room 0/01) does not contain asbestos.

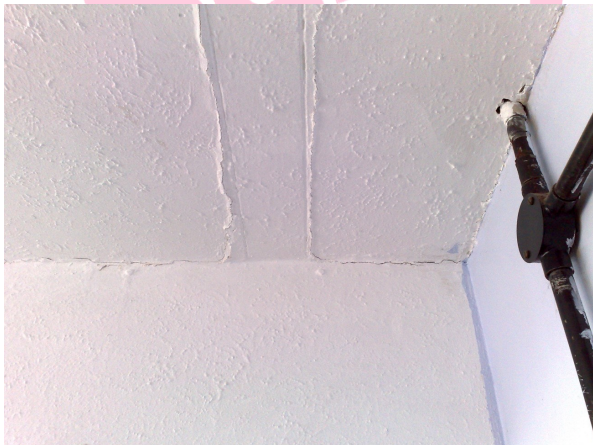
Item 56 - Ref: KR09/46

The textured coating to the ceiling in Store B (Room 0/03) contains asbestos.

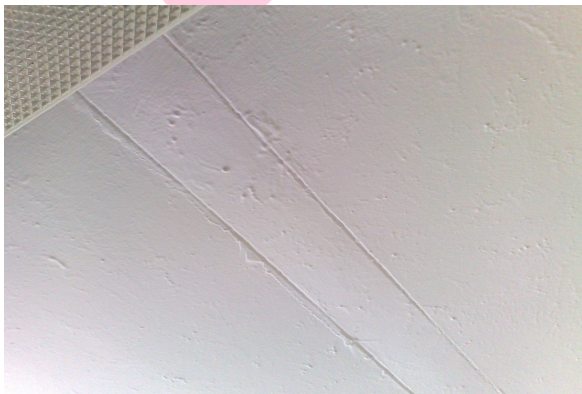
Item 94 - Ref: KR09/46

The textured coating to the ceiling in the craft area (Room 0/48) contains asbestos.

Any change in its appearance should be recorded and passed to Property Services.

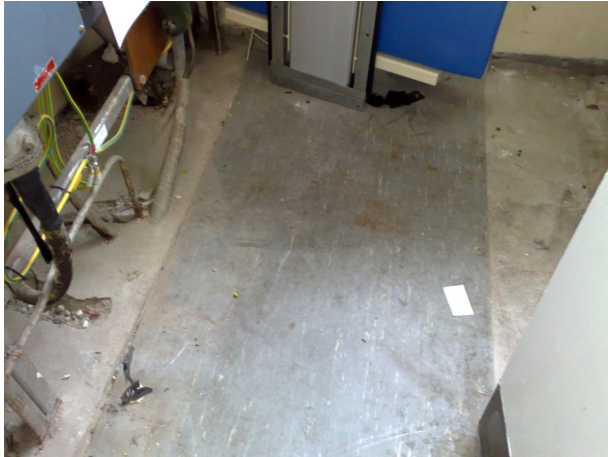
Item 103 - Ref: KR09/59

The vinyl floor strip in the electrical intake 2 (Room 0/63) does not contain asbestos.

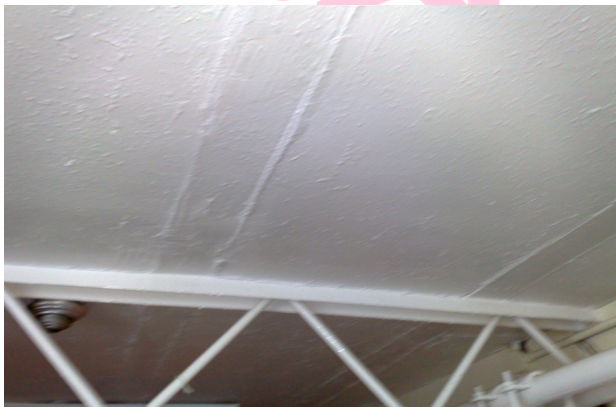
Item 109 - Ref: KR09/60

The textured coating to the ceiling Kitchen area corridor (Room 0/69) contains asbestos.

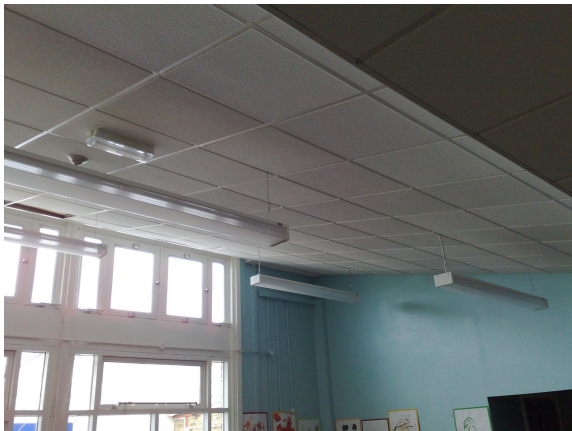
Item 126 - Ref: KR09/69

The suspended ceiling tiles in the Nursery and cloakroom (Room 0/97) does not contain asbestos.

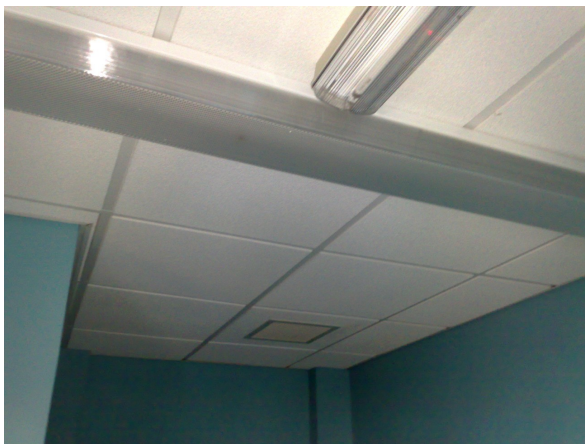
Item 127 - Ref: KR09/73

The suspended ceiling tiles in the Nursery toilet (Room 0/98) does not contain asbestos.

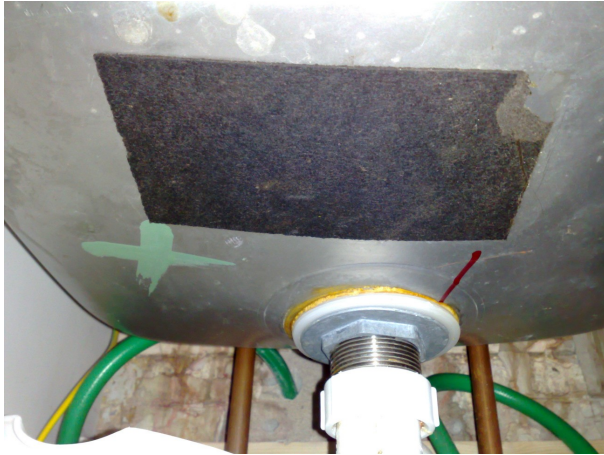
Item 132 - Ref: KR09/61

The sink pad in the kitchen area corridor (Room 0/69) does not contain asbestos.

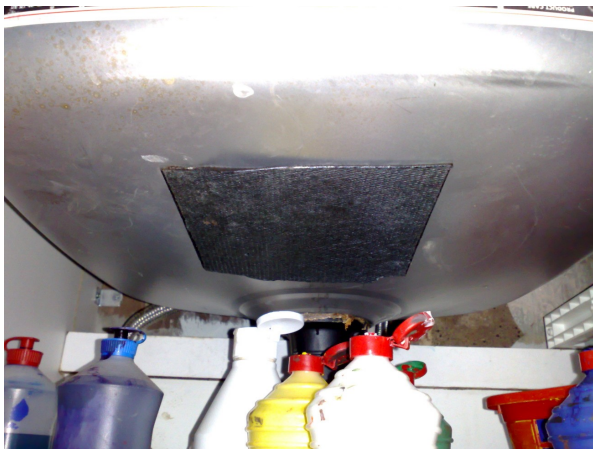
Item 133 - Ref: KR09/64

The sink pad in the toilet (Room 0/81) does not contain asbestos.

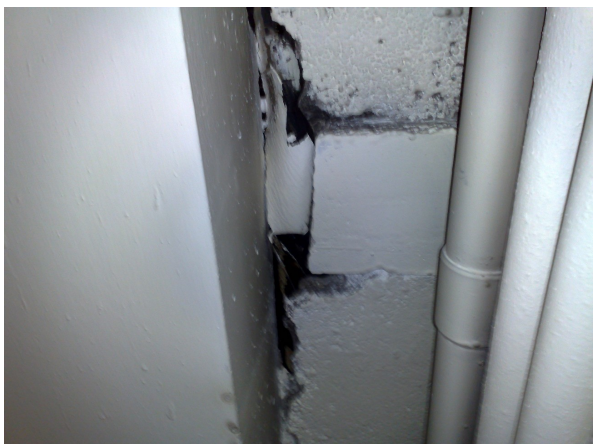
Item 134 - Ref: KR09/66

The bitumen material to ceiling above door in under stairs store (Room 0/83) does not contain asbestos.

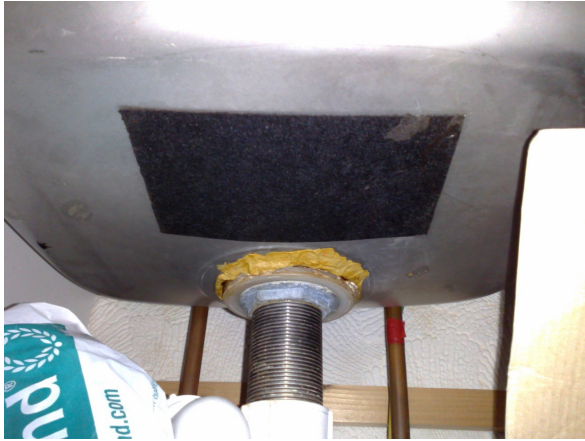
Item 135 - Ref: KR09/67

The sink pad in the clothes store/sink room (Room 1/085) does not contain asbestos.

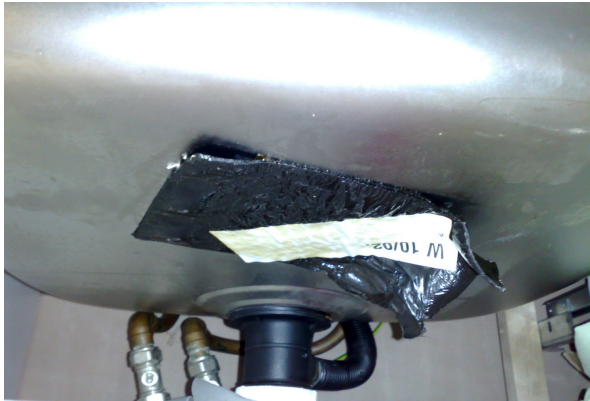
Item 143 - Ref: KR09/51

The sink pad in the kitchen (Room 0/021) does not contain asbestos.

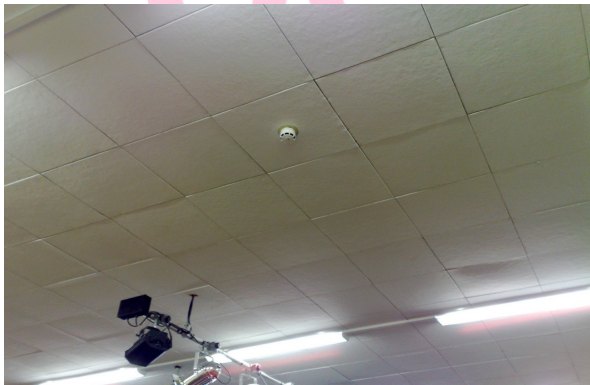
Item 144 - Ref: KR09/52A

The ceiling tiles in the hall (Room 0/30) does not contain asbestos.

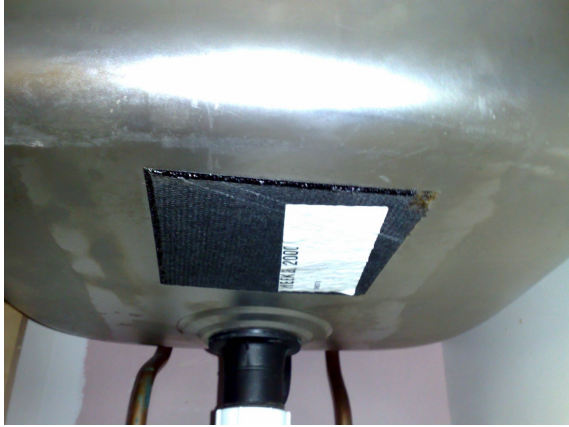
Item 145 - Ref: KR09/57

The sink pad in the Staff Room (Room 0/062) does not contain asbestos.

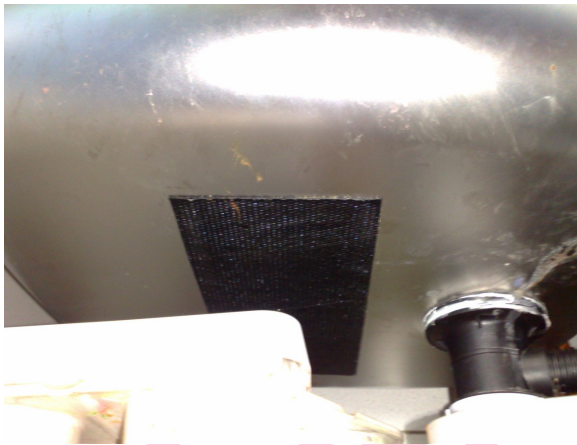
Item 146 - Ref: KR09/50

The sink pad in the Art Room (Room 0/016) does not contain asbestos.

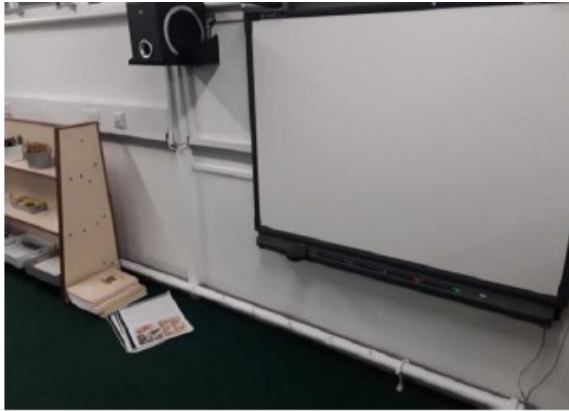
Item 179 - Ref: 22-42251-1

The textured coating to walls in Year 6 Learning Zone does not contain asbestos.

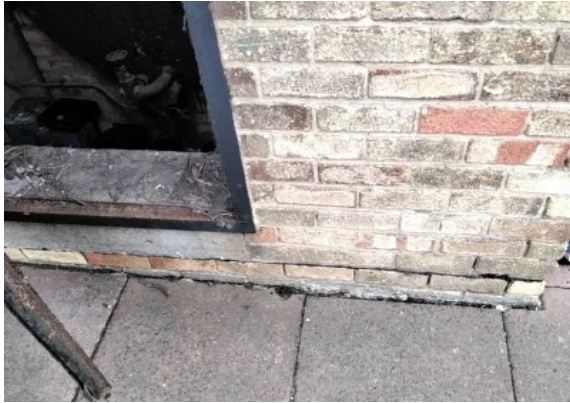
Item 182 - Ref: SC005256

The damp proof course in the Boiler Room (External) does not contain asbestos.

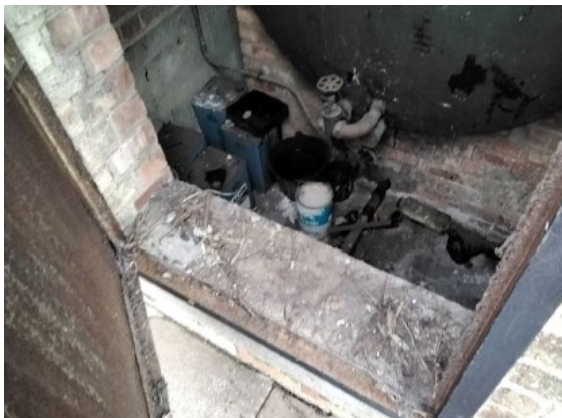
Item 183 - Ref: SC005253

The debris to access step in the Boiler Room (External) does not contain asbestos.

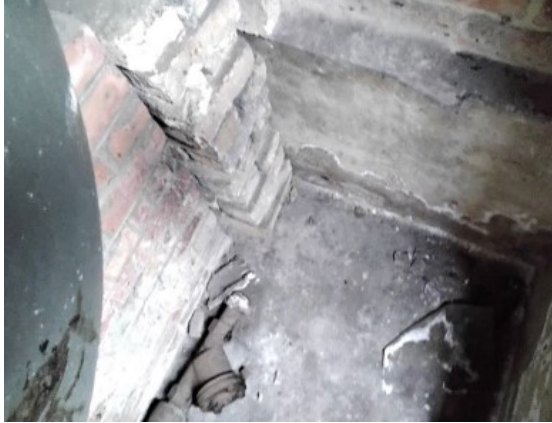
Item 185 - Ref: SC005252

The debris/residue to the floor in the Boiler Room (External) does contain asbestos.

This should be removed asap.

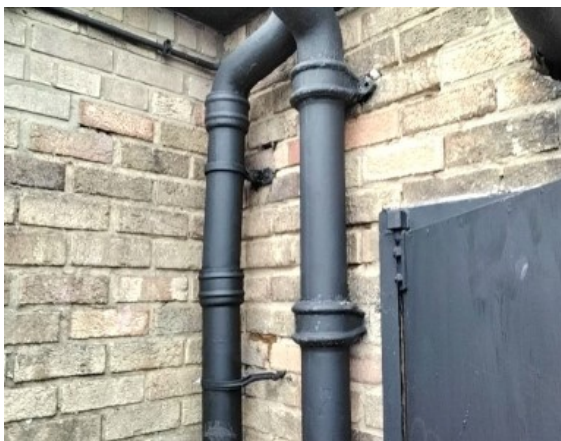
Item 187 - Ref: SC005255

The pipe joints caulking/packing in the Boiler Room (External) does not contain asbestos.

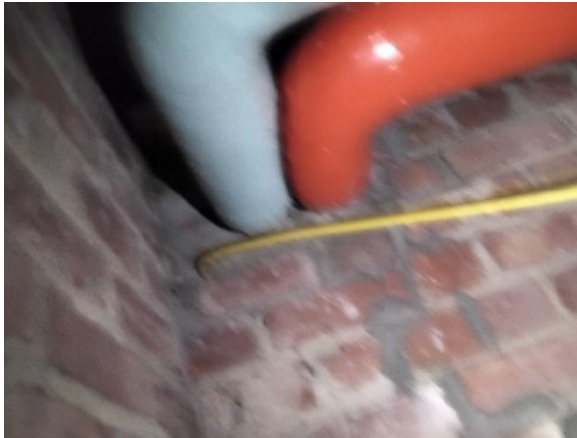
Item 188 - Ref: SC005250

The pipework insulation in the Boiler Room (External) does contain asbestos.

Any change in appearance should be reported to Property Services.

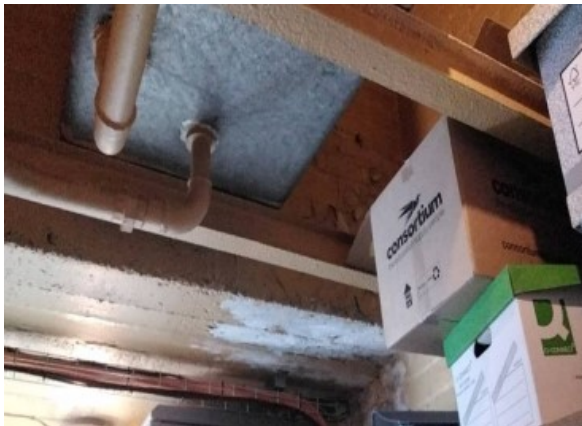
Item 189 - Ref: NO000640

The wall coating in the Store Room (Rm 1/001) does not contain asbestos.

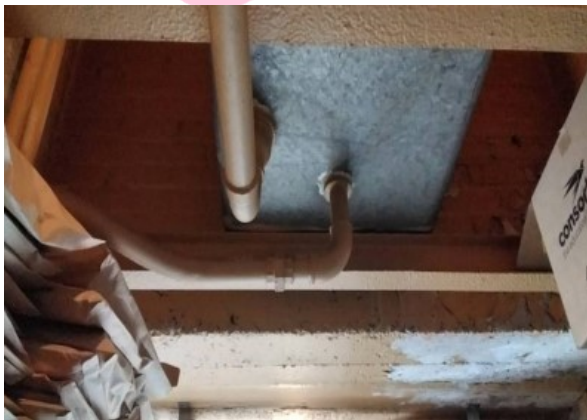
Item 190 - Ref: NO000641

The wall coating to tank support girders in the Store Room (Rm 1/001) does not contain asbestos.

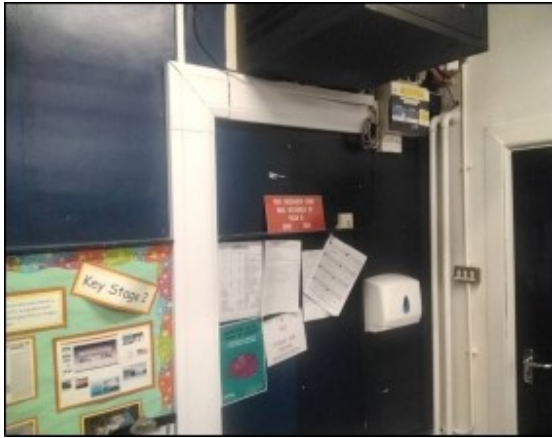
Item 191 - Ref: NG002283

The wall coating in the ITC Room (Rm G/001) does not contain asbestos.

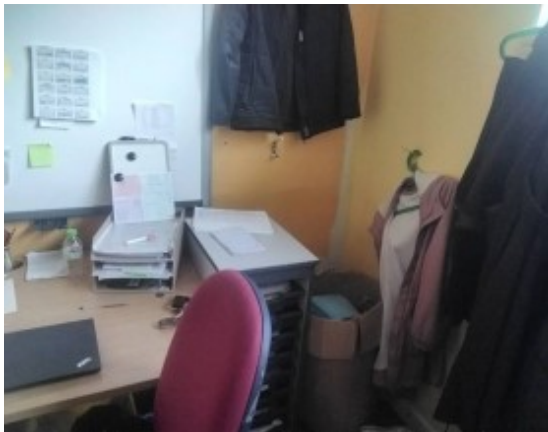
Item 192 - Ref: NG002302

The wall coating in the Canteen Office (Rm G/002) does not contain asbestos.

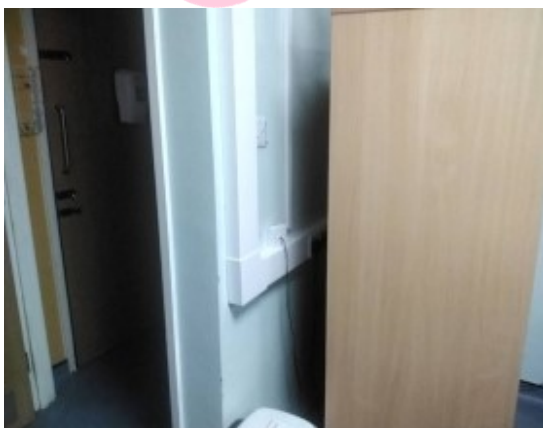
Item 193 - Ref: NG002303

The wall coating in the Caretakers Room (Rm G/003) does not contain asbestos.

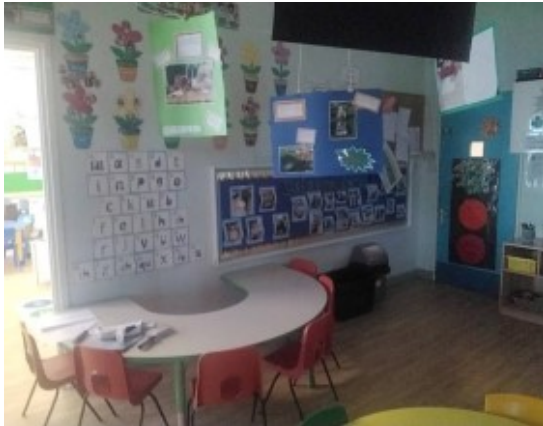
Item 194 - Ref: NG002286

The wall coating in Nursery 1 (Rm G/004) does not contain asbestos.

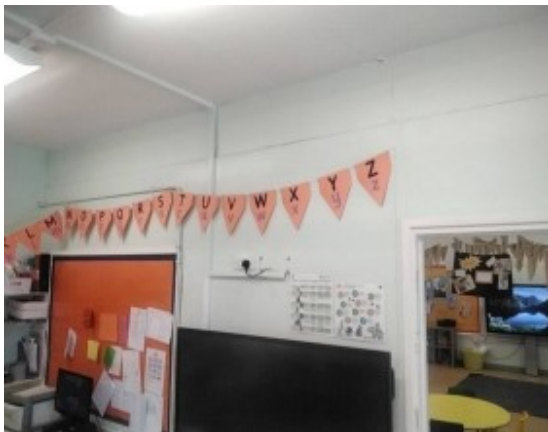
Item 195 - Ref: NG0023287

The wall coating in Nursery 2 (Rm G/005) does not contain asbestos.

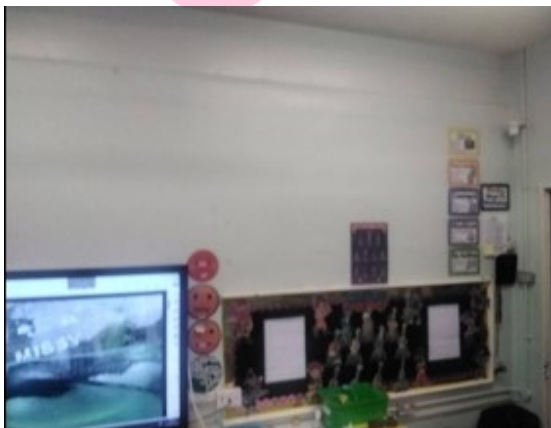
Item 196 - Ref: NG002288

The wall coating in the Year 3 Classroom (Rm G/006) does not contain asbestos.

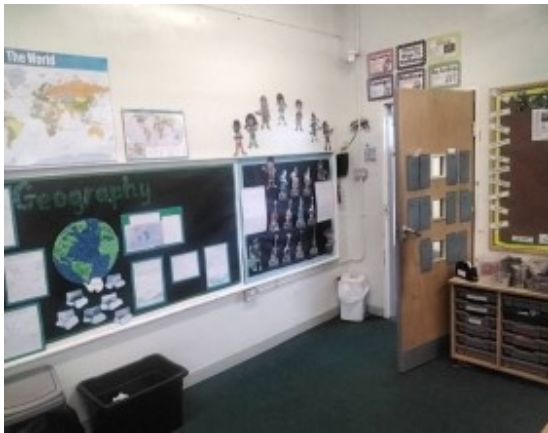
Item 197 - Ref: NG002289

The wall coating in the Year 3B Classroom (Rm G/007) does not contain asbestos.

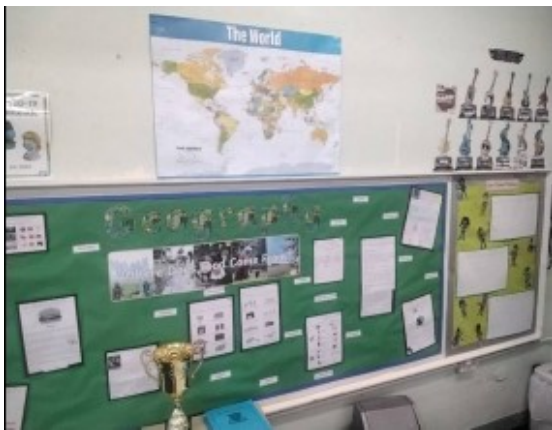
Item 198 - Ref: NG0023290

The wall coating in the 4A Classroom (Rm G/008) does not contain asbestos.

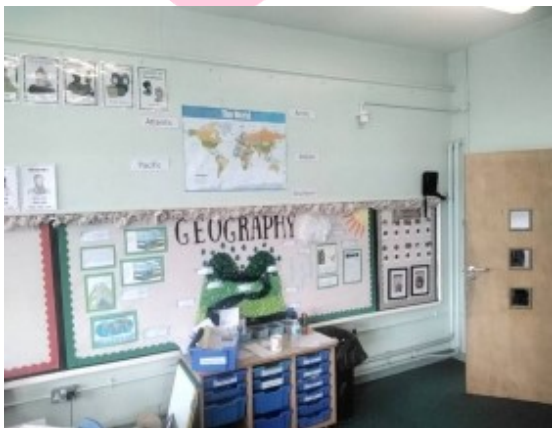
Item 199 - Ref: NG002291

The wall coating in the 5A Classroom (Rm G/009) does not contain asbestos.

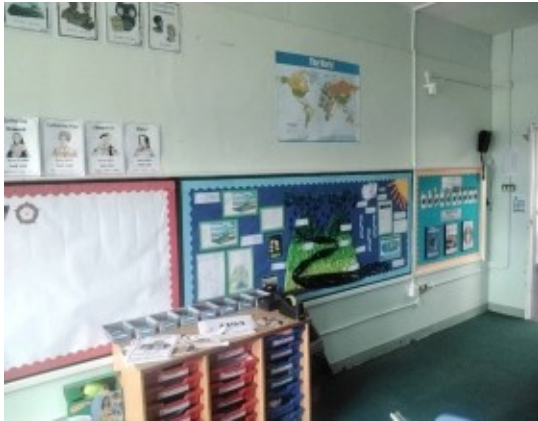
Item 200 - Ref: NG002292

The wall coating in the 5B Classroom (Rm G/010) does not contain asbestos.

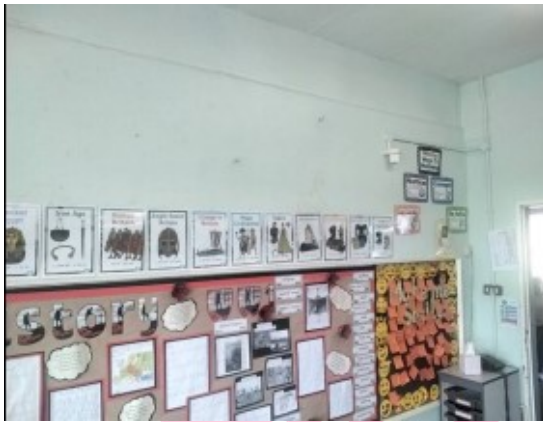
Item 201 - Ref: NG0023293

The wall coating in the 6A Classroom (Rm G/011) does not contain asbestos.

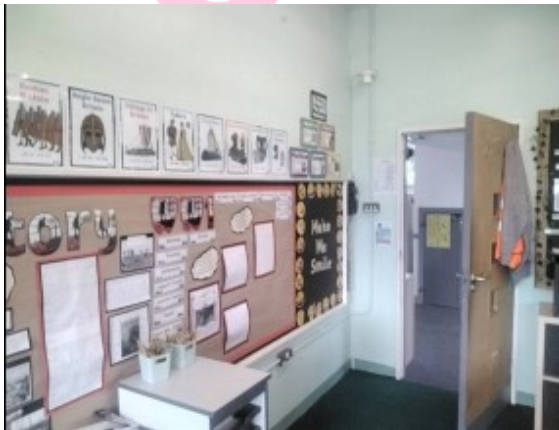
Item 202 - Ref: NG002294

The wall coating in the 6B Classroom (Rm G/012) does not contain asbestos.

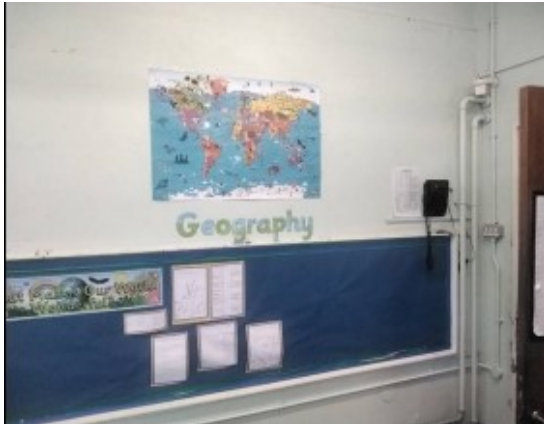
Item 203 - Ref: NG002296

The wall coating in the 2B Classroom (Rm G/013) does not contain asbestos.

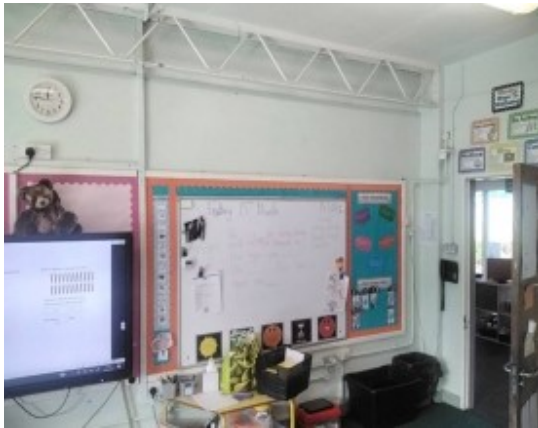
Item 204 - Ref: NG0023297

The wall coating in the 2A Classroom (Rm G/014) does not contain asbestos.

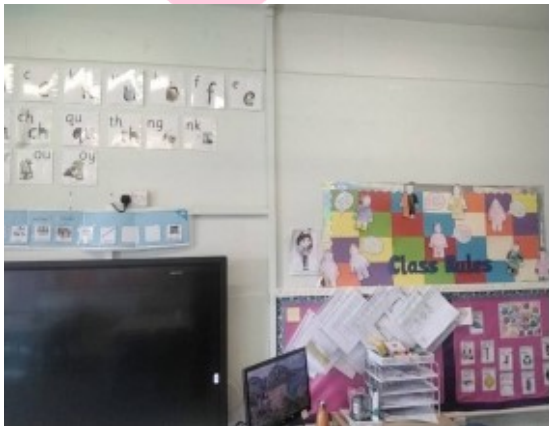
Item 205 - Ref: NG002298

The wall coating in the 1B Classroom (Rm G/015) does not contain asbestos.

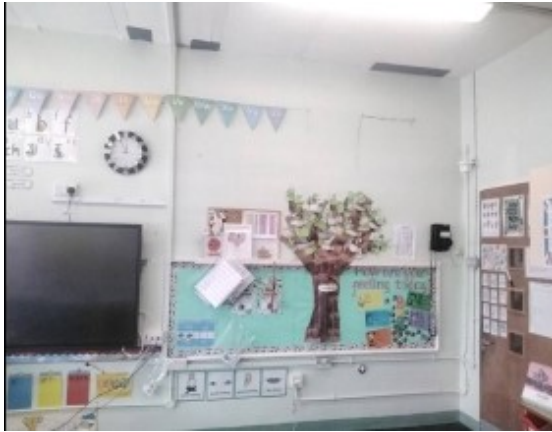
Item 206 - Ref: NG002299

The wall coating in the 1A Classroom (Rm G/016) does not contain asbestos.

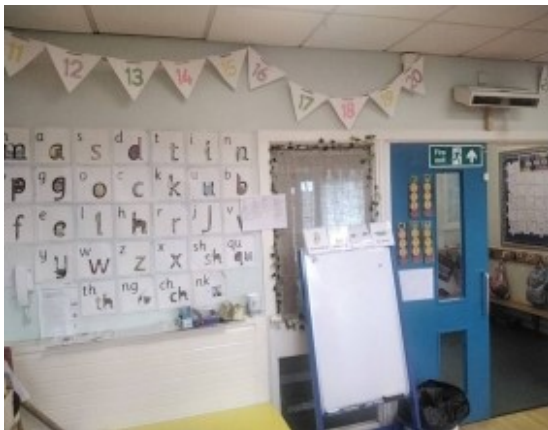
Item 207 - Ref: NG0023300

The wall coating in the Reception Classroom (Rm G/017) does not contain asbestos.

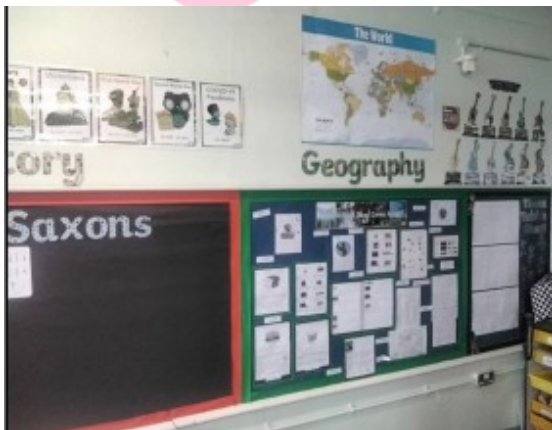
Item 208 - Ref: NG002304

The wall coating in the 4B Classroom (Rm G/018) does not contain asbestos.

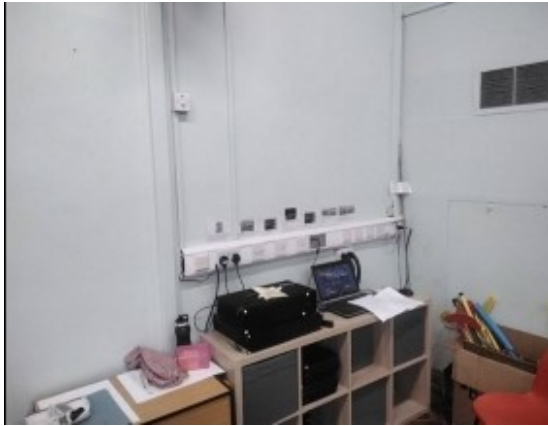
Item 209 - Ref: NG002305

The wall coating in the Main Hall (Rm G/019) does not contain asbestos.

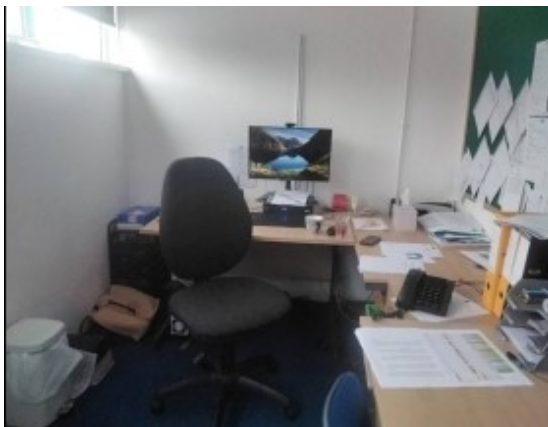
Item 210 - Ref: NG0023306

The wall coating in the Assistant Heads Office (Rm G/020) does not contain asbestos.

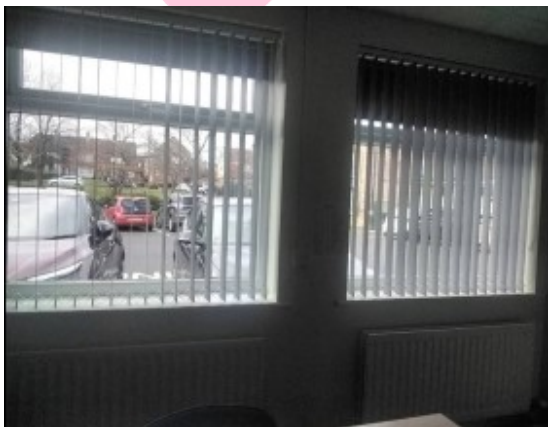
Item 211 - Ref: NG002307

The wall coating in the TLR Room (Rm G/021) does not contain asbestos.

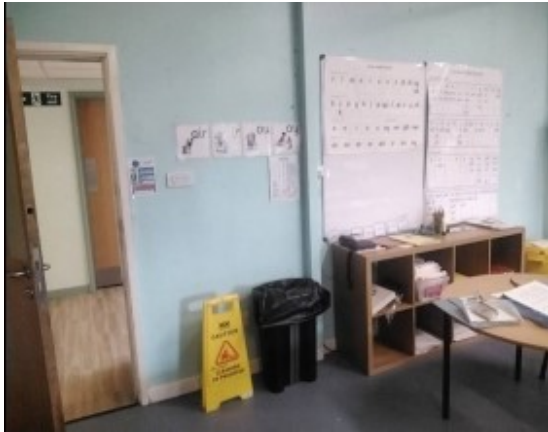
Item 212 - Ref: NG002301

The wall coating in the Art Room (Rm G/022) does not contain asbestos.

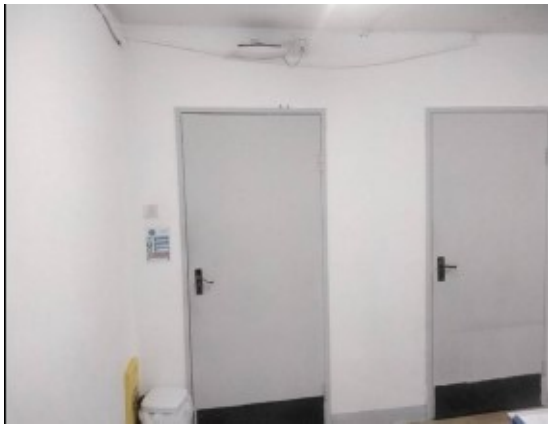
Item 213 - Ref: NG0023284

The wall coating in the Phonics Room (Rm G/023) does not contain asbestos.

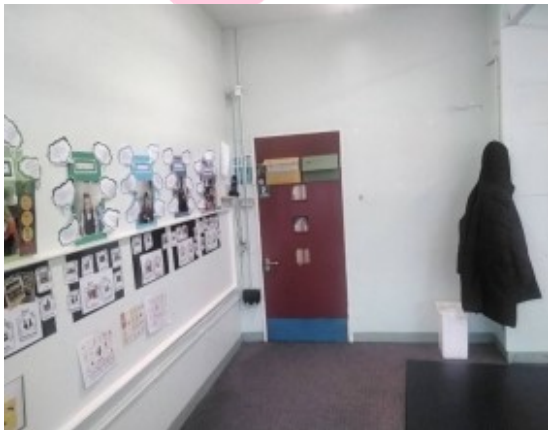
Item 214 - Ref: NG002285

The wall coating in the Soft Play (Rm G/024) does not contain asbestos.

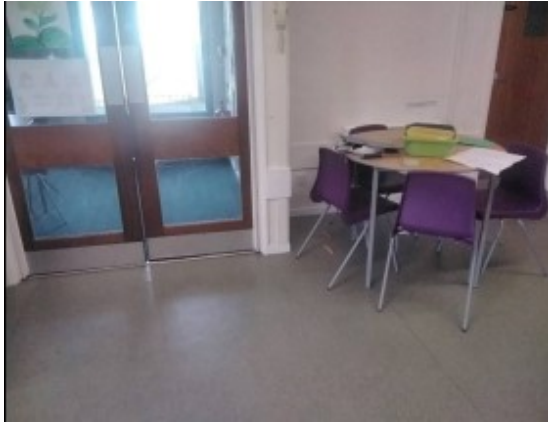
Item 215 - Ref: NG002295

The wall sheet/cladding in the Nurture Room (Rm G/001) does not contain asbestos.

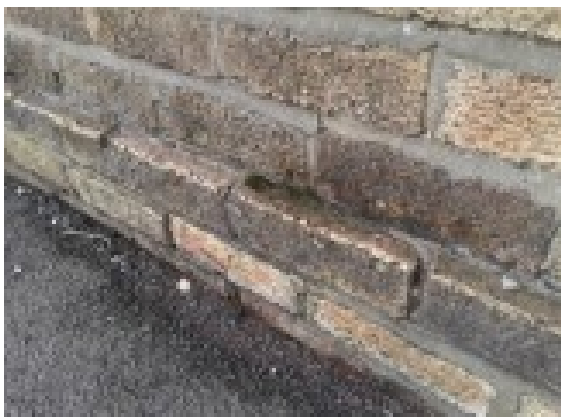
Item 217 - Ref: NZ001565

The Damp proof course (External area 2 pointing E/002).

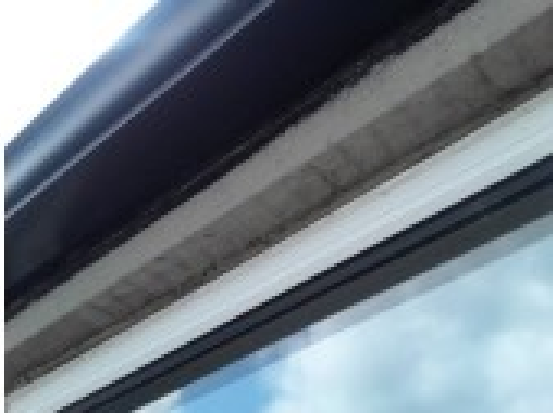
Item 218 - Ref: NZ001566

The Soffits (External area 2 pointing E/002).

Any change in appearance should be reported to Property Services.

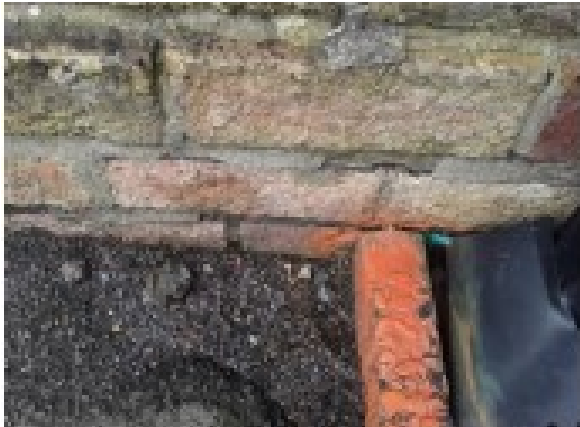
Item 219 - Ref: NZ001567

The Damp proof course (External area 1 pointing E/003).

Any change in appearance should be reported to Property Services.

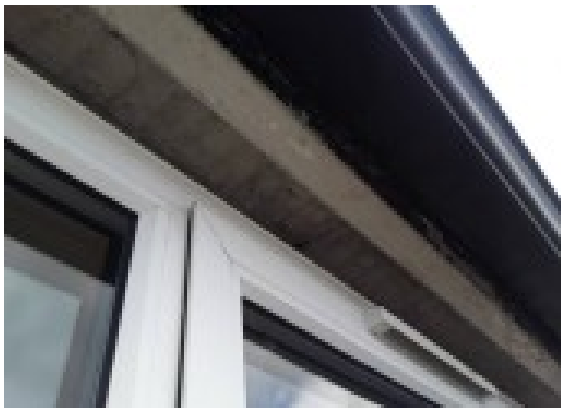
Item 220 - Ref: As NZ001566

The Soffits (External area 1 pointing E/003).
