ASBESTOS SURVEY REPORT FOR KEPIER ACADEMY, DAIRY LANE,  
HOUGHTON LE SPRING, DH5 9JZ

**Asbestos Register for**

**Kepier Academy School**

**Date: 03 December 2024**

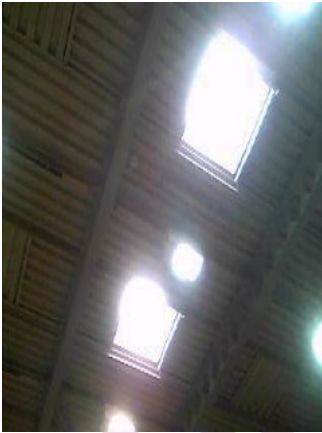
### **Item 2 – Presumed**

The skylight fascia in R206 is presumed to contain asbestos. (Due to inaccessible due to height)

Any change in its appearance should be noted and reported to Property Services.

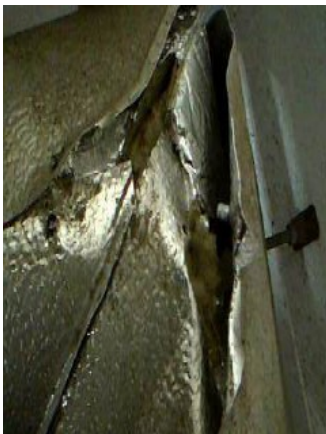
### **Item 3 – Ref: BB003120**

The pipe insulation in R219 does not contain asbestos.

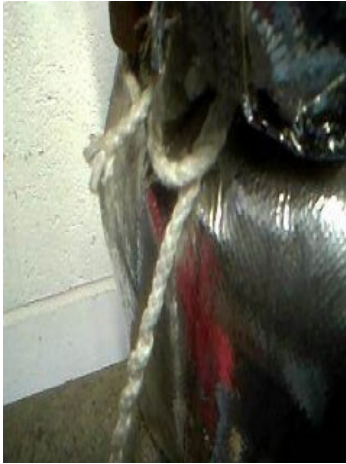
**Item 4 – Ref: BB003121**

The rope to pipe flange covers in R219 does not contain asbestos.

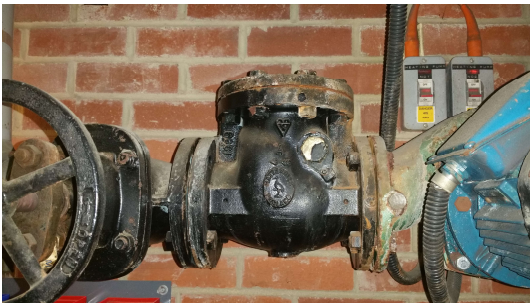
**Item 6 – Ref: 263742-1**

The gasket to pipework flange in plant room (R 187) contains asbestos.

*Removed October 2019*

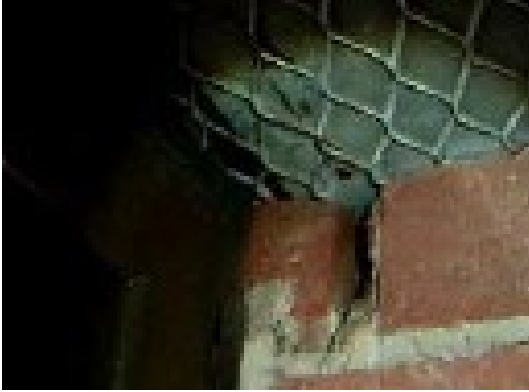
**Item 7 – Ref: BB003121**

The composite wall debris in R187 does not contain asbestos.

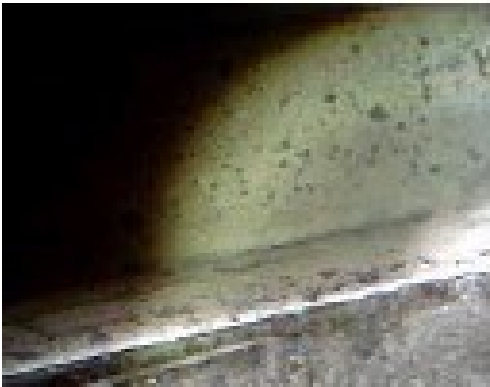
**Item 8 – Ref: BB003126**

The composite floor debris in R187 does not contain asbestos.

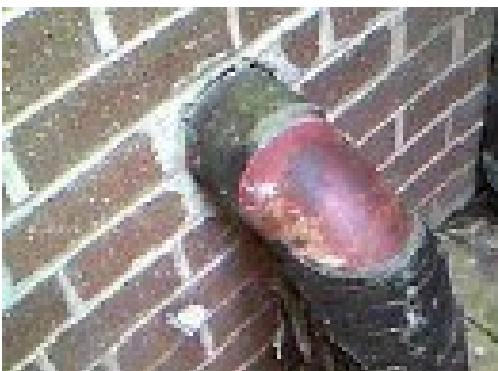
**Item 9 – Ref: BB003127**

The pipe wrapping (External) to Sports building does not contain asbestos.

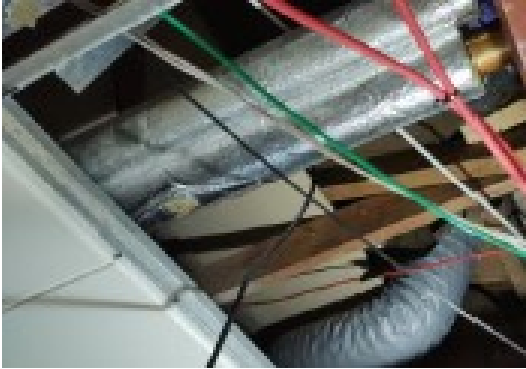
### **Item 10 – Ref: 21-38551-1**

The bitumen sarking felt to the ceiling in the corridor ceiling void (Area 3) does not contain asbestos.

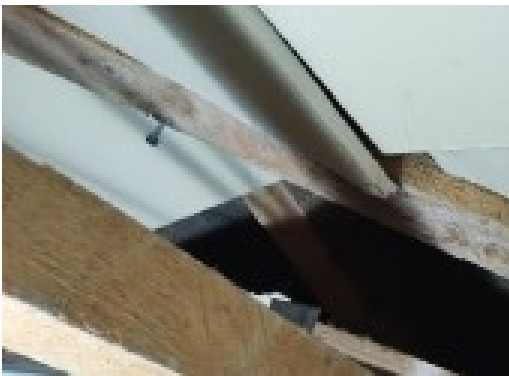
### **Item 11 – Ref: 21-38551-1**

The bitumen to the ceiling in the Music Room 2 ceiling void (Area 9) does not contain asbestos.

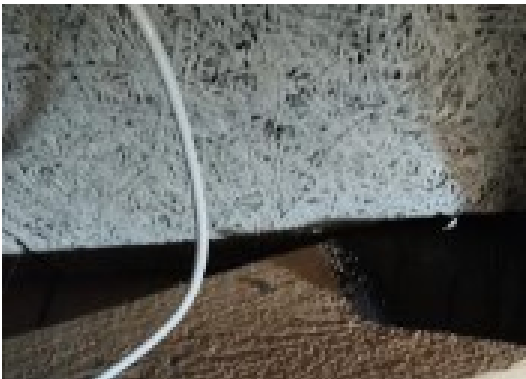
### **Item 12 – Ref: 21-38551-2**

The bitumen sarking felt to the ceiling in the Practice Room 1 ceiling void (Area 10) does not contain asbestos.

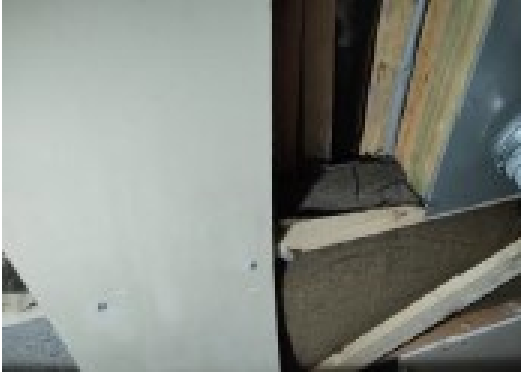
### **Item 13 – Ref: 21-38551-1**

The bitumen to the ceiling in the Practice Room 2 ceiling void (Area 11) does not contain asbestos.

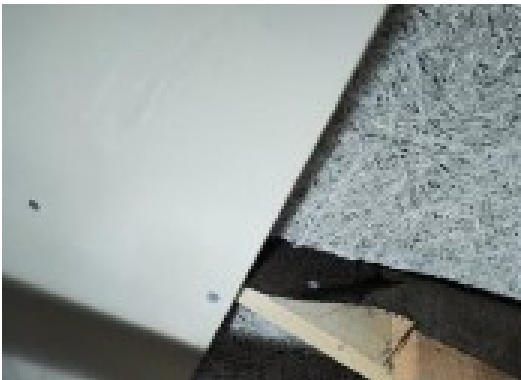
### **Item 14 – Ref: 21-38551-2**

The bitumen sarking felt to the ceiling in the Practice Room 3 ceiling void (Area 12) does not contain asbestos.

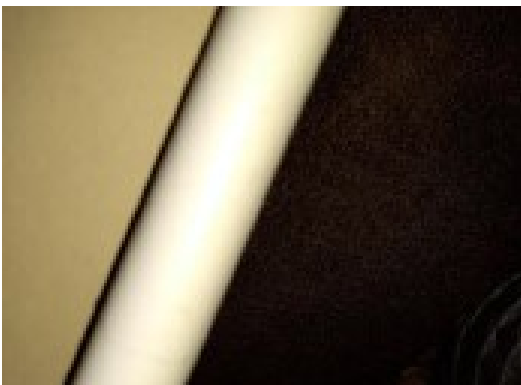
### **Item 15 – Ref: 21-38551-1**

The bitumen to the ceiling in the Recording Studio ceiling void (Area 13) does not contain asbestos.

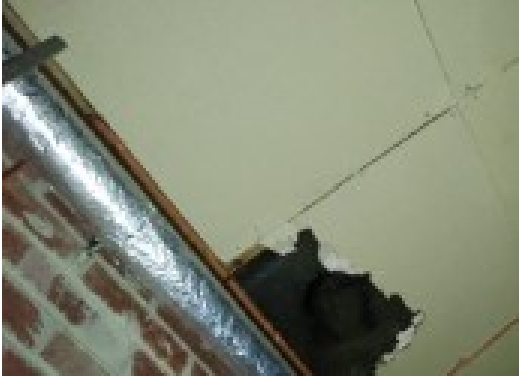
### **Item 16 – Ref: 21-38551-1**

The bitumen to the ceiling in the Boiler Room (Area 14) does not contain asbestos.

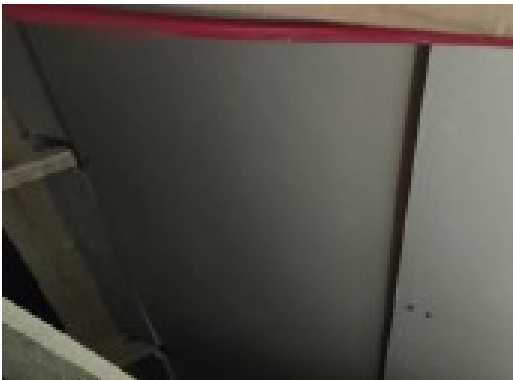
### **Item 17 – Ref: 21-38551-2**

The bitumen to the ceiling in the Head of music ceiling void (Area 15) does not contain asbestos.

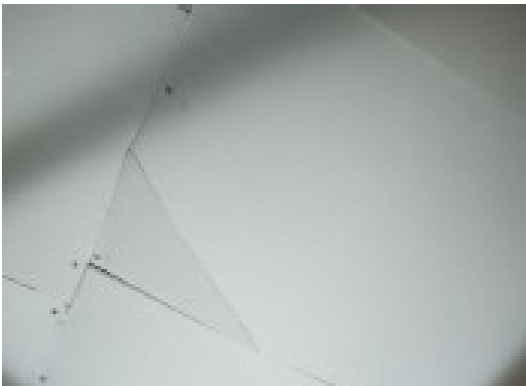
### **Item 18 – Ref: 21-38551-1**

The bitumen to the ceiling in the Music Store 1 ceiling void (Area 16) does not contain asbestos.

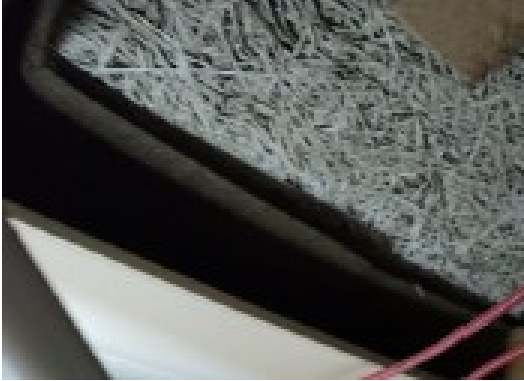
### **Item 19 – Ref: 21-38551-2**

The bitumen to the ceiling in the Table Store 2 ceiling void (Area 18) does not contain asbestos.

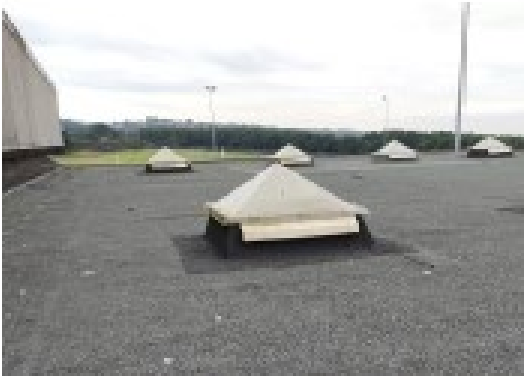
### **Item 20 – Ref: 21-38551-3**

The bitumen roof felt to the roof of gym 1 (Area 20) does not contain asbestos.

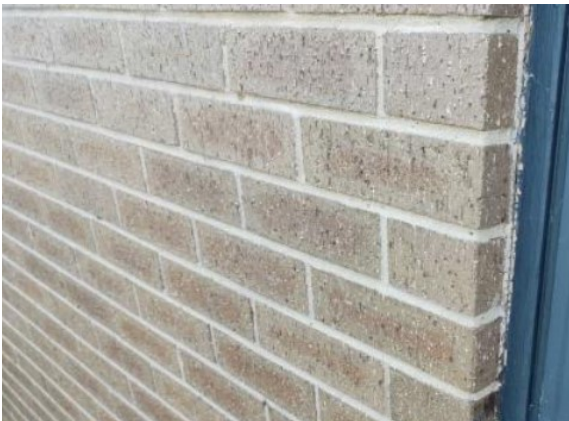
### **Item 21 – Ref: 22-50810-1**

The frame sealants to windows of R195 and R188 (External/Area 3) contains asbestos.

Removed 2022
