ASBESTOS SURVEY REPORT FOR NORTHERN SAINTS C OF E PRIMARY SCHOOL, SUNDERLAND

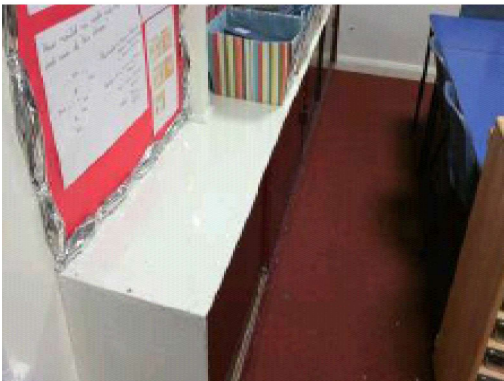
Item 33: Presumed

The skirting to the base of the wall behind the cupboards in the classroom (Room 33) was presumed to contain asbestos.

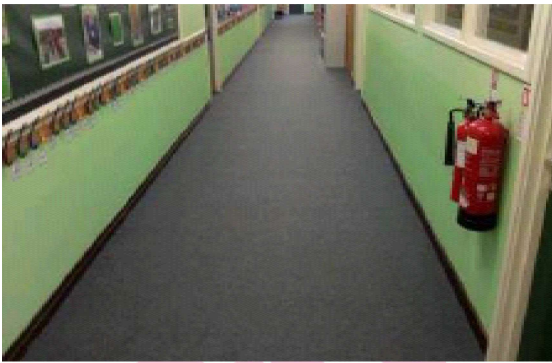
Item 44: Presumed

The vinyl floor tiles beneath the carpet in the corridor (Room 43) were presumed to contain asbestos.

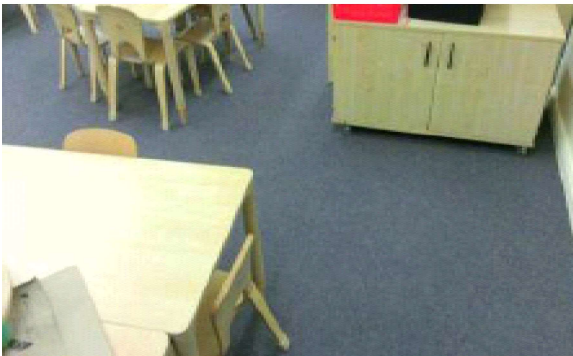
Item 50: Presumed

The vinyl floor tiles beneath the carpet in the classroom (Room 46) are presumed to contain asbestos.

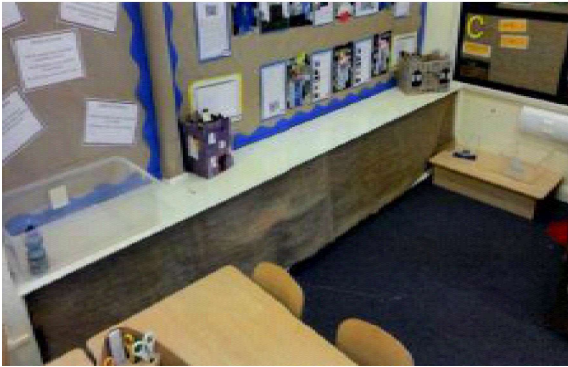
Item 55: Presumed

The skirting to wall beneath the lino in the classroom behind the cupboards (Room 47) was presumed to contain asbestos.

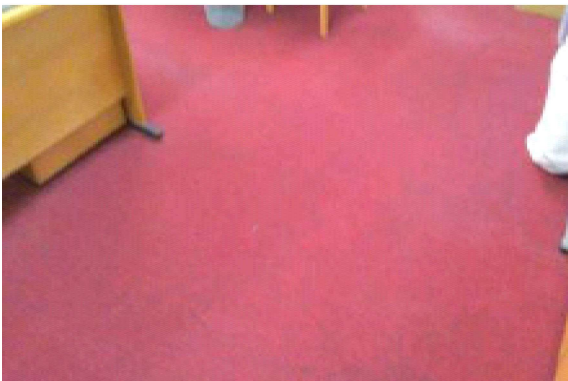
Item 57: Presumed

The bitumen adhesive to the floor in the office (Room 49) is presumed to contain asbestos.

Any changes in its appearance should be noted and passed to Property Services.

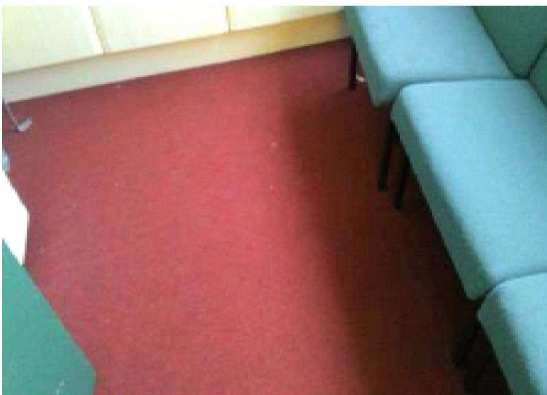
Item 59: Presumed

The bitumen adhesive to the floor below the carpet in the Medical Room (Room 50) is presumed to contain asbestos.

Any changes in its appearance should be noted and passed to Property Services.

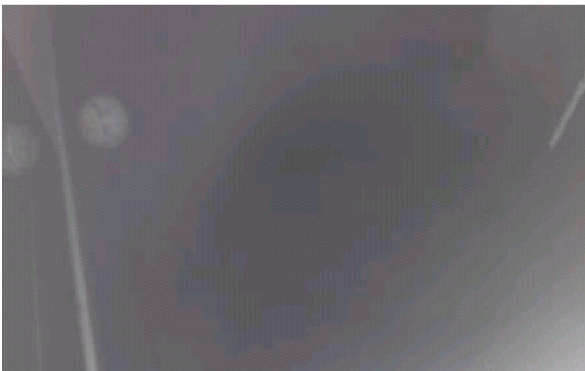
Item 65: Presumed

The vinyl floor tiles beneath the carpet in the office (Room 56) were presumed to contain asbestos.

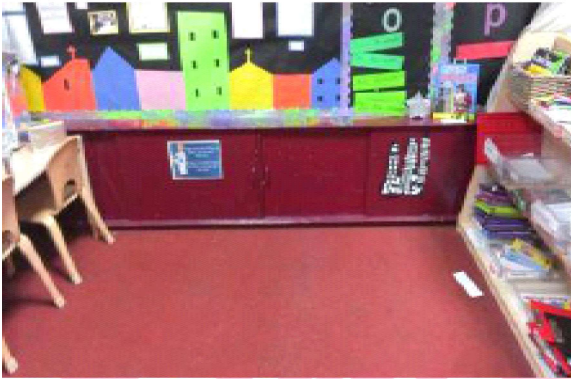
Item 68: Presumed

The skirting to base of wall behind the cupboards in the classroom (Room 57) is presumed to contain asbestos.

Any changes in its appearance should be noted and passed to Property Services.

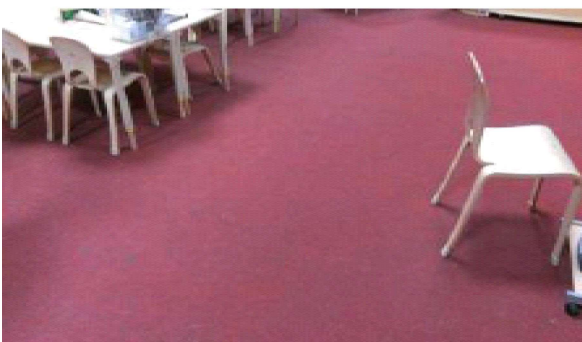
Item 69: Presumed

The bitumen adhesive below the carpet in the classroom (Room 58) is presumed to contain asbestos.

Any changes in its appearance should be noted and passed to Property Services.

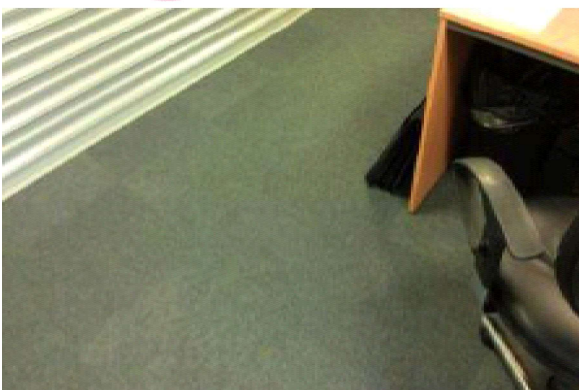
Item 72: Presumed

The bitumen adhesive to the floor below the cement skim to the floor in the reception office (Room 61) is presumed to contain asbestos.

Any changes in its appearance should be noted and passed to Property Services.

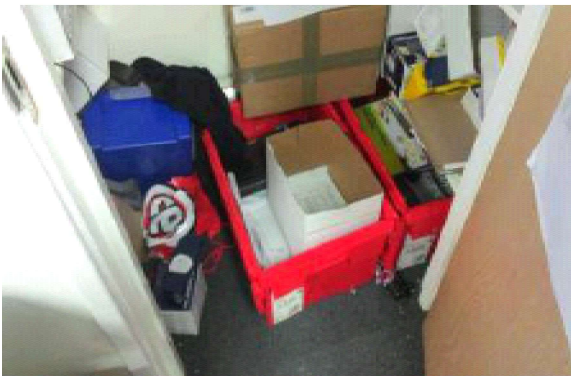
Item 74: Presumed

The bitumen adhesive to the floor below in the reception office cupboard (Room 63) is presumed to contain asbestos.

Any changes in its appearance should be noted and passed to Property Services.

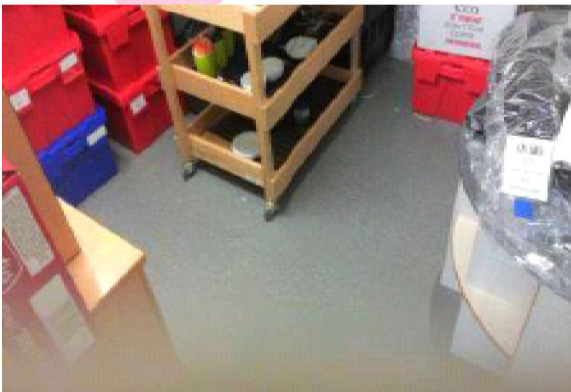
Item 75: Presumed

The bitumen adhesive to the floor below the cement skim in the store (Room 65) is presumed to contain asbestos.

Any changes in its appearance should be noted and passed to Property Services.

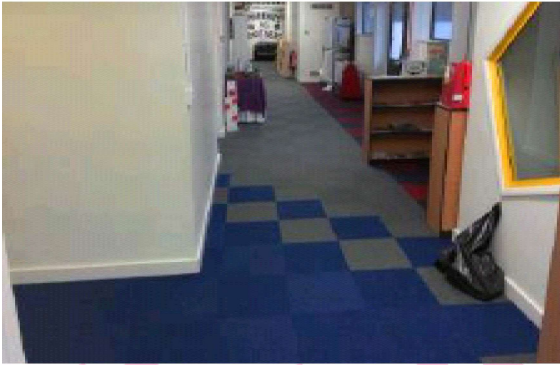
Item 77: NSPS/002

The bitumen adhesive to the floor below the cement skim to the floor in the corridor (Room G002) contains asbestos.

Any changes in its appearance should be noted and passed to Property Services.

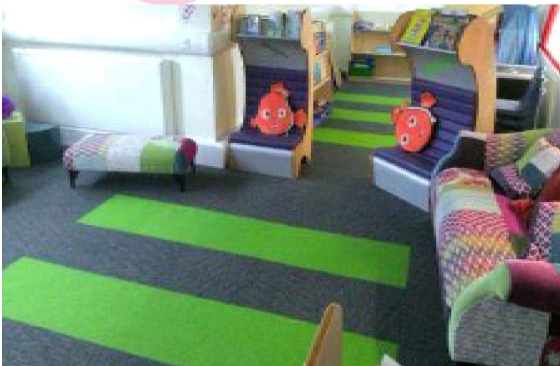
Item 78: Presumed

The bitumen adhesive to the floor below the cement skim to the floor in the library (Room 70) is presumed to contain asbestos.

Any changes in its appearance should be noted and passed to Property Services.

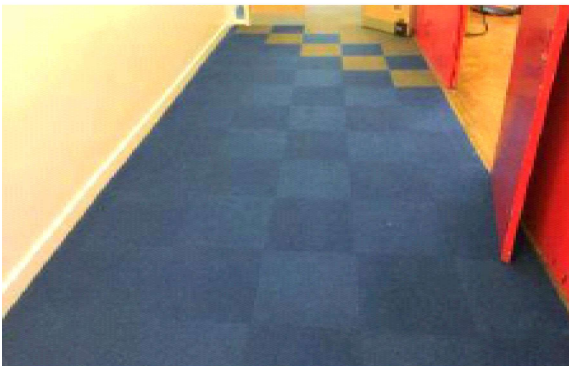
Item 80: Presumed

The vinyl floor tiles beneath the carpet in the corridor (Room 74) are presumed to contain asbestos.

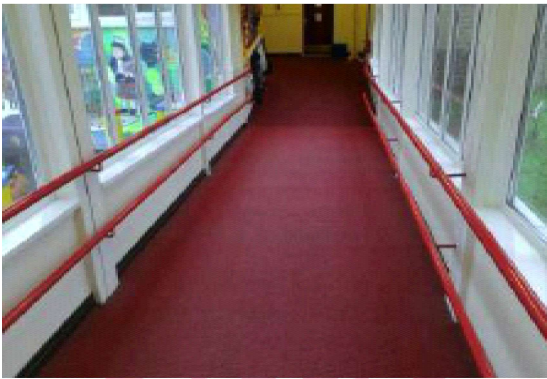
Item 83: Presumed

The bitumen adhesive to the floor in the corridor (Room 76) is presumed to contain asbestos.

Any changes in its appearance should be noted and passed to Property Services.

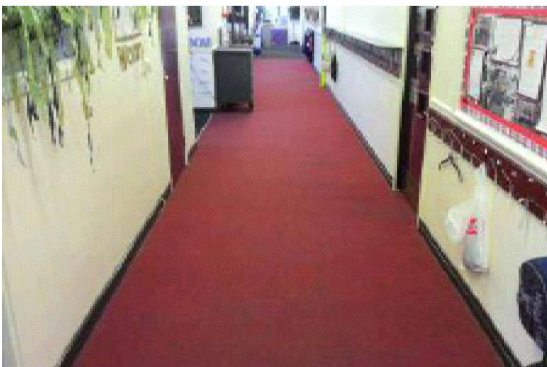
Item 84: Presumed

The vinyl floor tiles beneath the carpet in the corridor (Room 79) are presumed to contain asbestos.

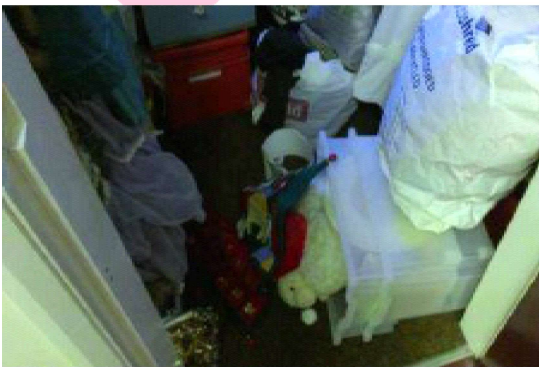
Item 90: Presumed

The vinyl floor tiles beneath the carpet in the store (Room 82) are presumed to contain asbestos.

Any changes in its appearance should be noted and passed to Property Services.

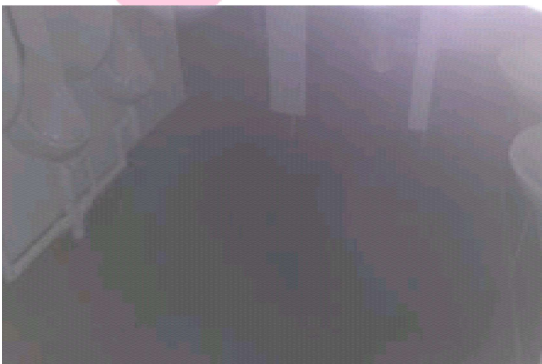
Item 93: Presumed

The bitumen adhesive to the floor below the cement skim to the floor in the Boys toilet (Room 86) is presumed to contain asbestos.

Any changes in its appearance should be noted and passed to Property Services.

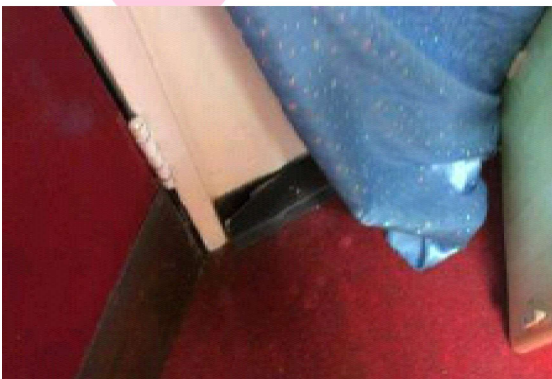
Item 96: Presumed

The skirting to base of wall behind modern in the classroom (Room 87) is presumed to contain asbestos.

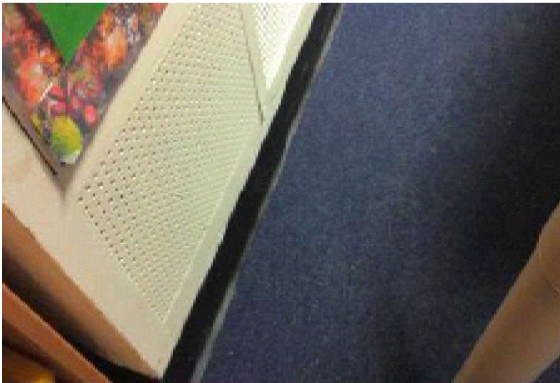
Item 98: Presumed

The skirting to base of wall behind modern in the classroom (Room 88) is presumed to contain asbestos.

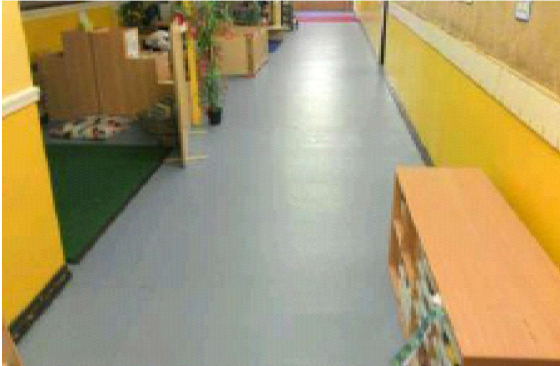
Item 103: NSPS/002

The bitumen adhesive beneath the modern lino to the corridor (Room 010) contains asbestos.

Any changes in its appearance should be noted and passed to Property Services.

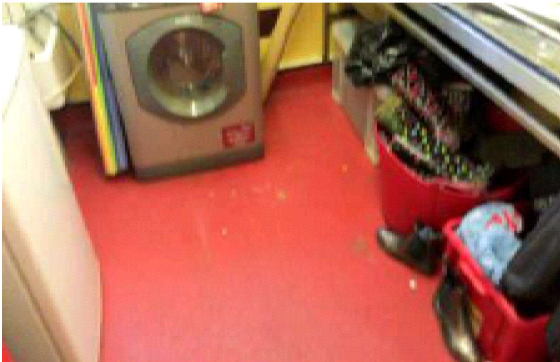
Item 104: Presumed

The bitumen adhesive to the floor in the store (Room 95) is presumed to contain asbestos.

Any changes in its appearance should be noted and passed to Property Services.

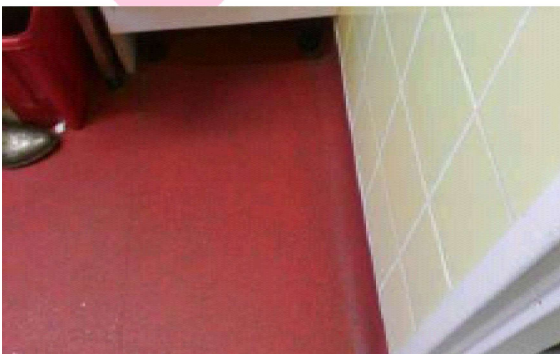
Item 105: As KR09/86

The skirting to base of wall in the store (Room 95) is presumed to contain asbestos.

Any changes in its appearance should be noted and passed to Property Services.

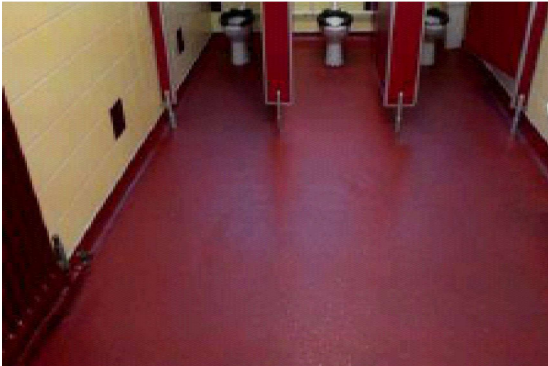
Item 106: Presumed

The vinyl floor tiles beneath the modern lino in the Girls toilets (Room 96) are presumed to contain asbestos.

Any changes in its appearance should be noted and passed to Property Services.

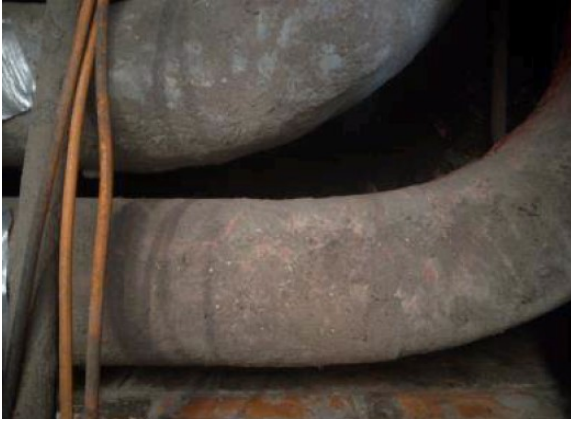
Item 139: BH000577

The large bore insulation – red pipework in the duct adjacent head teacher’s office contains asbestos.

Any changes in its appearance should be noted and passed to Property Services.

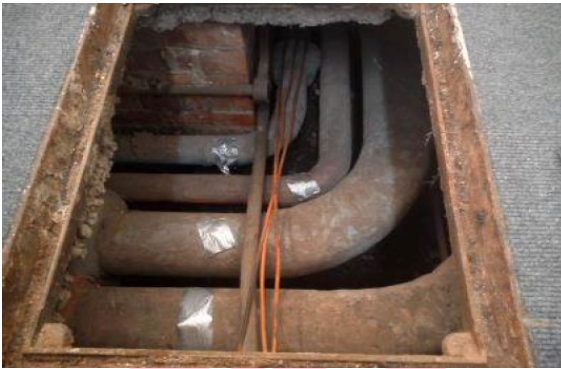
Item 143: Presumed

The mains cable sheath running high level in duct in the duct adjacent head teacher's office is presumed to contain asbestos.

Any changes in its appearance should be noted and passed to Property Services.

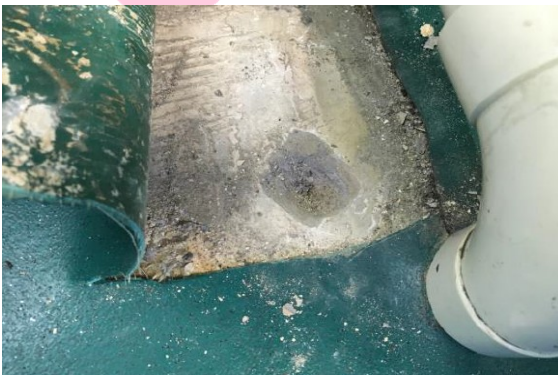
Item 144: BS001666

The floor screed in year 6 Girls toilets does not contain asbestos.
