ASBESTOS SURVEY REPORT FOR REDHOUSE CA , RUTHERGLEN ROAD,
SUNDERLAND, SR5 5LJ

Redhouse CA, Rutherglen Road, Sunderland

Date: 14 November 2024

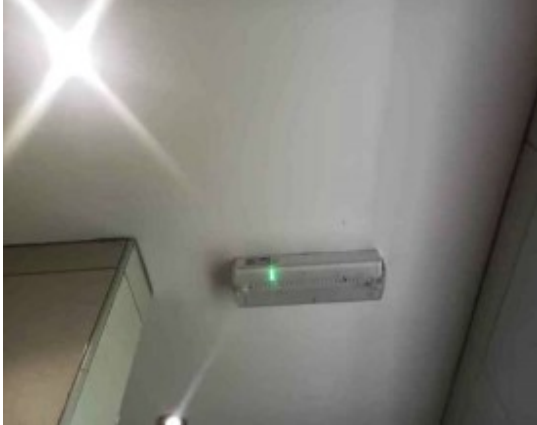
7	As TL000290	Ceiling void – ceiling above	Toilets Female G/18	No Risk

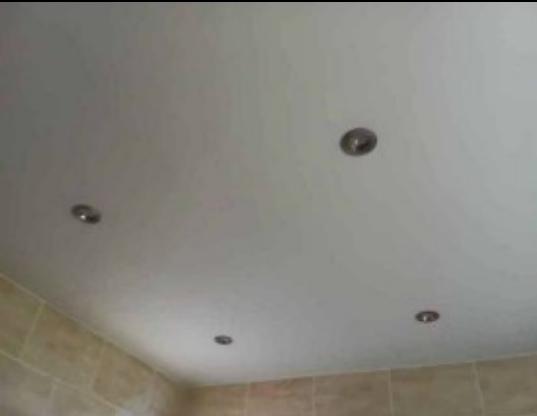
8	As TL000290	Ceiling void – ceiling above	Toilets Male G/019	No Risk

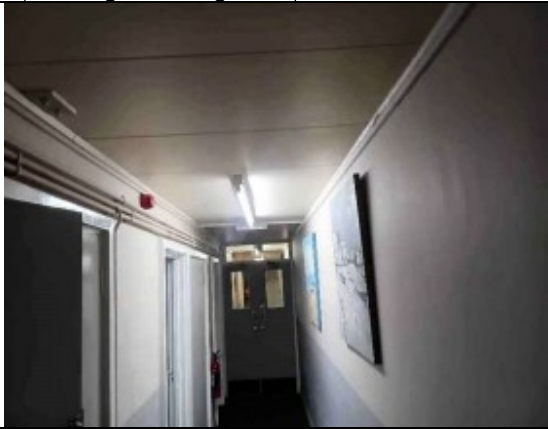
16	TL000296	Ceiling Cladding	Corridor G/004	No Risk

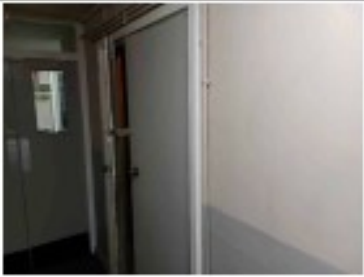
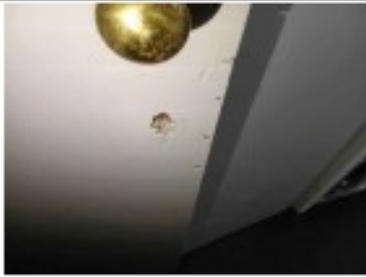
17	TL000297	Door – fire door inner lining	Corridor G/004	Any change in appearance should be recorded and passed to Property Services.
Photo 1: Wide Angle		Photo 2: Close-up

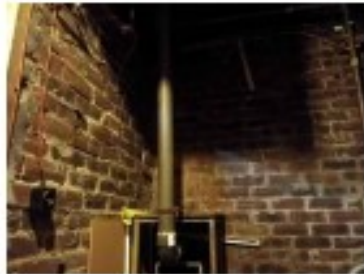
18	TL000298	Flue Pipe	Cupboard – Meter Sports store. Limited access to undercroft opposite wall G/005	Any change in appearance should be recorded and passed to Property Services.
Photo 1: Wide Angle		Photo 2: Close-up

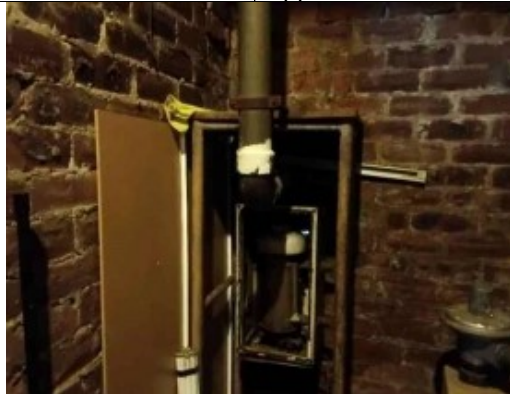
19	TL000299	Pipe joints Caulking/Packing	Cupboard – Meter Sports store. Limited access to undercroft opposite wall G/005	No Risk

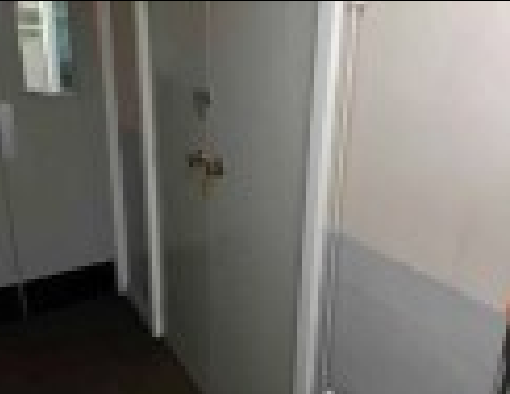
21	As TL000297	Door – fire door inner lining (same door as to corridor)	Cupboard – Meter Sports store. Limited access to undercroft opposite wall G/005	Any change in appearance should be recorded and passed to Property Services.

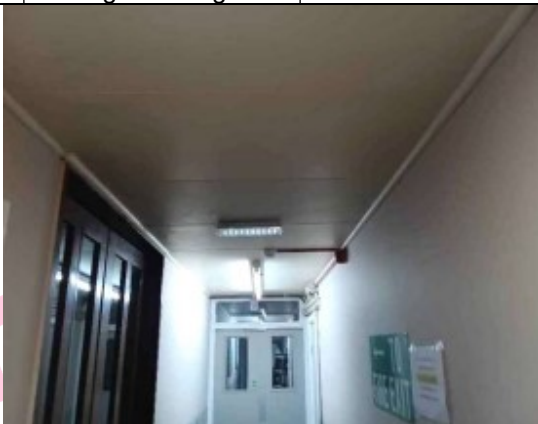
25	As TL000295	Floor covering	Corridor G/004a	No Risk
<p>No Photographic Evidence</p>				
26	TL000296	Ceiling Cladding	Corridor G/004a	No Risk

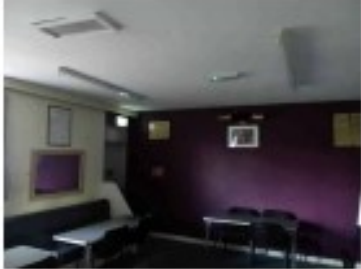
27	TL000302	Ceiling Coating	Room Large G/010	Any change in appearance should be recorded and passed to Property Services.
<p>Photo 1: Wide Angle</p>			<p>Photo 2: Close-up</p>

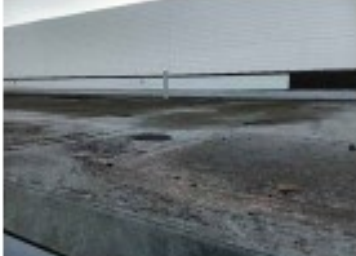
32	As TL000298	Flue Pipe	External E/001	Any change in appearance should be recorded and passed to Property Services.
Photo 1: Wide Angle			Photo 2: Close-up
