*Control of Asbestos  
Regulations 2012*

**Asbestos Register for**

**St Benets RC Primary School**

**Date: 18 September 2024**

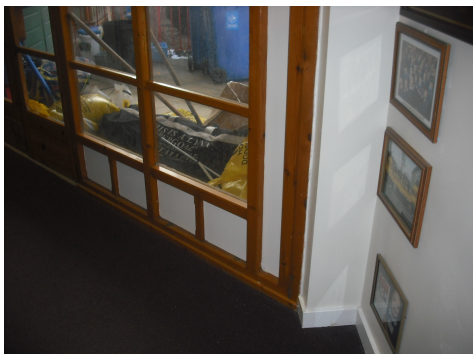
### **Various Ref: JJ0254/10**

The window Infill Panel to Corridor 0/02 does not contain asbestos.  
Similar Panels can be found in Entrance/Foyer/Lobby 0/01.

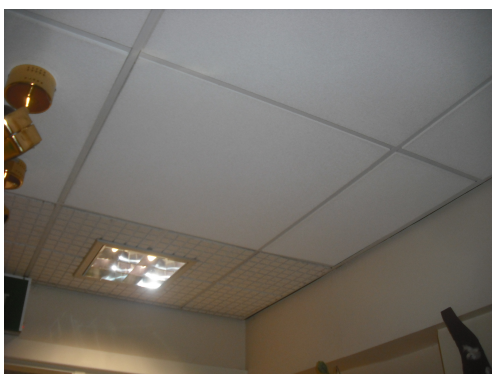
### **Item 2 Ref: JJ0255/10**

The ceiling tile to Corridor 0/02 does not contain asbestos.

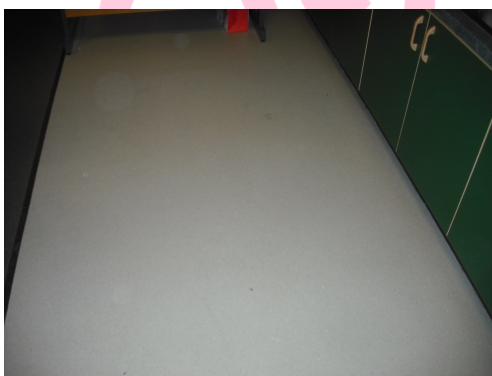
### **Various Ref: JJ0258/10**

The floor tiles to Classroom 10 0/10 do not contain asbestos.  
Similar tiles can be found in Classroom 9 0/12, Classroom 6 0/19, Classroom 5 0/21, Classroom 4 0/30, Classroom 3 0/31, Classroom 2 0/36, Classroom 1 0/37, Classroom Reception Class 1 0/39, Classroom Reception Class 2 0/41, Store to Classroom Reception Class 2 0/42, Toilets 0/47, Cupboard Store Nursery 0/52, Disabled Toilets 0/59, Male Toilets 0/60 and Female Toilets 0/61.

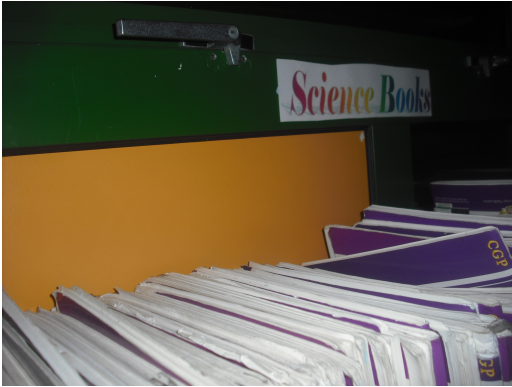
**Various Ref: JJ0260/10**

The window infill panel in the Classroom Group Room 0/11 does not contain asbestos. Similar panels can be found in Staff Room 0/08, Classroom group room 0/20 and External All Areas E/1.

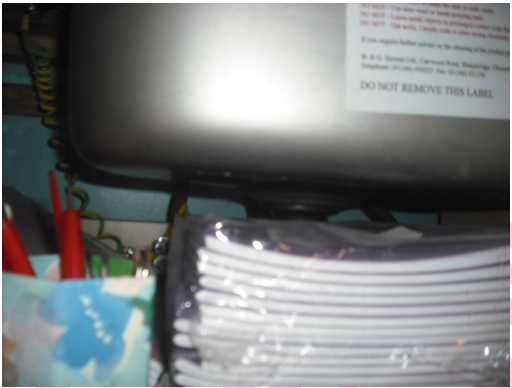
**Item 6 Ref: JJ0259/10**

The Sink Pad to Classroom 10 0/10 does not contain asbestos.

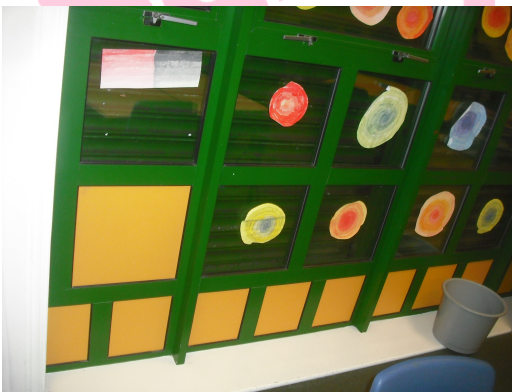
**Various Ref: JJ0257/10**

The window infill panel in Classroom 10 0/10 does not contain asbestos. Similar panels can be found in Classroom 9 0/12, Library/Classroom 0/14, Classroom 6 0/19, Classroom 5 0/21, ICT Room 0/27 and Classroom Reception Class 2 0/41.

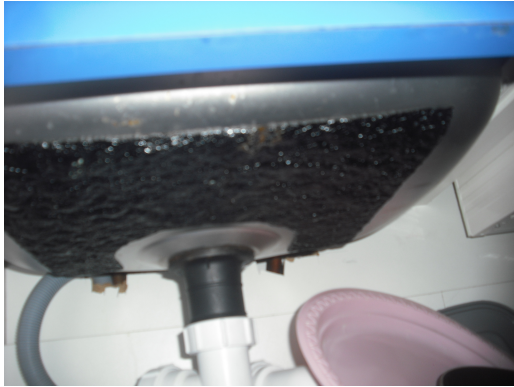
**Various Ref: JJ0261/10**

The sink pad in classroom 9 0/12 does not contain asbestos.

Similar Sink pads can be found in Classroom 6 0/19, Classroom 5 0/21, Classroom 4 0/30, Classroom 3 0/31, Classroom 2 0/36, Classroom 1 0/37, Classroom Reception Class 1 0/39 and Classroom Nursery 0/50.

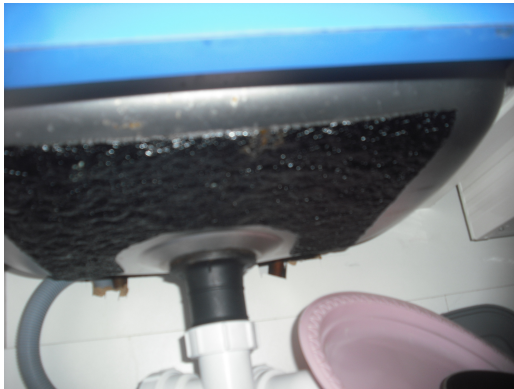
**Item 36 Ref: JJ0262/10**

The sink pad in the Office Rest Area 0/49 does not contain asbestos.

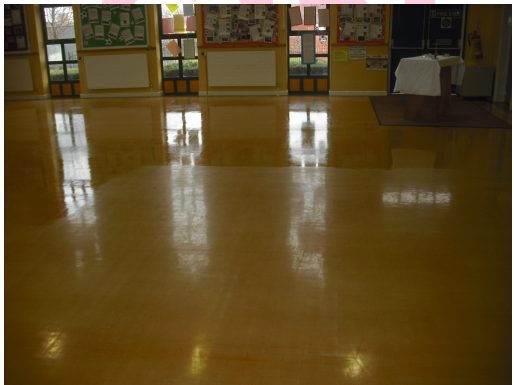
**Item 42 Ref: JJ0263/10**

The floor tiles in the Main Hall 0/62 do not contain asbestos.

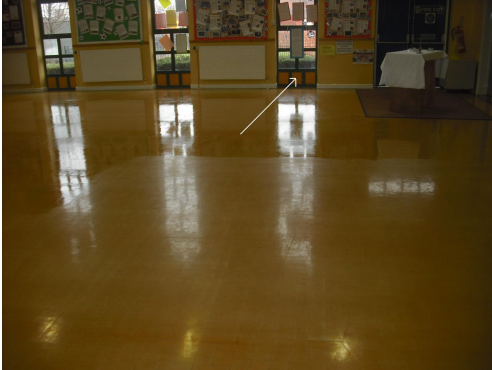
**Item 43 Ref: JJ0264/10**

The window infill panel in the Main Hall 0/62 does not contain asbestos.

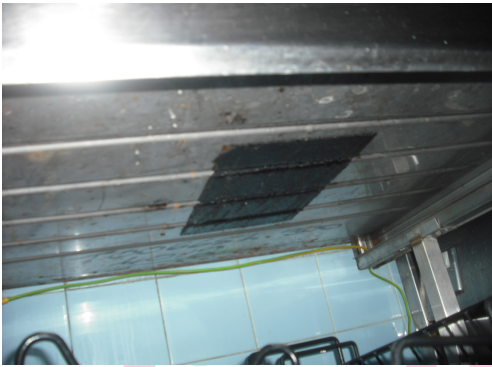
**Item 44 Ref: JJ0265/10**

The sink pad in the Kitchen Servery 0/65 does not contain asbestos.

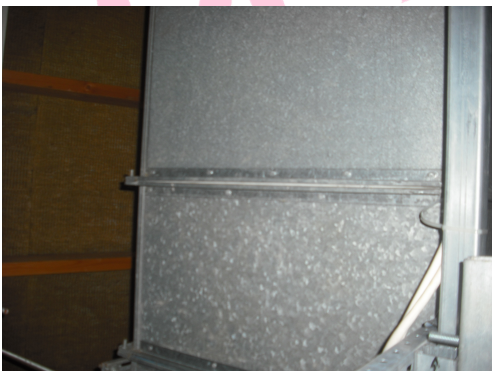
**Item 45 Ref: JJ0252/10**

The ductwork joints in the Boiler Room E1/04 do not contain asbestos.

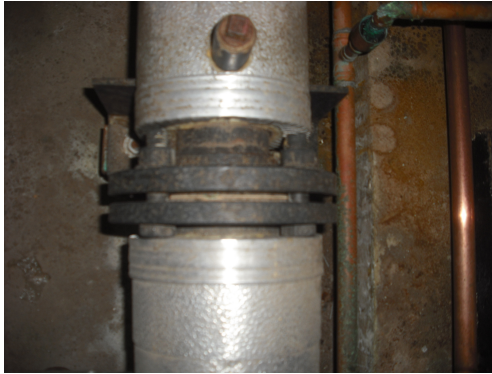
**Item 46 Ref: JJ0251/10**

The pipework gaskets in the Boiler Room E1/04 do not contain asbestos.

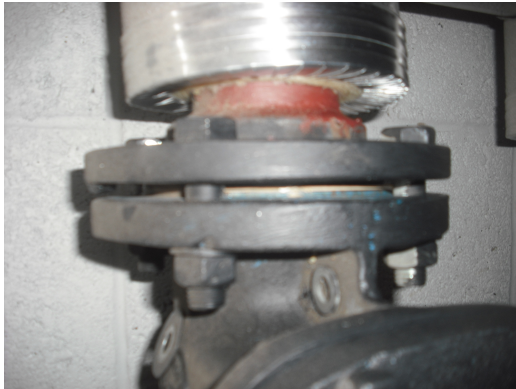
**Item 47 Ref: JJ0253/10**

The pipework gaskets in the Boiler Room E1/04 do not contain asbestos.

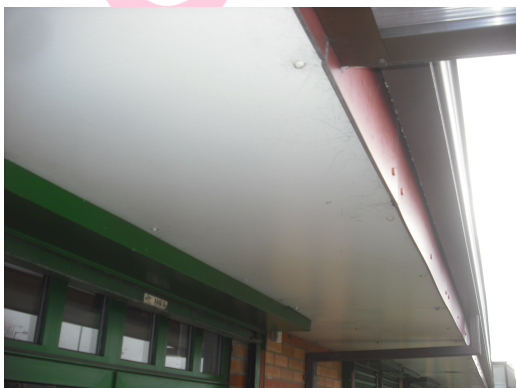
**Item 48 Ref: JJ0267/10**

The canopy ceiling to external all areas E/1 does not contain asbestos.

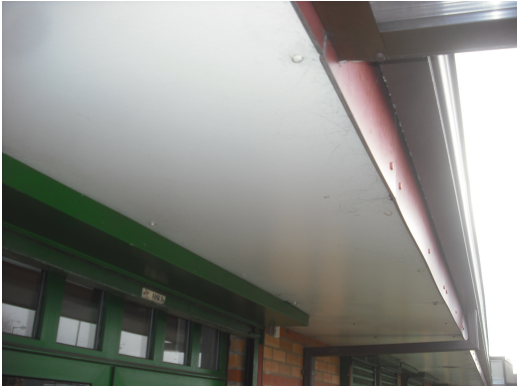
**Item 49 Ref: JJ0266/10**

The fascia to external all areas E/1 does not contain asbestos.

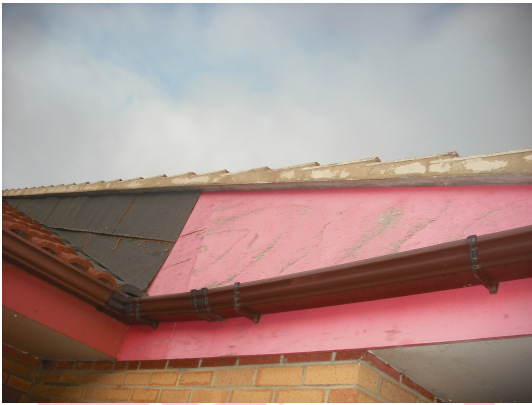
**Item 51 Ref: JJ0268/10**

The undercloak to external all areas E/1 does not contain asbestos. Similar undercloak can be found in the roof tiles of the externals E/1.

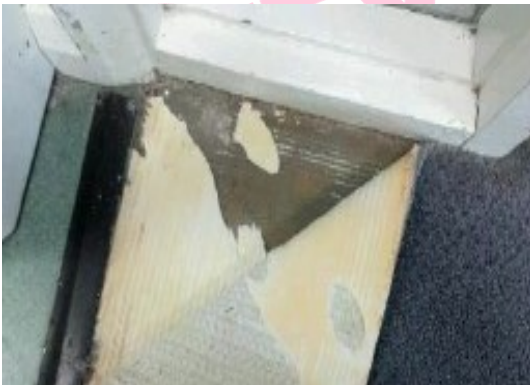
**Item 53 Ref: EB000485**

The floor screed below carpet in the Nursery (Room 1) does not contain asbestos.

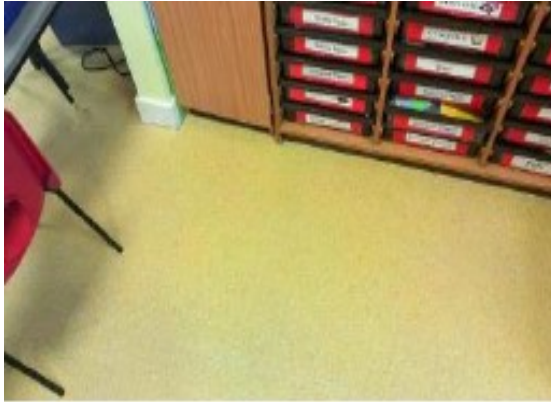
**Item 54 Ref: EB000486**

The floor screed in the Reception Class 1 (Room 2) does not contain asbestos.

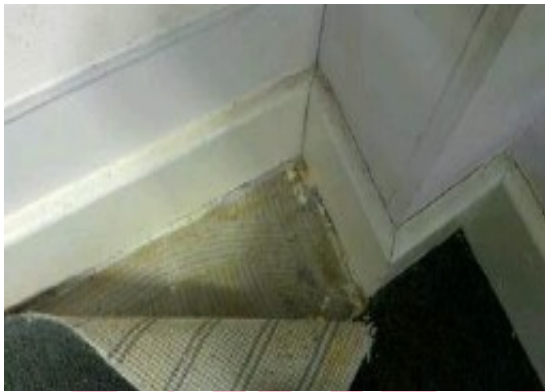
**Item 55 Ref:As EB000486**

The floor screed below carpet in Class 1 (Room 3) does not contain asbestos.

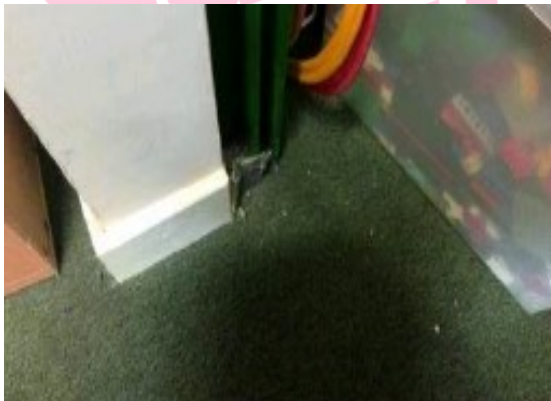
**Item 56 Ref:As EB000486**

The floor screed below carpet in Class 2 (Room 4) does not contain asbestos.

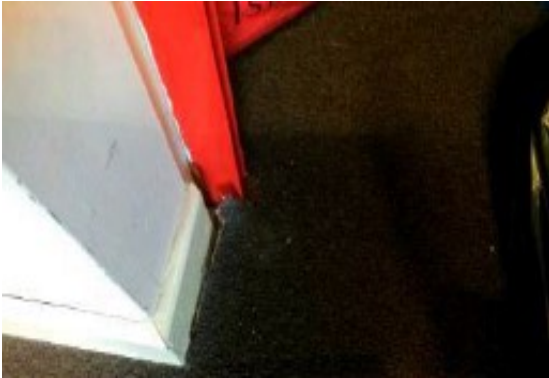
**Item 57 Ref:As EB000486**

The floor screed below carpet in Studio (Room 7) does not contain asbestos.

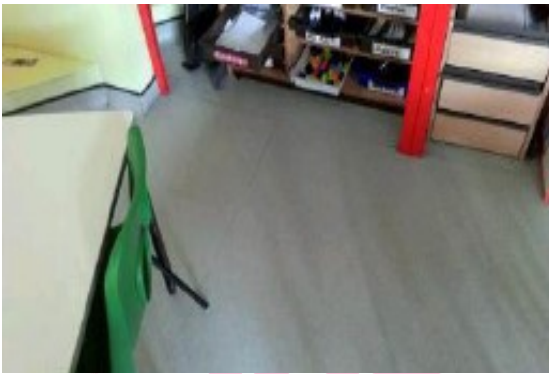
**Item 58 Ref: EB000487**

The floor screed below carpet in Food Technology (Room 8) does not contain asbestos.

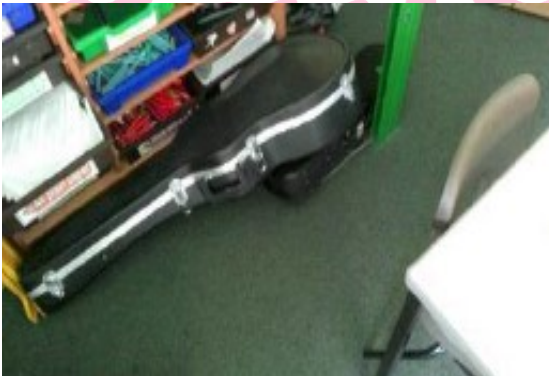
**Item 59 Ref:As EB000486**

The floor screed below carpet in Class 7 (Room 11) does not contain asbestos.

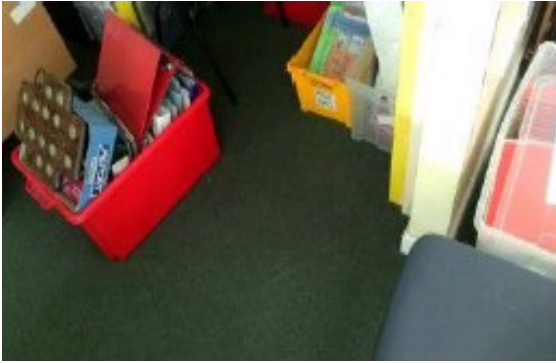
**Item 60 Ref:As EB000486**

The floor screed below carpet in Class 8 (Room 12) does not contain asbestos.

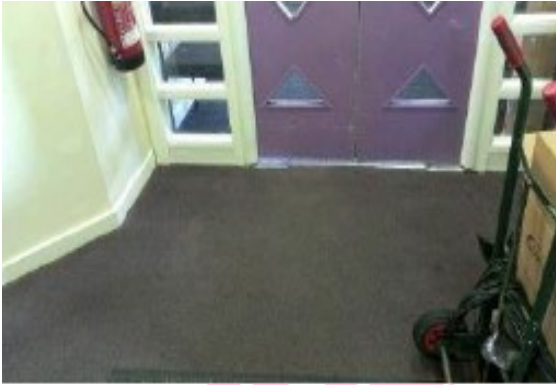
**Item 61 Ref: EB000488**

The floor screed below carpet in Circulation Corridor (Room 15) does not contain asbestos.

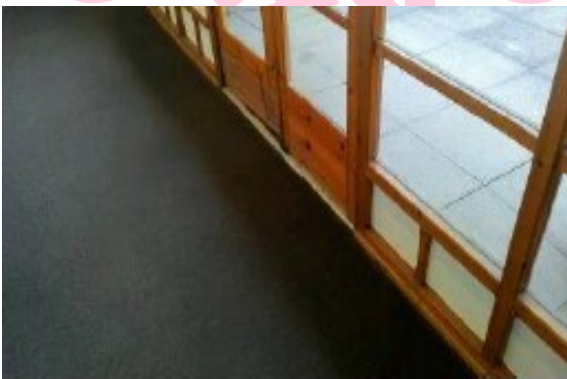
**Item 62 Ref:As EB000488**

The floor screed below carpet in Circulation Corridor (Room 15) does not contain asbestos.

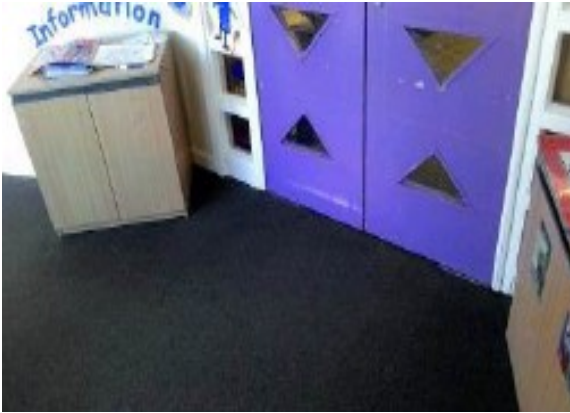
**Item 63 Ref:As EB000488**

The floor screed below carpet in Circulation Corridor (Room 15) does not contain asbestos.

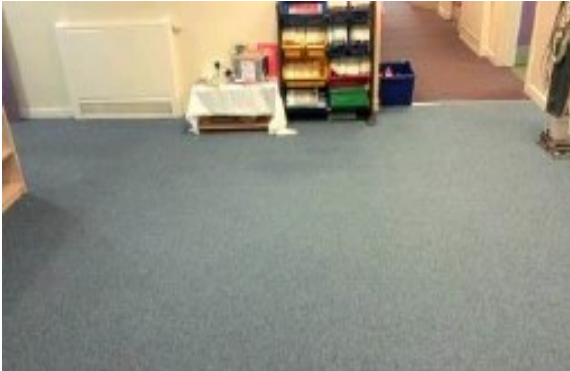
**Item 64 Ref:As EB000488**

The floor screed below carpet in Circulation Corridor (Room 15) does not contain asbestos.

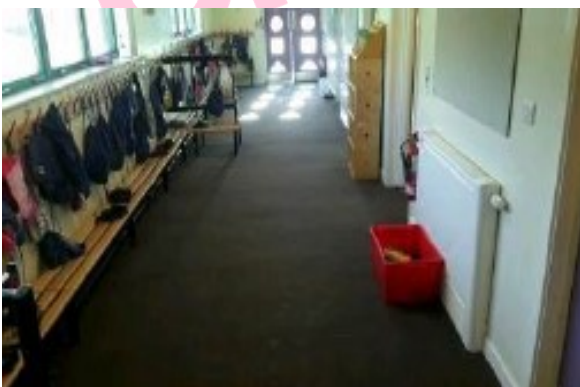
**Item 65 Ref:As EB000488**

The floor screed below carpet in Circulation Corridor (Room 15) does not contain asbestos.

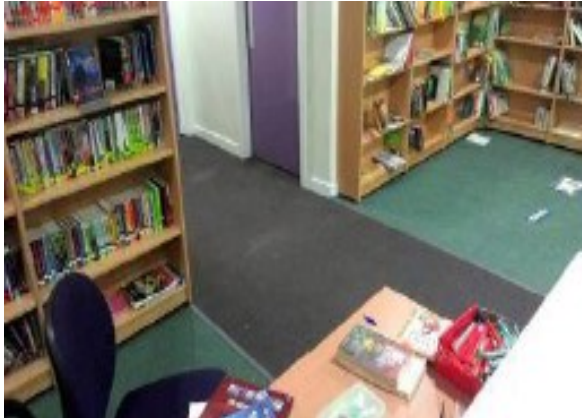
**Item 66 Ref:As EB000488**

The floor screed below carpet in Circulation Corridor (Room 15) does not contain asbestos.

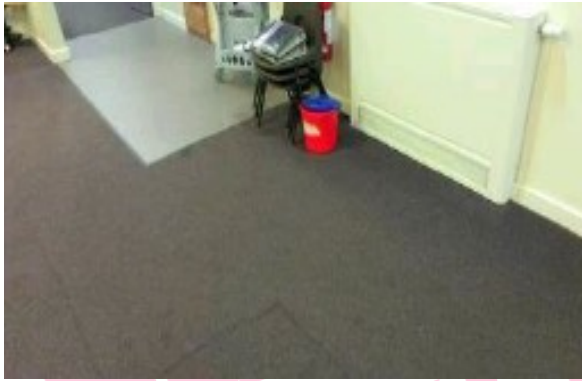
**Item 67 Ref:As EB000488**

The floor screed below carpet in Circulation Corridor (Room 15) does not contain asbestos.

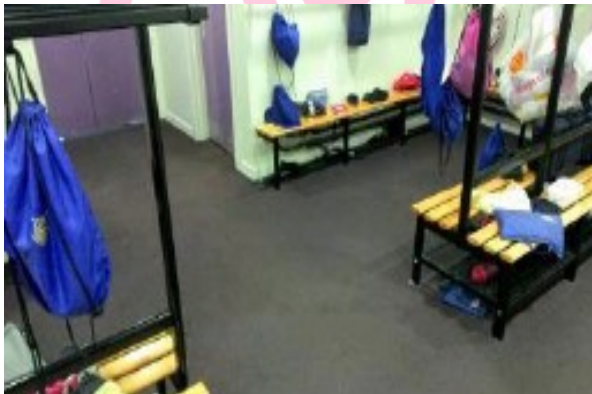
**Item 68 Ref:As EB000488**

The floor screed below carpet in Circulation Corridor (Room 15) does not contain asbestos.

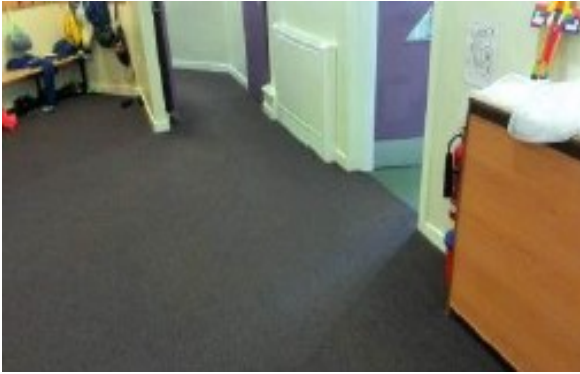
**Item 69 Ref:As EB000488**

The floor screed below carpet in Circulation Corridor (Room 15) does not contain asbestos.

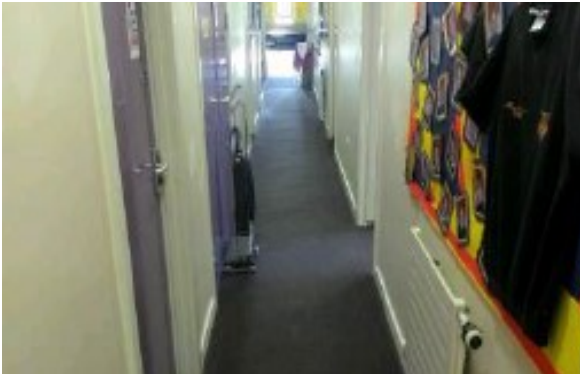
**Item 70 Ref:As EB000488**

The floor screed below carpet in Circulation Corridor (Room 15) does not contain asbestos.

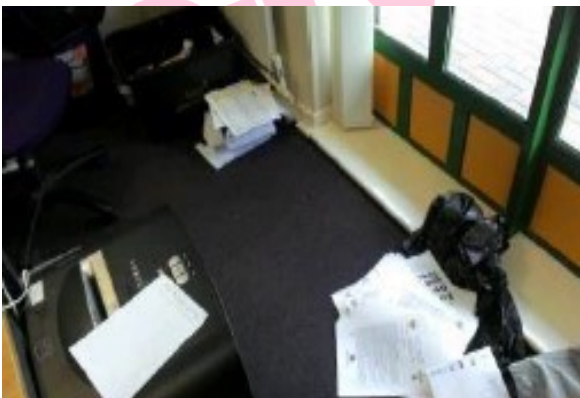
**Item 71 Ref:As EB000488**

The floor screed below carpet in Head Office (Room 16) does not contain asbestos.

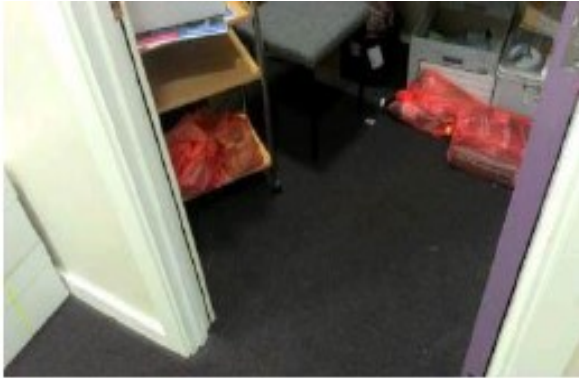
**Item 72 Ref:As EB000488**

The floor screed below carpet in Store Room (Room 17) does not contain asbestos.

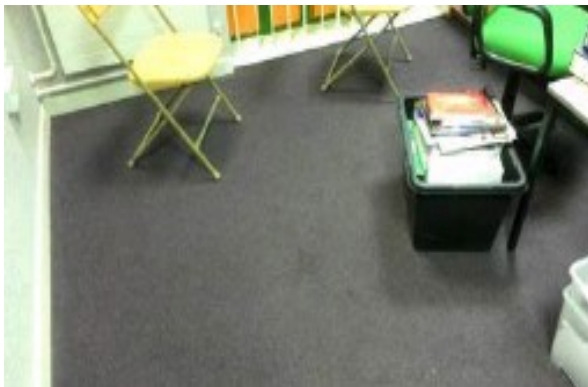
**Item 73 Ref:As EB000488**

The floor screed below carpet in Medical Room (Room 18) does not contain asbestos.

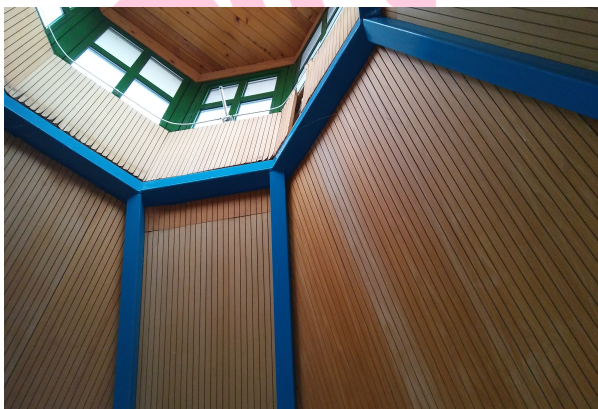
**Item 74 Ref: 226754-2**

The skylight surround in Classroom 10 (Room 0/01) does not contain asbestos.

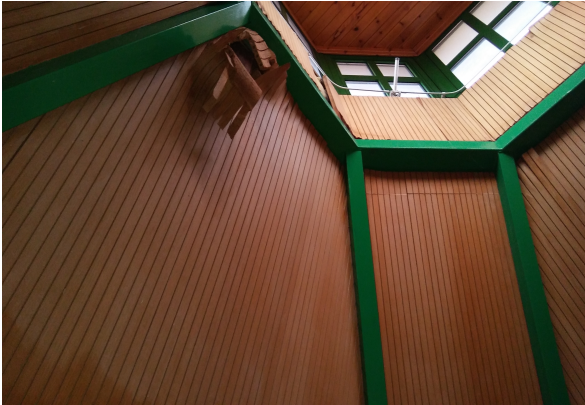
**Item 75 Ref:As 226754-2**

The skylight surround in Mr Aldersons Classroom (Room 0/02) does not contain asbestos.

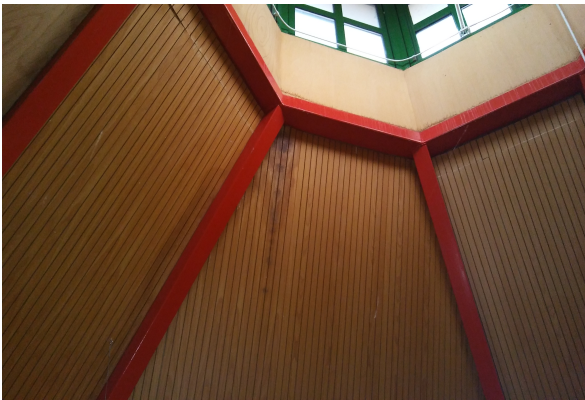
**Item 76 Ref: As 226754-2**

The skylight surround in Infants Corridor (Room 0/03) does not contain asbestos.

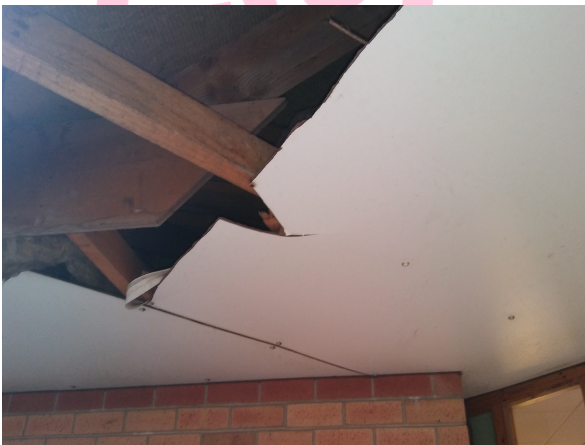
**Item 77 Ref: 226754-1**

The soffit boards (External) does not contain asbestos.

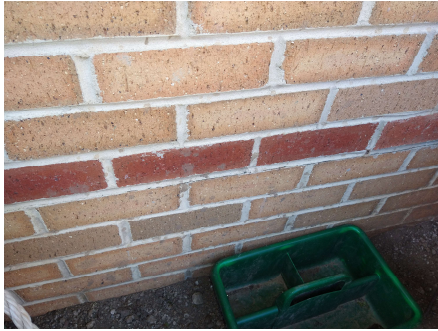
**Item 78 Ref: 419339-1**

The damp proof course (External) does not contain asbestos.

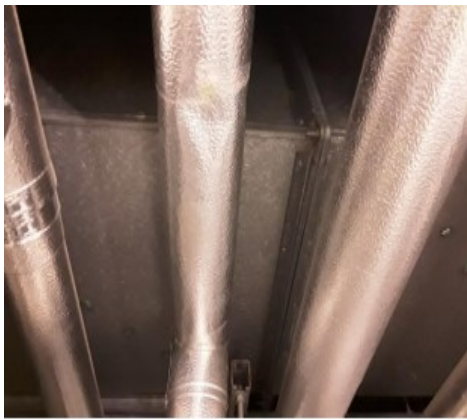
**Item 79 Ref: 21-36952-1**

The mastic to the vessel in the Plant Room (Area 2) does not contain asbestos.

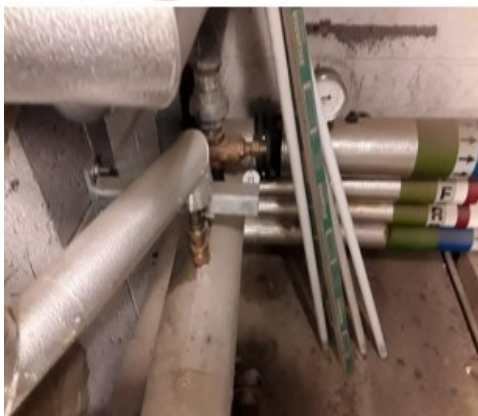
**Item 80 Ref: 21-36952-2**

The pipe flanges/gaskets in the Plant Room (Area 2) does contain asbestos.

Any change in appearance should be reported to Property Services.

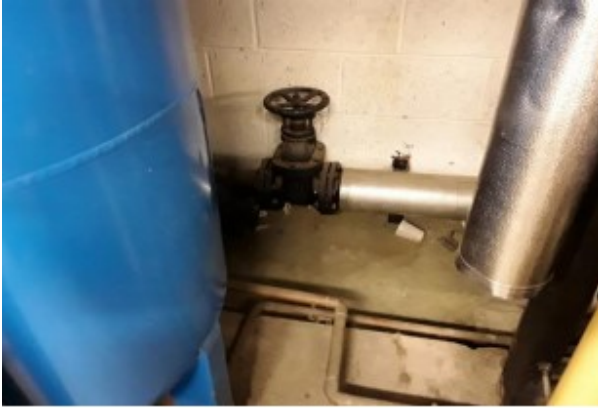
**Item 81 Ref: 21-36952-2**

The pipe flanges/gaskets in the Plant Room (Area 2) does contain asbestos.

Any change in appearance should be reported to Property Services.

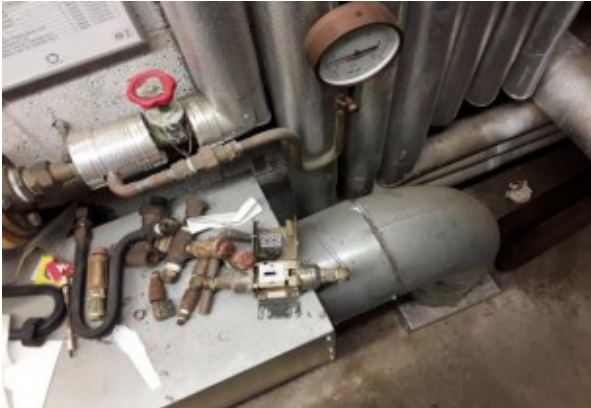
**Item 82 Ref: 21-36952-3**

The mastic to the extraction flue to floor in the Plant Room (Area 2) does not contain asbestos.

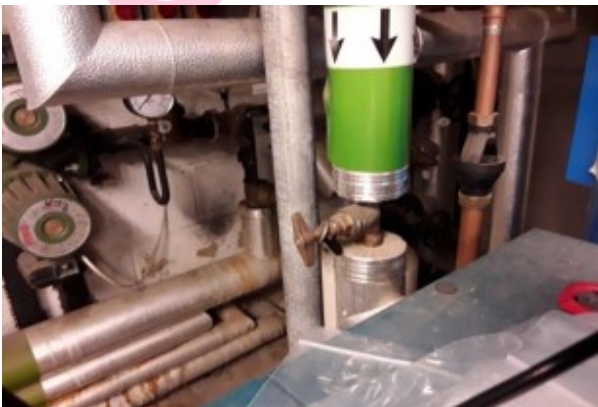
**Item 83 Ref: 21-36952-4**

The pipes/stop taps (gaskets) in the Plant Room (Area 2) does not contain asbestos.

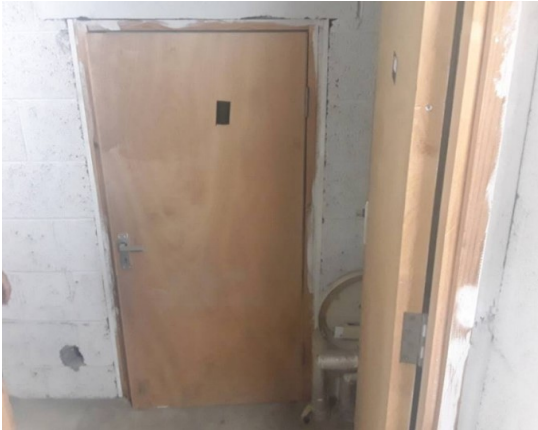
**Item 84 Ref: NZ000495**

The fire door x2 in the entrance hall/foyer/lobby including landing (E/003) does not contain asbestos.

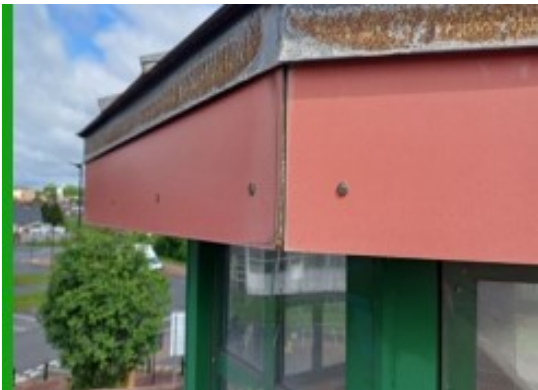
**Item 85 Ref: 628944-1**

The fascia externally does not contain asbestos.

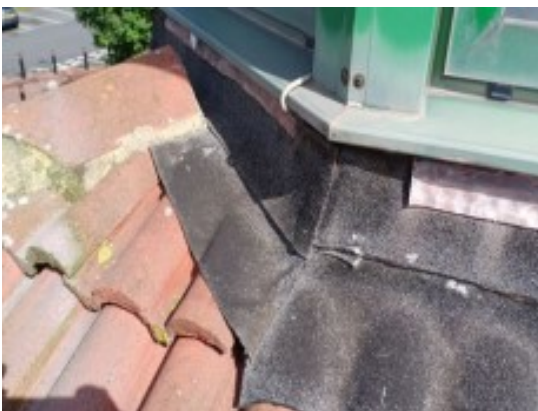
**Item 84 Ref: 628944-2**

The flashing externally does not contain asbestos.
