ASBESTOS SURVEY REPORT FOR RYHOPE INFANT SCHOOL ACADEMY, SUNDERLAND

Asbestos Register for

RYHOPE INFANT SCHOOL ACADEMY, SUNDERLAND

Date: 18 September 2024

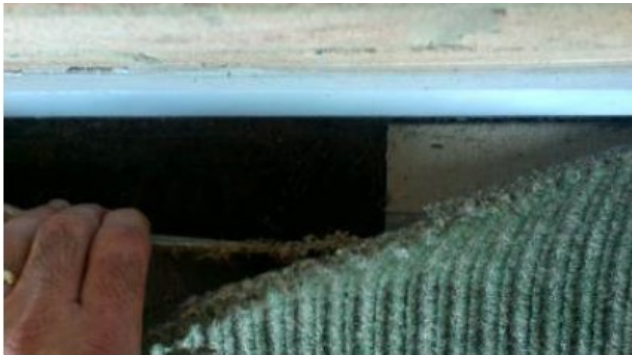
Item 1 Ref: AQ000013

Floor screed (Rm 0/01 Front Entrance Lobby) does not contain asbestos

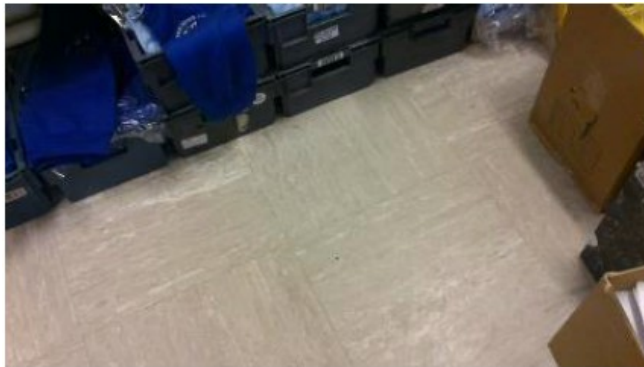
Item 2 Ref: AQ000014

Floor tiles and adhesive (Rm 0/03 Reception Office and Cupboard) do not contain asbestos.

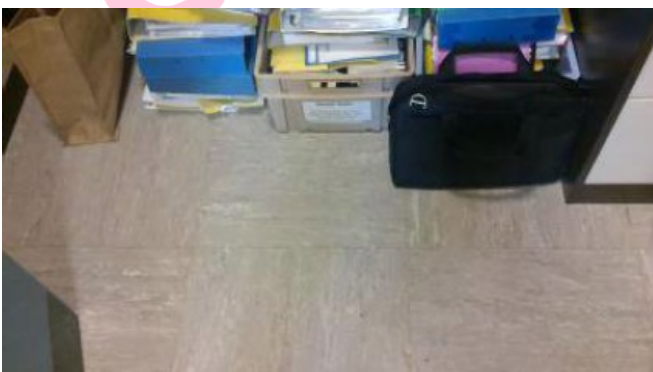
Item 3 Ref: As AQ000014

Floor tiles and adhesive (Rm 0/04 Managers Office and Cupboard) do not contain asbestos

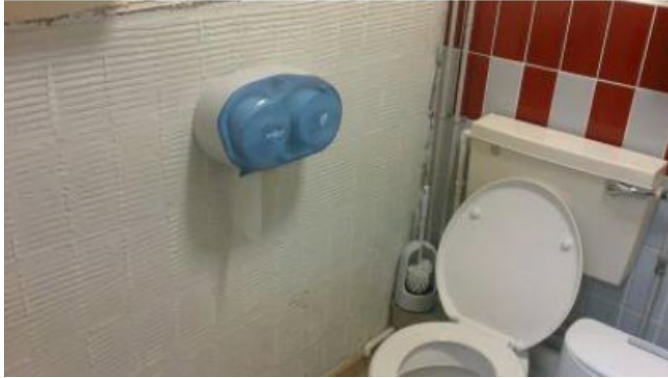
Item 4 Ref: AQ000015

Wall tile adhesive (Rm 0/10 Meeting Room WC) does not contain asbestos

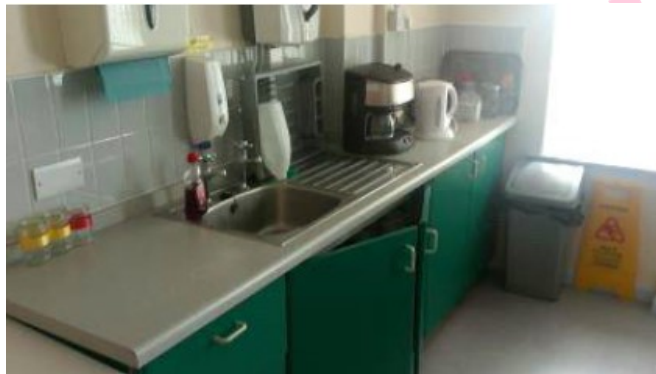
Item 5 Ref: AQ000016

Sink Pad (Rm 0/12 Training Room) does not contain asbestos

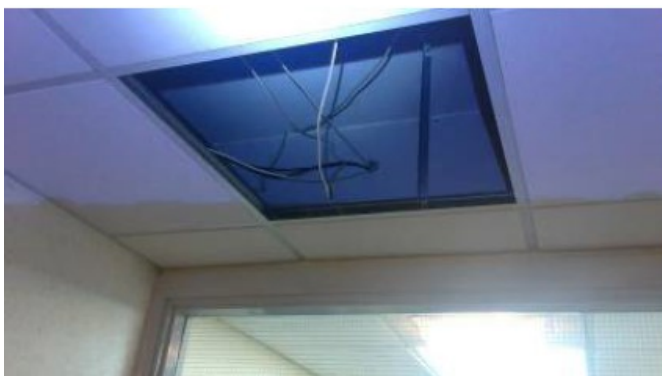
Item 6 Ref: AQ000018

Insulating Board (Rm 0/13 Corridor) does not contain asbestos

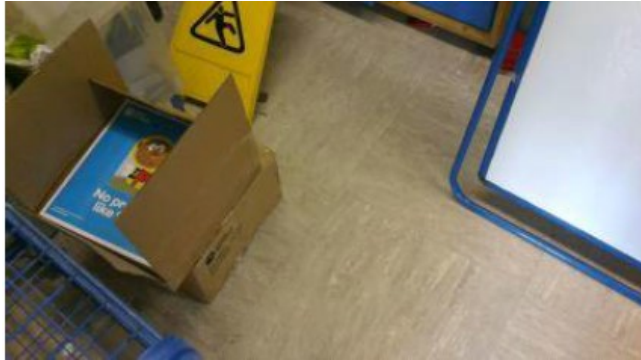
Item 7 Ref: As AQ000014

Floor tiles and adhesive (Rm 0/17 Reception Base 1&2) do not contain asbestos.

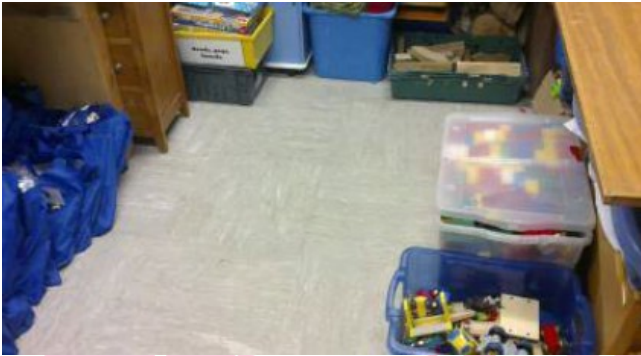
Item 8 Ref: AQ000019

Floor tiles and adhesive (Rm 0/21 Nursery Service Rooms) do not contain asbestos.

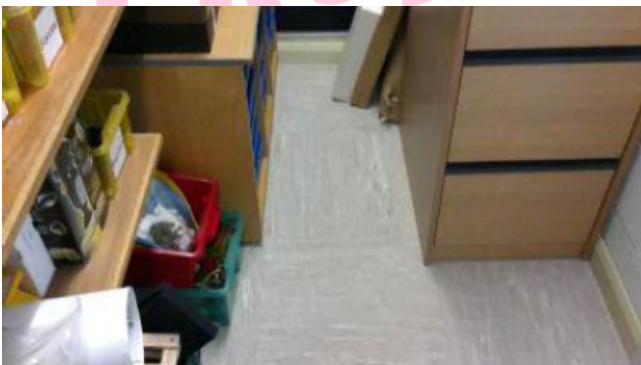
Item 9 Ref: As AQ000019

Floor tiles and adhesive (Rm 0/30 Classroom & Cupboard) do not contain asbestos.

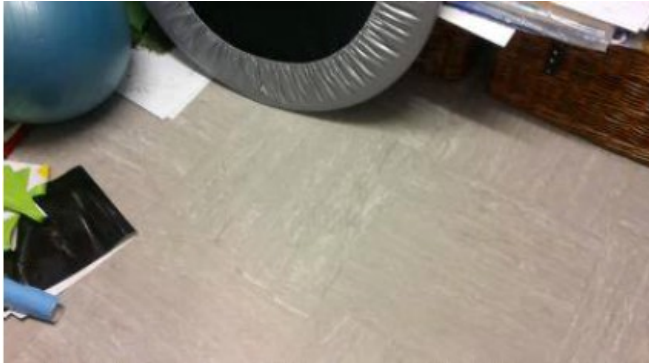
Item 10 Ref: AQ000020

Floor tiles and adhesive (Rm 0/35 Nurture Room and Cupboard) do not contain asbestos

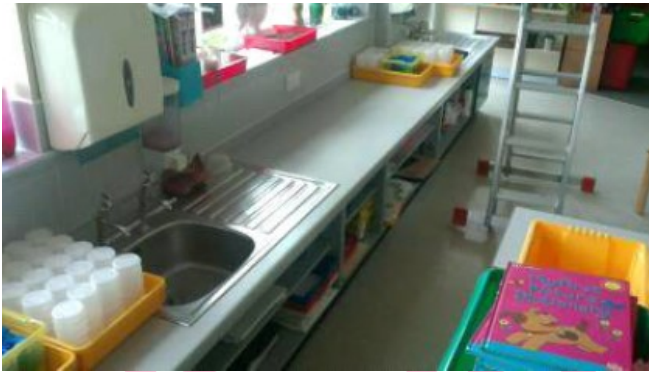
Item 11 Ref: AQ000021

Sink Pads (Rm 0/36 Year 2 Classroom & Cupboard) do not contain asbestos.

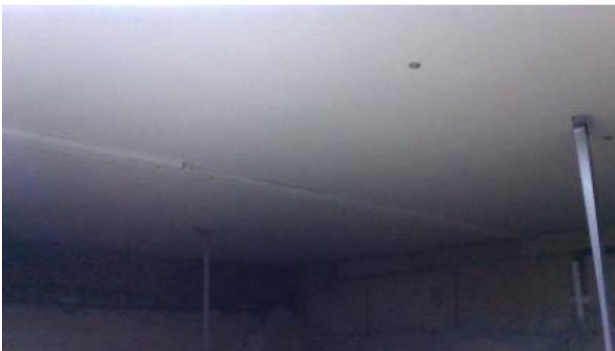
Item 12 Ref: AQ000022

Insulating Board (Rm 0/44 Corridor) does not contain asbestos.

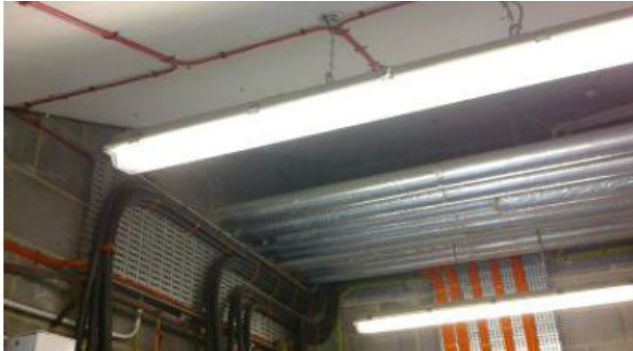
Item 13 Ref: AQ000023

Insulating Board (Rm 99/01 Electrical Room) does not contain asbestos.

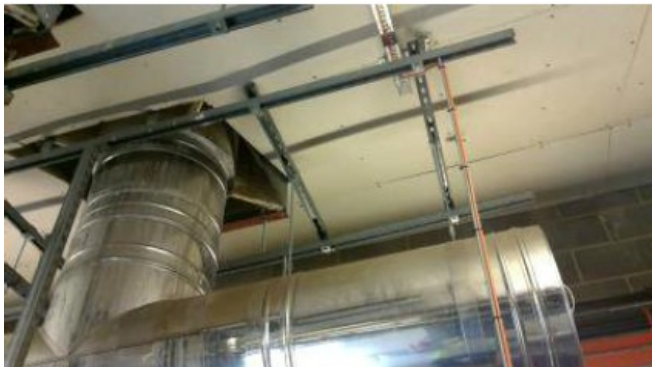
Item 14 Ref: AQ000024

Insulating Board (Rm 99/02 Plant Room) does not contain asbestos.

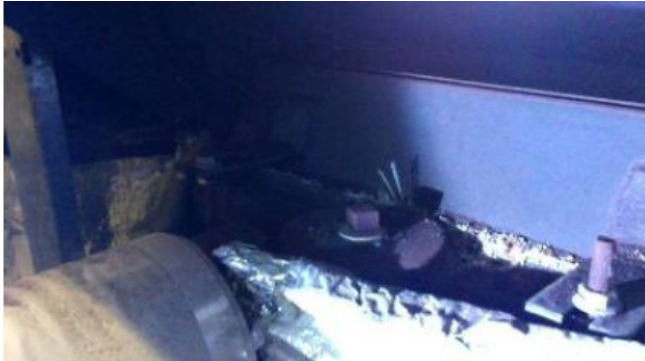
Item 16 Ref: AQ000026

Boiler Gaskets (Rm 99/02 Plant Room) do not contain asbestos.

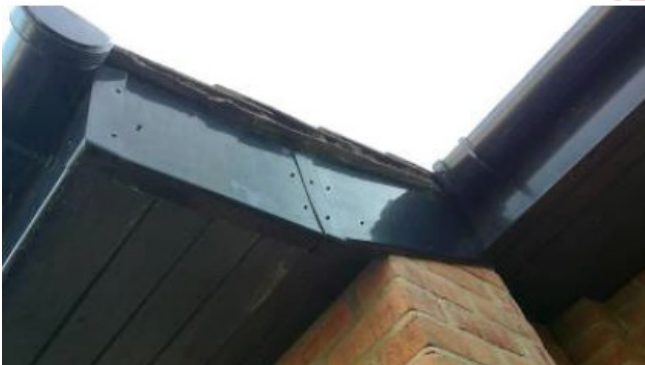
Item 17 Ref: AQ000027

Under Cloaking (Rm 99/03 Externals) does not contain asbestos.

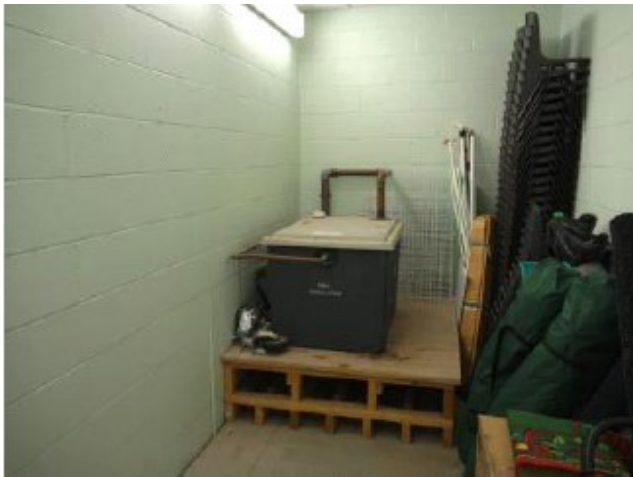
Item 20 Ref: AN000953

The coating to the water tank in the mezzanine tank room does not contain asbestos.

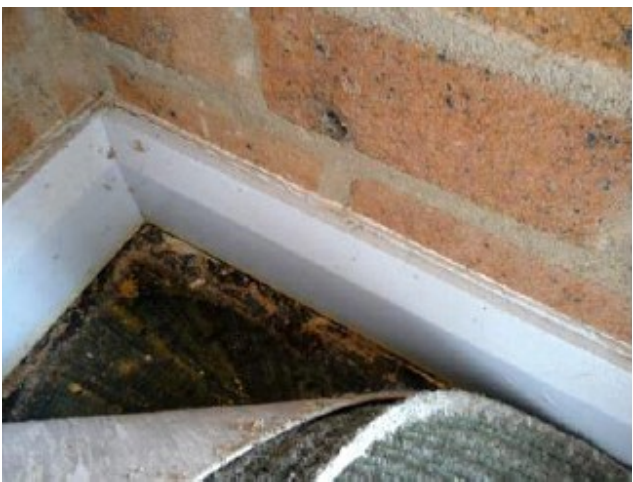
Item 21 Ref: AN000954

The adhesive below the lino in main reception entrance lobby does not contain asbestos.

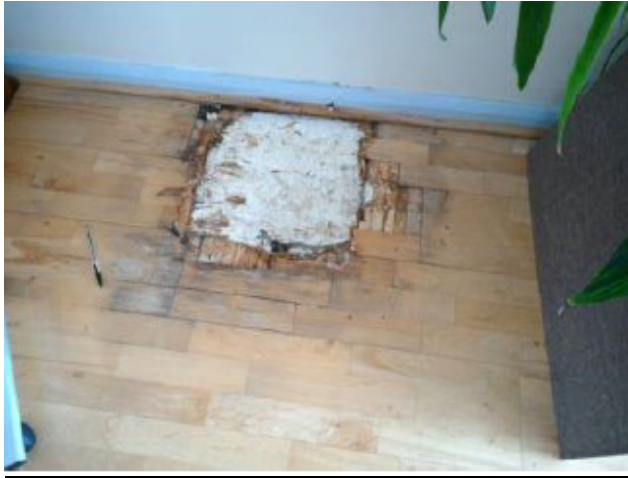
Item 22 Ref: As AN000954

The adhesive below the floor screed in main reception does not contain asbestos.

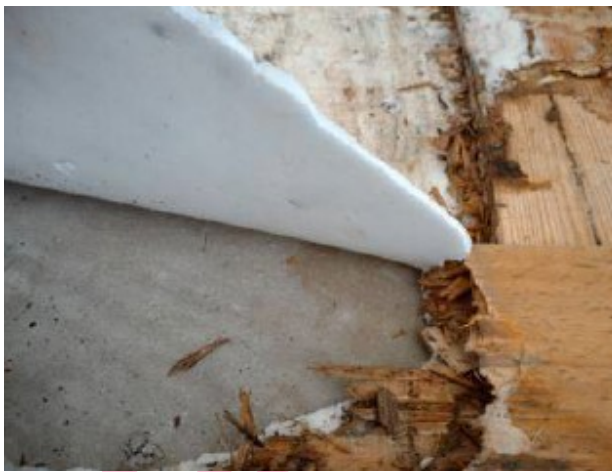
Item 23 Ref: AN000955

The screed beneath the wood flooring in main reception does not contain asbestos.

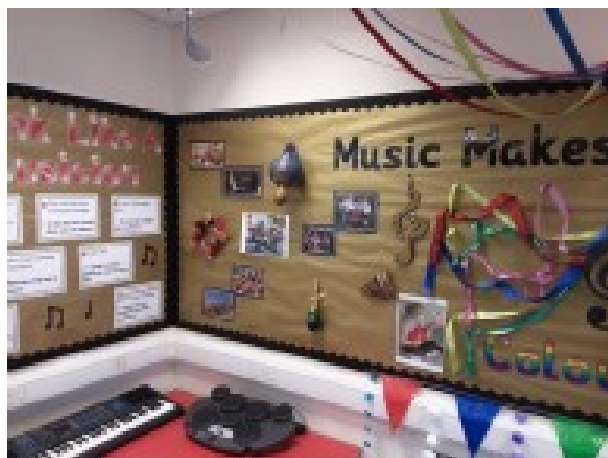
Item 24 Ref: DP002540

The core sample for the proposed new doorway in Room 0/030 does not contain asbestos.

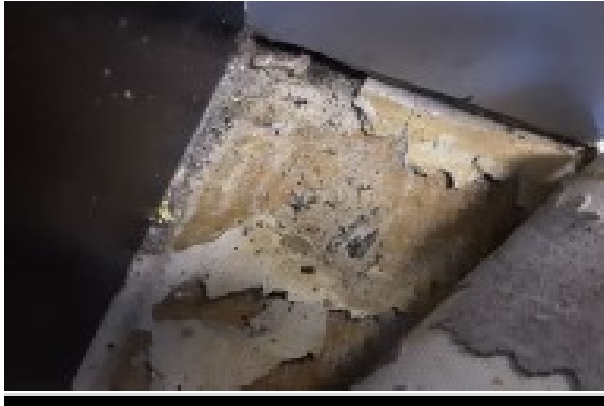
Item 25 Ref: DP002543

The bitumen screed below modern lino and modern screed in Room 0/36 does not contain asbestos.

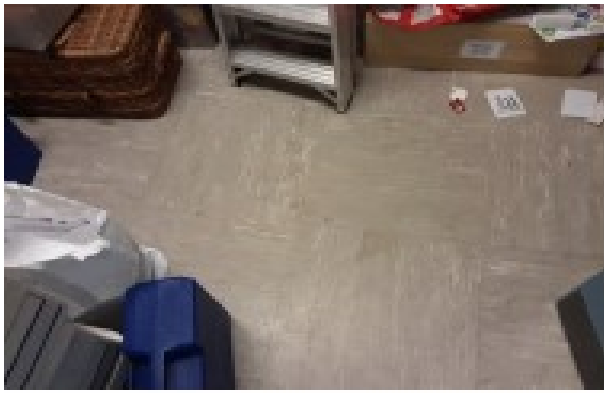
Item 26 Ref: DP002542

The vinyl floor tiles and adhesive in Room 0/36a does not contain asbestos.

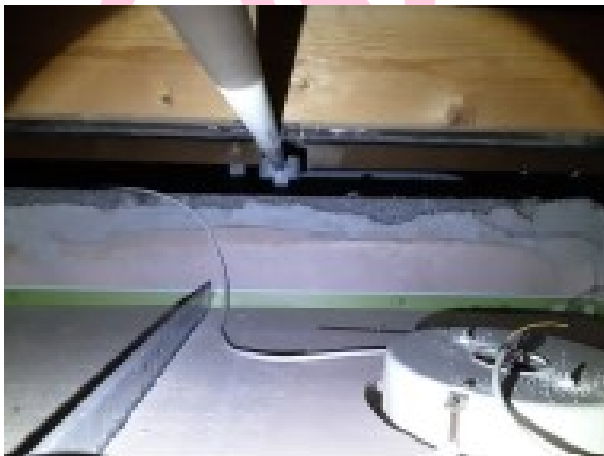
Item 27 Ref: DP002537

The core sample wall to toilet in Room 0/21 does not contain asbestos.

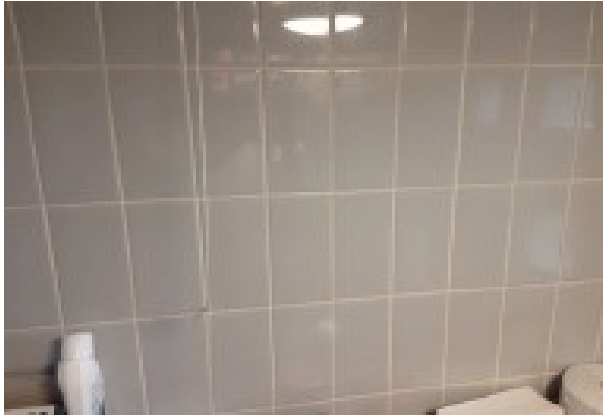
Item 28 Ref: DP002538

The grout to ceramic tiles (wall to interview room) in Room 0/21a does not contain asbestos.

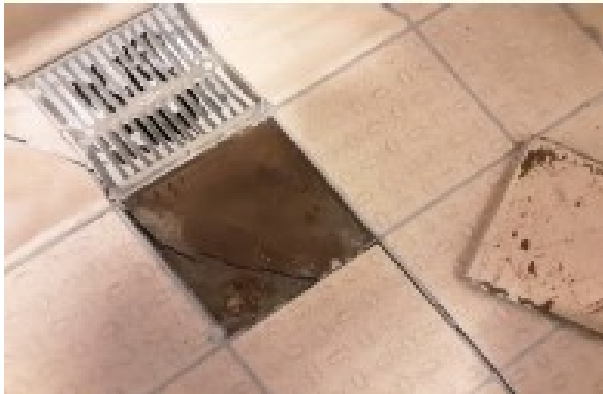
Item 29 Ref: DP002539

The screed below the quarry tiles in Room 0/21a does not contain asbestos.
