ASBESTOS SURVEY REPORT FOR BARNWELL ACADEMY, PENSHAW

Asbestos Register for

**BARNWELL ACADEMY,
PENSHAW**

Date: 06 February 2025

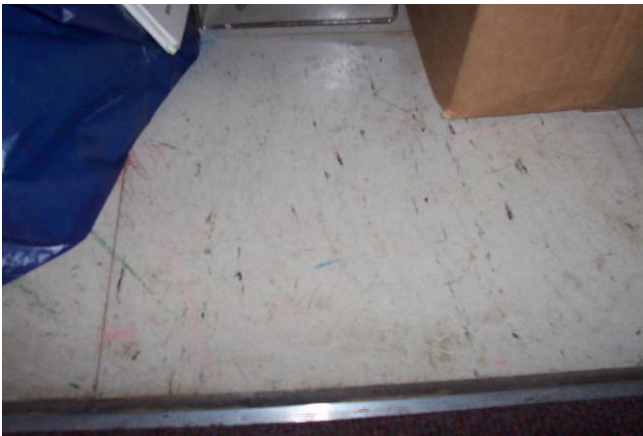
Item 8 – As JL06/4153

The white floor tiles and adhesive in area 11 (store cupboard) contains asbestos.

Any change in their appearance should be recorded, and passed to Property Services.

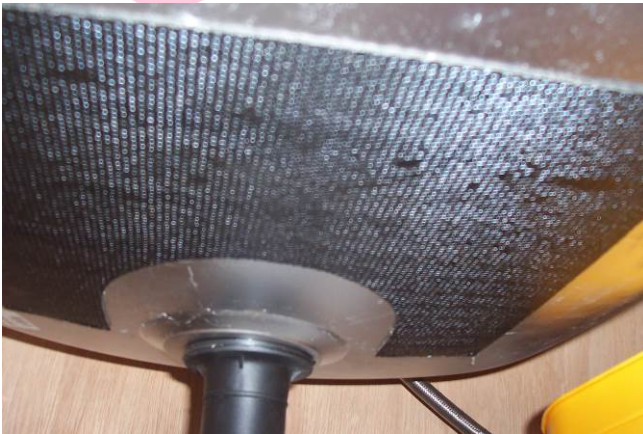
Item 9 – As JL06/4154

The sink pad in area 26 (classroom) does not contain asbestos.

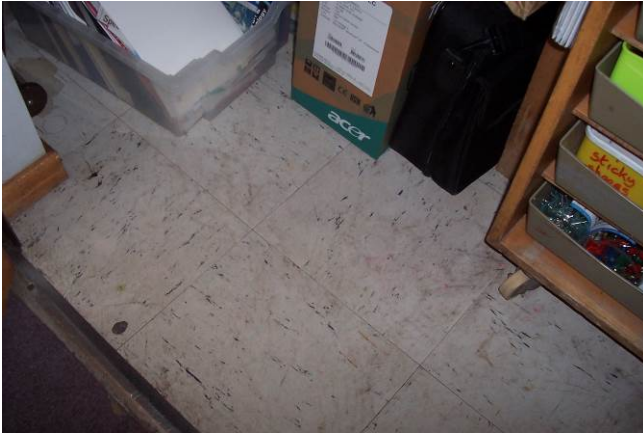
Item 10 – As JL06/4153

The white floor tiles and adhesive in area 6 (store cupboard) contains asbestos.

Any change in their appearance should be recorded, and passed to Property Services.

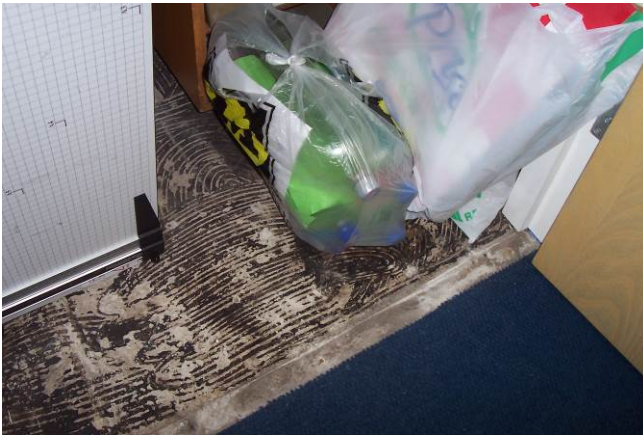
Item 13 – JL06/4155

The floor tiles and adhesive in area 3 (store cupboard) contains asbestos.

Any change in their appearance should be recorded, and passed to Property Services.

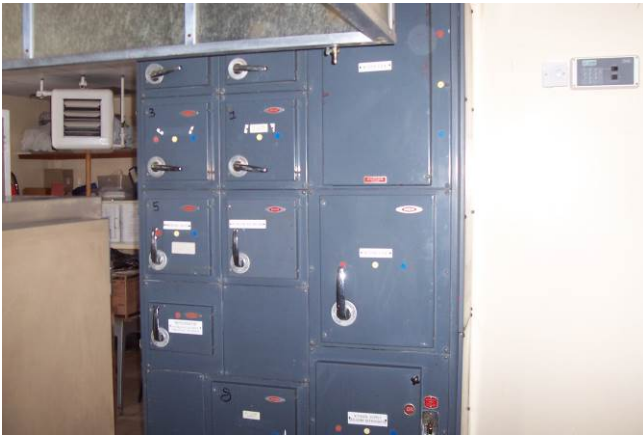
Item 19 – Presumed

The flash guards to fuse box in area 19 (kitchen) contains asbestos.

Any change in its appearance should be recorded, and passed to Property Services.

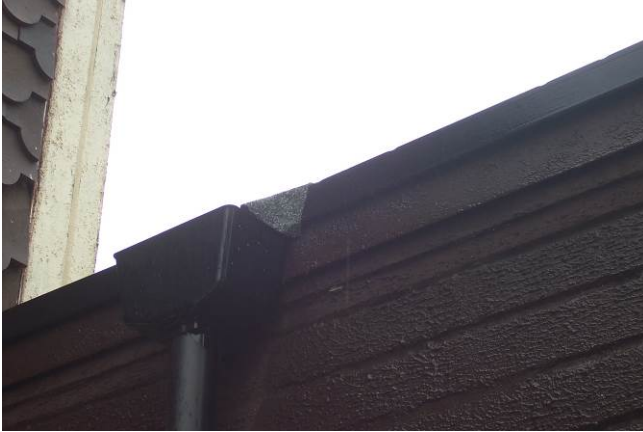
Item 22 – JL06/4158

The roofing felt to flat roofs (exterior) does not contain asbestos.

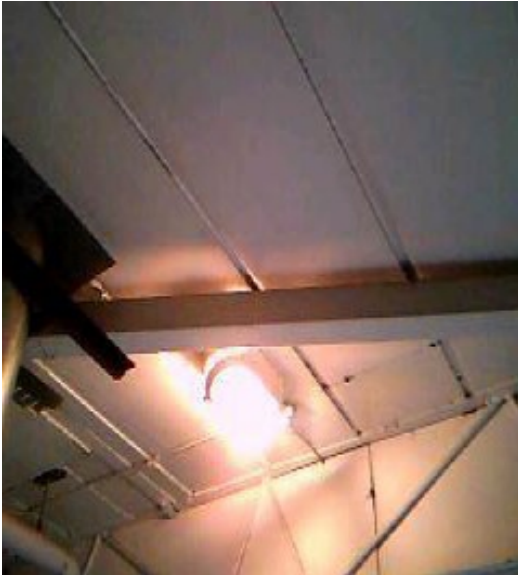
Item 23 – AD000530

The ceiling panels to the boiler room contain asbestos.

Any change in its appearance should be recorded, and passed to Property Services.

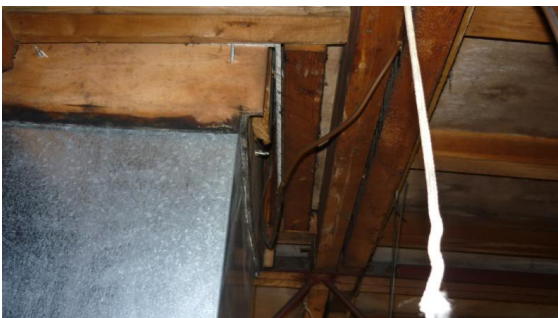
Item 32 Ref: Presumed

The central extraction duct lining in 0/32 Kitchen void above is presumed to contain asbestos.

Any change in its appearance should be recorded and passed to Property Services.

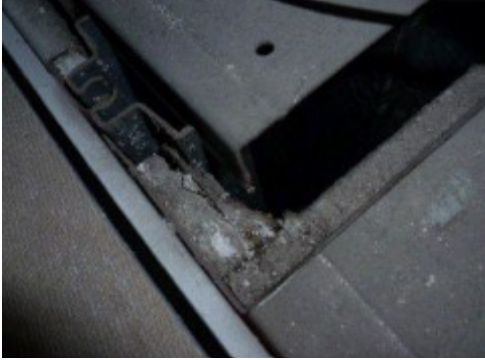
Item 40 Ref: AC000358

The column plasterboard in Room 1 office off reception does not contain asbestos.

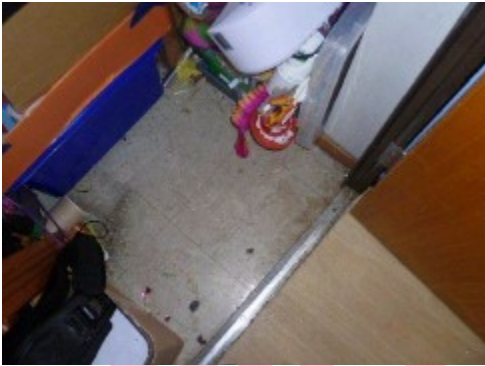
Item 41 Ref: AC000359

The vinyl floor tiles & bitumen adhesive below in Room 2 cupboard to class 1 contain asbestos.

Removed 2012

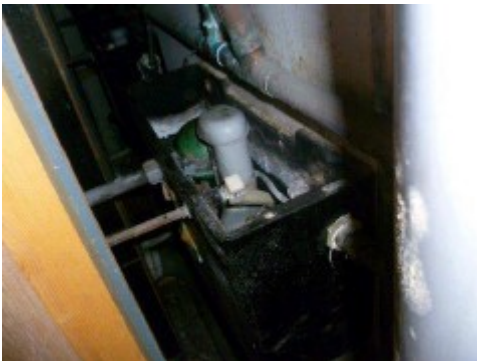
Item 42 Ref: AC000360

The toilet cistern in Room 3 Boys toilet behind panels contains asbestos.

Removed 2012

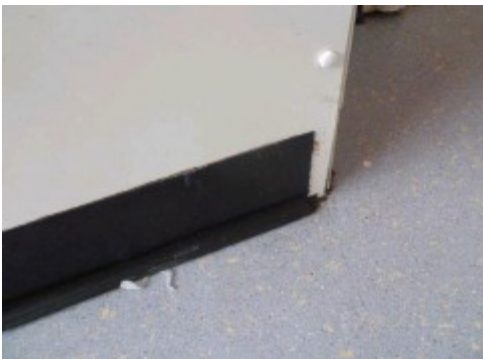
Item 44 Ref: AC000362

The vinyl skirting in Room 3 Boys toilet does not contain asbestos.

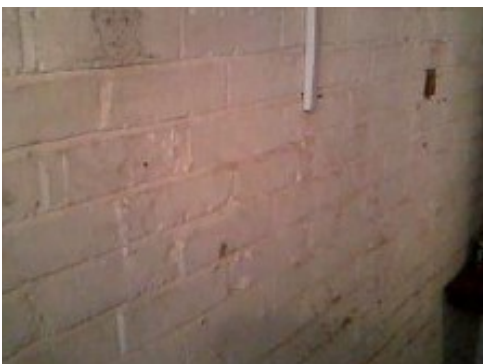
Item 45 Ref: AD000531

The debris to wall in Room 1 Boiler House does not contain asbestos.

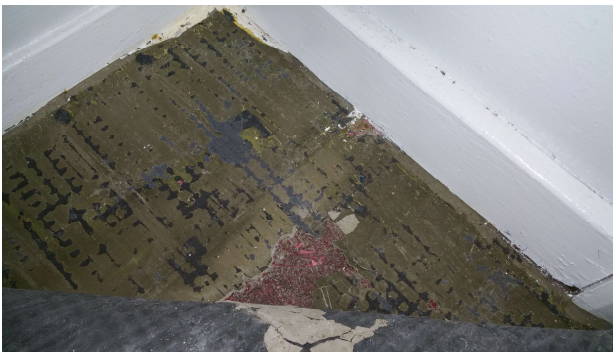
Item 62 Ref: 117113-2

The subfloor covering in 01/entrance lobby does not contain asbestos.

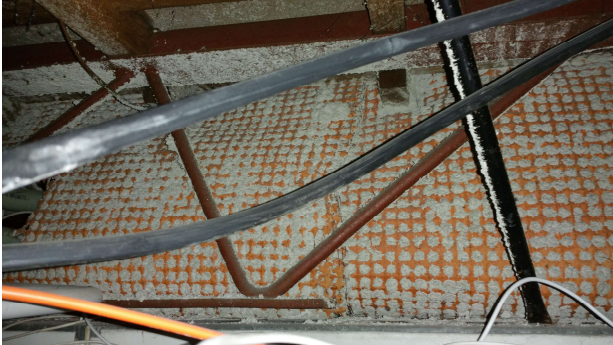
Item 64 Ref: As 117113-1

The firebreak & associated debris in 02/headteachers office-void above does not contain asbestos.

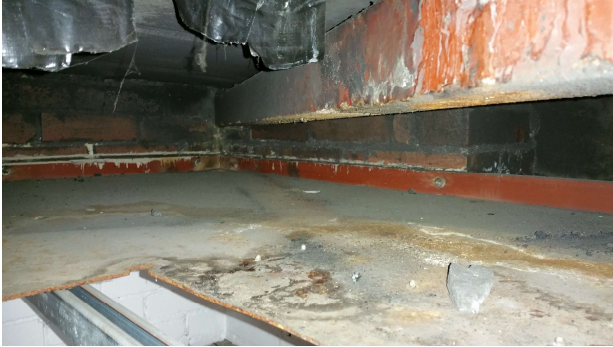
Item 67 Ref: 117113-6

The debris to topside of lower wood ceiling in 06/boiler room contains asbestos.

Any change in its appearance should be recorded and passed to Property Services.

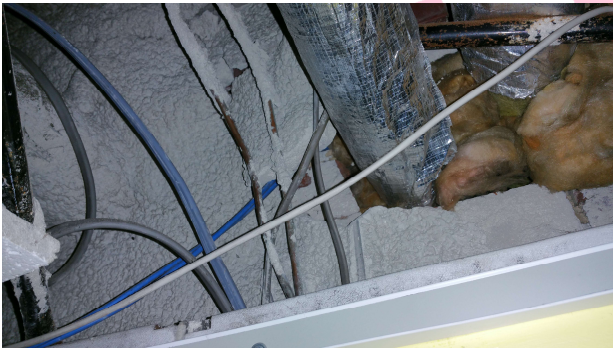
Item 68 Ref: As 117113-1

The firebreak & associated debris in 07/classroom-void above does not contain asbestos.

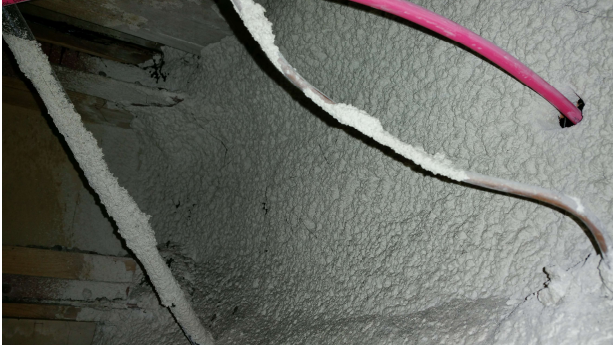
Item 70 Ref: 117113-10

The firebreak & associated debris in 019/staffroom-void above does not contain asbestos.

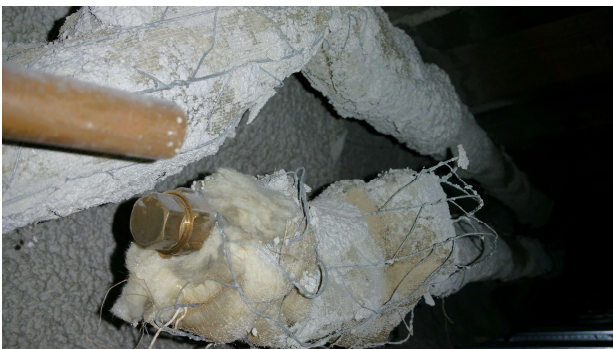
Item 75 Ref: As 117113-10

The firebreak & associated debris in 025/boys wc -void above does not contain asbestos.

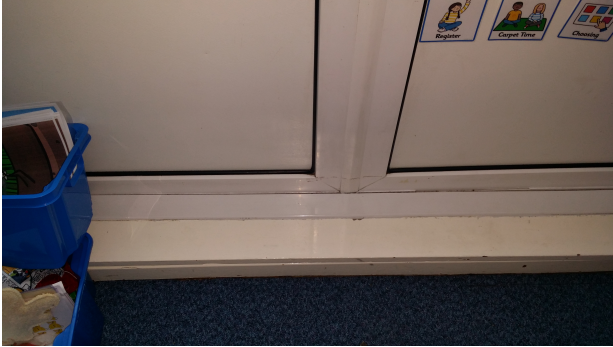
Item 79 Ref: 117113-14

The remnant floor covering within wood boxing below windows in 033/classroom contains asbestos.

Any change in its appearance should be recorded and passed to Property Services.

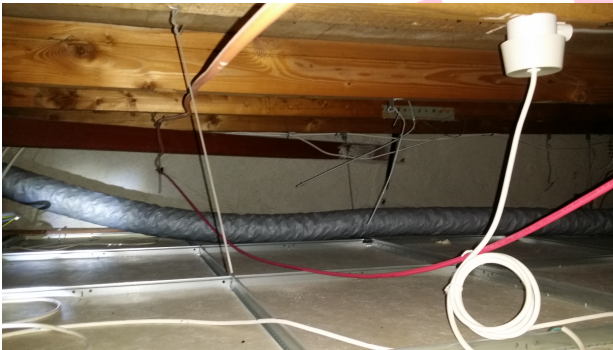
Item 80 Ref: As 117113-15

The firebreak & associated debris in 033/classroom - void above does not contain asbestos.

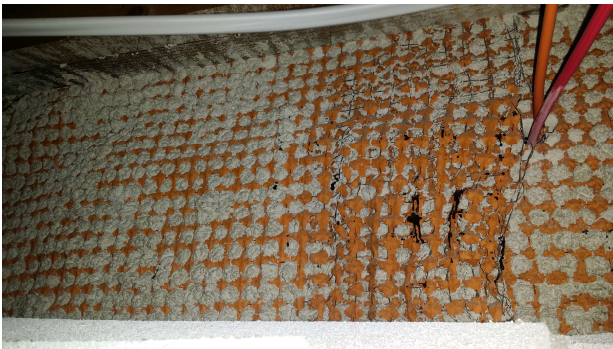
Item 81 Ref: 117113-15

The firebreak & associated debris in 034/classroom - void above does not contain asbestos.
