ASBESTOS SURVEY REPORT FOR BENEDICT BISCOP, SUNDERLAND

Asbestos Register for BENEDICT BISCOP, SUNDERLAND

Date: 13 February 2025

**BENEDICT BISCOP
CE PRIMARY SCHOOL**

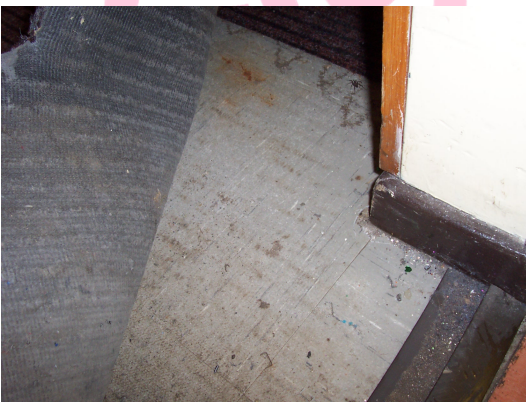
Item 3 - Ref: NO06/05

The floor tiles in year 5 & 6 classroom do not contain asbestos.

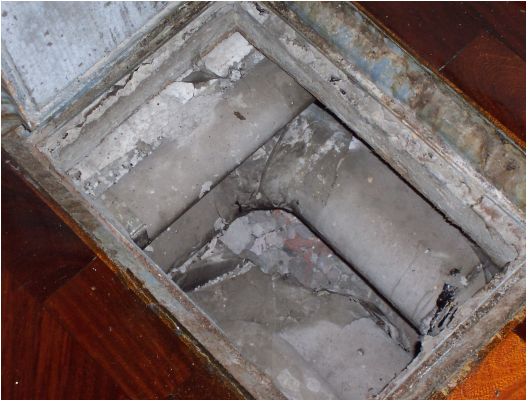
Item 4 - Ref: NO06/06

The pipe lagging throughout the school in the ducts does not contain asbestos.

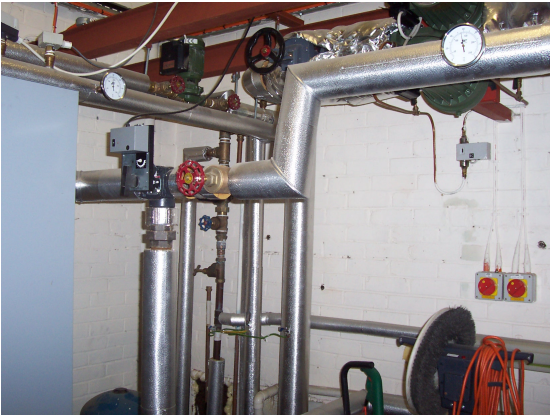
Item 5 - Ref:NO06/07

The pipe lagging in the boiler house does not contain asbestos.

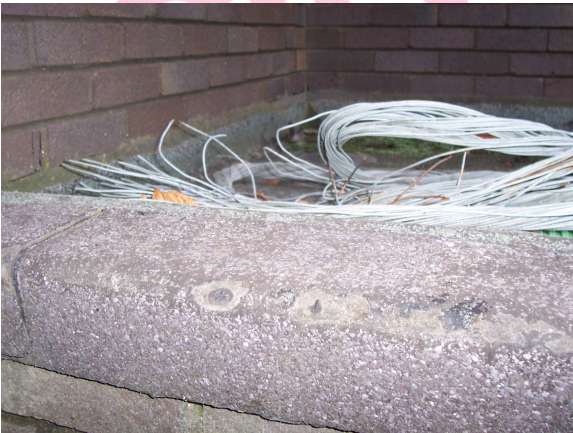
Item 6 - Ref: NO06/08

The felt to the roof in the cleaner's store does not contain asbestos.

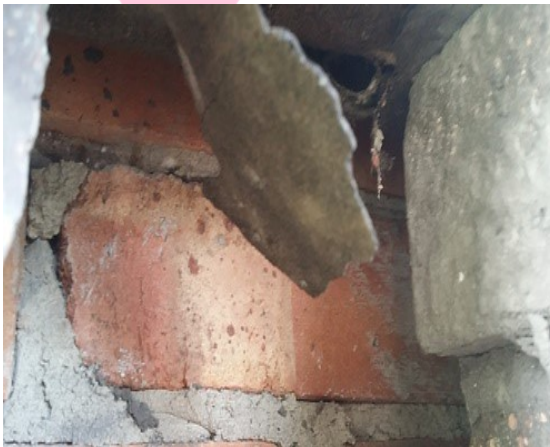
Item 19 - Ref: 87662-2

The membrane below windowsill (External) does not contain asbestos.

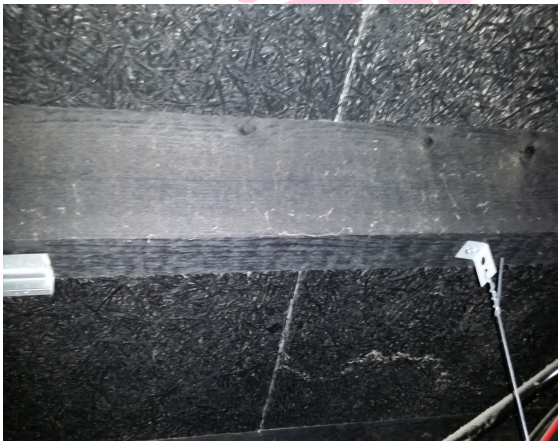
Items 22 - Ref: 117404-1

The underside of roof in Meeting Room (0/001) does not contain asbestos.

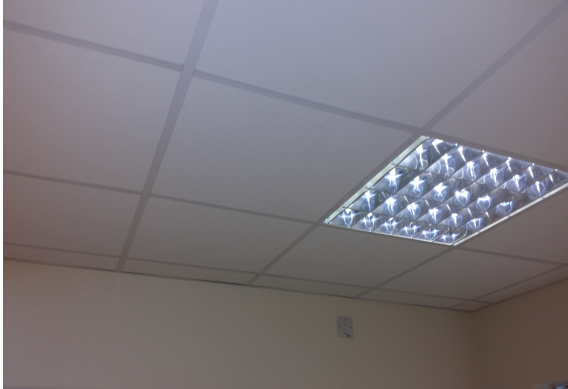
Items 23 - Ref: 117404-2

The suspended ceiling in Meeting Room (0/001) does not contain asbestos.

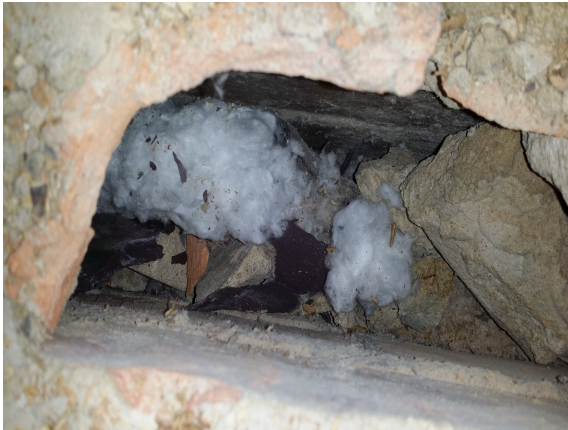
Items 24 - Ref: 117404-3

The cavity insulation in Meeting Room (0/001) does not contain asbestos.

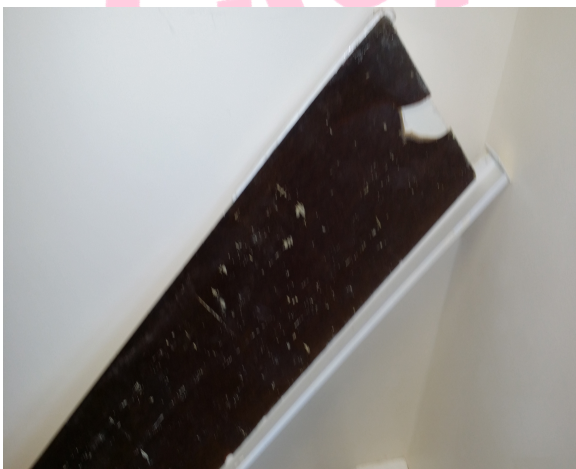
Items 25 - Ref: 117404-4

The lining to wood cill in Meeting Room (0/001) does not contain asbestos.

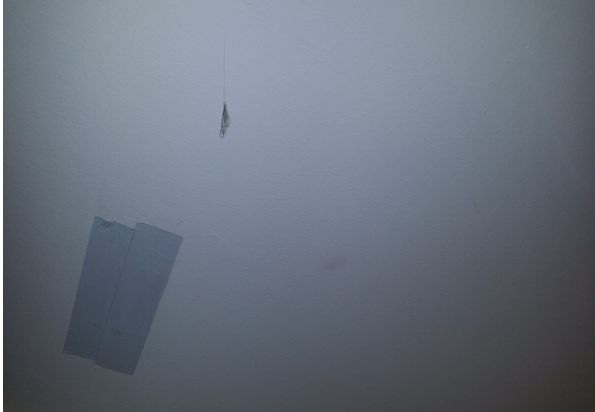
Items 26-Ref:As117404-1

The underside of roof in WC (0/002) does not contain asbestos.

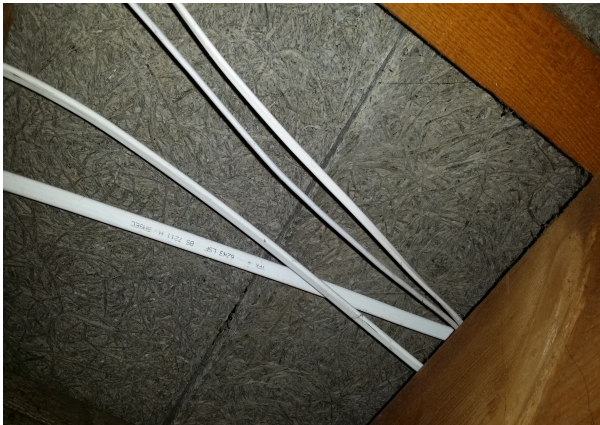
Items 27-Ref:As117404-1

The underside of roof in Reception Lobby ceiling void (0/003) does not contain asbestos.

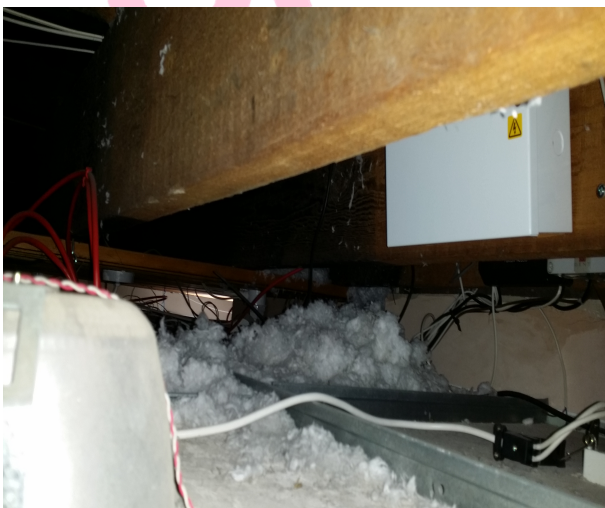
Items 28-Ref:As117404-3

The insulation in Reception Lobby ceiling void (0/003) does not contain asbestos.

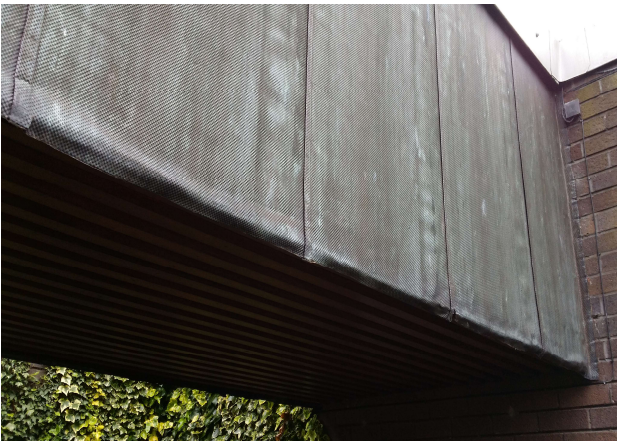
Items 31-Ref:As117404-1

The underside of roof canopy (External) does not contain asbestos.

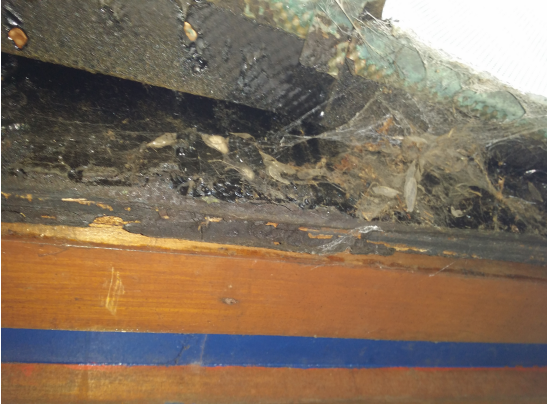
Items 32 - Ref: 117404-5

The felt to canopy walls (External) does not contain asbestos.

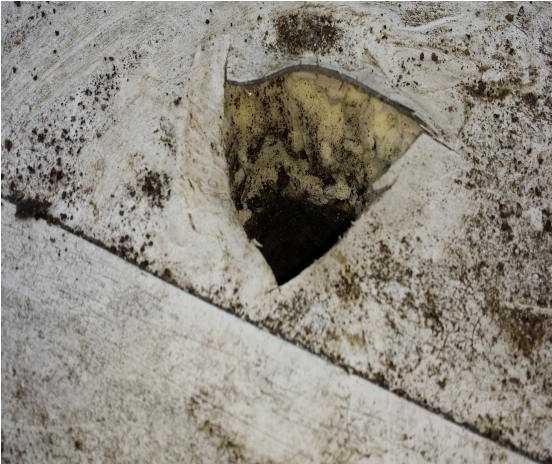
Items 33 - Ref: 117404-6

The original roof covering (External) does not contain asbestos.

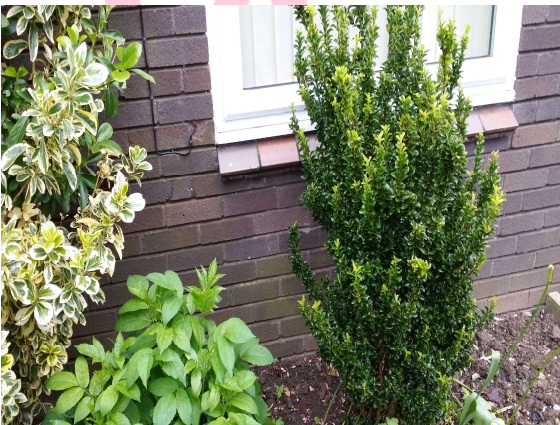
Items 34-Ref:As117404-3

The insulation to wall cavity (External) does not contain asbestos.

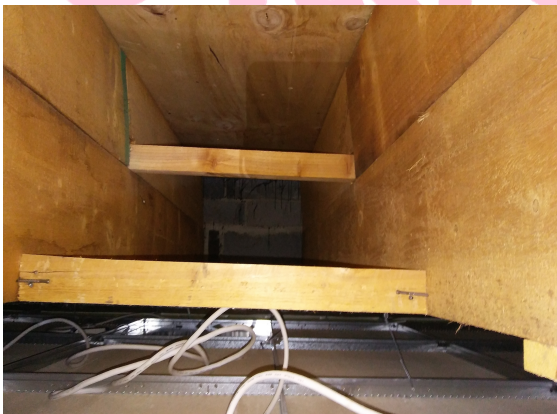
Items 37 - Ref: As 376631-1

The remnant roof covering adhesive in classroom (Rm 012) void above suspended ceiling does not contain asbestos.

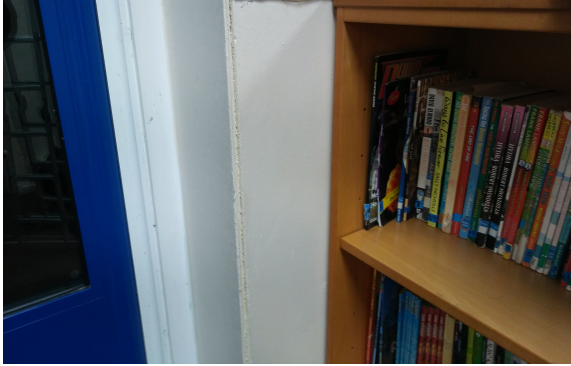
Items 38 - Ref: 376631-4

The cladding to wall in the corridor (Rm 013) does not contain asbestos.

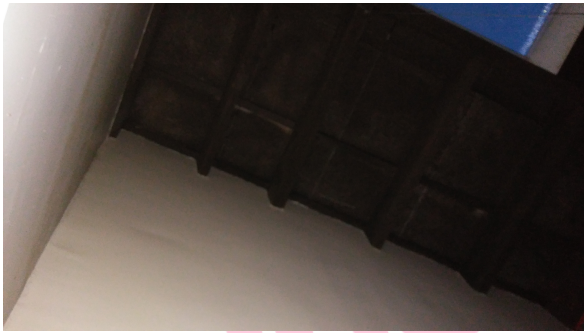
Items 39 - Ref: As 376631-5

The underside of roof in the corridor (Rm 013) void above suspended ceiling does not contain asbestos.

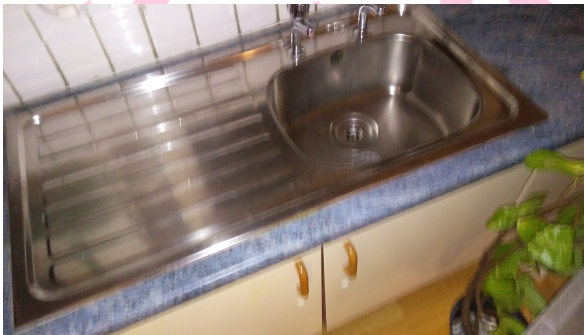
Items 40 - Ref: 376631-6

The acoustic sink pad in the nursery (Rm 014) does not contain asbestos.

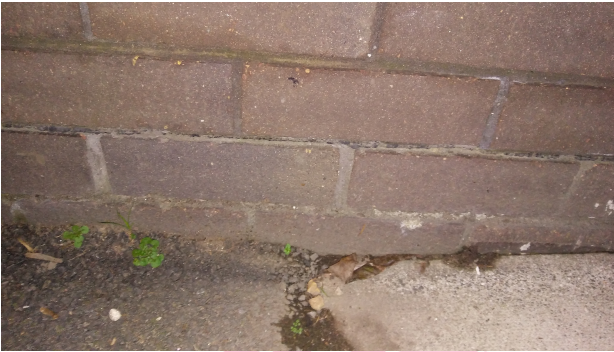
Items 42 - Ref: As 376631-3

The damp proof course (External) does not contain asbestos.

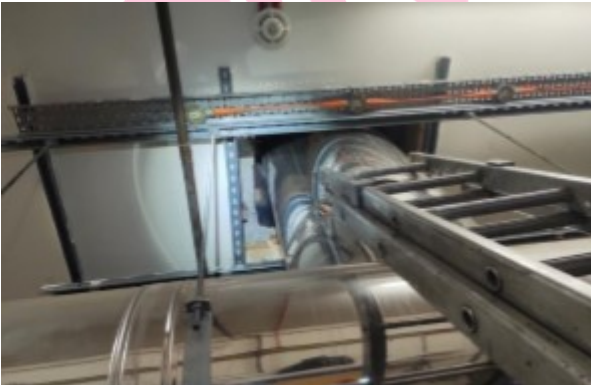
Items 43 - Ref: 21-30788-1

The ceiling in Area 1/Plant Room does not contain asbestos.

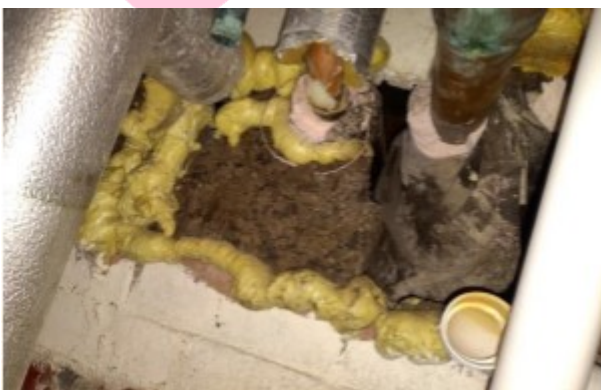
Items 46 - Ref: 21-30788-4

The pipes small bore penetration wall void in Area 1/Plant Room does not contain asbestos.

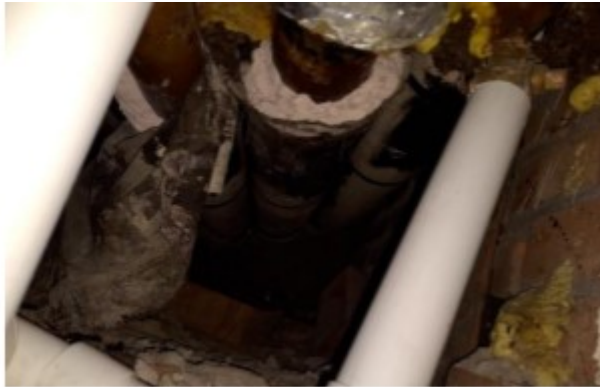
Items 47 - Ref: 21-30788-5

The pipes medium bore penetration wall in Area 1/Plant Room does not contain asbestos.

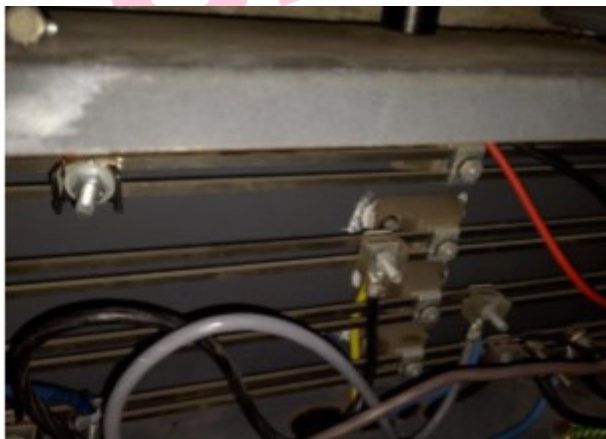
Items 49 - Ref: 21-30854-1

21-30854-1 – Insulators to electrical box (Area 2/Electrical Switch Room) (Item 49) – Low Risk

The insulators to electrical box in Area 2/Electrical Switch room does contain asbestos.

Any change in appearance should be reported to Property Services.
