ASBESTOS SURVEY REPORT FOR CASTLEVIEW ACADEMY, SUNDERLAND

Castle View Academy – Version 2.0 - Last updated 10/05/2024

CASTLEVIEW SPORTS CENTRE, SUNDERLAND

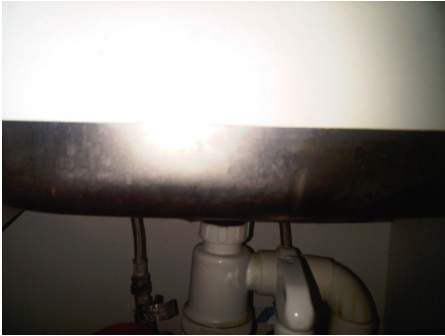
Item 1 Ref: MBA10/1787

The sink pad to the kitchen (Room 6) does not contain asbestos.

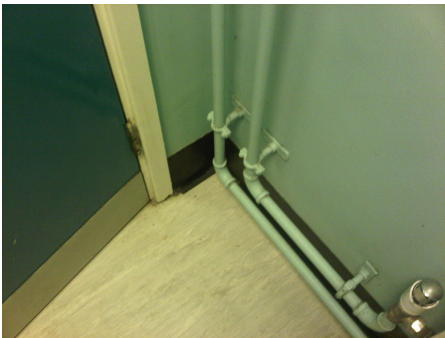
Item 2 - Ref: MBA10/1788

The skirting board to the kitchen (Room 6) does not contain asbestos.

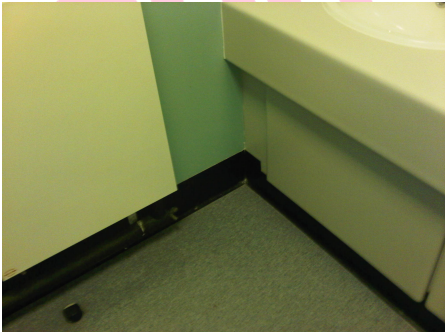
Item 3 - As MBA10/1788

The skirting board to the staff WC (Room 7) does not contain asbestos.

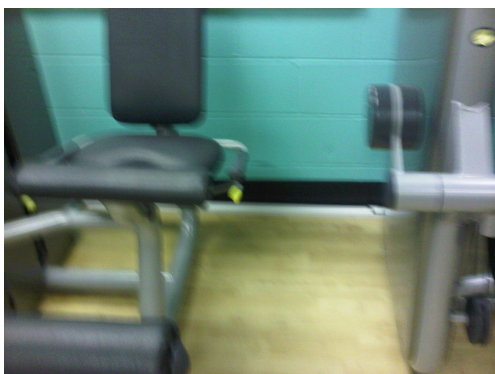
Item 4 – As MBA10/1788

The skirting board to the Gym and electric cupboard (Room 8) does not contain asbestos.

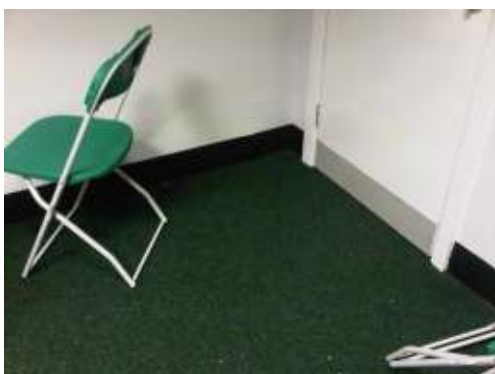
Item 5 – As MBA10/1788

The skirting board to the community room (Room 9) does not contain asbestos.

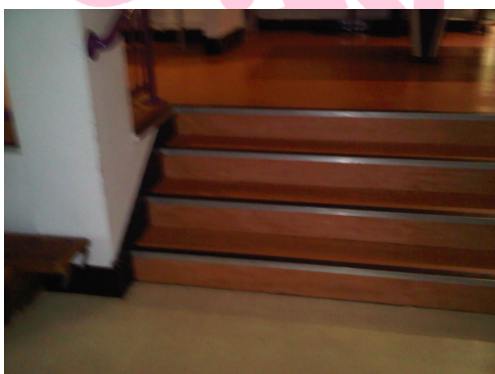
Item 6 - Ref: MBA101789

The stair nosing to the main area community room (Room 9) does not contain asbestos.

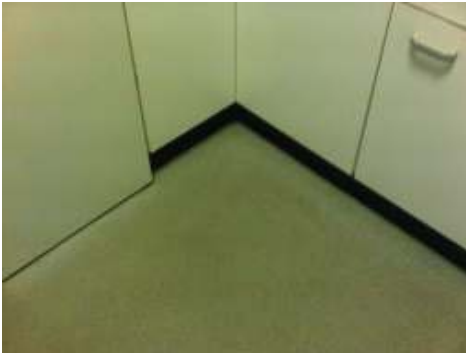
Item 7 – AS MBA10/1788

The skirting board to the kitchen and cleaners cupboard (Room 10) does not contain asbestos.

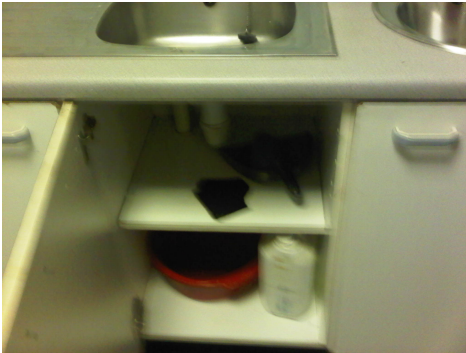
Item 8 - Ref: MBA10/1790

The sink pad to the kitchen and cleaners cupboard (Room 10) does not contain asbestos.

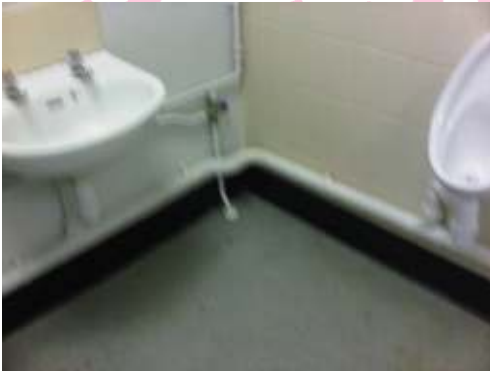
Item 9 – As MBA10/1788

The skirting board to the male WC community Room (Room 11) does not contain asbestos.

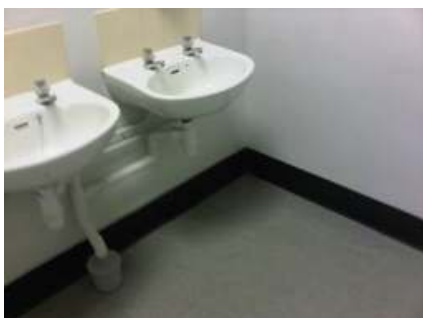
Item 10– As MBA10/1788

The skirting boards to the female WC community room (Room 12) do not contain asbestos.

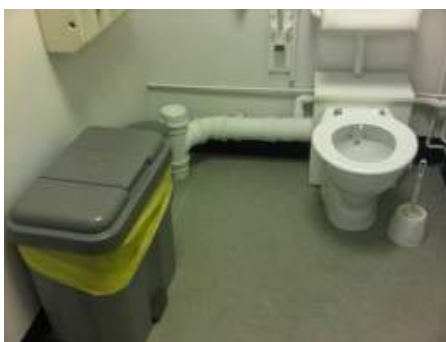
Item 11 –As MBA10/1788

The skirting boards to the disabled WC in the community area (Room 13) do not contain asbestos.

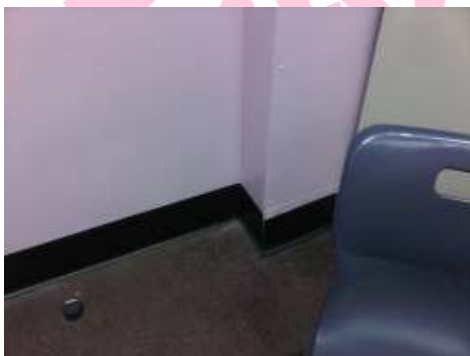
Item 12 –As MBA10/1788

The skirting boards to the IEU off the Community Room (Room 16) do not contain asbestos.

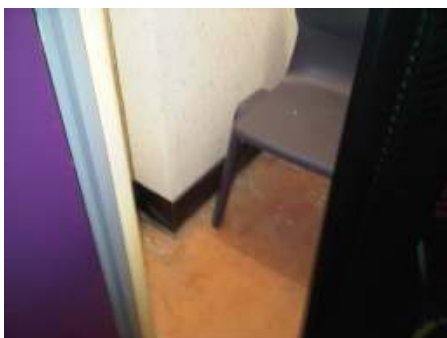
Item 13– As MBA10/1788

The skirting boards to the office area (Room 17) do not contain asbestos.

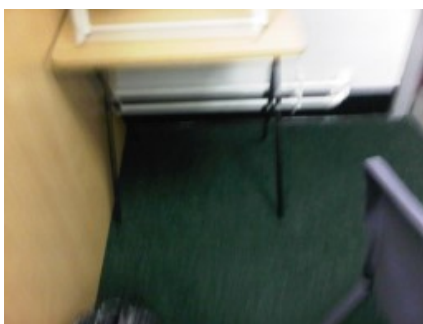
Item 14 –As MBA10/1788

The skirting boards to the classroom off the community area (Room 18) do not contain asbestos.

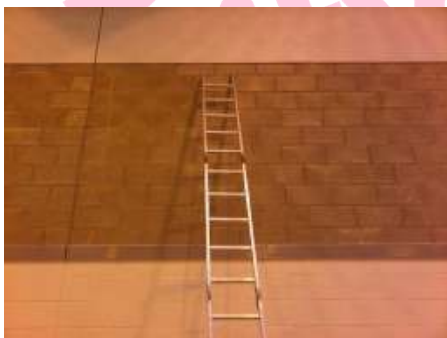
Item 15–Ref:MBA10/1791

The high level boards to the main sports hall (Room 19) do not contain asbestos.

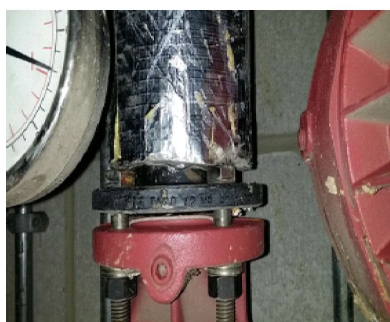
Item 17 Ref: 65006-1

The pipework flange gaskets x 4 (wet) to the pipework in the pool boiler room contains asbestos. Any change in its appearance should be noted and reported to Property Services. **(Confirmed on survey J251522 only 4 present AW005652**

Item 17	Gaskets to pipework x 4 – Pool boiler room (confirmed on survey J251522 only 4 present AW005652	Very Low	12 monthly	03.12.2024
Item 18	Gaskets to pipework x 2 – Pool boiler room	Very Low	12 monthly	Removed – no waste certificates

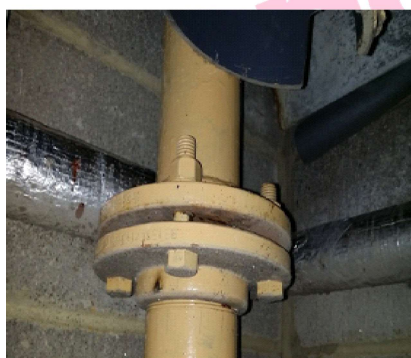
Item 18 Ref: 65006-2

The pipework flange gaskets x 2 (gas) to the pipework in the pool boiler room contains asbestos. Any change in its appearance should be noted and reported to Property Services.
Removed – no paperwork provided

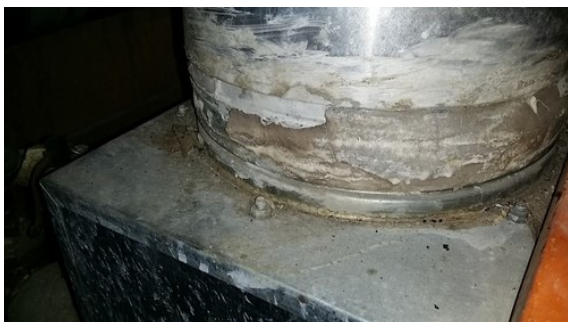
Item 19 Ref: 65006-3

The boilers packing to joint at base of flue in the Pool Boiler Room does not contain asbestos.

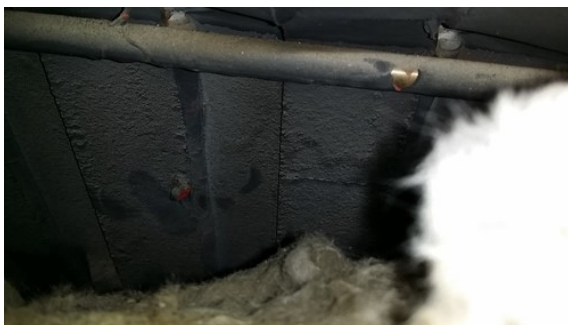
Item 20 Ref: 65006-4

The boilers (boiler segment gasket) in the Pool Boiler Room does not contain asbestos.

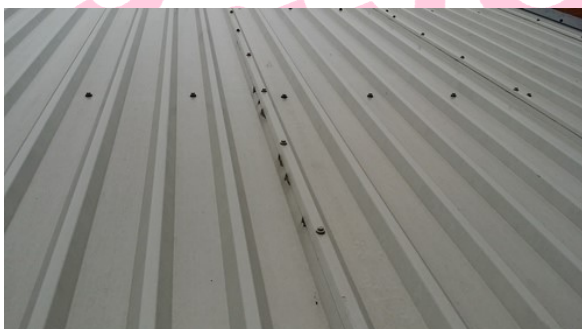
Item 21 Ref: 65006-5

The sealant to roofing panel overlaps (external-localised to proposed solar panel mounting on sports hall roof) does not contain asbestos.

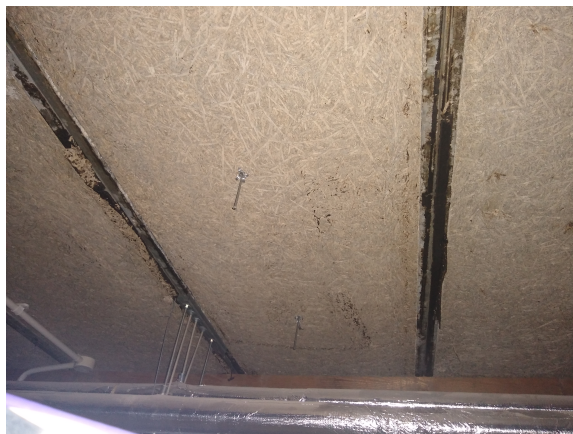
Item 22 Ref: 338853-1

The protruding roof felt and residue to underside of roof to the void above the classroom (Room 001) contains asbestos.

Any works planned within this area should be reported to Property Services.

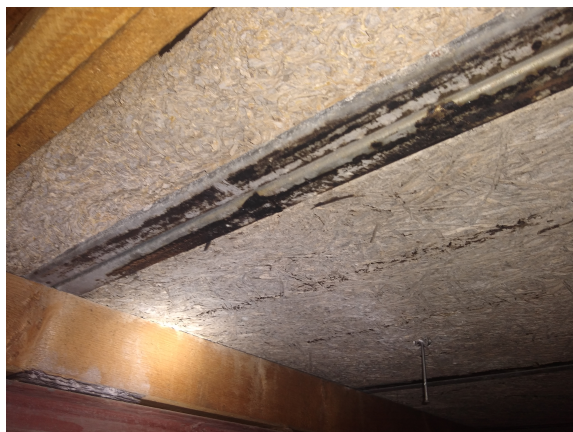
Item 23 Ref: 338853-2

The roof felt to the void above the classroom (Room 001) contains asbestos.

Item 23	Roof felt above – Room 001 void above	Very Low	12 monthly	Do not inspect
Item 24	Roof felt and residue - Room 002 void above	Very Low	12 monthly	Do not inspect

Any works planned within this area should be reported to Property Services.

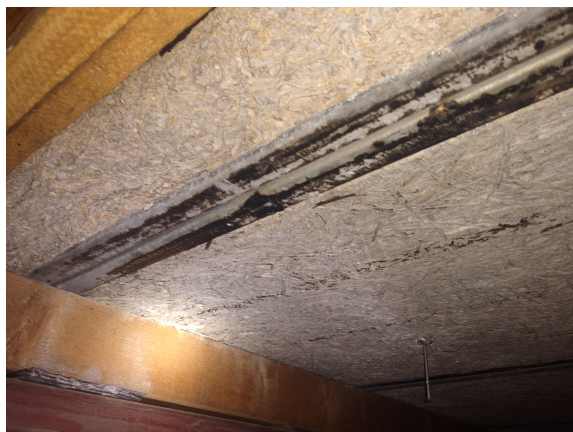
Item 24 Ref: As 338853-1

The protruding roof felt and residue to underside of roof to the void above the classroom (Room 002) contains asbestos.

Any works planned within this area should be reported to Property Services.

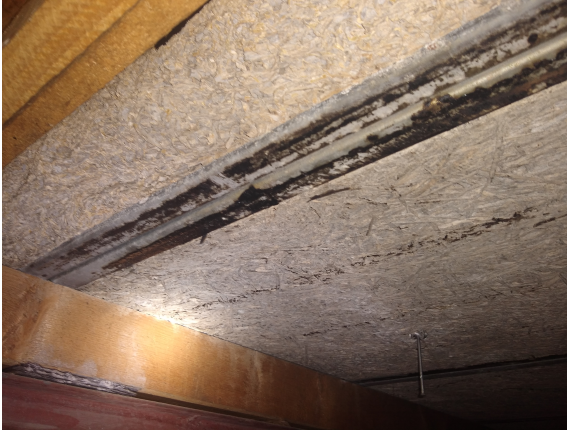
Item 25 Ref: As 338853-2

The roof felt to the void above the classroom (Room 002) contains asbestos.

Item 25	Roof felt above – Room 002 void above	Very Low	12 monthly	Do not inspect
<i>Item 26</i>	<i>No asbestos</i>	<i>Is present</i>

Any works planned within this area should be reported to Property Services.

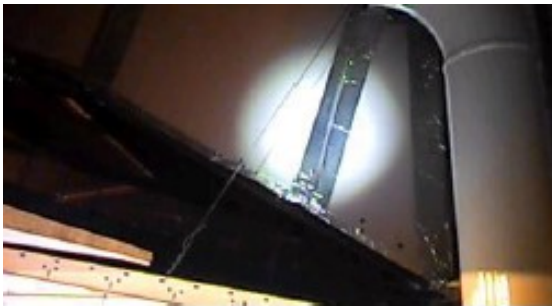
Item 26 Ref: EA000059

The cladding to roof joists (Room 1 Swimming Pool) does not contain asbestos.

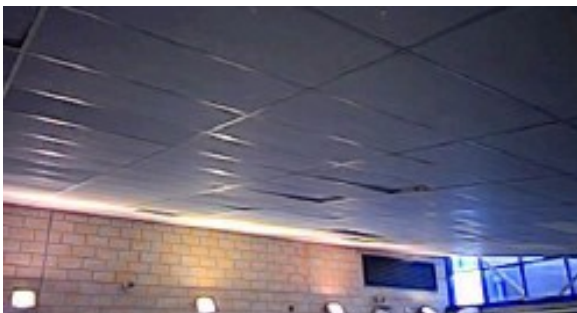
Item 27 Ref: EA000060

The suspended ceiling tiles (Room 1 Swimming Pool) do not contain asbestos.

Removed

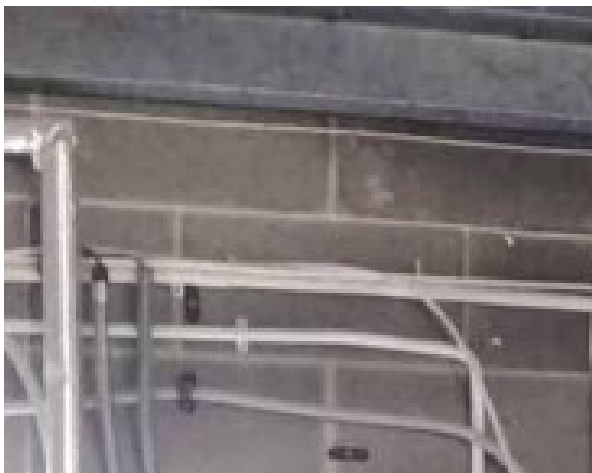
Item 30 Ref: AW005655

The wall joint sealant in the pool tank room (G/001) does not contain asbestos.

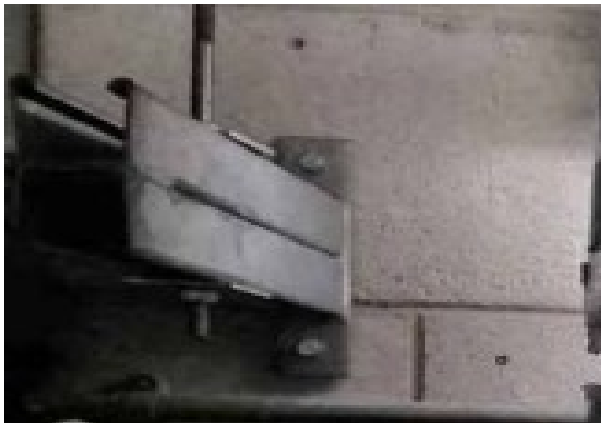
Item 34 Ref: AW005657

The wall joint sealant in the boiler room (G/002) does not contain asbestos.
