ASBESTOS SURVEY REPORT FOR DIAMOND HALL INFANT SCHOOL, SUNDERLAND

Asbestos Register for DIAMOND HALL INFANT ACADEMY, SUNDERLAND

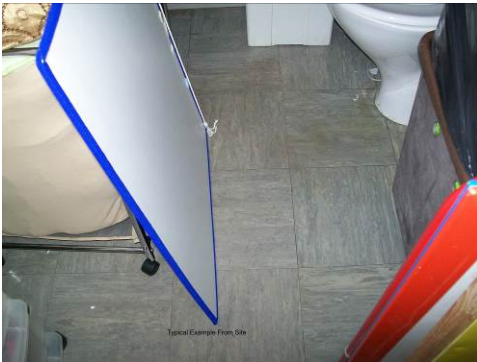
Item 2 - Ref: YA0328/10

The grey floor tiles to the toilets (Area 0/7a) do not contain asbestos.

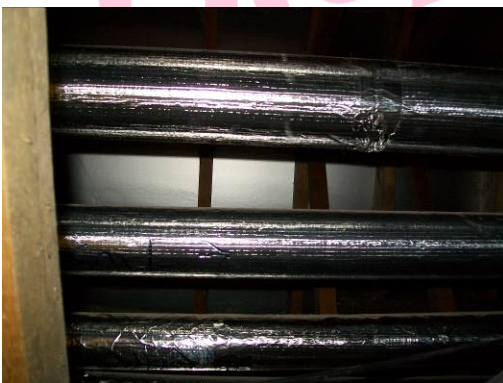
Item 3 - Ref: YA0329/10

The pipe insulation on the pipework in the ceiling void of the toilets (Area 0/9) does not contain asbestos.

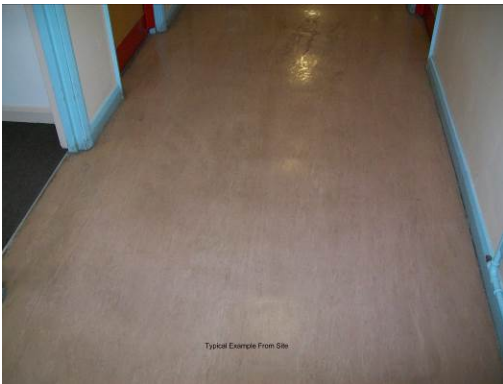
Item 14 - Ref: YA0339/10

The floor covering to the corridor (Area 0/53) does not contain asbestos.

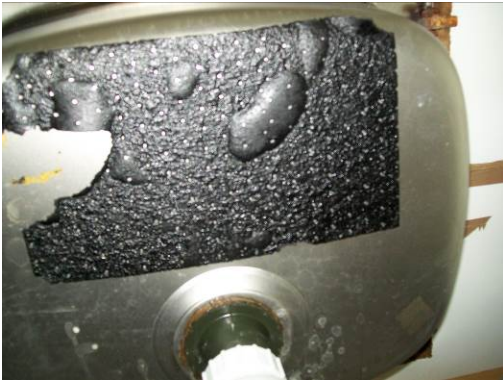
Item 19 - Ref: YA0342/10

The sink pad to the photocopy room (Area 0/81) does not contain asbestos.

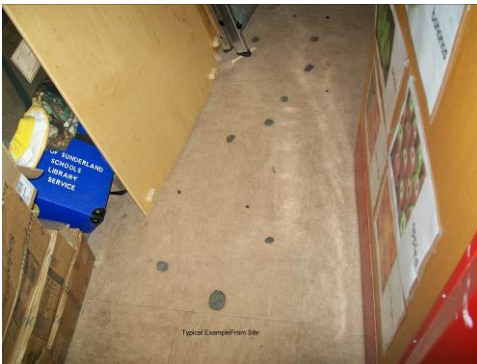
Item 20 - Ref: YA0343/10

The floor covering to the corridor (Area 0/89) does not contain asbestos.

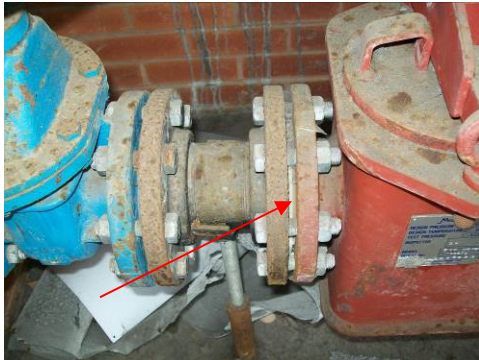
Item 22 - Ref: YA0346/10

The gaskets to the pipework in the gas meter cupboard (Area 0/90) contain asbestos.

This was removed in September 2016.

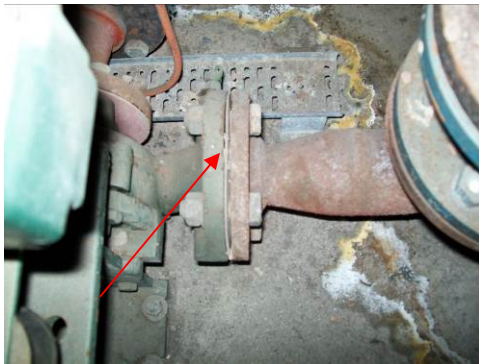
Item 23 - Ref: Presumed

The gaskets to the pipework in the boiler room (Area 0/99) contain asbestos.

Any change in its appearance should be recorded, and passed to Property Services.

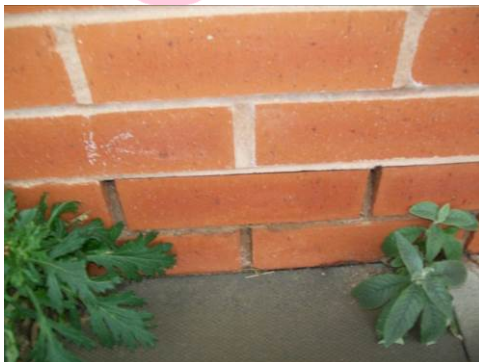
Item 24 - Ref: YA0347/10

The damp proof course to the external of the building (Area E/1) does not contain asbestos.

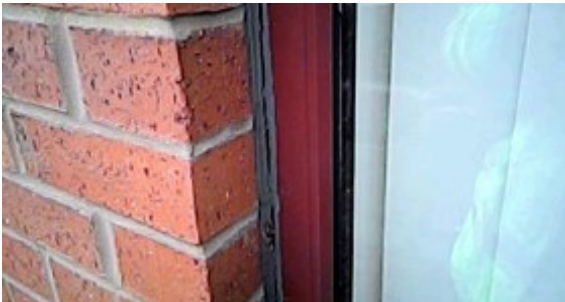
Item 32 - Ref: EC000061

The windows, composite putty sample (external) does not contain asbestos.
