ASBESTOS SURVEY REPORT FOR DIAMOND HALL JUNIOR SCHOOL, SUNDERLAND

Asbestos Register for DIAMOND HALL JUNIOR SCHOOL

Diamond Hall Juniors - Last updated 16/02/2024 – Version 2

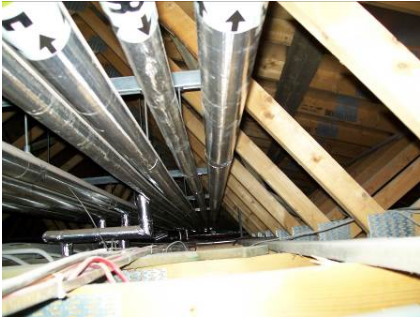
Item 1 Ref: YA305/10

The pipe insulation to the ceiling void in the store room (Area 0/2) does not contain asbestos.

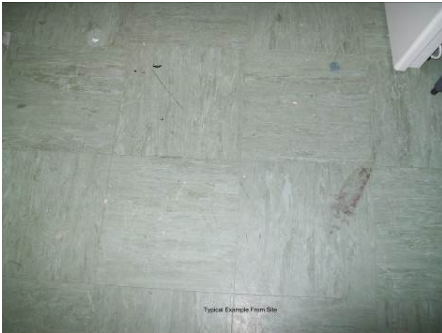
Item 2 - Ref: YA306/10

The green floor tiles to the store cupboard (Area 0/3) do not contain asbestos.

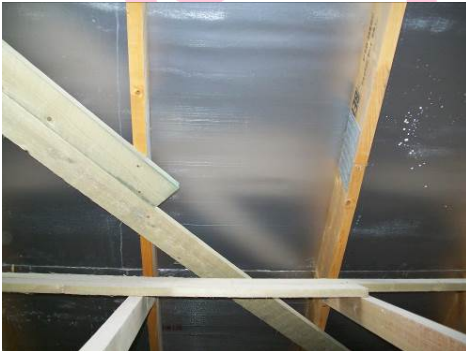
Item 3 - Ref: YA0307/10

The lining to the ceiling void in the office (Area 0/4) does not contain asbestos.

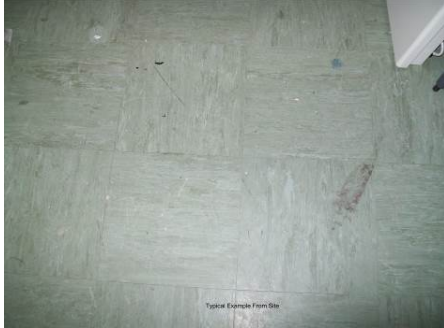
Item 4 - Ref: YA0308/10

The green floor tiles to the photocopy room (Area 0/5) do not contain asbestos.

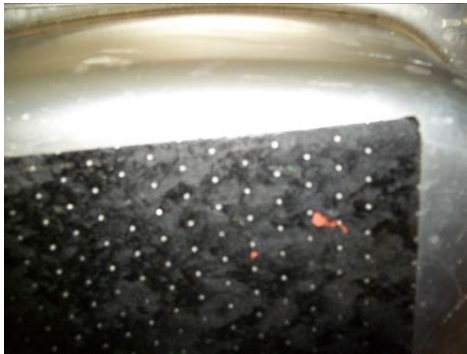
Item 5 - Ref: YA0309/10

The sink pad to the photocopy room (Area 0/5) does not contain asbestos.

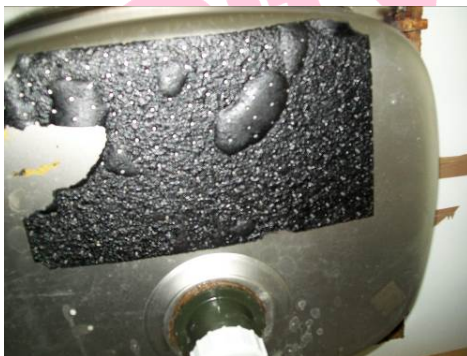
Item 6 - Ref: YA0310/11

The sink pad to the kitchen (Area 0/10) does not contain asbestos.

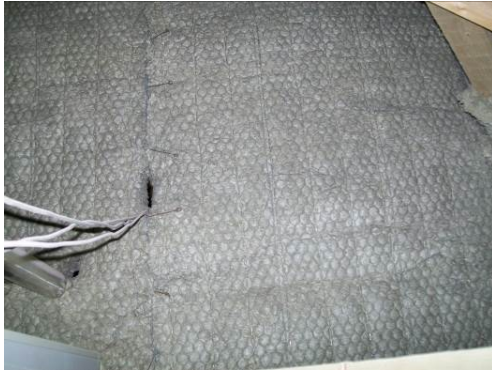
Item 7 - Ref: YA0311/10

The firebreak in the Store Room (Area 0/17) does not contain asbestos.

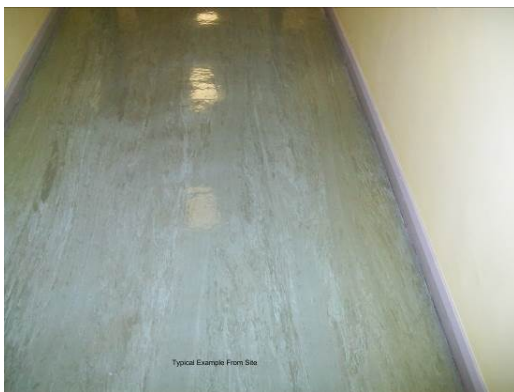
Item 8 - Ref: YA0312/10

The floor tile in the corridor (Area 0/18) does not contain asbestos.

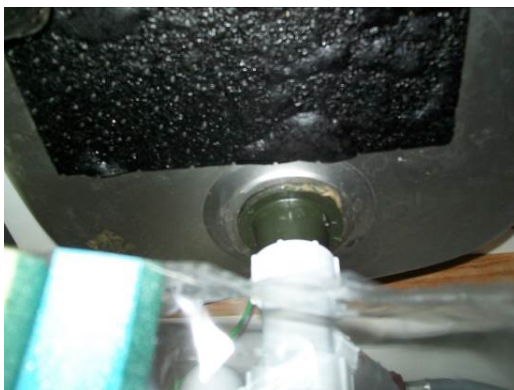
Item 9 - Ref: YA0313/10

The sink pad in the kitchen (Area 0/22) does not contain asbestos.

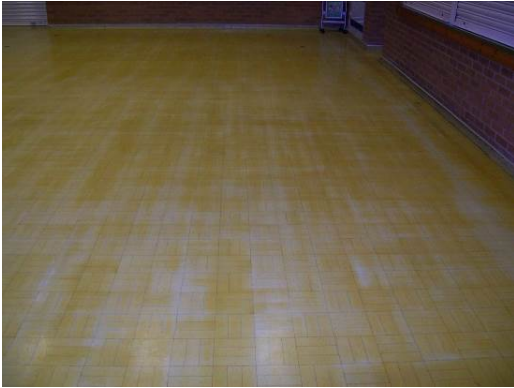
Item 10 - Ref: YA0318/10

The floor tile in the main hall (Area 0/28) does not contain asbestos.

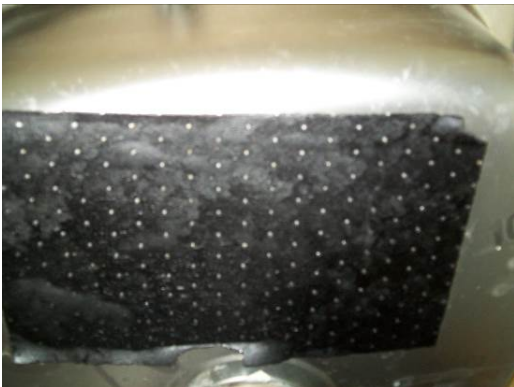
Item 11 - Ref: YA0319/10

The sink pad in the school main kitchen (Area 0/31) does not contain asbestos.

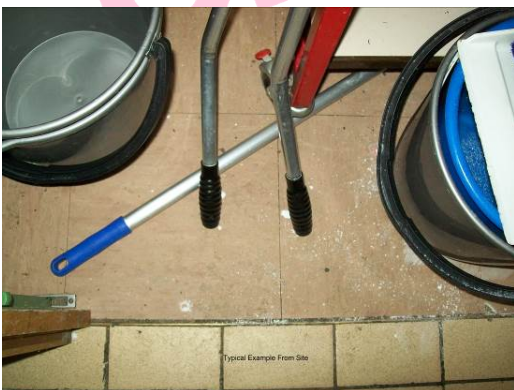
Item 12 - Ref: YA0320/10

The floor tile in the cleaners cupboard (Area 0/33) does not contain asbestos.

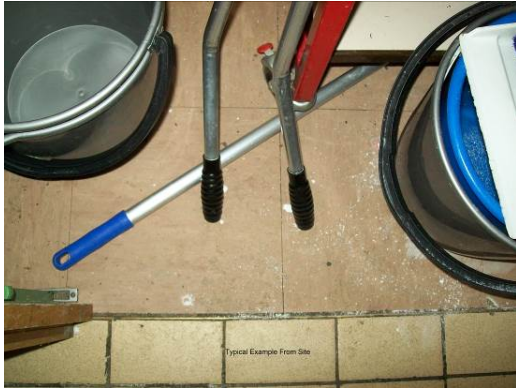
Various - Ref: YA0321/10

The floor tile in the store room pantry (Area 0/37) does not contain asbestos.

Similar floor tiles can be found in toilets (Area 0/35).

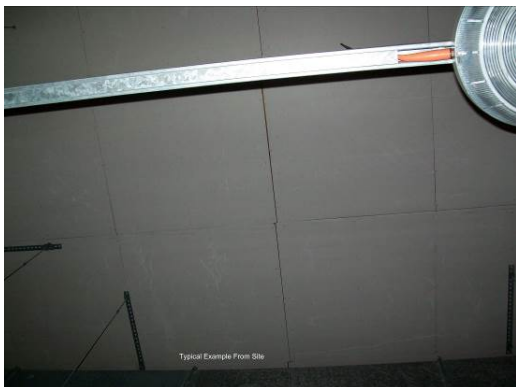
Item 14 - Ref: YA0322/10

The ceiling in the electrical cupboard (Area 0/39) does not contain asbestos.

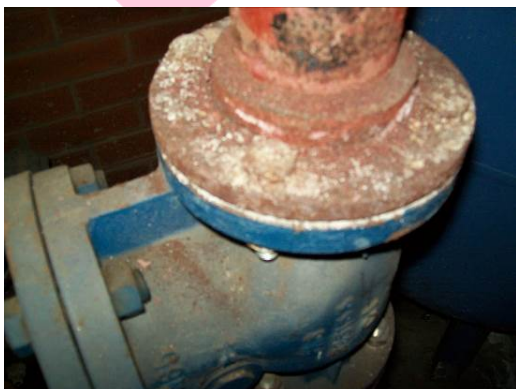
Item 15 - Ref: YA0324/10

The gasket in the Boiler Room (Area 0/39a) contains asbestos.

Removed October 2022

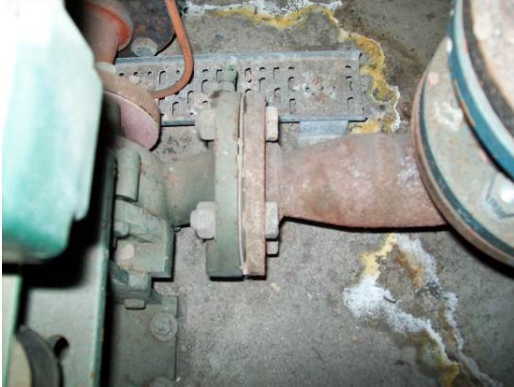
Item 16 - Ref: YA0323/10

The debris to the Boiler Room (Area 0/39a) does not contain asbestos.

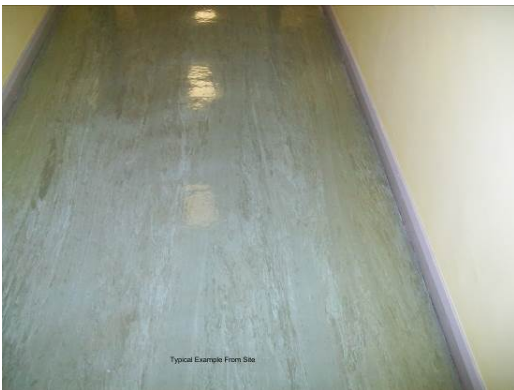
Item 17 - Ref: YA0314/10

The floor tiles in the classroom (Area 0/49) do not contain asbestos.

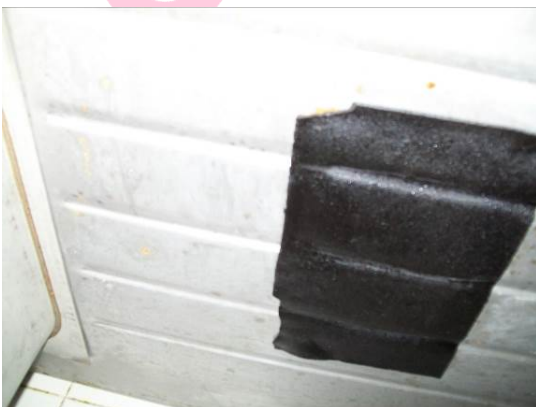
Item 18 - Ref: YA0315/10

The sink pad in the classroom (Area 0/49) does not contain asbestos.

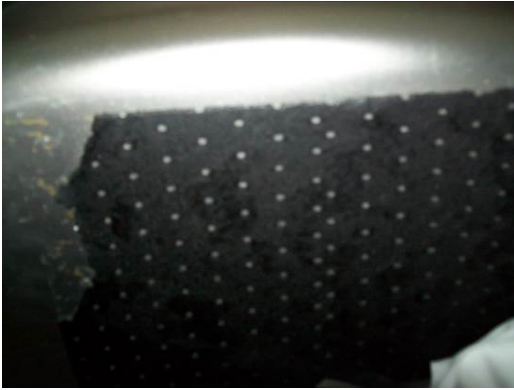
Item 19 - Ref: YA0326/10

The sink pad in the classroom (Area 0/60) does not contain asbestos.

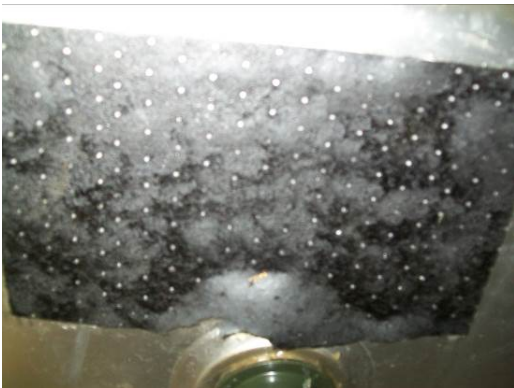
Item 20 - Ref: YA0316/10

The sink pad in the classroom (Area 0/78) does not contain asbestos.

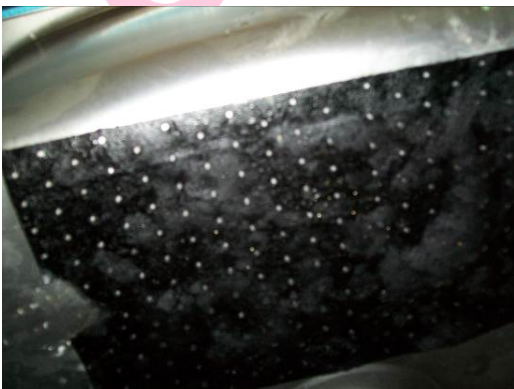
Item 21 - Ref: YA0317/10

The sink pad in the classroom (Area 0/88) does not contain asbestos.

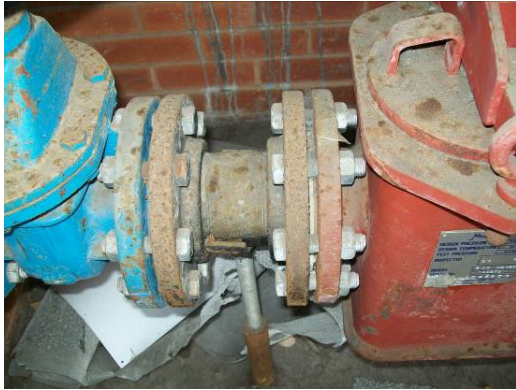
Item 22 - Ref: Presumed

The gasket in the gas meter cupboard (Area 0/101) was presumed to contain asbestos.

Removed September 2016

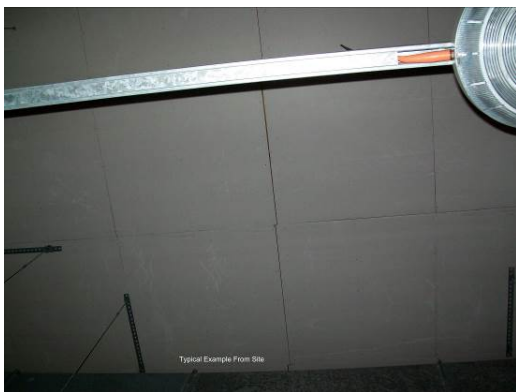
Item 23 - Ref: YA0325/10

The ceiling in the Tank Room (Area 1/1) does not contain asbestos.

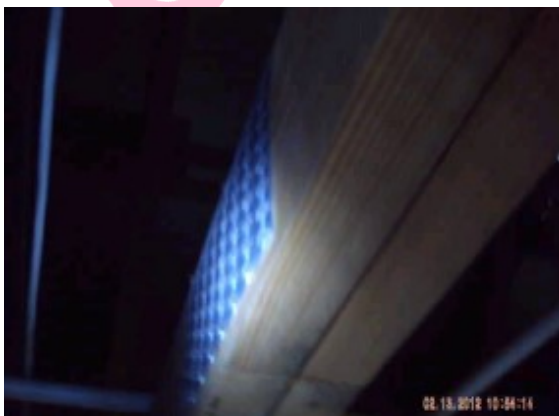
Item 24 - Ref: BB000012

The mastic to ducts in Room 13 does not contain asbestos.

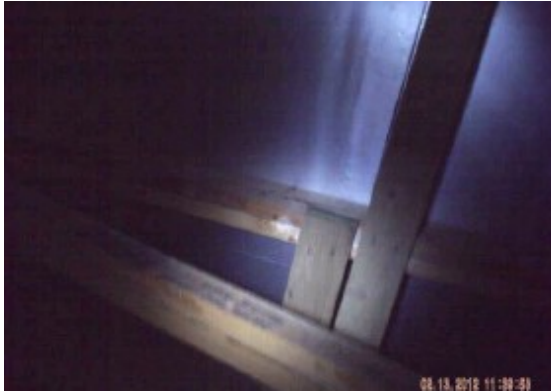
Item 25 - Ref: As BB000012

The mastic to ducts in Room 22 does not contain asbestos.

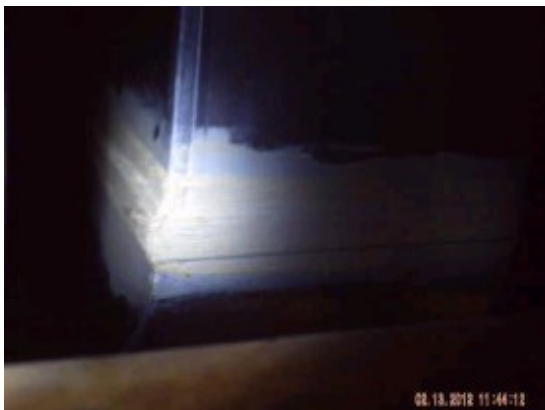
Item 26 - Ref: As BB000012

The mastic to ducts in Room 23 does not contain asbestos.

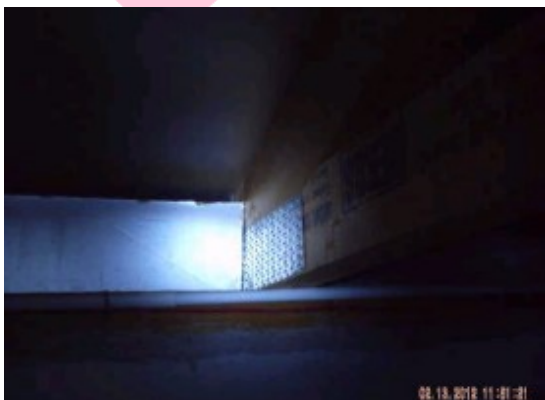
Item 27 - Ref: As BB000012

The mastic to ducts in Room 24 does not contain asbestos.

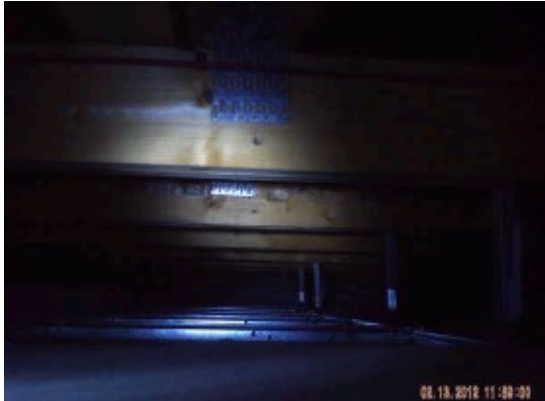
Item 28 - Ref: As BB000012

The mastic to ducts in Room 26 does not contain asbestos.

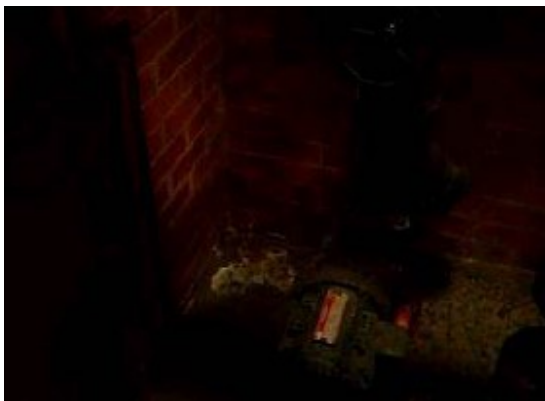
Item 30 - Ref: AA002392

The debris to floor in Room 99/Boiler Room does not contain asbestos.

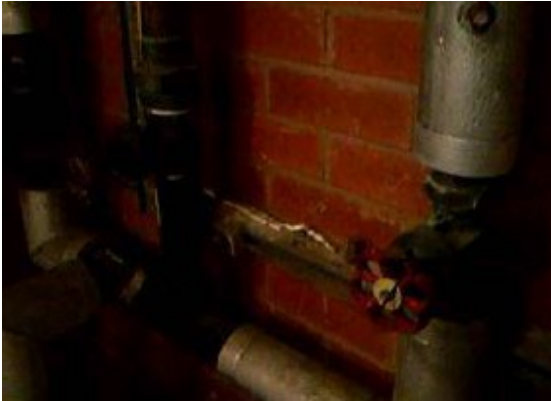
Item 31 - Ref: AA002393

The debris to pipework from ceiling in Room 99/Boiler Room does not contain asbestos.

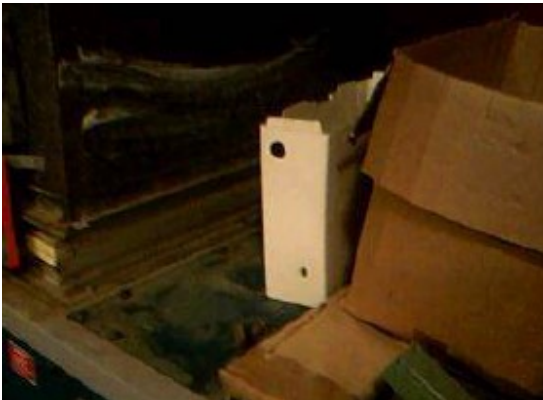
Item 32 - Ref: AA002394

The debris/dust to machinery in Room 99/Boiler Room does not contain asbestos.

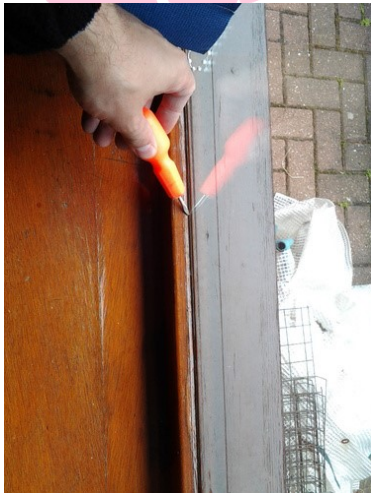
Item 36 - Ref: 50099-1

The putty to window panes in Room 001/corridor does not contain asbestos.

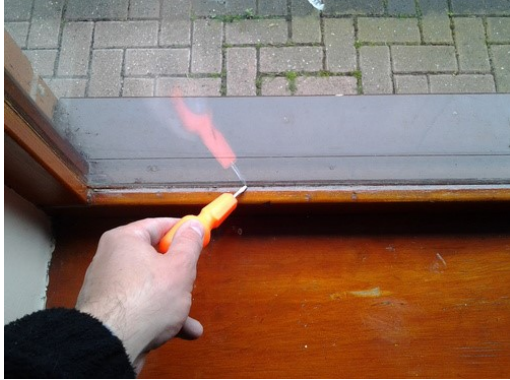
Item 37 - Ref: As 50099-1

The putty to window panes in Room 002/corridor does not contain asbestos.

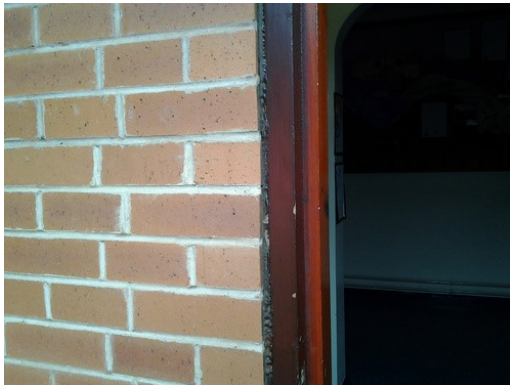
Item 38 - Ref: 50099-2

The sealant to door frames (External) does not contain asbestos.

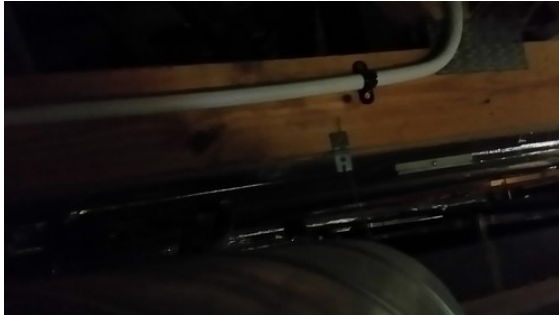
Item 40 - Ref: 80198-1

The debris to room 005/Library (void above) does not contain asbestos.

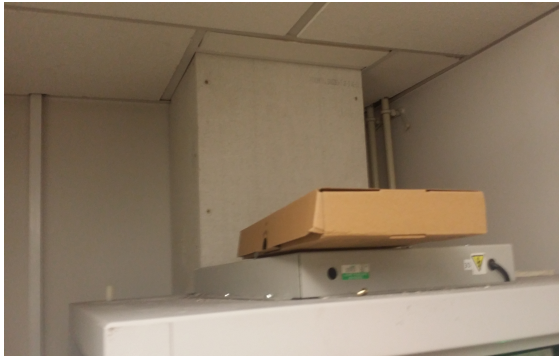
Item 41 - Ref: 395468-1

The boxing in the Server Room (Room 018) does not contain asbestos.

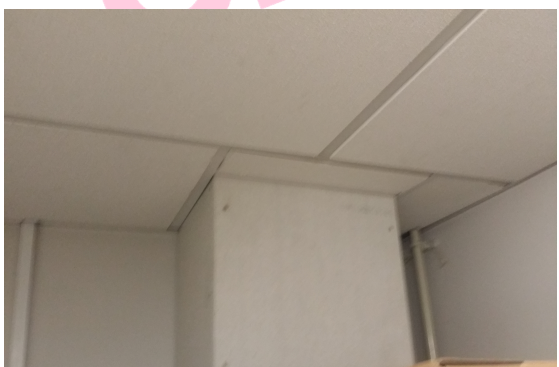
Item 42 - Ref: As 395468-1

The supalus boxing in the Server Room (Room 018) (void above) does not contain asbestos.

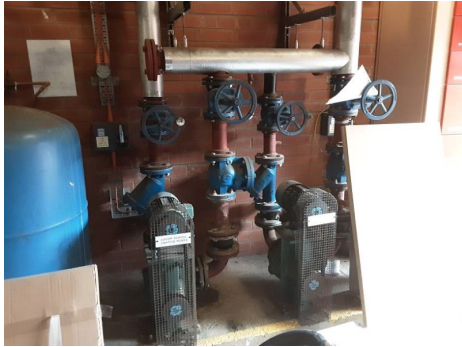
Item 43 - Ref: NA001336

The gaskets (Boiler House)
contain asbestos.

Removed October 2022

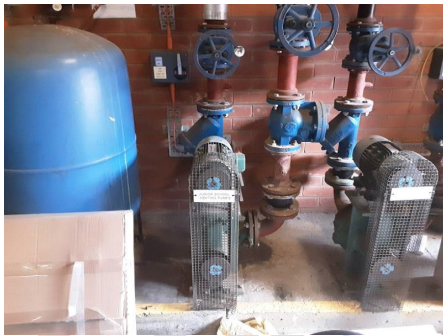
Item 44 - Ref: NA001336

The gaskets (Boiler House)
contain asbestos.

Removed October 2022
