### **ASBESTOS SURVEY REPORT FOR FULWELL INFANT ACADEMY SCHOOL, SUNDERLAND**

## **Asbestos Register for FULWELL INFANT ACADEMY**

**Date: 01 February 2024**

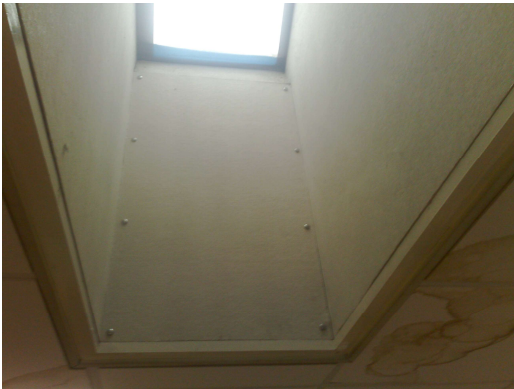
### **Various - Ref: NO09/175**

The skylight upstands to the waiting area do not contain asbestos.

Similar upstands are located in reception 2.

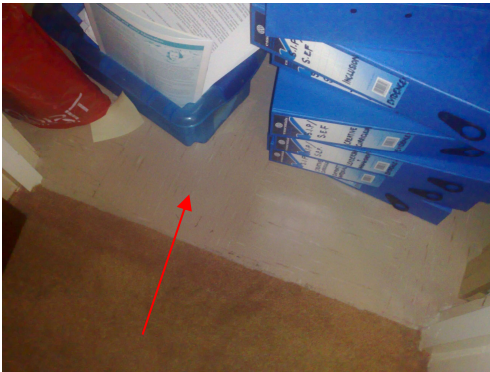
### **Various - Ref: NO09/176**

The floor tiles to the Deputy Heads office do not contain asbestos.

Similar flooring is located in: HT office, Elec intake, Emerg battery room, Stationary store, Gents WC, Ladies WC, Middle Inf store, Teaching area 2021, Mixed hazard store, Disabled WC, Recep Area 1, Chemical store, Top infants store, Hall store, Kitchen WC, Kitchen office, Dry store and cleaners store.

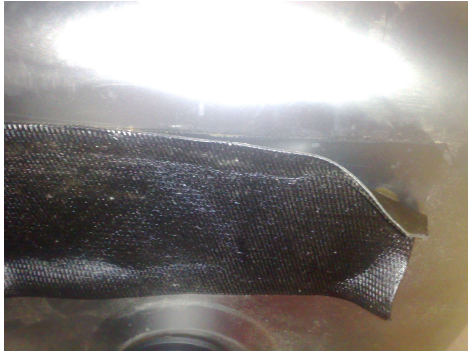
**Item 4 - Ref: NO09/177**

The sink pad to the staff room does not contain asbestos.

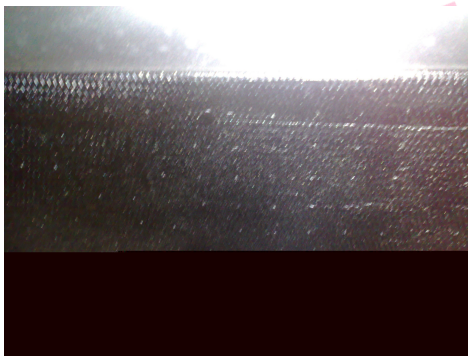
**Item 10 - Ref: NO09/179**

The sink pad to reception 2 does not contain asbestos.

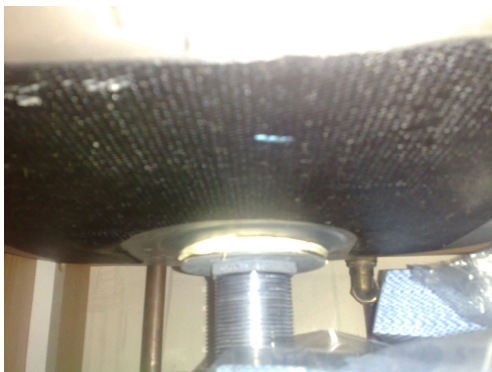
**Item 12 - Ref: NO09/180**

The sink pad in the middle infants does not contain asbestos.

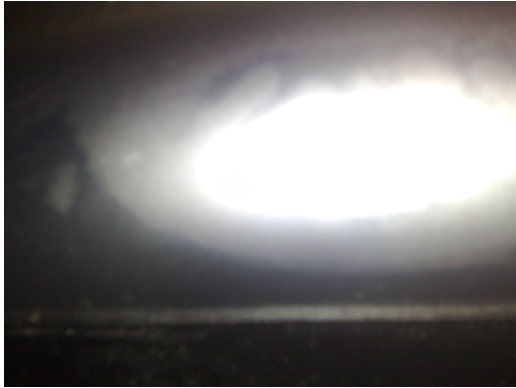
**Item 18 - Ref: NO09/178**

The sink pad to reception area 1 does not contain asbestos.

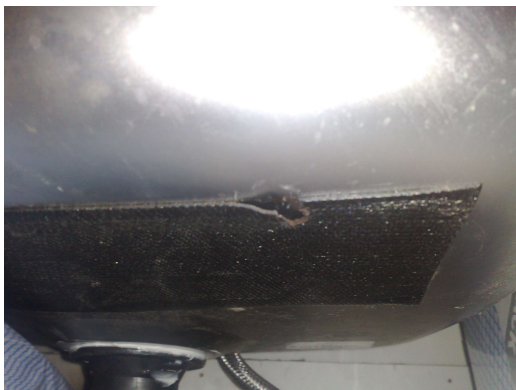
**Item 21 - Ref: NO09/181**

The sink pad to the top infants does not contain asbestos.

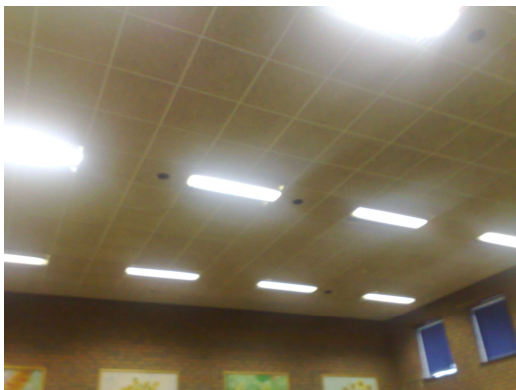
**Item 23 - Ref: NO09/182**

The ceiling tiles to the hall do not contain asbestos.

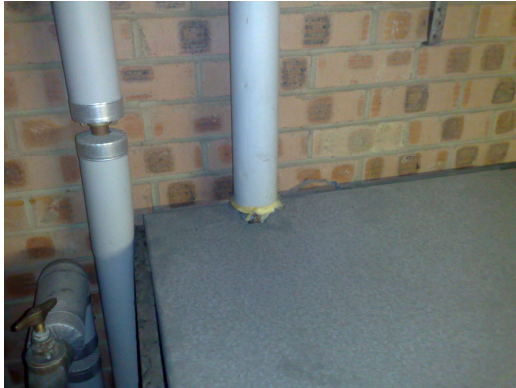
**Item 29 - Ref: NO09/183**

The pipe insulation in the boiler house on the first floor does not contain asbestos.

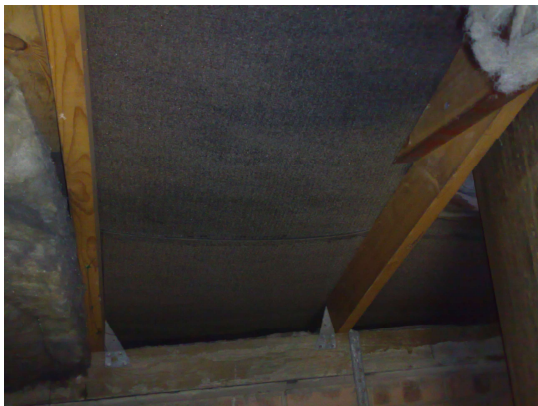
**Item 30 - Ref: NO09/184**

The felt to the roof of the first floor boiler room does not contain asbestos.

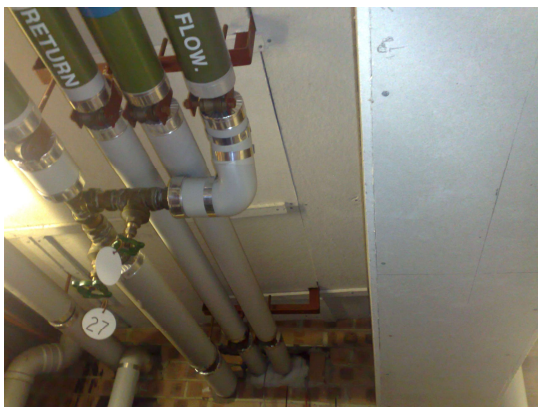
**Item 31 - Ref: NO09/185**

The ceiling boards to the boiler house on the ground floor do not contain asbestos.

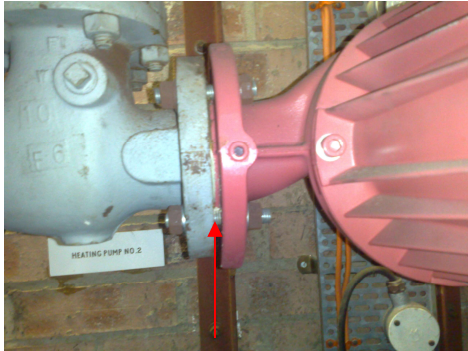
**Item 32 - Ref: NO09/186**

The gasket material in the boiler house on the ground floor contained asbestos.

*This was removed in July 2015.*

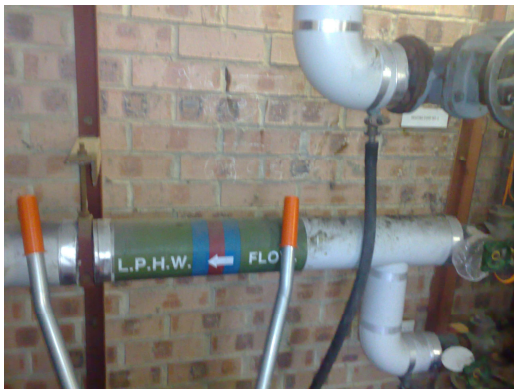
**Various - Ref: NO09/187**

The pipe insulation to the boiler house on the ground floor does not contain asbestos.

Similar insulation is located in the ceiling void.

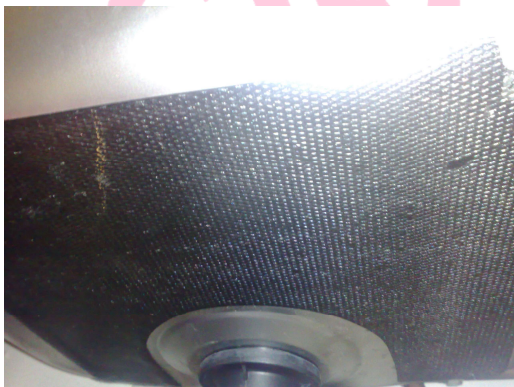
**Item 34 - Ref: NO09/188**

The sink pad to the nursery does not contain asbestos.

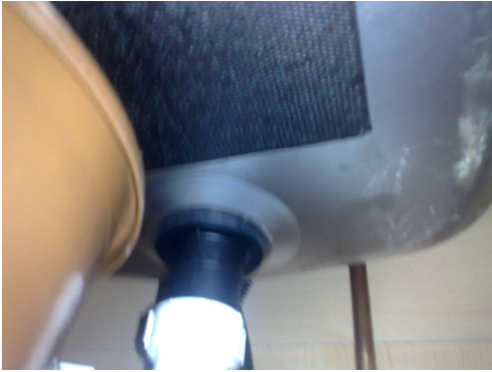
**Item 35 - Ref: NO09/191**

The sink pad to the circular sink in the nursery does not contain asbestos.

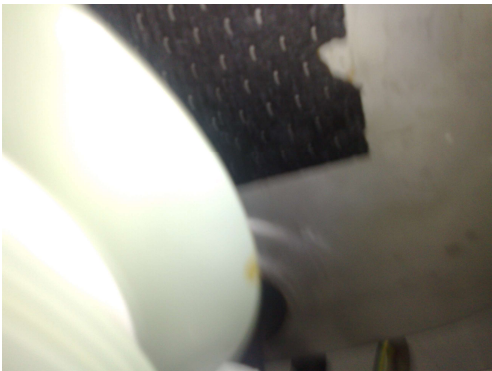
**Item 36 - Ref: NO09/189**

The sink pad to the sink in the nursery boiler room does not contain asbestos.

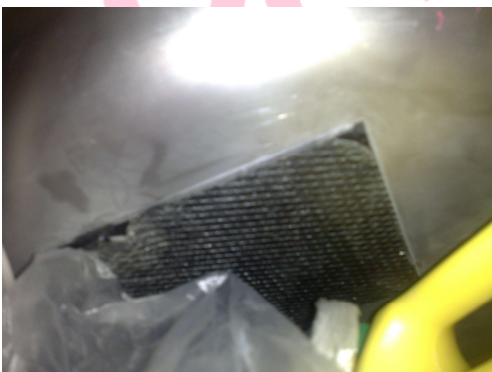
**Item 37 - Ref: NO09/190**

The sink pad to the nursery kitchen does not contain asbestos.

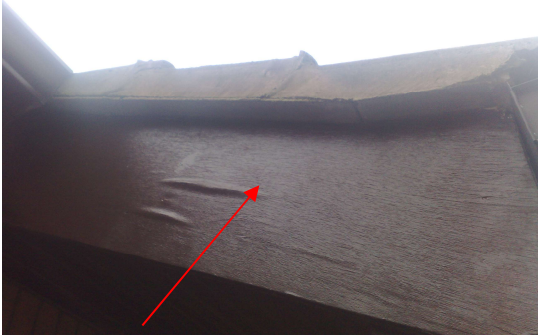
**Item 38 - Ref: NO09/192**

The fillet board to the external of the building does not contain asbestos.

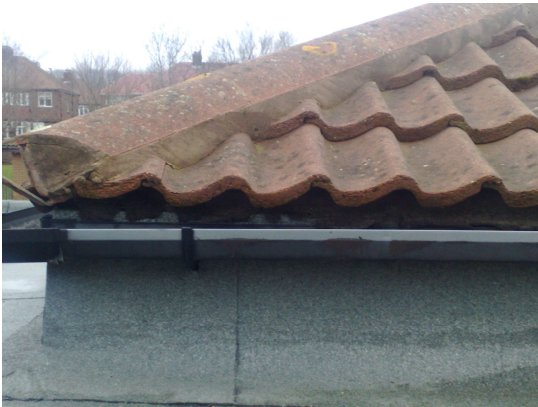
**Item 39 - Ref: NO09/193**

The roof felt to the external does not contain asbestos.

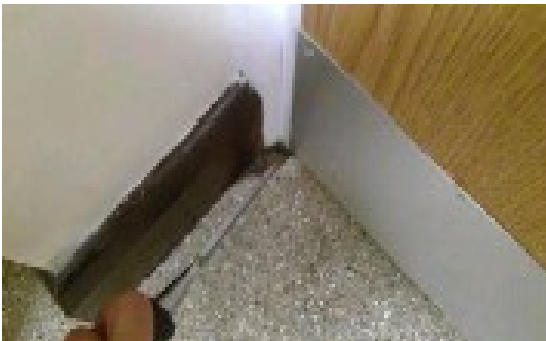
**Visual**

The floor beneath the lino in the kitchen was accessed and no suspect materials were found.

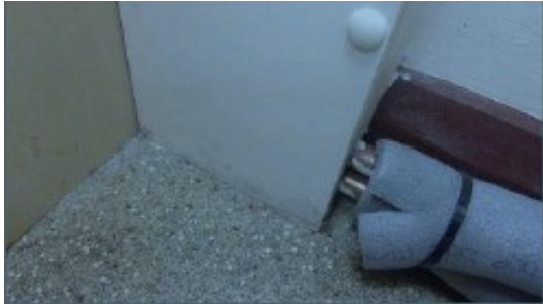
**Visual**

The boxing void in the kitchen was accessed. No suspect materials were found.

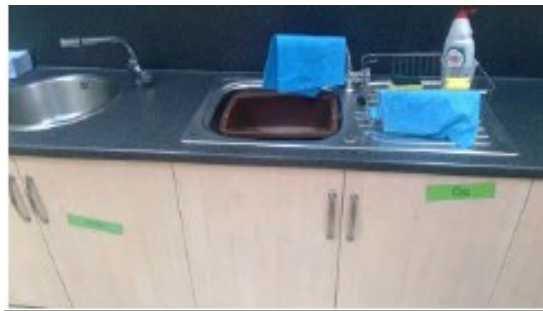
**Item 41 - Ref: AK000133**

The sink pad in the kitchen does not contain asbestos.

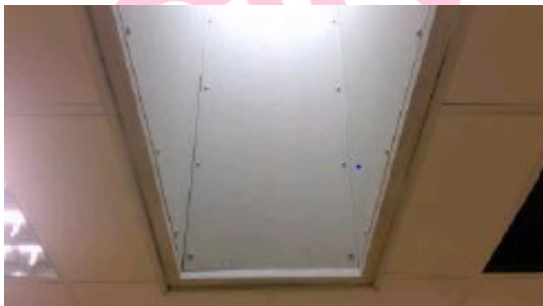
**Item 42 – Ref: AK000134**

The insulation board to the sky light window in the kitchen does not contain asbestos.

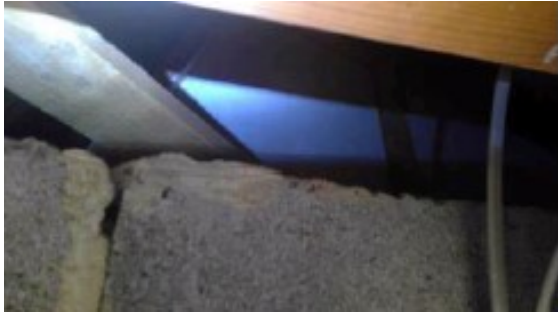
**Item 43 – Ref: As AK000134**

The insulation board above the ceiling tiles in the kitchen does not contain asbestos.

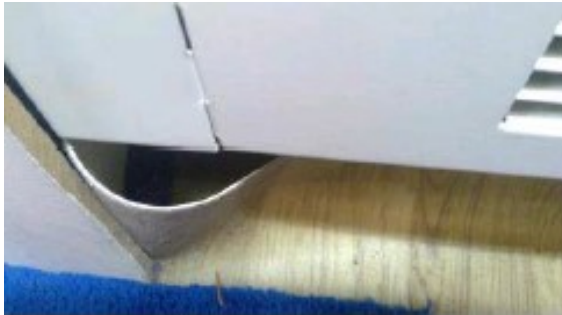
**Visual**

The lino below the floor in the link room was accessed and no suspect materials were found.

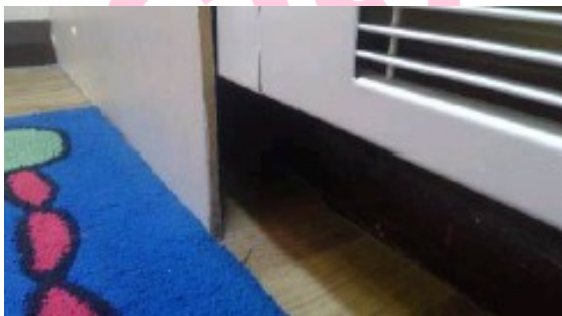
**Visual**

The boxing void in the link room was accessed and no suspect materials were found.

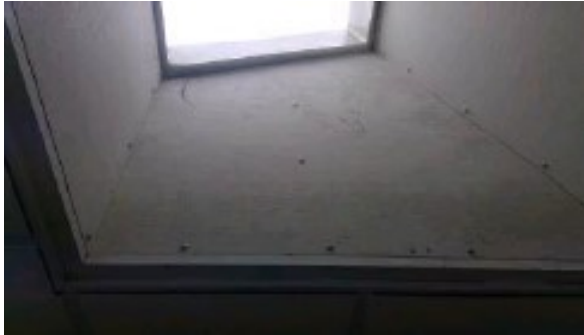
**Item 44 – Ref: As AK000134**

The insulation board to the sky light window in the link room does not contain asbestos.

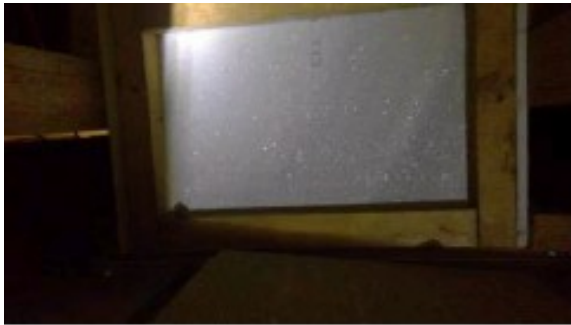
**Item 45 - Ref: As AK000134**

The insulation board above the ceiling tiles in the link room does not contain asbestos.

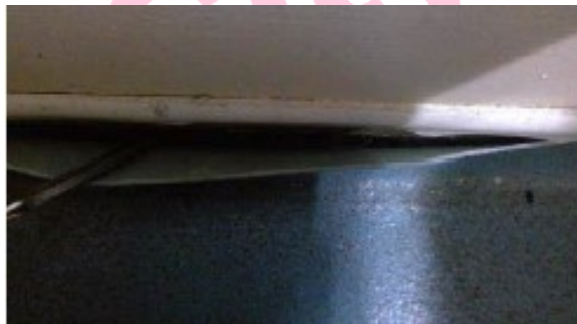
**Visual**

The floor below the lino in the medical room was accessed and no suspect materials were found.

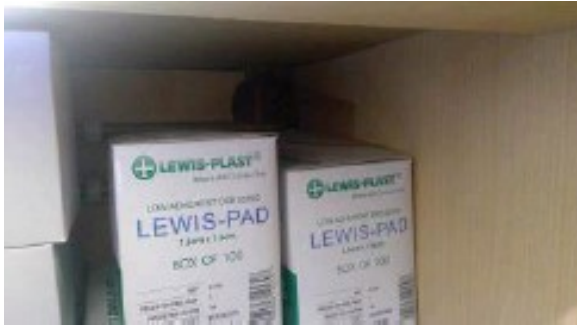
**Visual**

The boxing void in the medical room was accessed and no suspect materials were found.

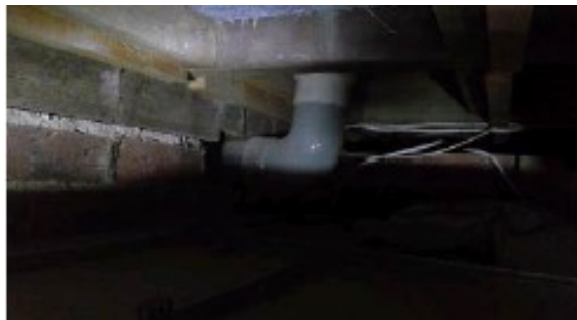
**Visual**

The ceiling void in the medical room was accessed and no suspect materials were found.

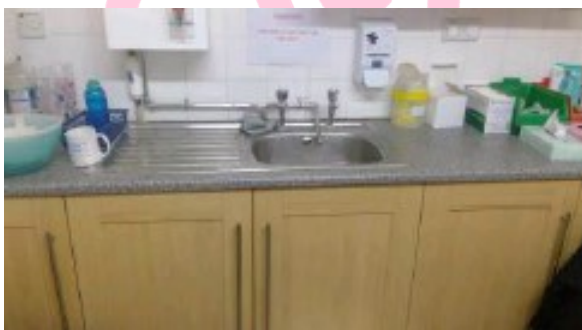
**Item 46 – Ref: AK000135**

The sink pad in the medical room does not contain asbestos.

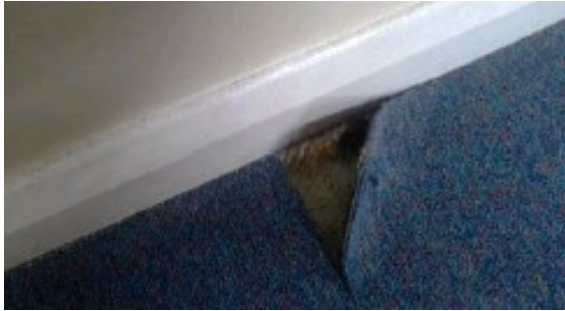
**Visual**

The floor below the carpet tiles in the staff room was accessed and no suspect materials were found.

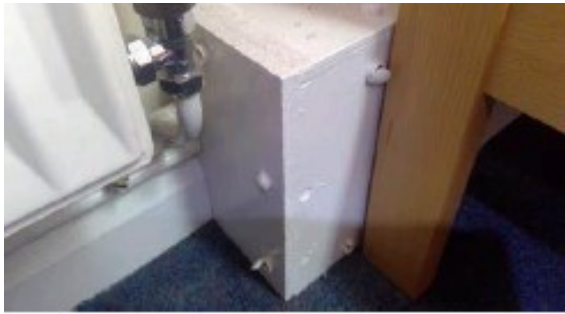
**Visual**

The boxing void in the staff room was accessed and no suspect materials were found.

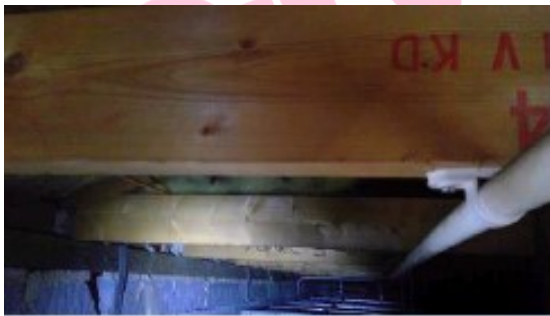
**Visual**

The ceiling void in the staff room was accessed and no suspect materials were found.

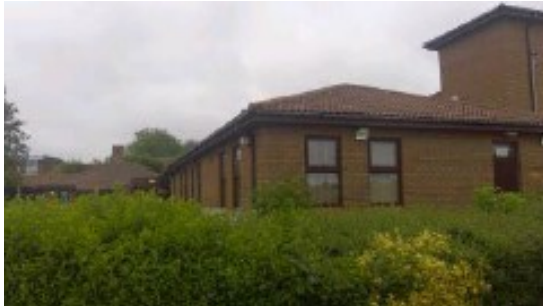
**Visual**

The external area to the school was accessed and no suspect materials were found.

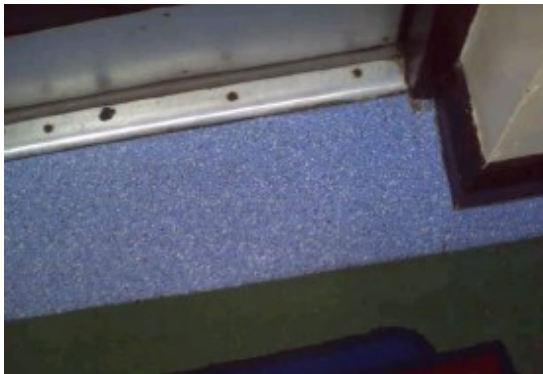
**Item 47 – Ref: BB000343**

The Lino on concrete in the Reception area 1 does not contain asbestos.

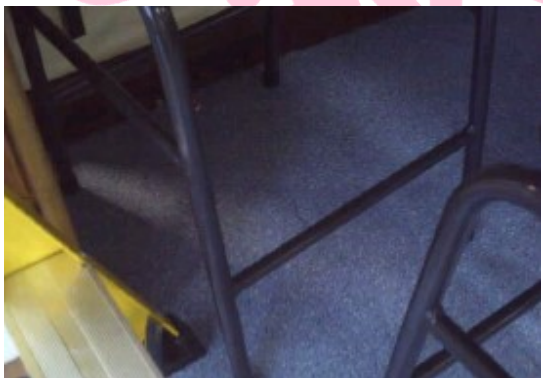
**Item 48 – Ref: As BB000343**

The Lino on concrete in the Quiet Room 2 does not contain asbestos.

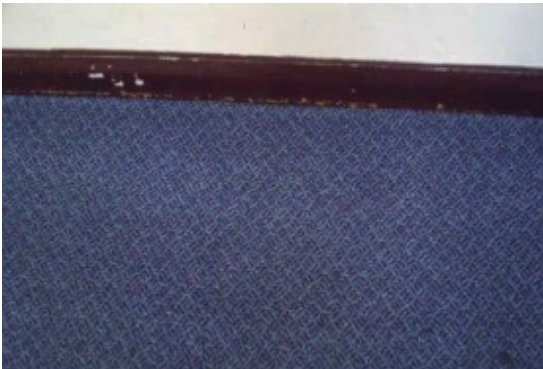
**Item 50 – Ref: As BB000343**

The Lino under carpet in Reception area 2 does not contain asbestos.

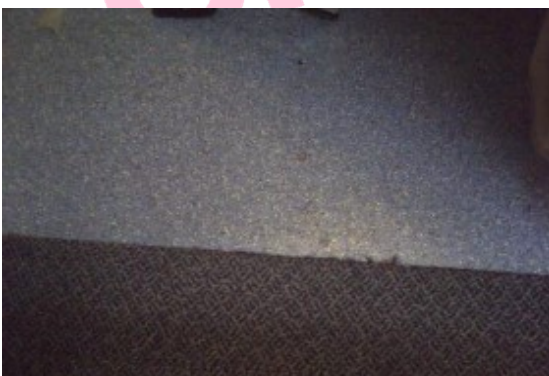
**Item 51 – Ref: As BB000343**

The Lino on concrete in the Store does not contain asbestos.

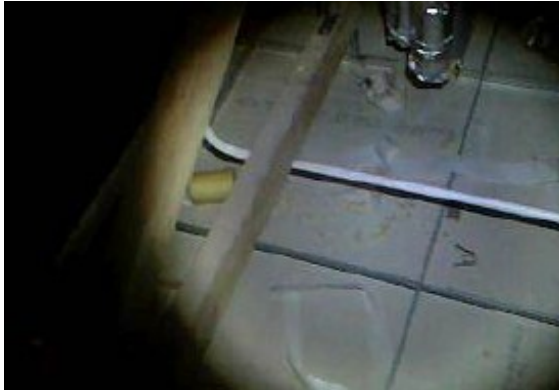
**Item 52 – Ref: AD001191**

The Debris to ceiling in the Nursery Roof Void does not contain asbestos.

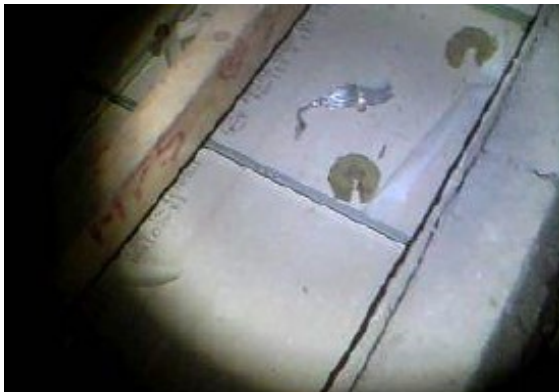
**Item 53 – Ref: AD001192**

The Debris to ceiling top in the Nursery Roof Void does not contain asbestos.

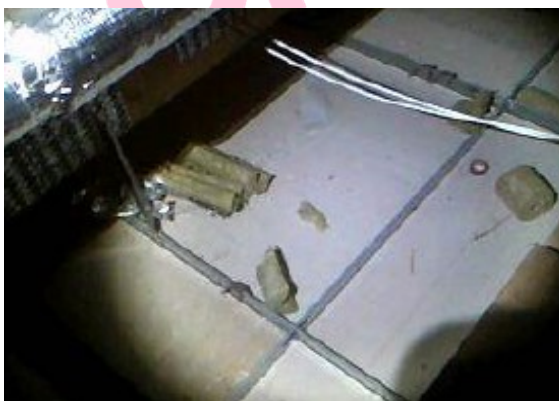
**Item 54 – Ref: AD001193**

The Debris to ceiling top in the Nursery Roof Void does not contain asbestos.

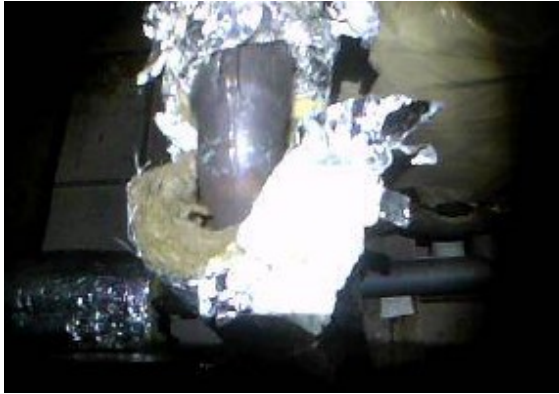
**Item 55 – Ref: AD001194**

The residue to pipework in the Nursery Roof Void does not contain asbestos.

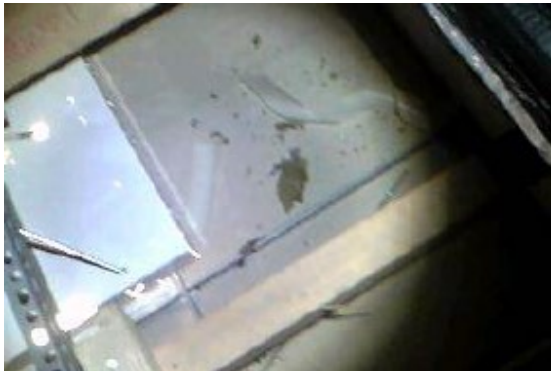
**Item 56 – Ref: AD001195**

The debris to ceiling top in the Nursery Roof Void does not contain asbestos.

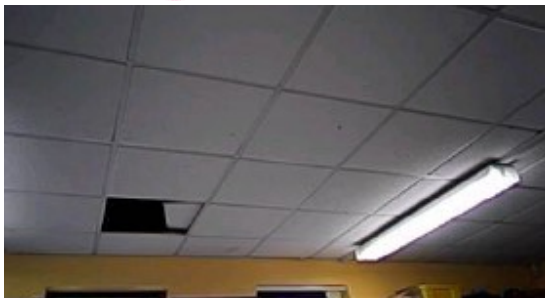
**Item 57 – Ref: EB000309**

The ceiling tiles in room 1 do not contain asbestos.

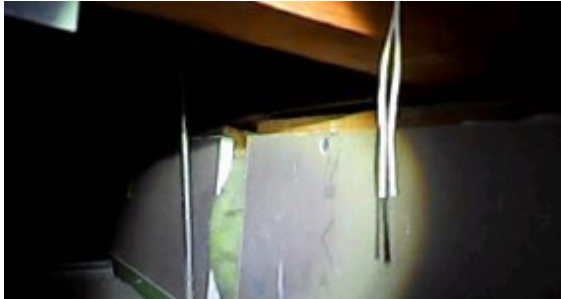
**Item 58 – Ref: EB000310**

The partition wall in the Practical area & Class 6 does not contain asbestos.

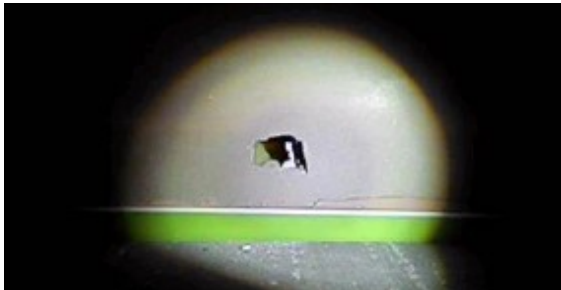
**Item 59 – Ref: As EB000310**

The partition wall in Class 6 & Class 5 does not contain asbestos.

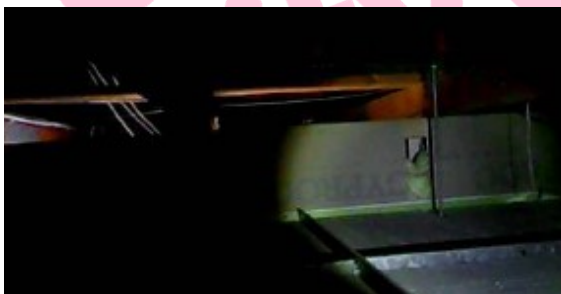
**Item 60 – Ref: As EB000310**

The partition wall in the Practical area & Class 5 does not contain asbestos.

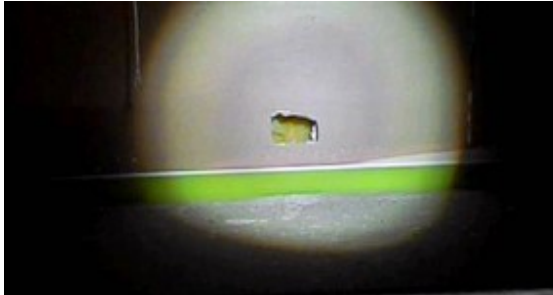
**Item 61 – Ref: As EB000310**

The partition wall in the Practical area & Class 4 does not contain asbestos.

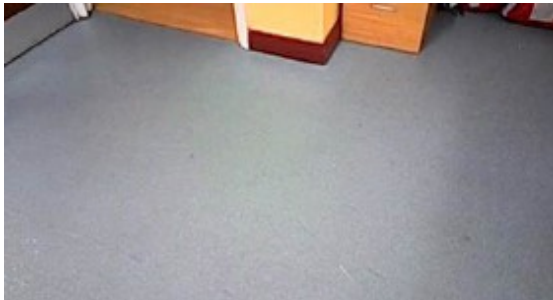
**Item 62 – Ref: EB000311**

The blue vinyl floor covering in Room 1 does not contain asbestos.

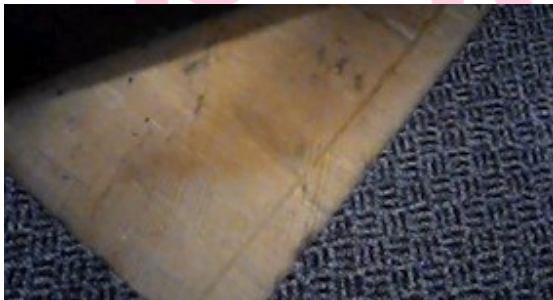
**Item 63 – Ref: EB000313**

The beige vinyl tiles in Class 6/Room 1 does not contain asbestos.

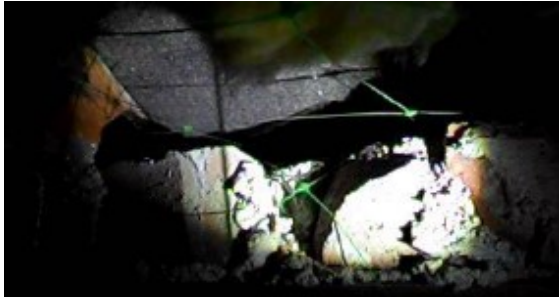
**Item 64 – Ref: EB000314**

The sarking to felt roof in Room 2 roof void does not contain asbestos.

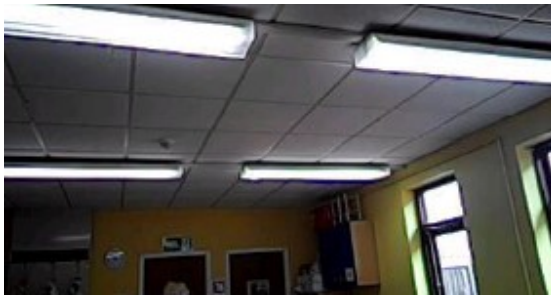
**Item 65 – Ref: As EB000309**

The Ceiling tiles in Room 3 do not contain asbestos.

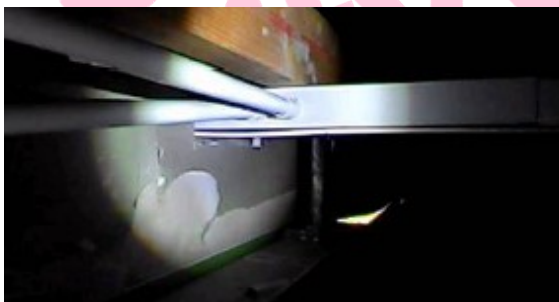
**Item 66 – Ref: As EB000310**

The Partition wall between Practical area & class 3 in Room 3 does not contain asbestos.

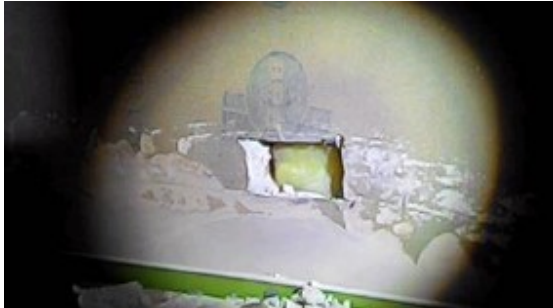
**Item 67 – Ref: As EB000310**

The Partition wall between Practical area & class 2 & 1 in Room 3 does not contain asbestos.

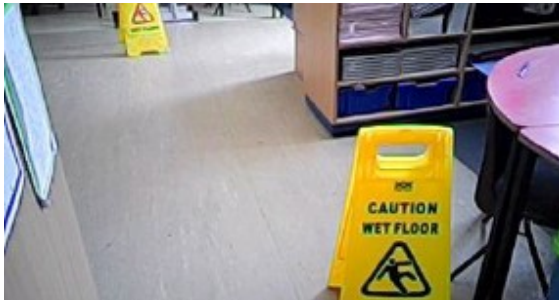
**Item 68 – Ref: As EB000313**

The Beige vinyl tiles in Room 3 do not contain asbestos.

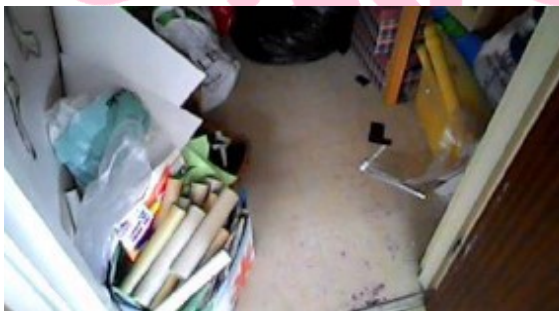
**Item 69 – Ref: As EB000312**

The Beige vinyl tiles in Room 3 do not contain asbestos.

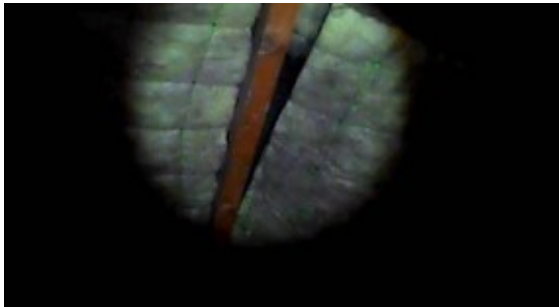
**Item 71 – Ref: As EB000314**

The Sarking to felt roof in Room 4 roof void does not contain asbestos.

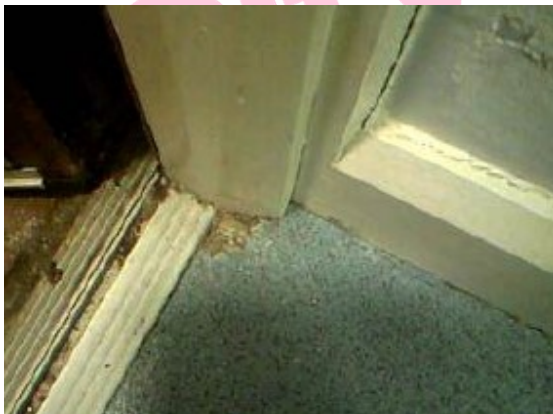
**Item 72 – Ref: BB004336**

The Lino and bitumen in Nursery Staff Room does not contain asbestos.

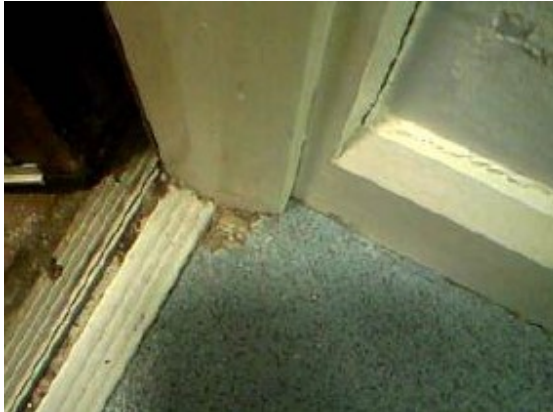
**Item 72 – Ref: BB004336**

The Lino and bitumen in Nursery Staff Room does not contain asbestos.

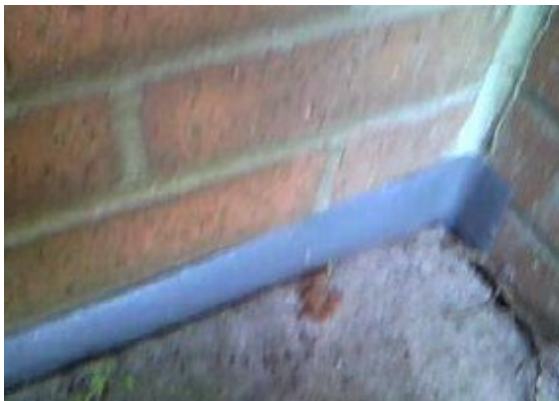
**Item 73 – Ref: BB004337**

The Damp proof course (external) does not contain asbestos.

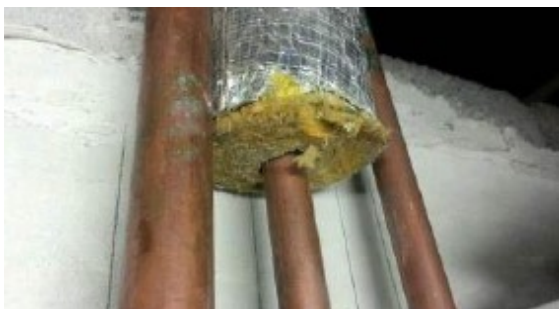
**Item 74 – Ref: EY001751**

The Pipe lagging in the Nursery Chemical Cupboard ceiling void does not contain asbestos.

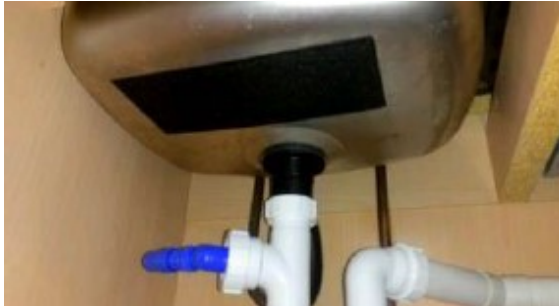
**Item 75 – Ref: EY001752**

The Sink pad in the Nursery Chemical Cupboard does not contain asbestos.

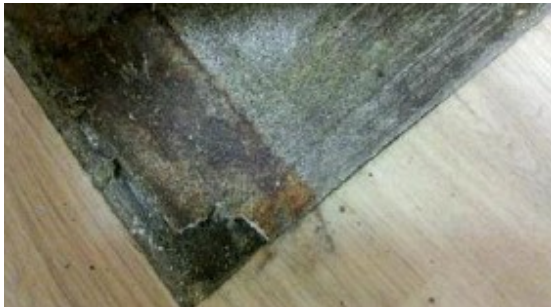
**Item 76 – Ref: EY001753**

The Old Lino in the Nursery Chemical Cupboard does not contain asbestos.

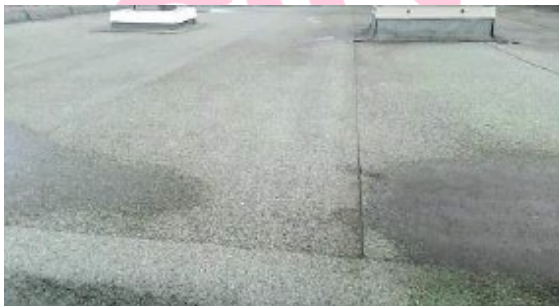
**Item 77 – Ref: EO005428**

The Flat roof over kitchen (external) does not contain asbestos.

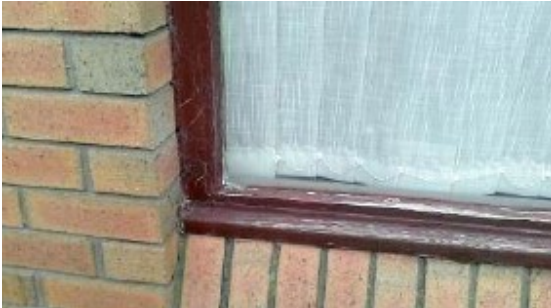
**Item 78 – Ref: EO005429**

The Putty to window frames (external) does not contain asbestos.
