ASBESTOS SURVEY REPORT FOR HOUGHTON NURSERY, NEASHAM PLACE, HOUGHTON LE SPRING, DH5 8AE.

Houghton Nursery, Neasham Place, Houghton le Spring

Date: 17 February 2025

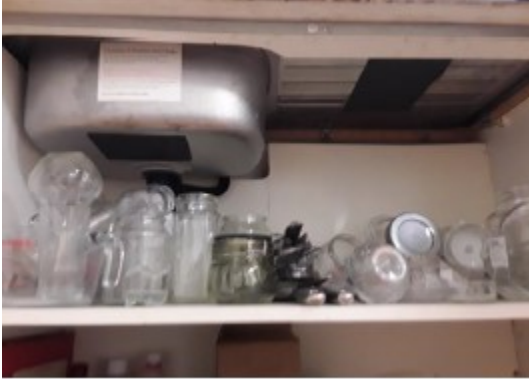
Item 1 Ref: 21-35335-1

- (Item 1) Ref: 21-35335-1 – Sink pad (Floor G/Room 5 Playrooms) – No Risk
- (Item 2) Ref: 21-35335-2 - Sink pad (Floor G/Room 8 Kitchen) – No Risk
- (Item 3) Ref: 21-35335-3 – Frame Sealant to door brickwork to toy storage room (Floor G/Room 12 Covered Play Area) – No Risk

The sink pad in Room 5 (Playrooms) does not contain asbestos.

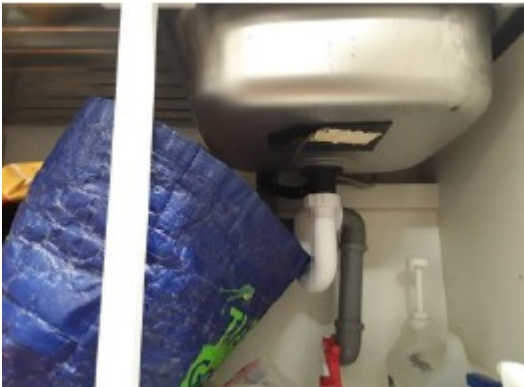
Item 2 Ref: 21-35335-2

The sink pad in Room 8 (Kitchen) does not contain asbestos.

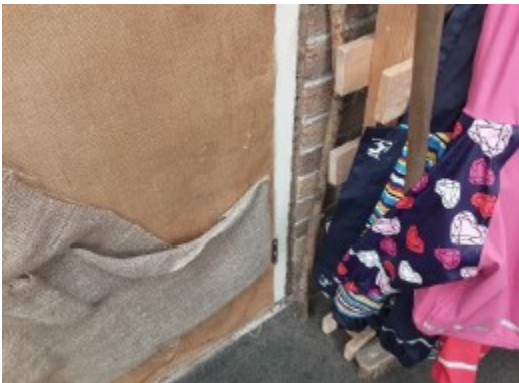
Item 3 Ref: 21-35335-3

The frame sealant to the brickwork to toy storage room (Room 12) does not contain asbestos.

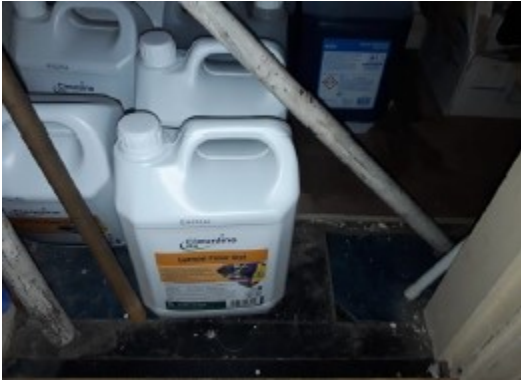
Item 4 Ref: 21-35335-4

The floor tiles and adhesive in the cleaners cupboard (Room 18) do not contain asbestos.

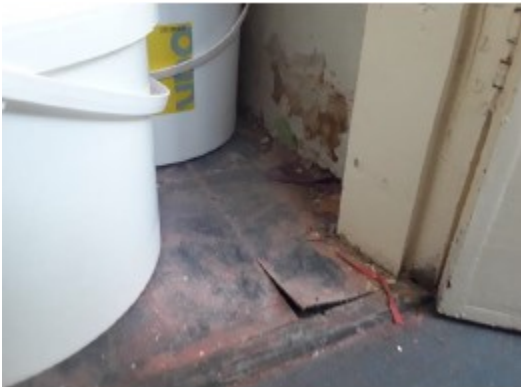
Item 5 Ref: 21-35335-4

The floor tiles and adhesive in the store cupboard (Room 22) do not contain asbestos.

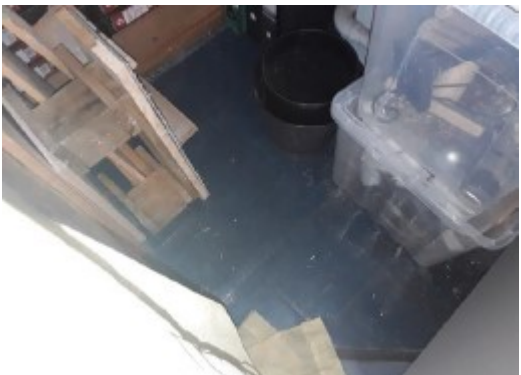
Item 6 Ref: 21-35335-4

The floor tiles and adhesive in the store cupboard (Room 23) do not contain asbestos.

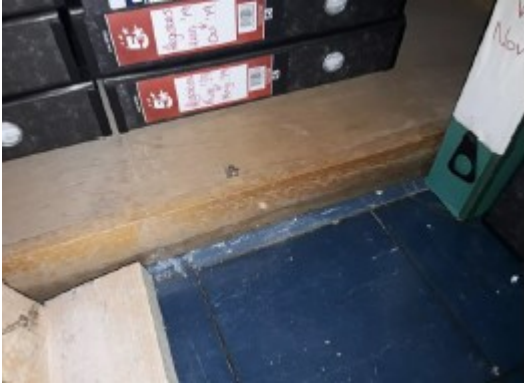
Item 7 Ref: 21-35335-5

- (Item 6) Ref: 21-35335-4 – Floor tiles and adhesive (Floor G/Room 23 Store Cupboard) – No Risk
- (Item 7) Ref: 21-35335-5 – Floor tiles and adhesive (Floor G/Room 23 Store Cupboard) – Low Risk

The floor tiles and adhesive in the store cupboard (Room 23) does contain asbestos.

Any change in appearance should be reported to Property Services.

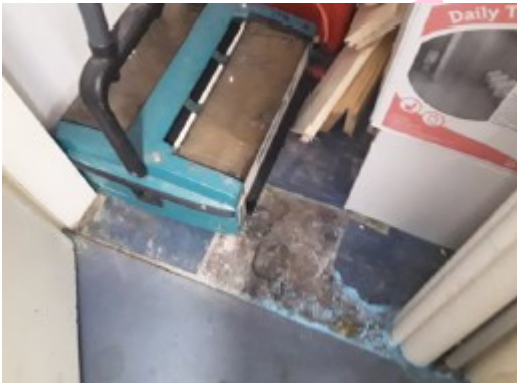
Item 8 Ref: 21-35335-5

- (Item 8) Ref: 21-35335-5 – Floor tiles and adhesive (Floor G/Room 24 Cleaners Cupboard) – Low Risk
- (Item 9) Ref: 21-35335-6 – Door frame sealant (Floor G/Room 37 Boiler Room) – No Risk

The floor tiles and adhesive in the cleaners cupboard (Room 24) does contain asbestos.

Any change in appearance should be reported to Property Services.

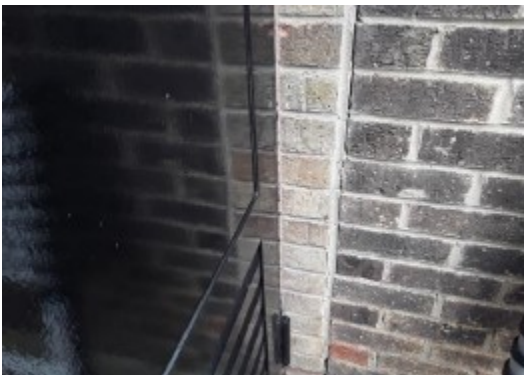
Item 9 Ref: 21-35335-6

The frame sealant to the door in the Boiler Room (Room 37) does not contain asbestos.

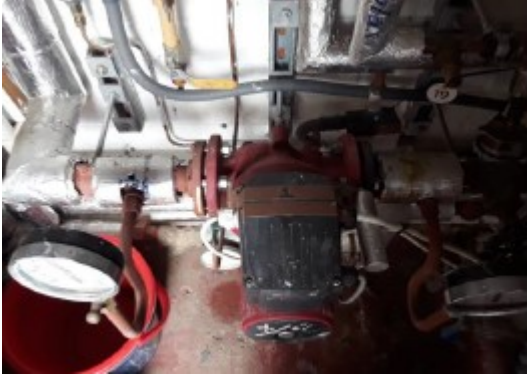
Item 10 Ref: 21-35335-7

The pipe flanges (Gaskets) in the Boiler Room (Room 37) do not contain asbestos.

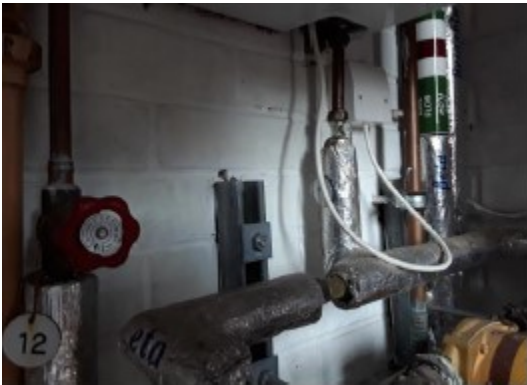
Item 11 Ref: 21-35335-9

The debris to the encapsulated walls in the Boiler Room (Room 37) does not contain asbestos.

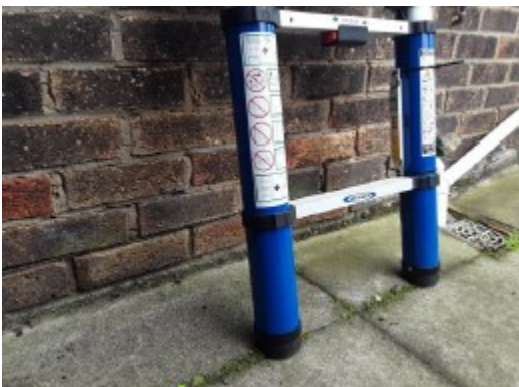
Item 12 Ref: 21-35335-8

- (Item 12) Ref: 21-35335-8 – Damp proof course (External/Area 38) – Very Low Risk
- (Item 13) Ref: 21-35335-8 – Damp proof course (External/Area 38) – Very Low Risk

The damp proof course (Externally) does contain asbestos.

Any change in appearance should be reported to Property Services.

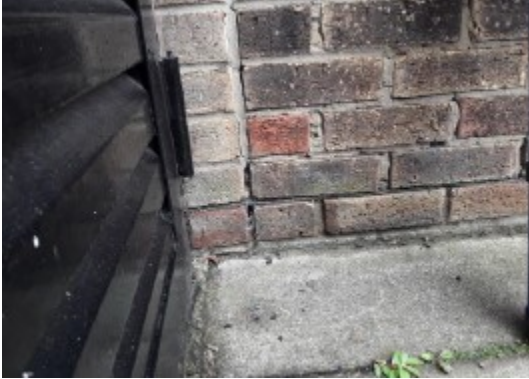
Item 13 Ref: 21-35335-8

The damp proof course (Externally) does contain asbestos.

Any change in appearance should be reported to Property Services.

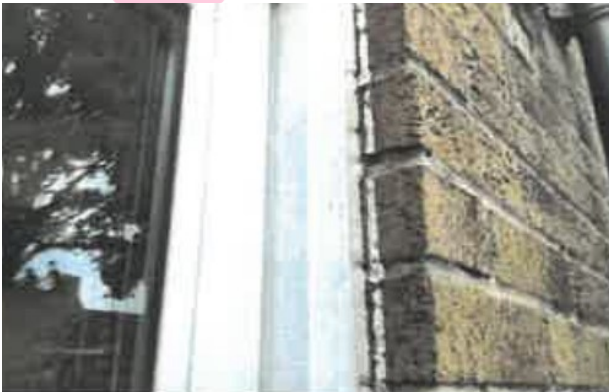
Item 15 Ref: VA008071

- (Item 14) Ref: VA008070 – Floor bitumen adhesive below screed (Kitchen) – No Risk
- (Item 15) VA008071 – Sealant to door frame (Exterior to exit door) – Very Low Risk

The mastic to the frame of the exterior exit door does contain asbestos.

Any change in appearance should be reported to Property Services.
