ASBESTOS SURVEY REPORT FOR OXCLOSE NURSERY, BRANCEPETH ROAD, WASHINGTON, TYNE AND WEAR, NE38 0LA

Asbestos Register for

Oxclose Nursery, Brancepeth Road, Washington

Date: 16 December 2024

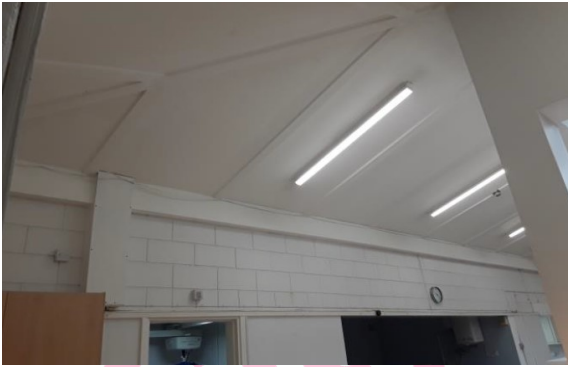
Item 5 Ref: 21-35338-4

The insulating board ceiling (Area 8 / Main Nursery and Wet play area) does contain asbestos.

Any change in its appearance should be recorded and passed to property services.

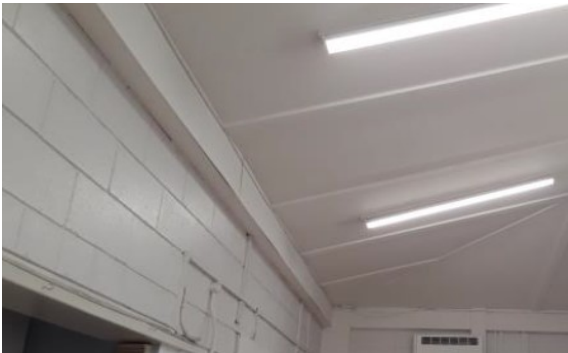
Item 6 Ref: 21-35338-5

The insulating board ceiling (Area 8 / Main Nursery and Wet play area) does contain asbestos.

Any change in its appearance should be recorded and passed to property services.

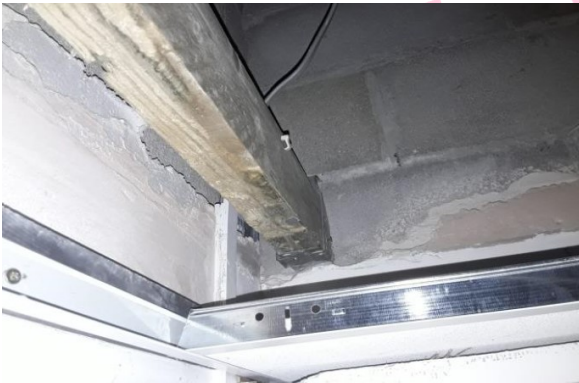
Item 11 Ref: 21-35338-10

The residual insulation debris to nails in wood joists (Area 11 / Ceiling void above area 10 office and area 11 disabled toilets / shower) does not contain asbestos.

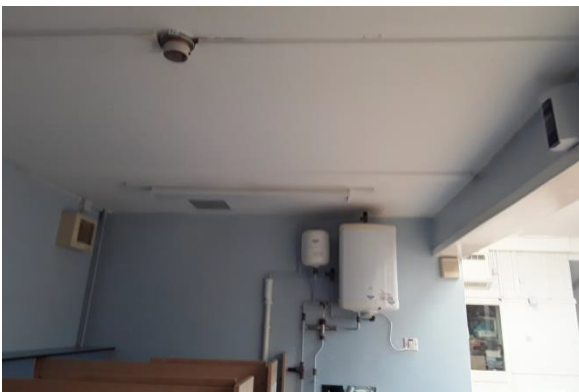
Item 12 Ref: 21-35338-11

The insulating board ceiling (Area 13 / Main nursery toilet) does contain asbestos.

Any change in its appearance should be recorded and passed to property services.

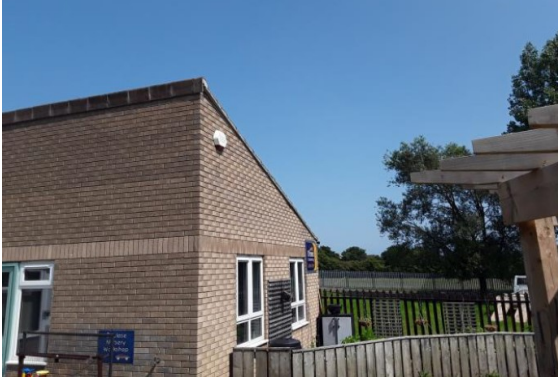
Item 19 Ref: 21-35338-18

The cement undercloaks to roof (Area 25 / External) does not contain asbestos.

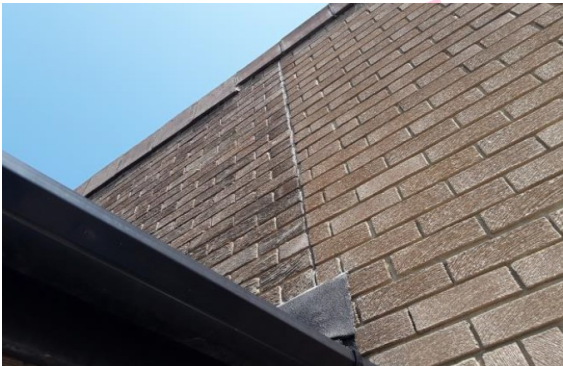
Item 20 Ref: 21-35338-19

The putty to expansion joints (Area 25 / External) does not contain asbestos.

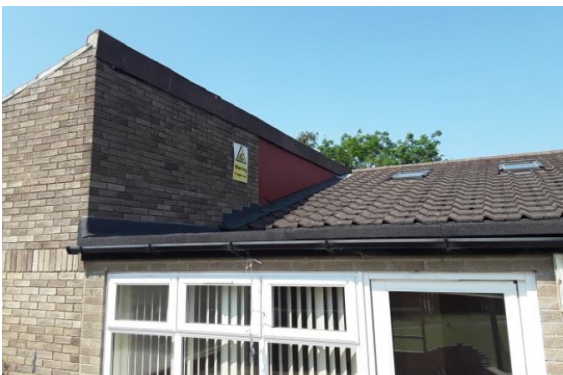
Item 21 Ref: Presumed

The infill panels to roof (Area 25 / External) are presumed to contain asbestos.

Any change in its appearance should be recorded and passed to property services.

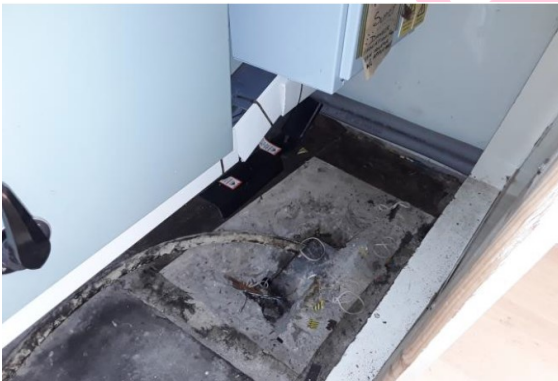
Item 23 Ref: 21-35338-17

The damp proof course (Area 30 / Photocopy room and cupboard) does not contain asbestos.
