ASBESTOS SURVEY REPORT FOR USWORTH COLLIERY NURSERY,  
MANOR ROAD, WASHINGTON, TYNE AND WEAR, NE37 3BL

**Usworth Collier Nursery, Manor Road,  
Washington, NE37 3BL**

**Date: 26 September 2024**

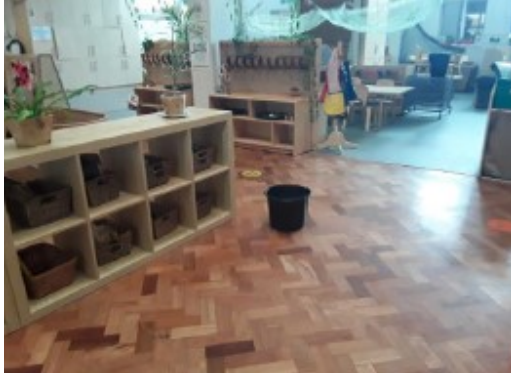
### **Item 1 Ref: Presumed**

- (Item 1) Ref: Presumed – Adhesive beneath fitted parquet flooring (Area 3/Main nursery playroom) – Low Risk
- (Item 2) Ref: 21-35337-2 – Textured coating to walls (Area 10/Cloakroom) – No Risk

The adhesive beneath fitted parquet flooring to the main nursery playroom (Area 3) contains asbestos.

Any change in its appearance should be recorded and passed to Property Services.

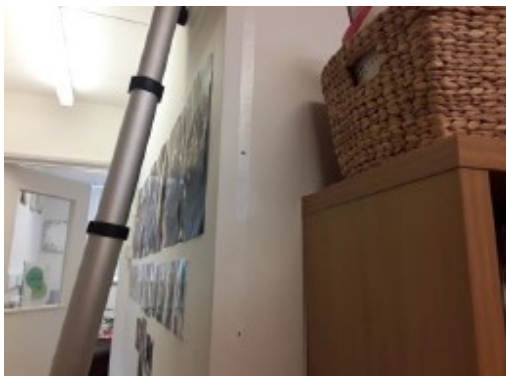
### **Item 3 Ref: 21-35337-2**

The textured coating to the walls in the hallway (Area 12) does not contain asbestos.

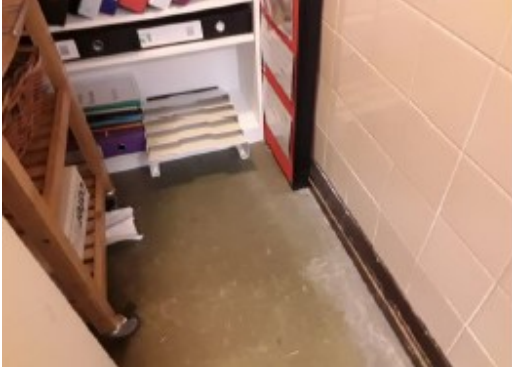
### **Item 4 Ref: 21-35337-3**

- (Item 3) Ref: 21-35337-2 – Textured coating to walls (Area 12/Hallway) – No Risk
- (Item 4) Ref: 21-35337-3 – Floor tiles and adhesive (Area 17/Server Cupboard) – Very Low Risk

The floor tiles and adhesive in the server cupboard (Area 17) contains asbestos.

Any change in its appearance should be recorded and passed to Property Services.

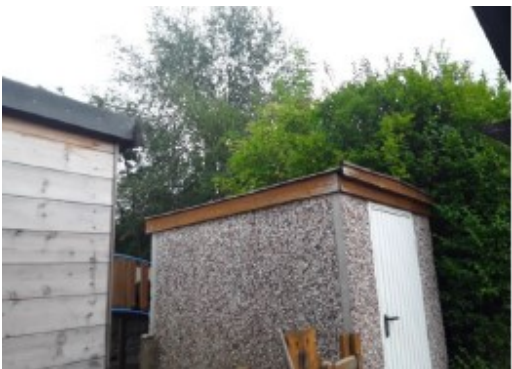
### **Item 5 Ref: 21-35337-6**

The roof to the outhouse (Area 32) does not contain asbestos.

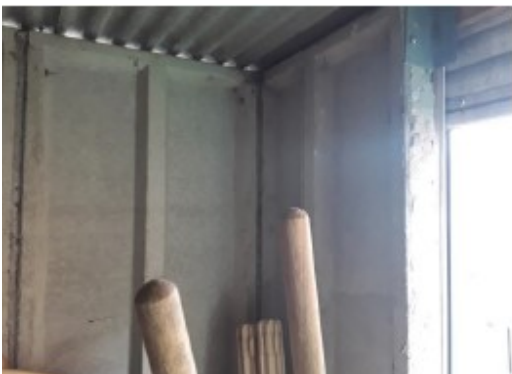
### **Item 6 Ref: 21-35337-11**

The expansion joints to the Garage (Area 33) does not contain asbestos.

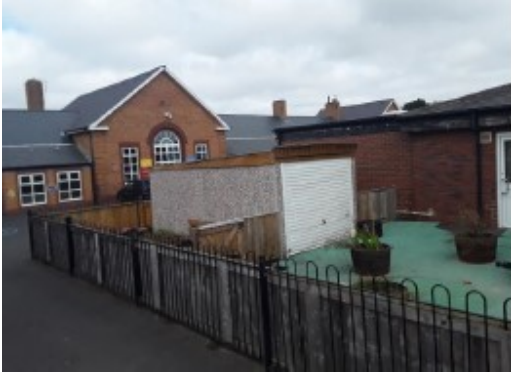
**Item 7 Ref: 21-35337-7**

The roof to the Garage (Area 33) does not contain asbestos.

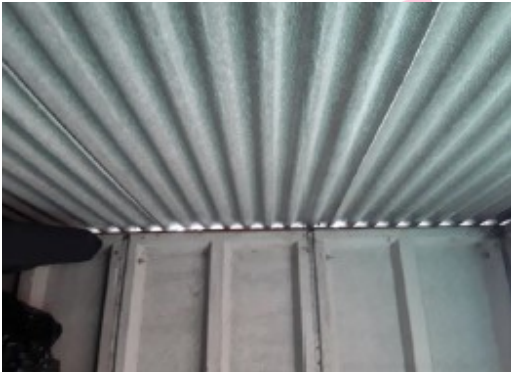
**Item 8 Ref: 21-35337-7**

The ceiling to the Garage (Area 33) does not contain asbestos.

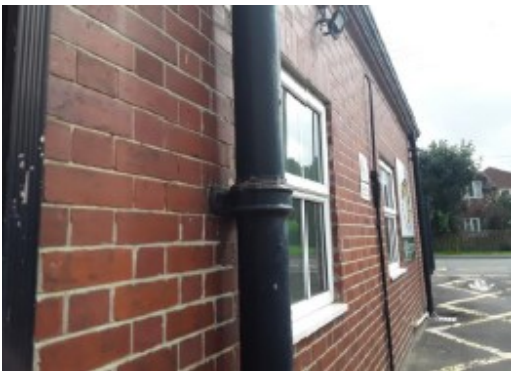
**Item 9 Ref: 21-35337-4**

The capping compound around the soil pipe externally (Area 34) does not contain asbestos.

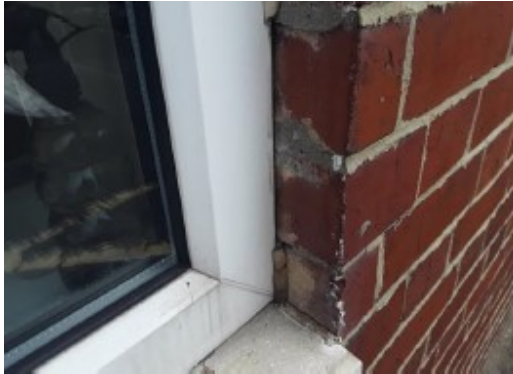
**Item 10 Ref: 21-35337-5**

The frame sealant to the brickwork externally (Area 34) does not contain asbestos.

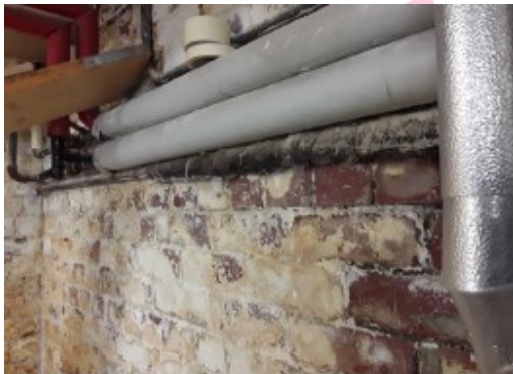
**Item 11 Ref: 21-35337-10**

The string to hessian lagged metal pipes in the Boiler Room (Area 35) does not contain asbestos.

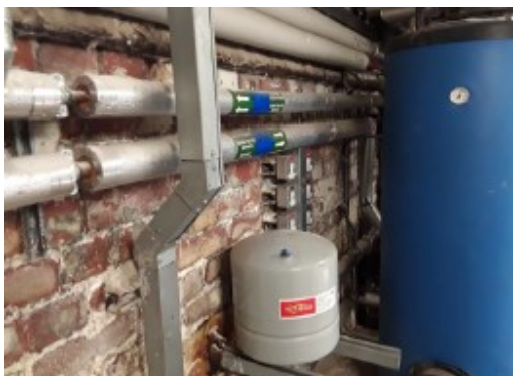
**Item 12 Ref: 21-35337-8**

The debris to the walls in the Boiler Room (Area 35) does not contain asbestos.

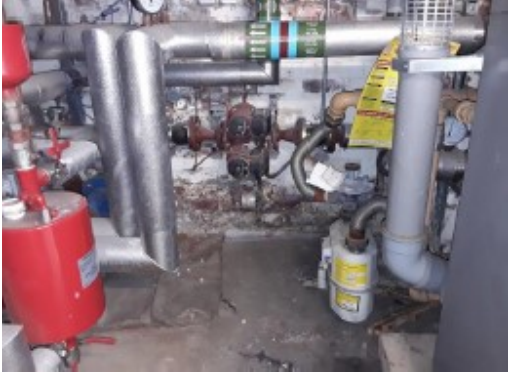
**Item 13 Ref: 21-35337-9**

The pipe flanges (Gaskets) in the Boiler Room (Area 35) do not contain asbestos.
