## **Asbestos Register for New Silksworth Junior School**

**UPRN: - 2904074**

**Date: 15 July 2024**

New Silksworth Jnrs – Last updated 15/07/2024

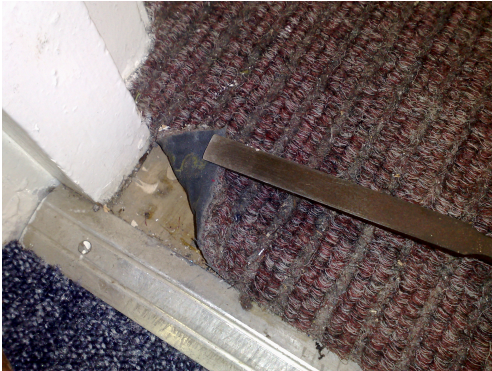
### **Item 1 Ref: AL09/1351**

The floor tiles in reception lobby 2 do not contain asbestos.

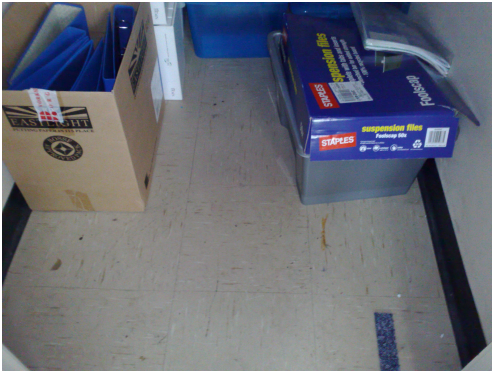
### **Various - Ref: AL09/1352**

The floor tiles in room 4 store do not contain asbestos. Similar tiles can be found in room 5 toilet, room 6 tea bar, room 11 dry store, room 12 supervisor, Staff room and WC Room 13, Room 14 Sports store, Room 15 table Store, room 16 cleaners store, Room 17 disabled WC, Room 20 Stores, Room 22 male WC, Room 24 Store, Room 25 Electrical Cupboard, Room 26 Corridor, Room 29 Caretakers Store, Room 32 music Store, Room 35 library, Room 36 physiotherapy, Room 42 Canteen, Room 52 Quiet Area, Room 54 Cleaners Store, Room 57 quiet room, Room 6 Store, Room 68 store 20, Room 71 store, Room 73 store 2D, Room 75 Staff Resources, Room 79 Cleaners Store, Room 81 Electrical Cupboard, Room 83 Store, Room 84 Staff Resources, Room 86 Quite Room, Room 87 Store 1D, Room 89 Store, Room 91 and Store Room 93 Store 1B.

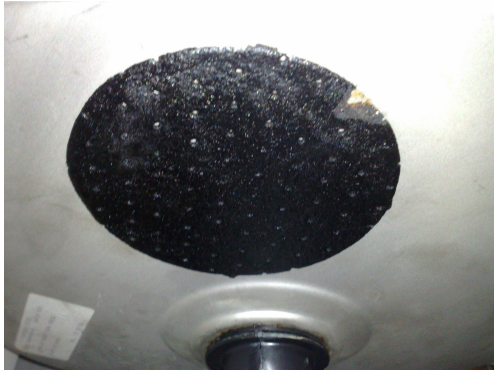
**Item 5 - Ref: AL09/1353**

The sink pad in room 6 of the tea bar does not contain asbestos.

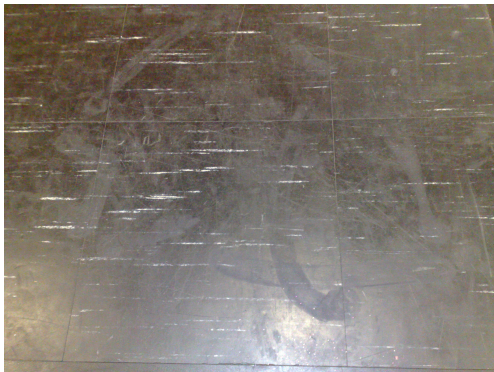
**Item 6 - Ref: AL09/1354**

The floor tiles in Room 7 the main hall do not contain asbestos.

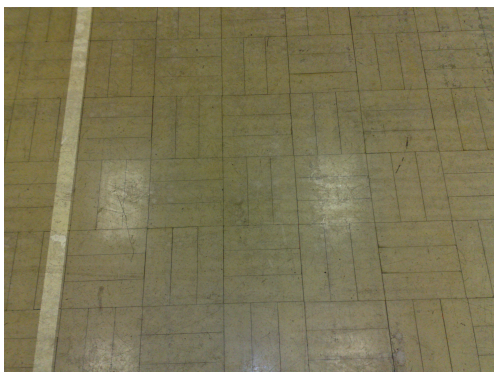
**Item 7 - Ref: AL09/1355**

The floor tiles in the room 9 the main hall do not contain asbestos.

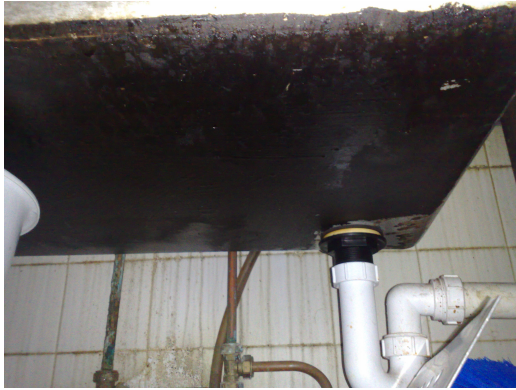
**Item 6 - Ref: AL09/1356**

The sink pad in the kitchen room 10 does not contain asbestos.

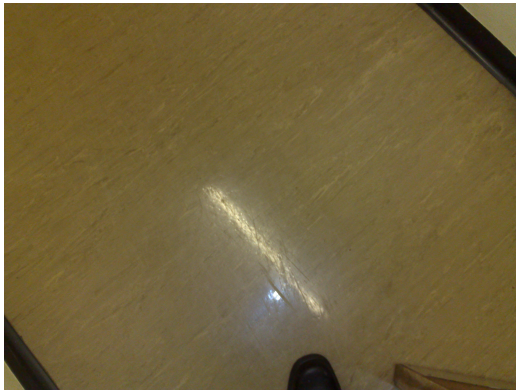
**Item 18 - Ref: AL09/1357**

The floor tiles in room 18 corridor do not contain asbestos.

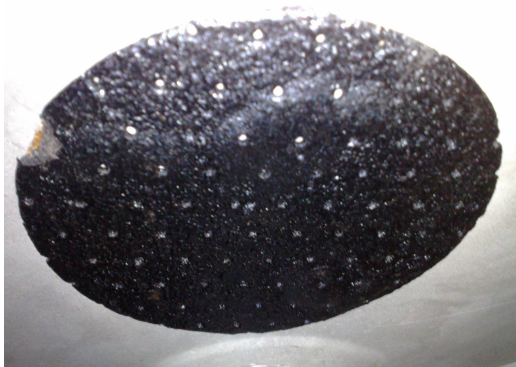
**Item 7 - Ref: AL09/1358**

The sink pad in Room 19 Staff room does not contain asbestos.

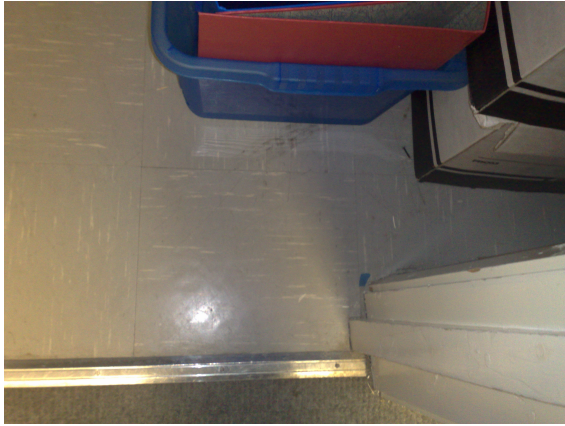
### **Various - Ref: AL09/1359**

The floor tiles in room 28 store do not contain asbestos. Similar tiles can be found in Room 31 Store and Room 34 Store.

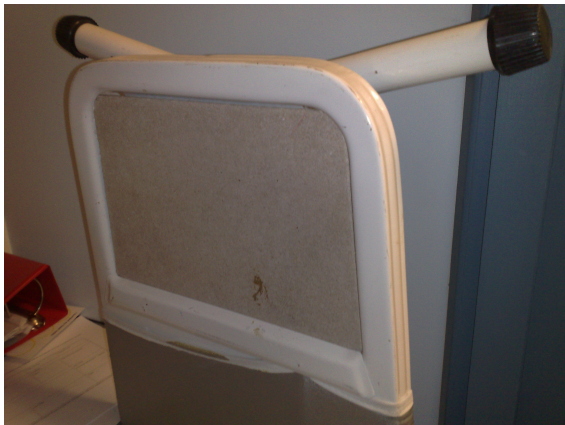
### **Item 32 - Ref: AL09/1360**

The heat plate to the ironing board does not contain asbestos.

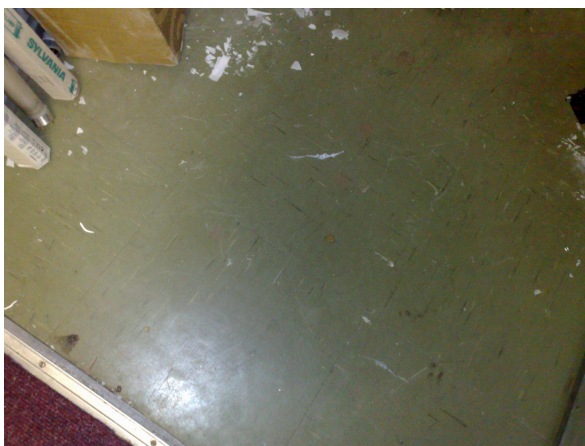
### **Item 33 - Ref: AL09/1362**

The floor tiles in Room 40 Corridor do not contain asbestos.

Similar tiles can be found in Room 42 Area 4, Room 51 Cloakroom and Room 56 Year 5.

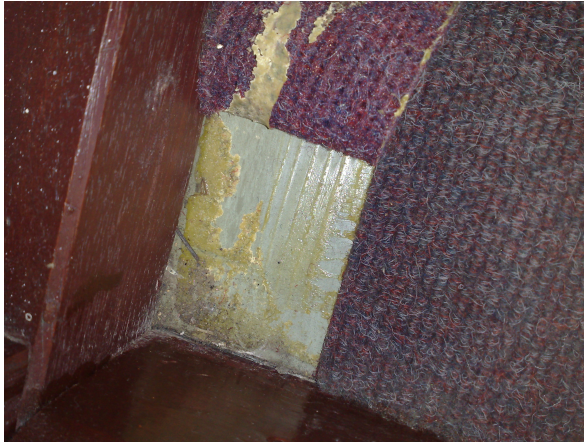
**Item 33 - Ref: AL09/1361**

The floor tiles in Room 41 Cleaners do not contain asbestos. Similar tiles can be found in Room 43 store 4B, Room 44 store 4A, Room 46 store, Room 49 store, Room 50 Staff Resources, Room 58 store, Room 60 store, Room 63 store C3 and 64 store 3D.

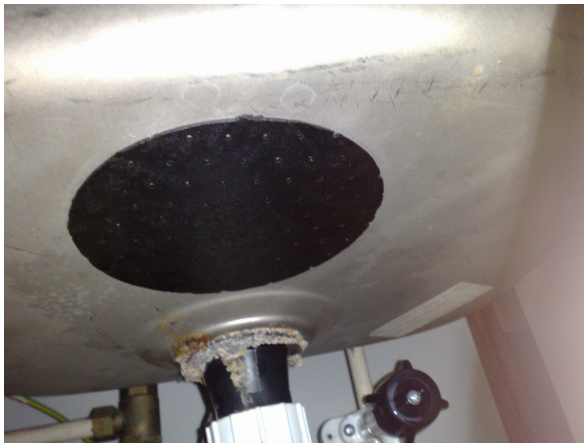
**Item 40 - Ref: AL09/1363**

The sink pad in room 42 canteen does not contain asbestos.

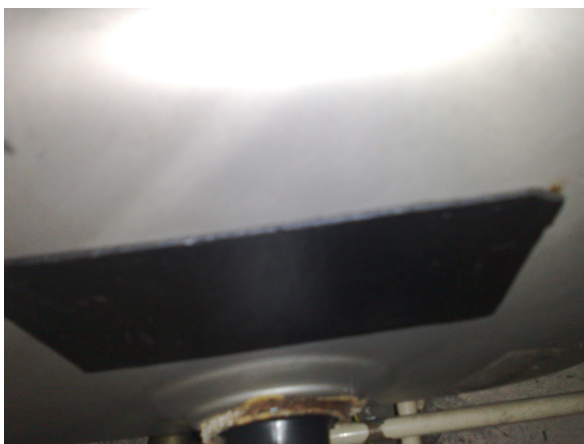
**Item 44 - Ref: AL09/1364**

The sink pad in room 56 year 5 does not contain asbestos.

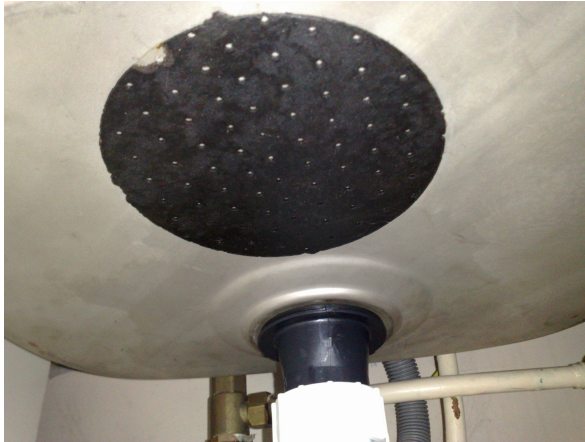
**Item 54 - Ref: AL09/1365**

The sink pad in room 67 year 3 contains asbestos.

Item 52	No asbestos	Is present		
Item 53	No asbestos	Is present		
Item 54	<b>Sink pad x2 (Rm 67 Yr 3)</b>	<b>Very Low</b>	<b>Removed</b>	<b>Sept 20</b>
Item 55	No asbestos	Is present

***Removed September 2020***

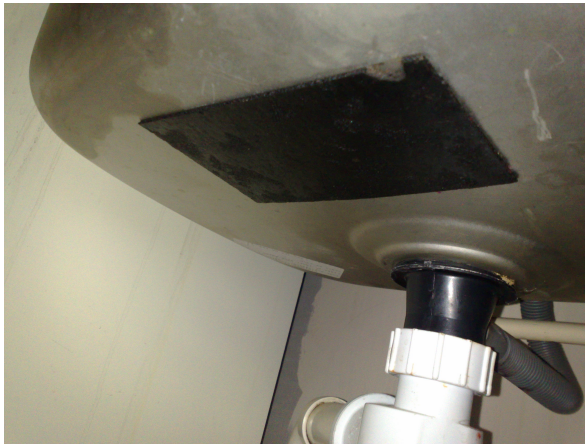
**Item 63 - Ref: AL09/1366**

The two sink pads in room 85 year 6 do not contain asbestos.

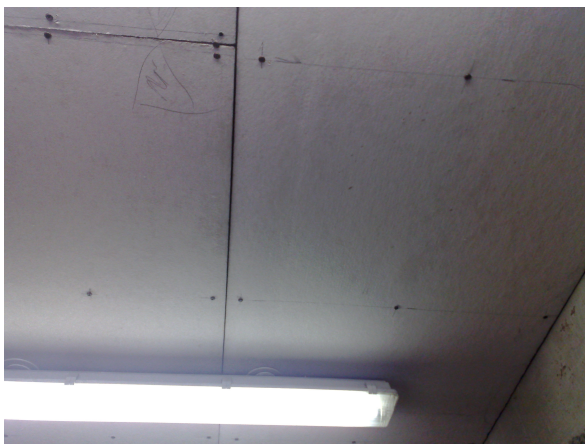
**Item 69 - Ref: AL09/1367**

The ceiling board to room 95 boiler room do not contain asbestos.

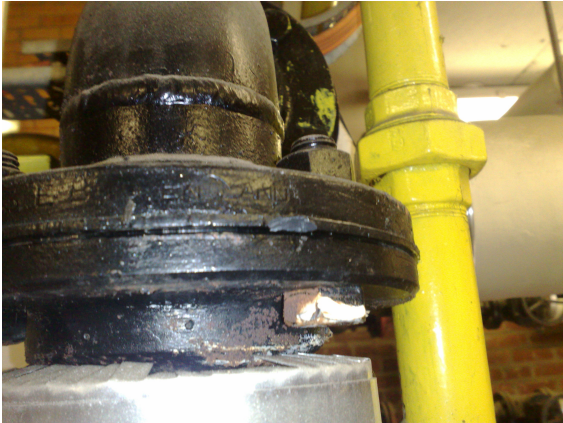
**Item 70 - Ref: AL09/1368**

The flange gaskets to pipe work in room 95 boiler room do not contain asbestos.

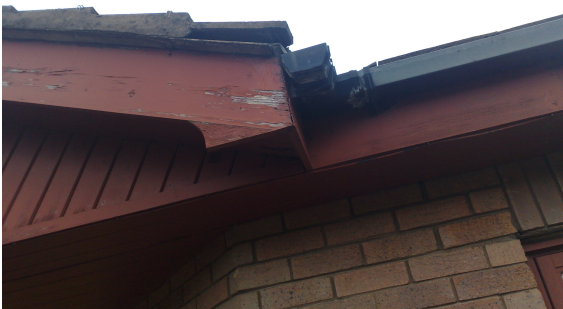
**Item 71 - Ref: AL09/1367**

The cement fillet tiles to the external contain asbestos.

Item 71	<b>Cement Fillet Tile (External)</b>	<b>Very Low</b>	<b>Removed</b>	<b>2017</b>
Item 72	No asbestos	Is present		
Item 73	No asbestos	Is present

Any change in appearance should be recorded and passed to Property Services.

***Removed 2017***

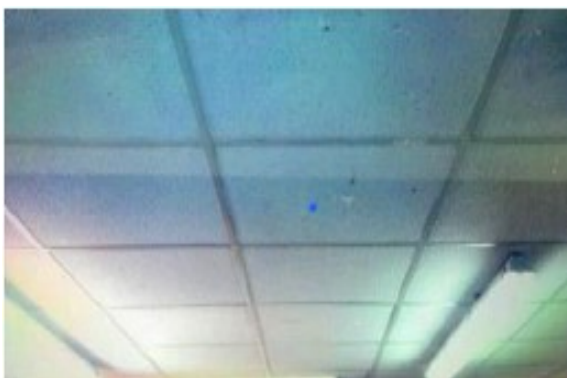
**Item 72 - Ref: EB000498**

The ceiling tiles in Year 3 & 6 Boys WC do not contain asbestos.

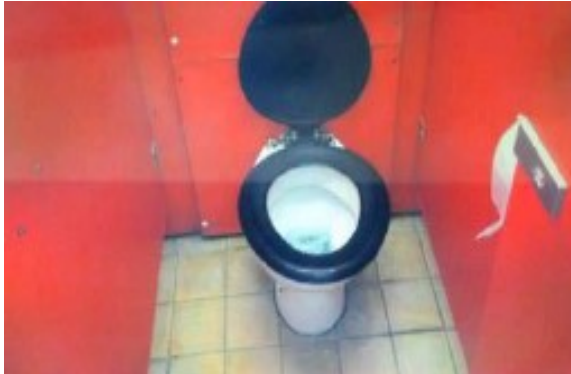
**Item 73 - Ref: EB000499**

The toilet seats in Year 3 & 6 Boys WC do not contain asbestos.

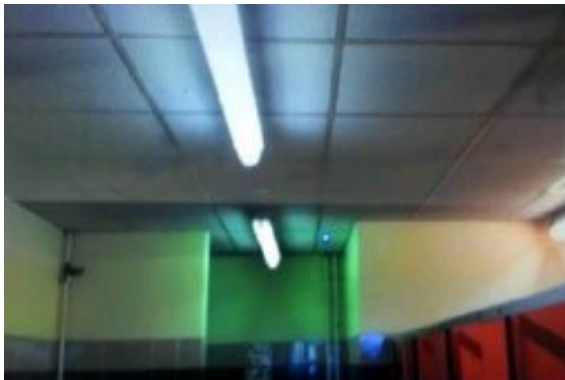
**Item 74-Ref:AsEB000498**

The ceiling tiles in Year 3 & 6 Girls WC do not contain asbestos.

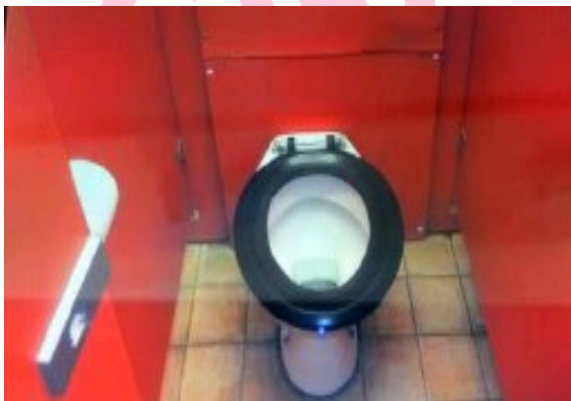
**Item 75-Ref:AsEB000499**

The toilet seats in Year 3 & 6 Girls WC do not contain asbestos.

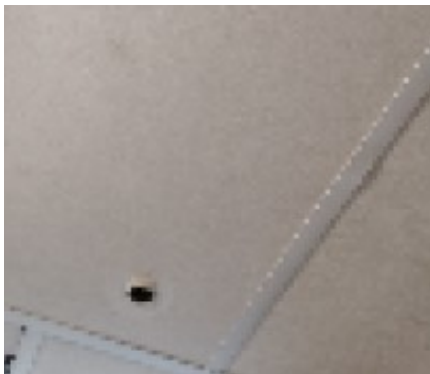
**Item 77 Ref: SO07**

The ceiling tiles (Plant Room/ Room 002) do not contain asbestos.

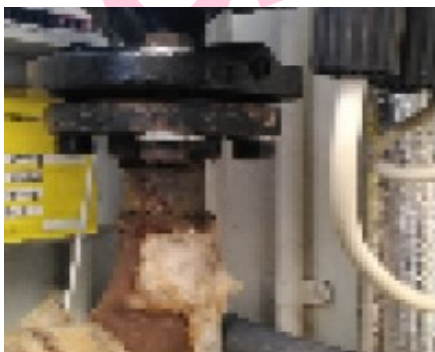
**Item 78 Ref: SO08**

The gasket to pipework (Plant Roo/Room 002) does not contain asbestos.

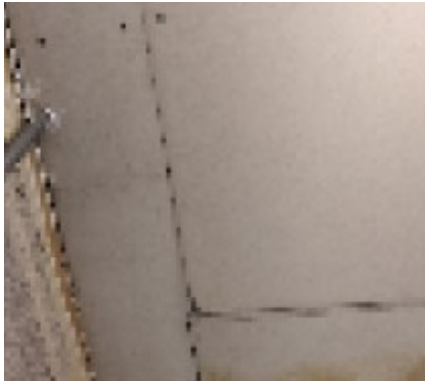
**Item 79 Ref: SO07**

The ceiling (Plant Room/  
Room 002) does not contain  
asbestos.

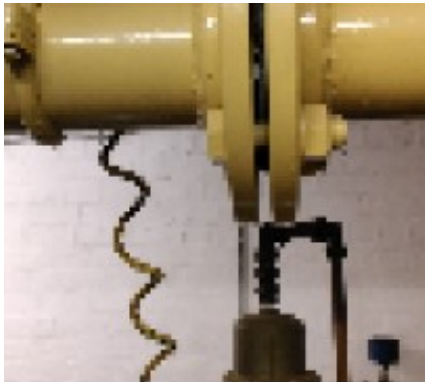
**Item 80 Ref: SO01**

The gaskets to gas pipes  
(Boiler Room/Room 001) do  
not contain asbestos.

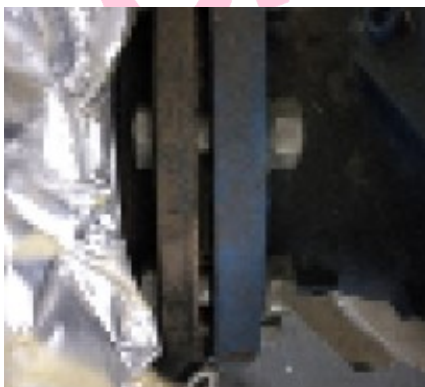
**Item 81 Ref: SO02**

The gaskets to heating pipes  
(Boiler Room/Room 001) do  
not contain asbestos.

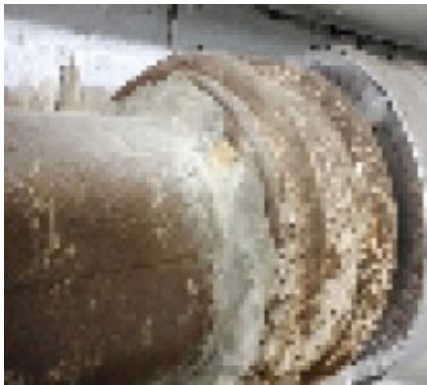
**Item 83 Ref: SO04**

The packing to pipework (Boiler Room/Room 001) does not contain asbestos.

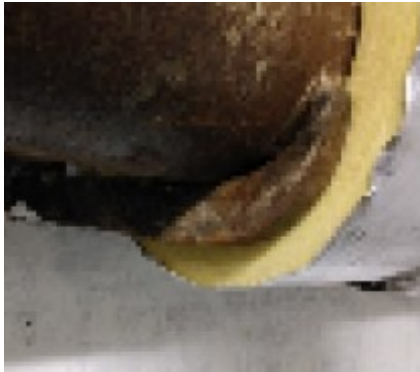
**Item 85 Ref: SO06**

The residue to pipe hanger (Boiler Room/Room 001) does not contain asbestos.

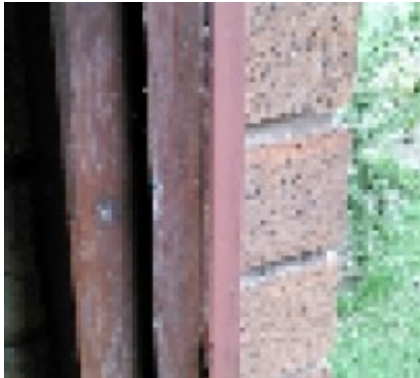
**Item 86 Ref: SO01**

The putty to wall 1 (Juniors Corridor/001) does not contain asbestos.

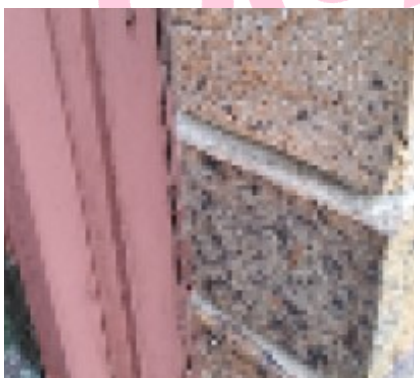
**Item 87 Ref: SO02**

The mastic to wall 1 (Juniors External/002) does not contain asbestos.

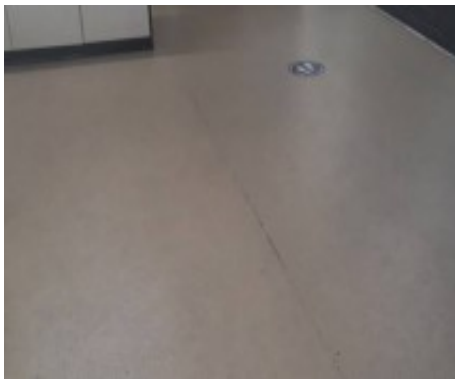
**Item 89 Ref: NZ001424**

The Floor screed brown screed under modern flooring (Classroom breakout area G/001) does not contain asbestos.

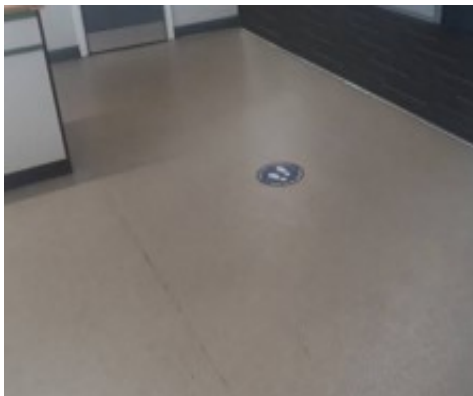
**Item 90 Ref: NZ001425**

The Floor covering bottom layer under modern flooring (Classroom breakout area G/001) does not contain asbestos.

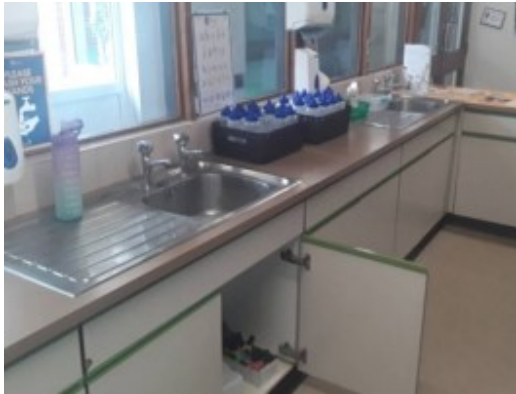
**Item 91 Ref: NZ001426**

The Under sink mat  
(Classroom breakout area  
G/001) does not contain  
asbestos.

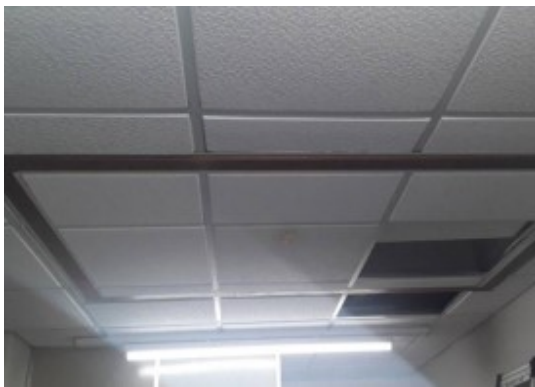
**Item 92 Ref: NZ001427**

The Ceiling Sky light panels  
(Classroom breakout area  
G/001) does not contain  
asbestos.

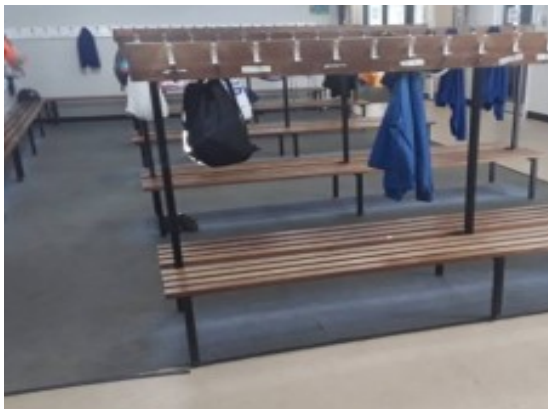
**Item 93 Ref: NZ001428**

The Floor screed brown screed  
under modern flooring  
(Cloakroom G/002) does not  
contain asbestos.

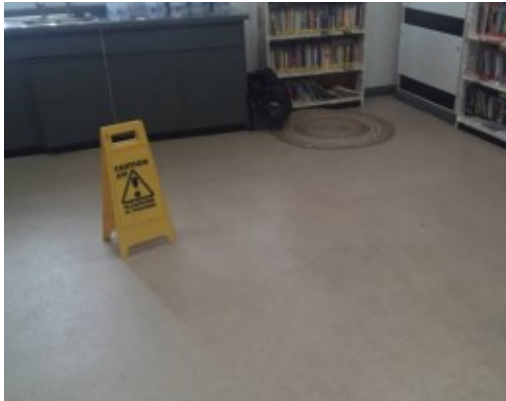
**Item 94 Ref: As NZ001428**

The Floor screed brown screed under modern flooring (Classroom breakout area G/003) does not contain asbestos.

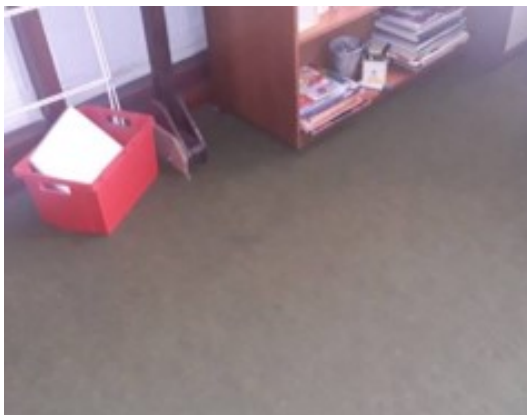
**Item 96 Ref: As NZ001424**

The Floor screed brown screed under modern flooring (Library G/004) does not contain asbestos.
