ASBESTOS SURVEY REPORT FOR NEWBOTTLE PRIMARY ACADEMY AND NURSERY SCHOOL HOUGHTON ROAD, HOUGHTON

Asbestos Register for

NEWBOTTLE ACADEMY AND NURSERY SCHOOL

Date: 06 November 2024

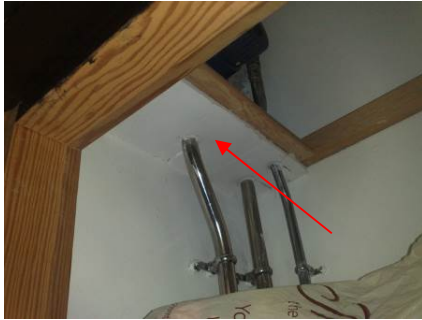
Item 1 Ref: IC09/1437

The board to the ceiling in the small cupboard (Area 2) does not contain asbestos.

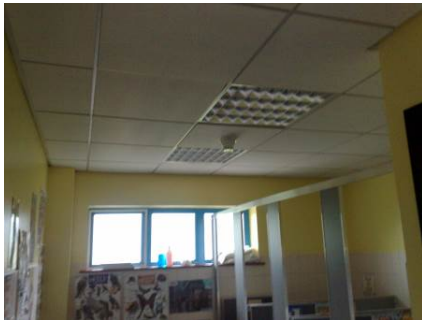
Various - Ref: IC09/1438

The suspended ceiling tiles in area 3 do not contain asbestos.

Similar ceiling tiles are located in area 7, area 9 and corridors throughout.

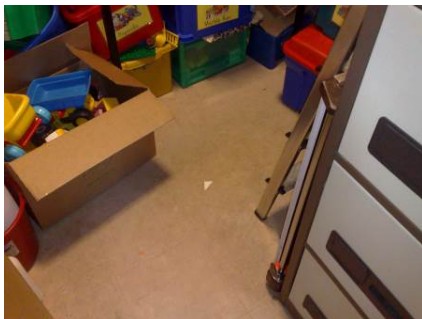
Various - Ref: IC09/1439

The floor tiles in area 6 do not contain asbestos.

Similar floor tiles are located in area 32, area 34, area 36, area 38, area 41, area 46, area 50, area 55, area 57, area 59, area 61, area 64, area 65, area 67, area 74 and area 75.

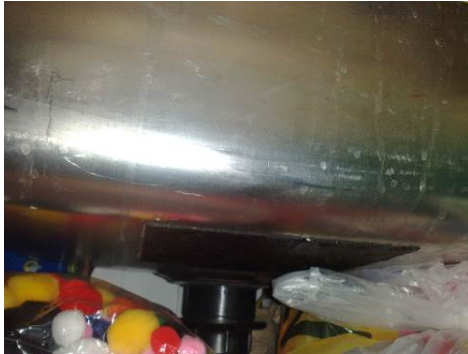
Item 5 - Ref: IC09/1440

Sink pad in area 7 does not contain asbestos.

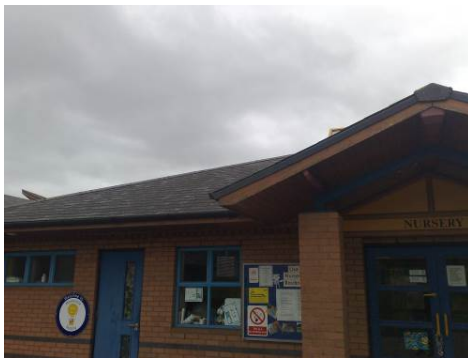
Item 7 - Ref: IC09/1441

The roof tiles on the external nursery do not contain asbestos.

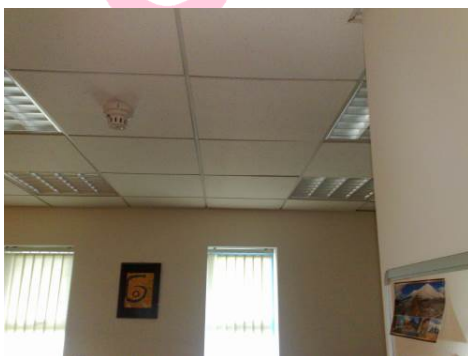
Various – Ref: IC09/1442

The suspended ceiling tiles in area 10 do not contain asbestos.

Similar ceiling tiles can be located in area 11, area 13, area 22, area 33, area 35, area 37, area 39, area 42, area 43, area 44, area 45, area 53, area 54, ,area 56, area 58, area 60, area 66 and area 72.

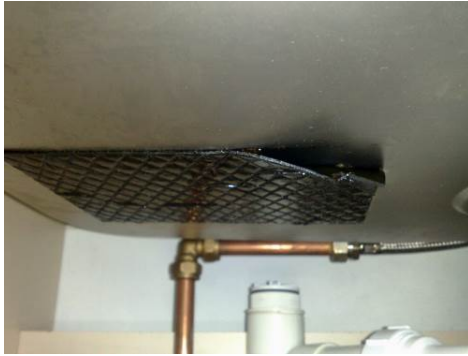
Item 11 – Ref: IC09/1443

The sink pad in area 13 does not contain asbestos.

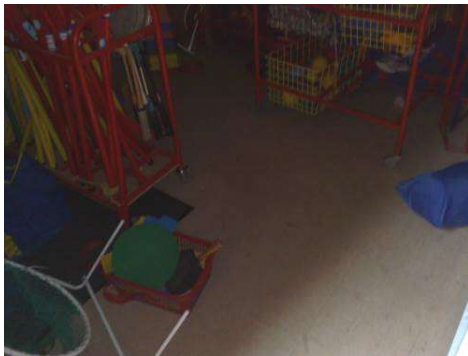
Various – Ref: IC09/1444

The floor tiles in area 16 do not contain asbestos.

Similar floor tiles can be located in area 17 and area 23.

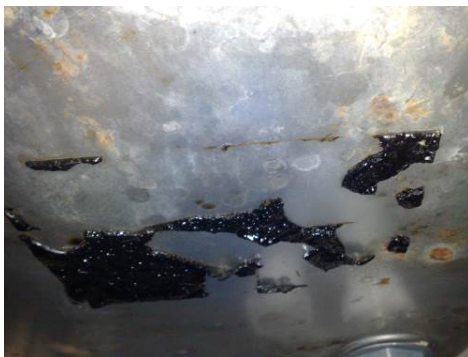
Item 14 – Ref: IC09/1445

The sink pad in area 19 does not contain asbestos.

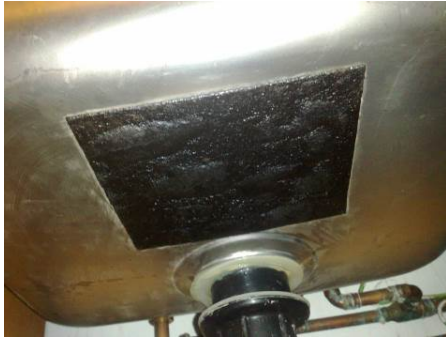
Item 15 – Ref: IC09/1446

The sink pad in area 21 does not contain asbestos.

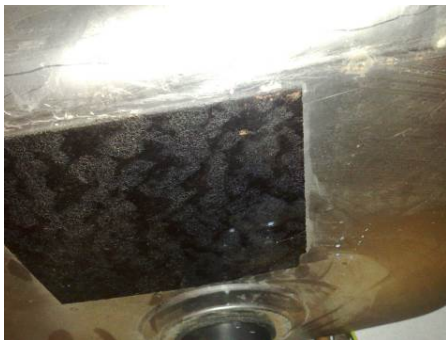
Item 26 – Ref: IC09/1447

The sink pad in area 39 does not contain asbestos.

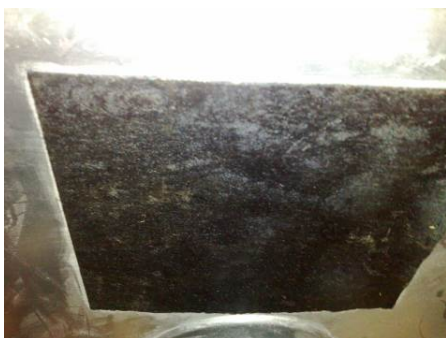
Item 38 – Ref: IC09/1449

The sink pad in area 53 does not contain asbestos.

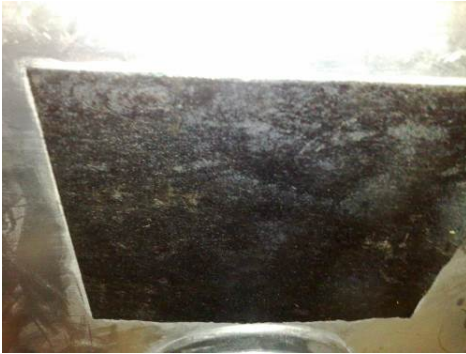
Item 39 - Ref: IC09/1450

The sink pad in area 53 does not contain asbestos.

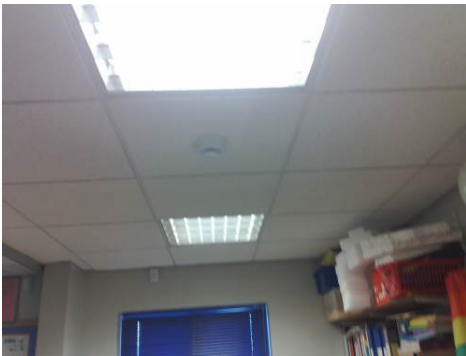
Item 56 - Ref: IC09/1451

The suspended ceiling tiles in area 73 do not contain asbestos.

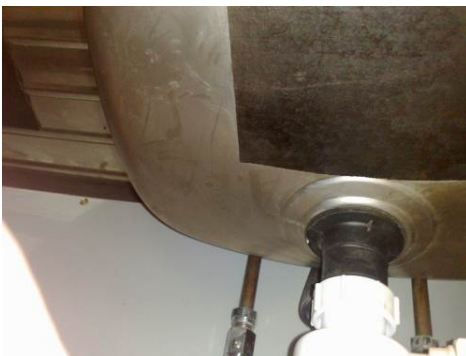
Item 57 - Ref: IC09/1452

The sink pad in area 76 does not contain asbestos.

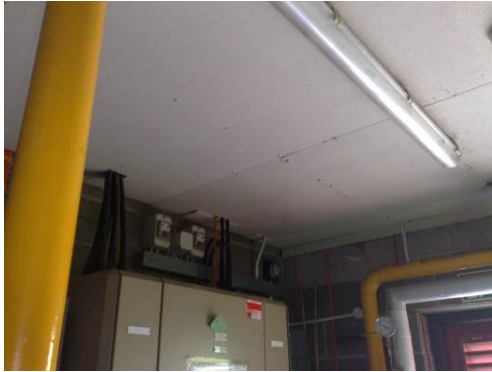
Item 58 – Ref: IC09/1453

The ceiling board in area 77 (plant room) does not contain asbestos.

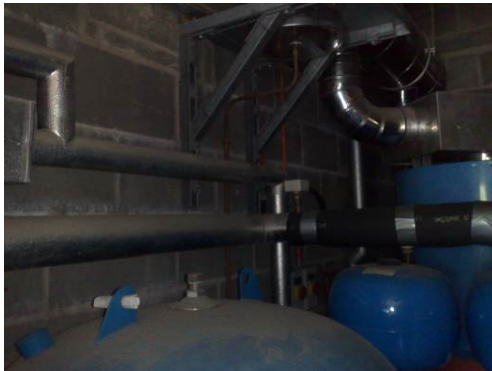
Item 59 - Ref: IC09/1454

The pipe lagging in area 77 (plant room) had limited access due to metal covering on pipes but does not contain asbestos.

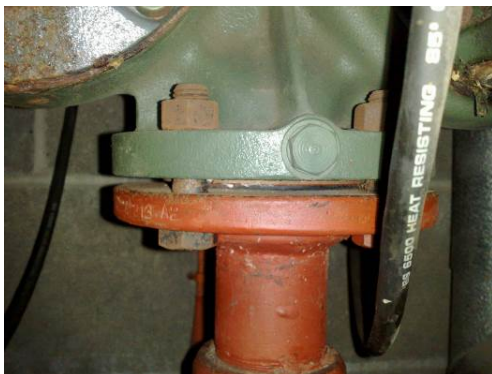
Item 60 – Ref: IC09/1455

The gasket material in area 77 (plant room) contains asbestos.

Item 56	No asbestos	Is present		
Item 57	No asbestos	Is present		
Item 58	No asbestos	Is present		
Item 59	No asbestos	Is present		
Item 60	Gasket – Area 77	Low	6 Monthly	03.03.2025

Any changes in appearance should be recorded and passed to property services.

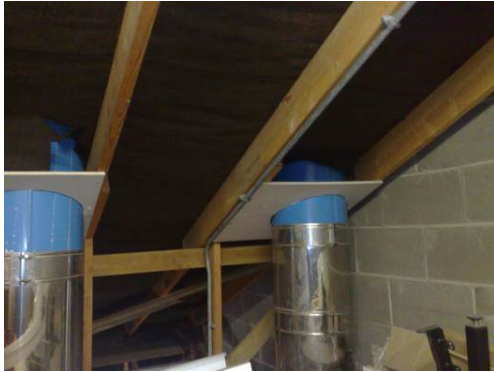
Item 61 – Ref: IC09/1456

The sarking felt in area 77 (plant room) does not contain asbestos.

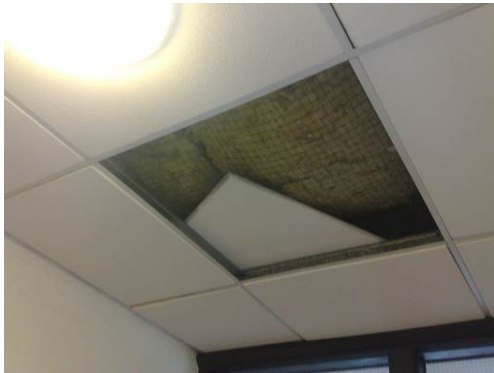
Item 63 – Ref: IC09/1457

The ceiling void throughout contains fibreglass insulation suspended in mesh but does not contain asbestos.

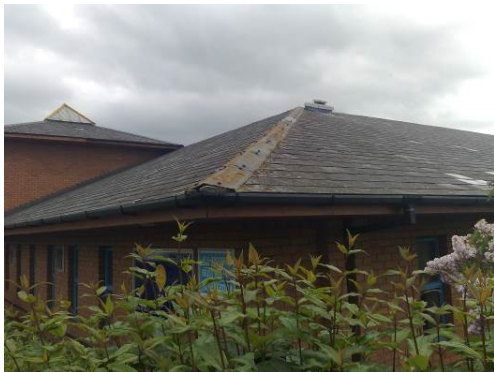
Item 64 – Ref: IC09/1459

The ridge tiles in the external area of the main school do not contain asbestos.

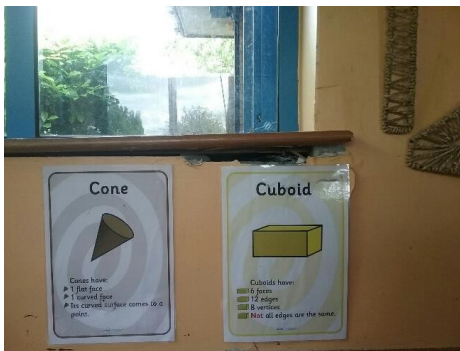
Item 66 – 16-24614-1

The packers beneath the wood window sill in the Nursery do not contain asbestos.

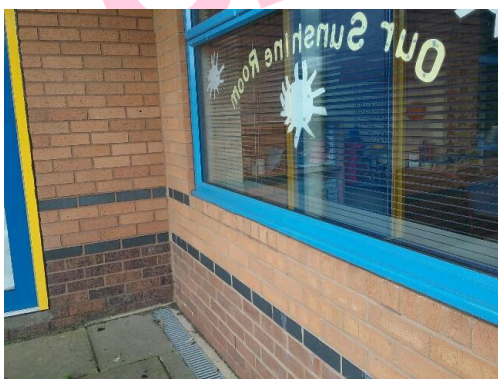
Item 67 – 16-24614-2

The mastic to the external windows does not contain asbestos.

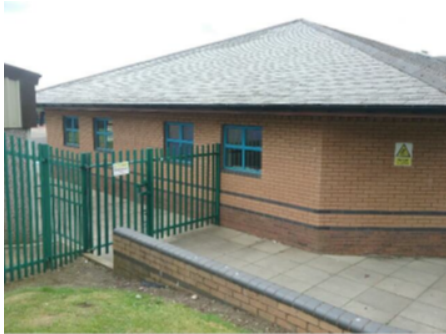
Item 68 – 16-24614-3

The putty to the external windows does not contain asbestos.

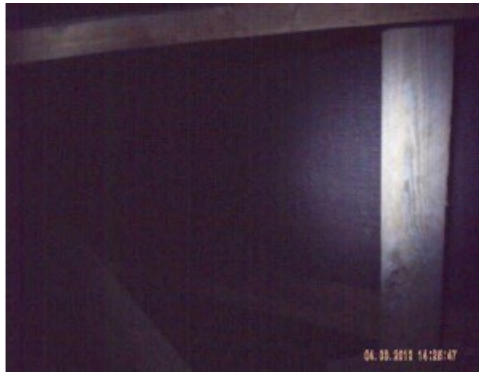
Item 69 – BB000381

The roof felt in the Infant Entrance ceiling void does not contain asbestos.

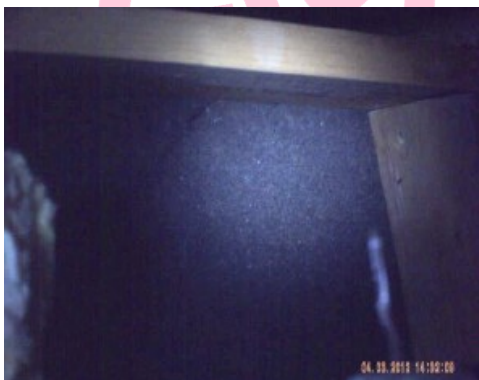
Item 70 – As BB000381

The roof felt in the Nursery Entrance ceiling void does not contain asbestos.

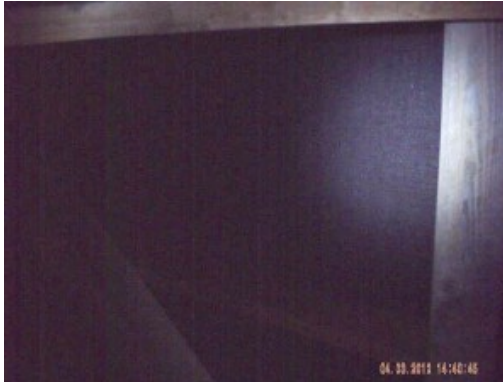
Item 71 – As BB000381

The roof felt in the External area between Infants & Nursery - ceiling void does not contain asbestos.

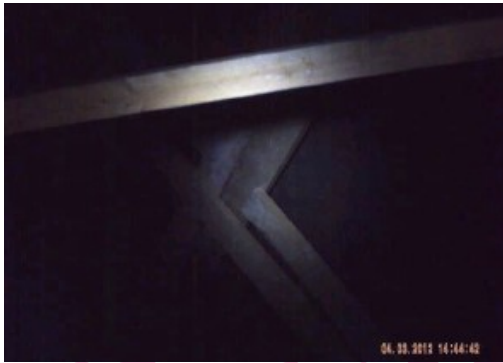
Item 72 – As BB000381

The roof felt above all soffits in the External area between Infants & Nursery does not contain asbestos.
