### **ASBESTOS SURVEY REPORT FOR SOUTH HYLTON PRIMARY SCHOOL, SUNDERLAND**

### **Asbestos Register for SOUTH HYLTON PRIMARY SCHOOL, SUNDERLAND**

**Date: 13 June 2024**

South Hylton Primary School - Last updated 13/06/2024 - Version 2

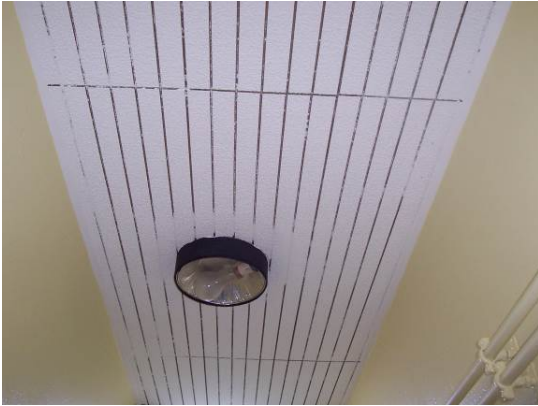
### **Item 1 Ref: Sample NO06/531**

The ceiling boards in the staff gents/female toilet does not contain asbestos.

Similar ceilings are located in the Ladies WCs and head teachers office.

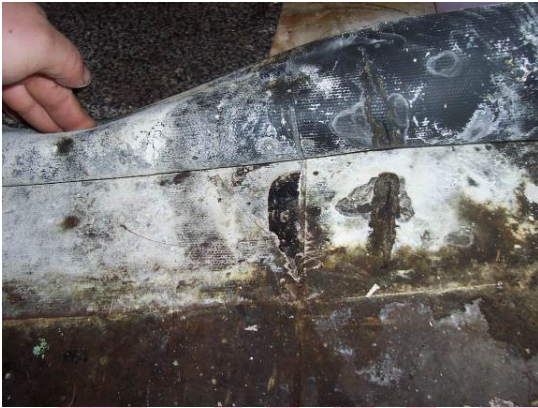
### **Item 2 - Ref: Sample NO06/532**

The floor tiles in the electrical intake room do not contain asbestos.

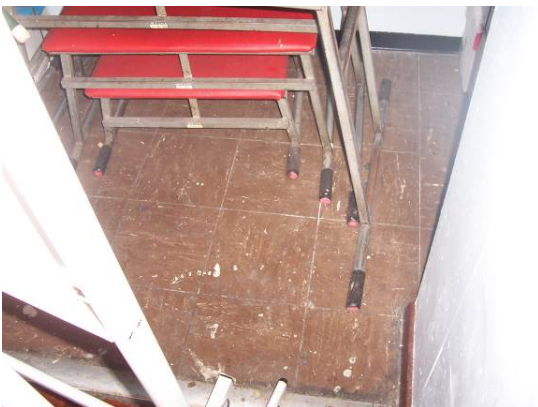
### **Item 3 - Ref: Sample NO06/533**

The floor tiles in hall store 1 do not contain asbestos.

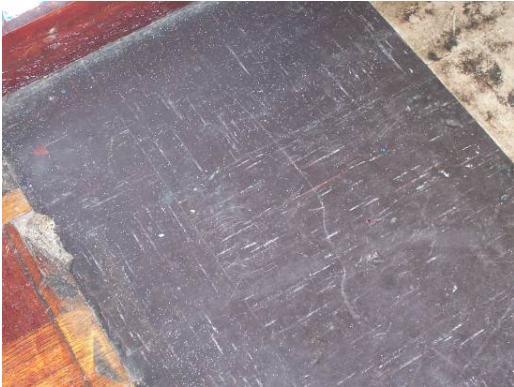
**Item 4 - Ref: Sample NO06/534**

The black floor tiles to hall store 2 entrance do not contain asbestos.

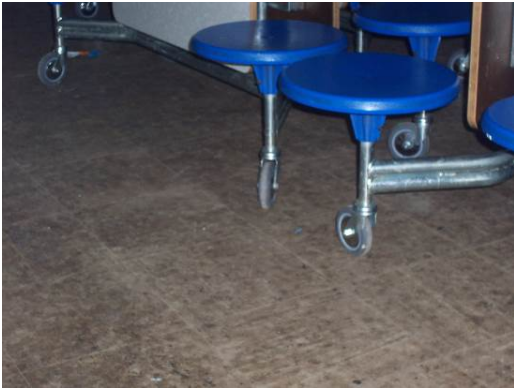
**Item 5 - Ref: Sample NO06/535**

The hall store 2 floor tiles do not contain asbestos.

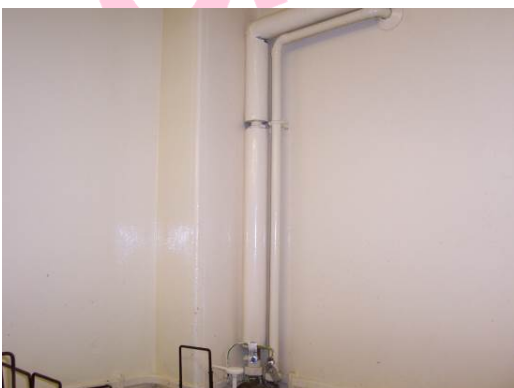
**Item 6 - Ref: Sample NO06/536**

The pipe insulation in kitchen main floor area does not contain asbestos.

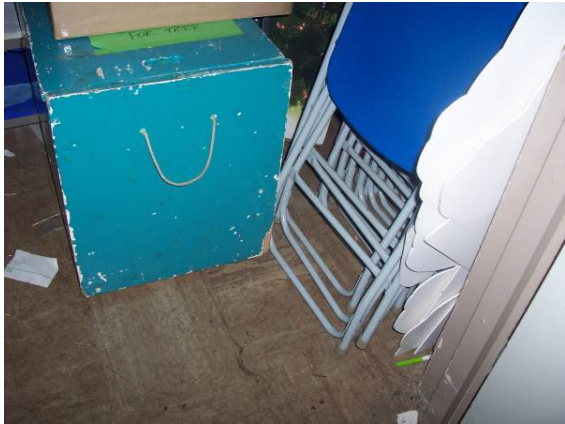
**Item 7 - Ref: Sample NO06/537**

The floor tiles in the community store do not contain asbestos.

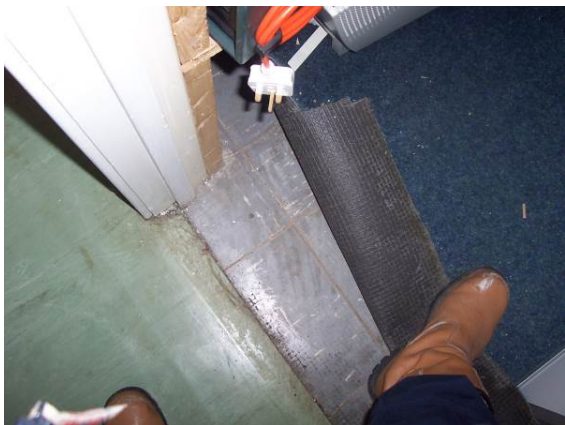
**Item 8 - Ref: Sample NO06/538**

The floor tiles in computer store do not contain asbestos.

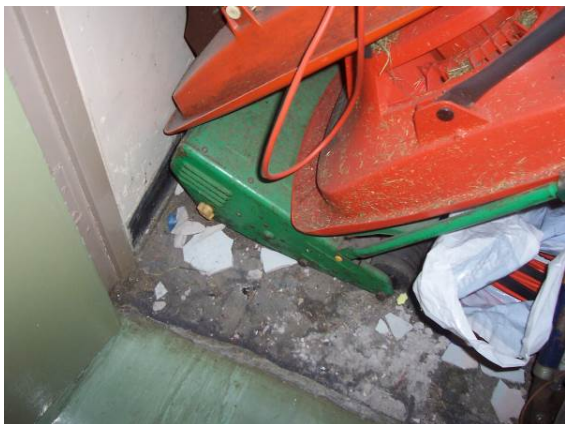
**Item 9 - Ref: Sample NO06/539**

The floor tiles in junior practical 2 (electrical intake) room do not contain asbestos.

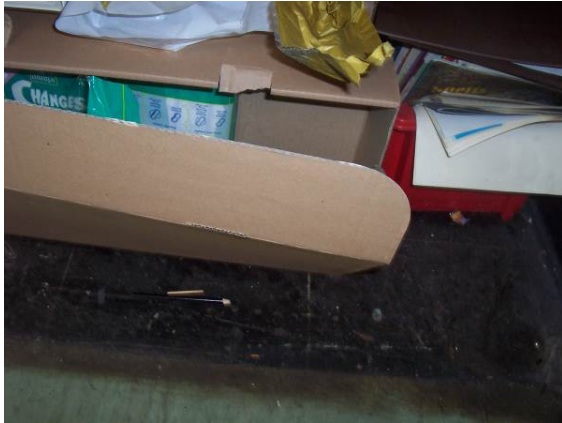
**Item 10 - Ref: Sample NO06/540**

The floor tiles in junior practical 2 paper store do not contain asbestos.

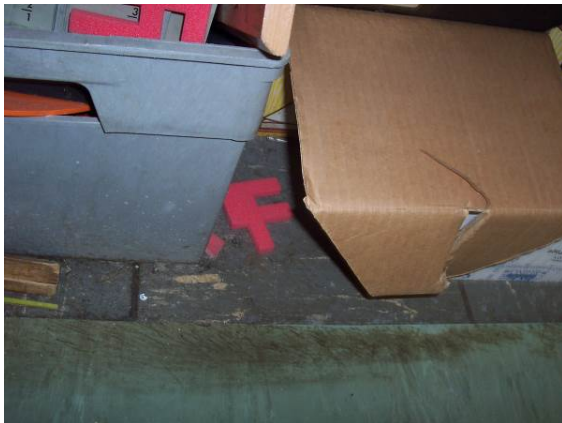
**Item 11 – Ref: Sample NO06/541**

The floor tiles in junior practical 2 book store do not contain asbestos.

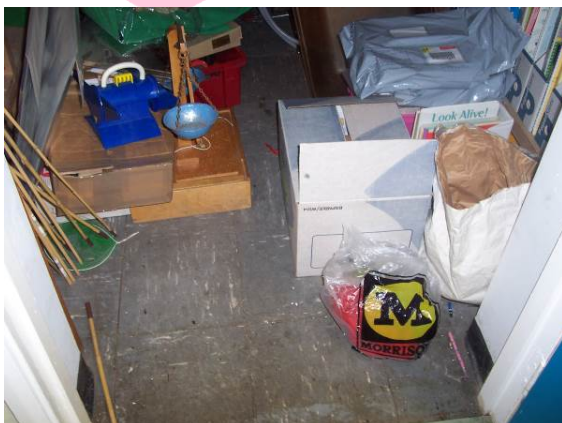
**Item 12 – Ref: Sample NO06/542**

The floor tiles in Junior Practical 2 Equipment store room do not contain asbestos.

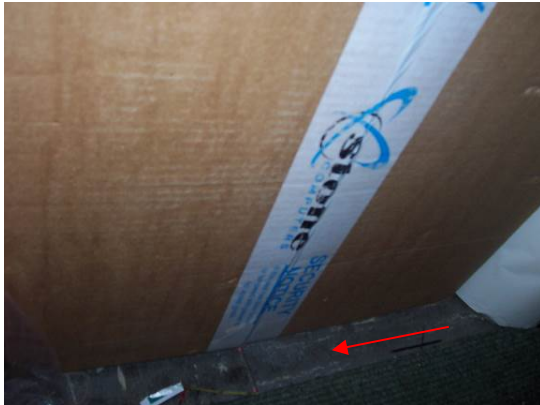
**Item 13 – Ref: Sample NO06/543**

The floor tiles in junior class 4 store do not contain asbestos.

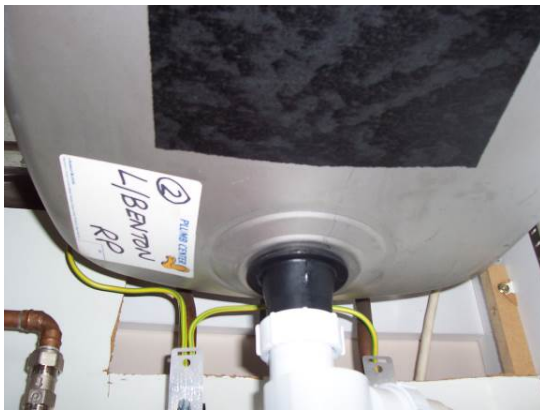
**Item 14 – Ref: Sample NO06/544**

The sink pad in Junior class 6 does not contain asbestos.

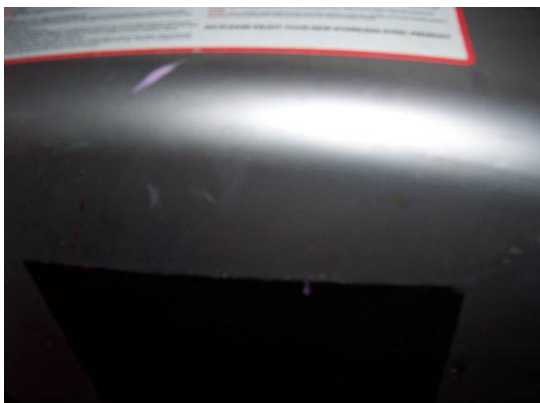
**Item 15 – Ref: Sample NO06/545**

The sink pad in Junior class 7 does not contain asbestos.

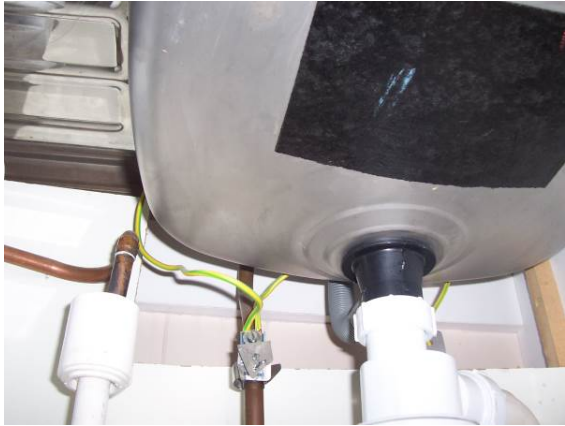
**Item 16 – Ref: Sample NO06/546**

The sink pad in Junior class 8 does not contain asbestos.

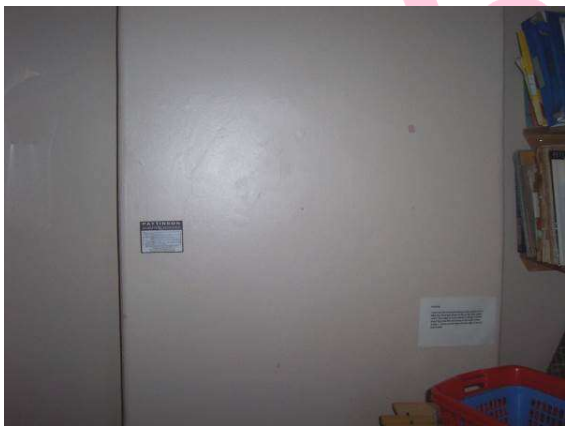
**Item 17 – Ref: Sample NO06/547**

The insulation to the heater in the infants class 3 store does not contain asbestos.

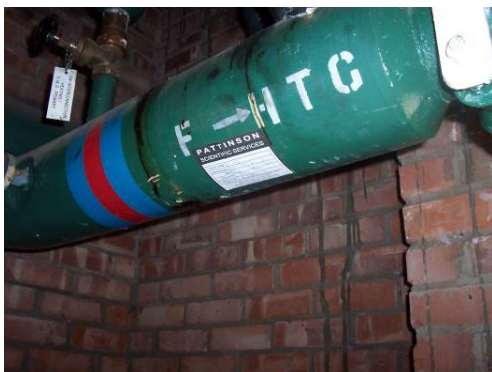
**Item 18 – Ref: Sample NO06/548**

The pipe insulation in the boiler room does not contain asbestos.

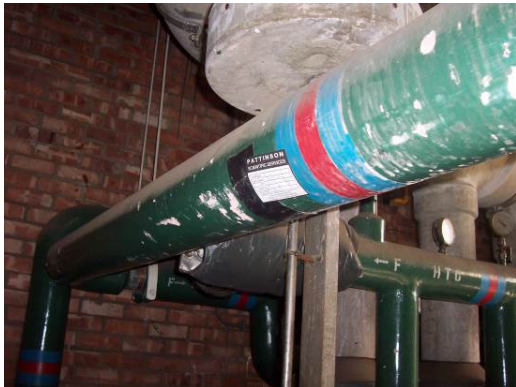
**Item 19 – Ref: Sample NO06/549**

The pipe insulation in the boiler room does not contain asbestos.

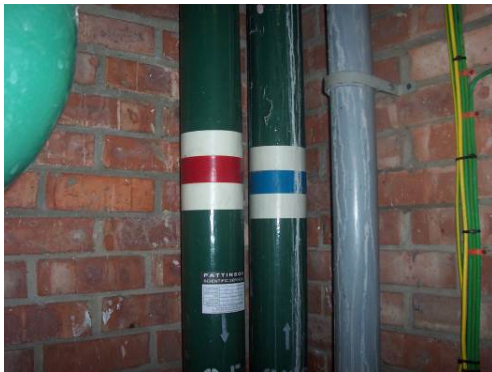
**Item 20 – Ref: Sample NO06/550**

The pipe insulation in the boiler room does not contain asbestos.

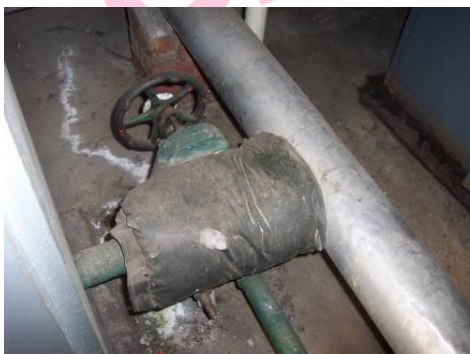
**Item 21 – Ref: sample NO06/551**

The pipe insulation in the boiler room does not contain asbestos.

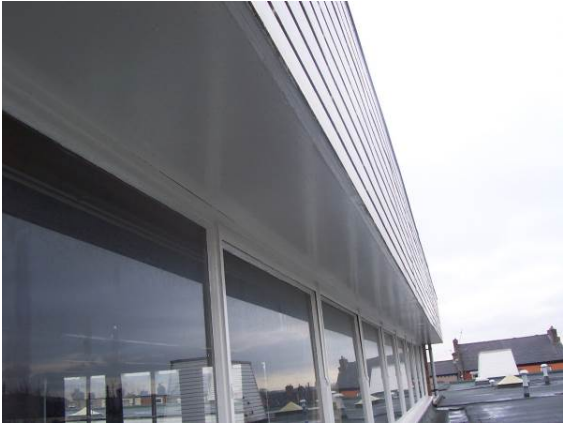
**Item 22 – Ref: Sample NO06/555**

The soffit boards to the hall do not contain asbestos.

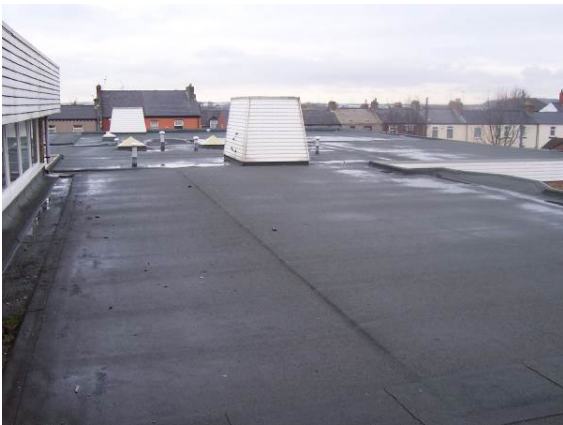
**Item 23 – Ref: Sample NO06/556**

The felt to the roof does not contain asbestos.

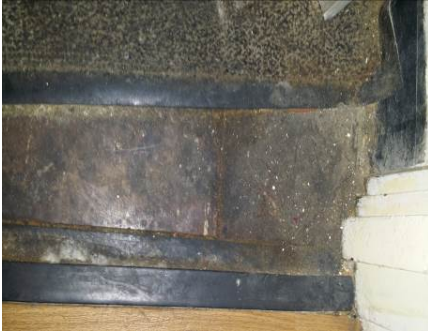
**Item 24 – Ref: 107247-2**

The floor covering to the electrical cupboard contains asbestos.

Any change in its appearance should be noted and passed to Property Services.

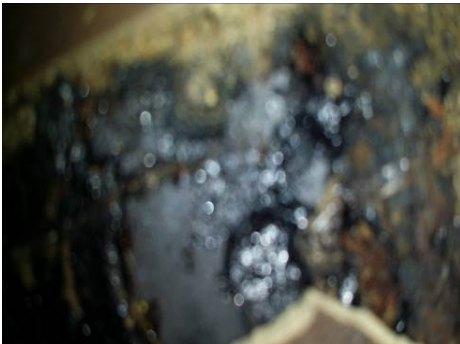
**Item 25 – Ref: 107247-3**

The adhesive to the flooring in the electrical cupboard contains asbestos.

Any change in its appearance should be noted and passed to Property Services.

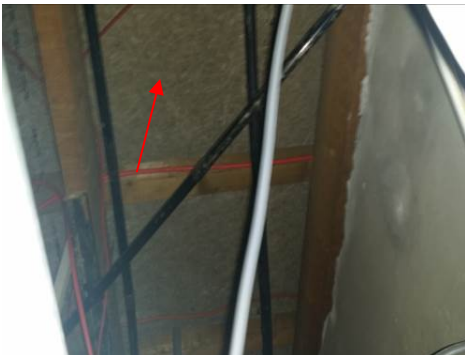
**Item 26 – Ref: 107247-1**

The underside of the roof in the void above the electrical cupboard does not contain asbestos.

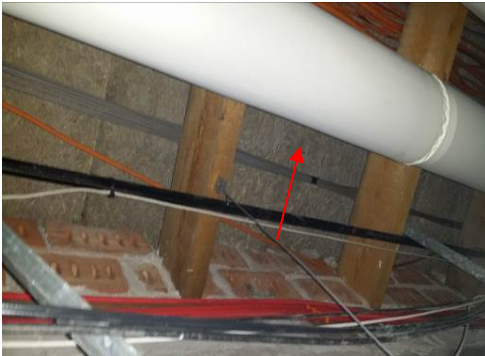
**Item 27 – As 107247-1**

The underside of the roof in the void above the stock room does not contain asbestos.

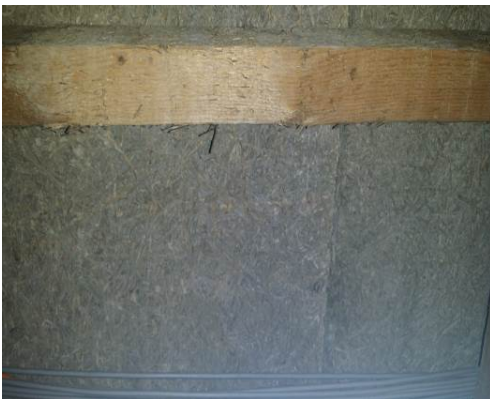
**Item 28 – As 107247-1**

The underside of the roof in the void above the corridor does not contain asbestos.

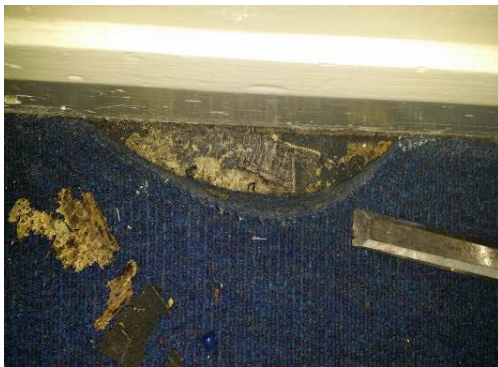
**Item 34 – Ref: 107247-6**

The screed to the floor in the nursery/practical area contains asbestos.

*Removed - However no paperwork or waste certificates held. Item has to remain on register until this paperwork is received.*

Any change in its appearance should be noted and passed to Property Services.

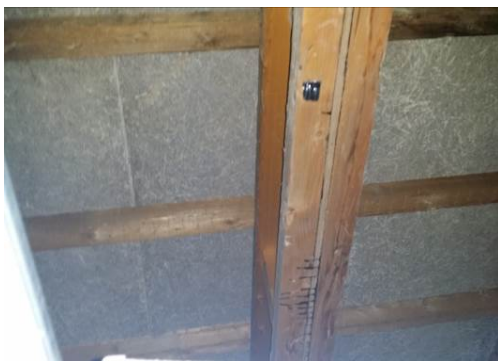
**Item 35 – As 107247-4**

The underside of the roof in the void above the nursery/practical area does not contain asbestos.

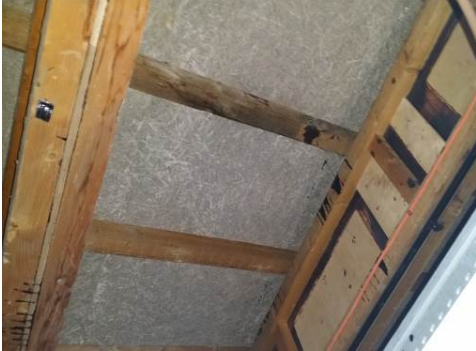
**Item 36 – As 107247-4**

The underside of the roof in the void above the store does not contain asbestos.

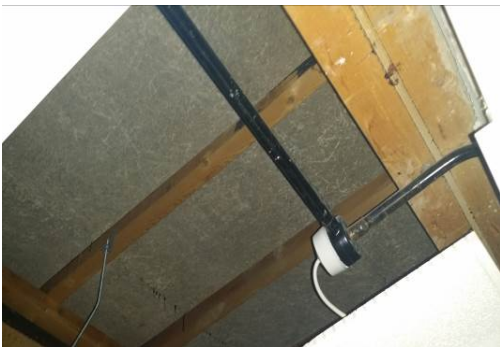
**Item 38 – Ref: 107247-5**

The underside of the roof in the void above the Resources cupboard does not contain asbestos.

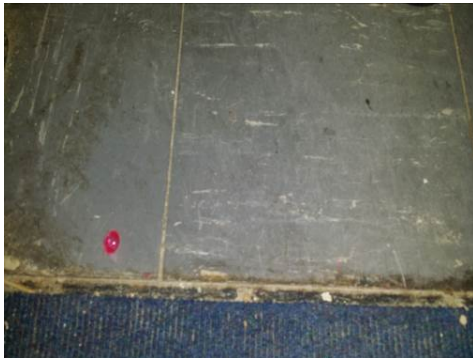
### **Item 39 – Ref:107247-5**

The floor covering to the reception classroom area contains asbestos.

*Removed - However no paperwork or waste certificates held. Item has to remain on register until this paperwork is received.*

Any change in its appearance should be noted and passed to Property Services.

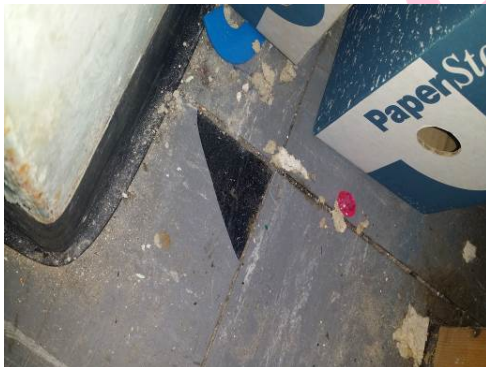
### **Item 40 – As 107247-6**

The screed to floor in the reception classroom contains asbestos.

*Removed - However no paperwork or waste certificates held. Item has to remain on register until this paperwork is received.*

Any change in its appearance should be noted and passed to Property Services.

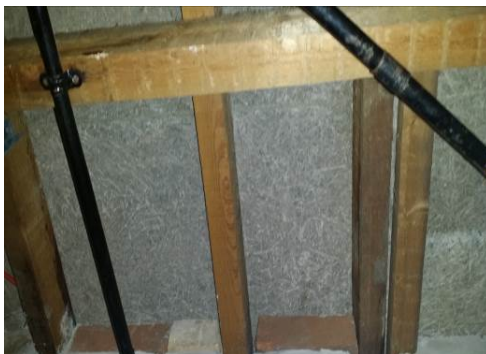
### **Item 41 – As 107247-5**

The underside of the roof in the void above the reception classroom area does not contain asbestos.

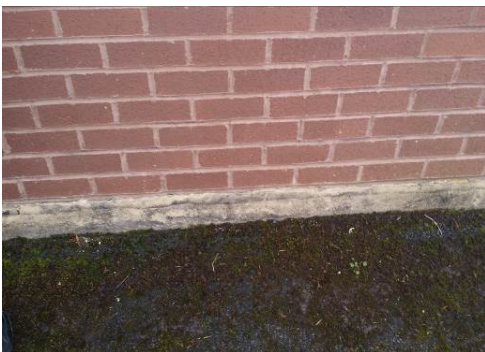
**Item 47 – Ref: 107247-10**

The damp proof course to the external does not contain asbestos.

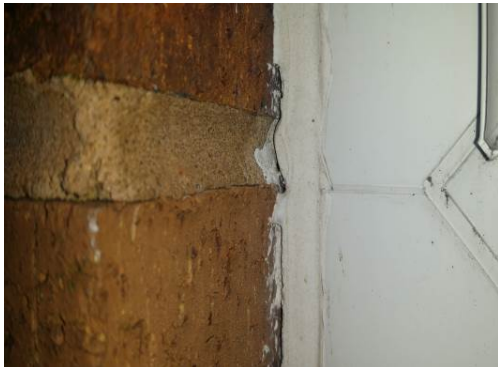
**Item 48 – Ref:107247-11**

The remnant mastic to the window and door frames to the external contains asbestos.

Any change in its appearance should be noted and passed to Property Services.

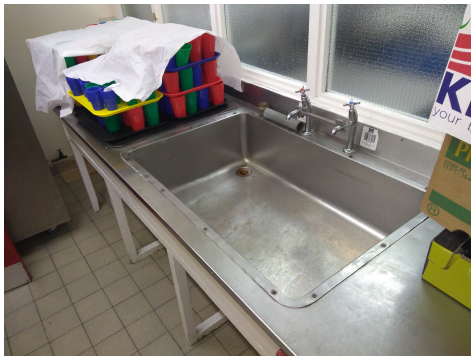
**Item 49 – Ref 277974-1**

The acoustic paint to underside of sinks in the kitchen does not contain asbestos.

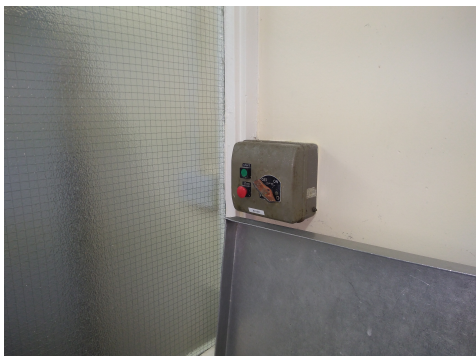
**Item 50 – Ref Presumed**

The electrics in the kitchen is presumed to contain asbestos.

Further investigation will be required before any work can commence.

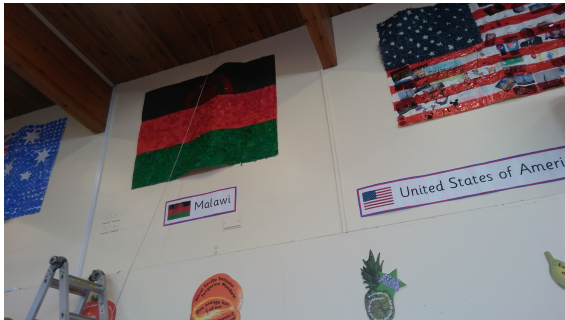
**Item 51 – Ref: 288787-1**

The coating to the wall in the hall does not contain asbestos.

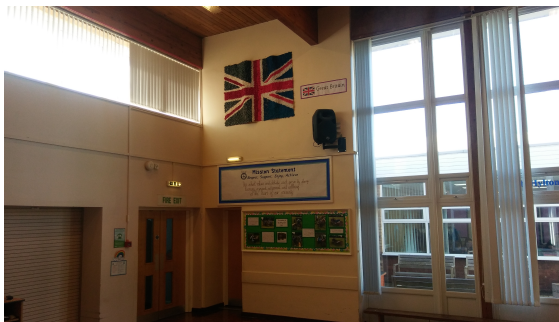
**Item 52 – Ref 288787-2**

The plaster to the wall in the hall does not contain asbestos.

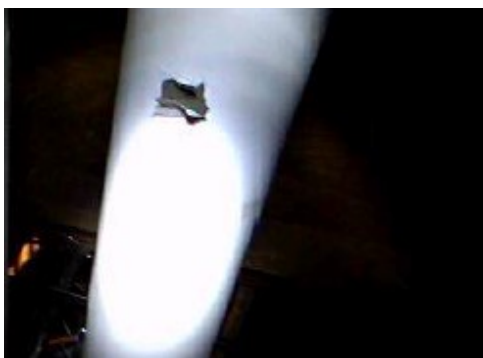
**Item 53 – Ref BB000978**

The Pipe lagging in Room 1 (Water Tank 1) does not contain asbestos.

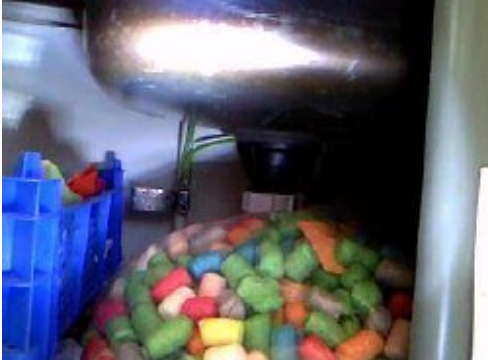
**Item 54 – Ref BB000979**

The Sink Pad in Room 4 (Nursery sink area) does not contain asbestos.

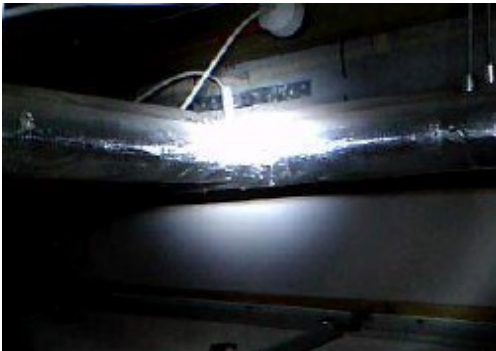
**Item 55 – Ref As BB000978**

The Pipe lagging in Room 6 (Water Tank 2) does not contain asbestos.

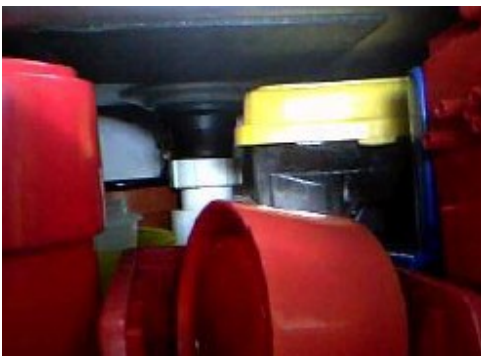
**Item 56 – Ref BB000980**

The Sink Pad in Room 7 (Reception sink area) does not contain asbestos.

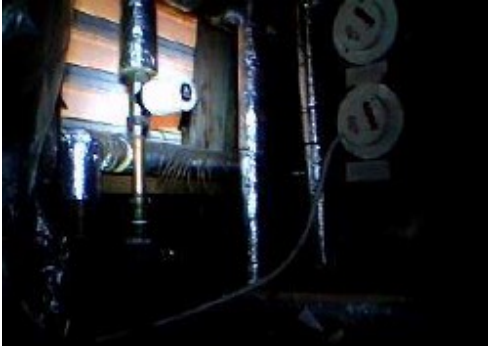
**Item 57 – Ref As BB000978**

The Pipe lagging in Room 10 (Water Tank 3) does not contain asbestos.

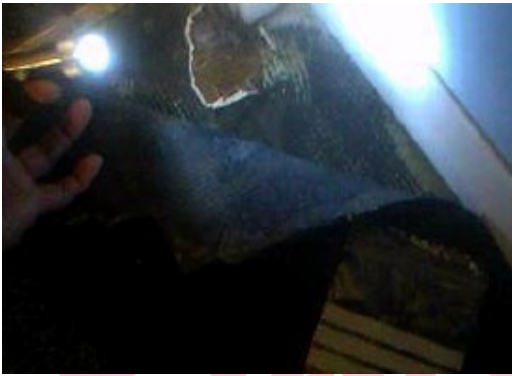
**Item 76 – Ref CB007003**

The Carpet to sampled lino (Room 1 Key stage 1 activity area) does not contain asbestos.

*Further investigation will be required before any work can commence.*

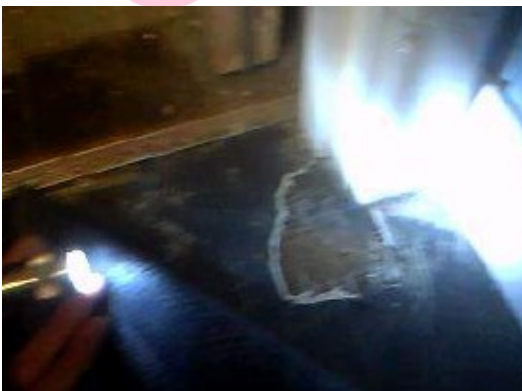
**Item 77 – Ref CB007004**

The Bitumen adhesive below lino (Room 1 Key stage 1 activity area) does not contain asbestos.

*Further investigation will be required before any work can commence.*

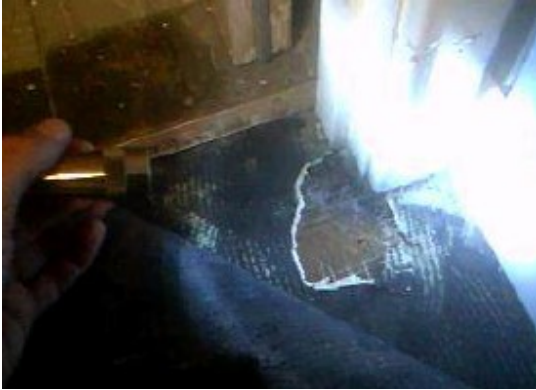
**Item 78 – Ref CB007005**

The Ashfelt floor (Room 1 Key stage 1 activity area) contains asbestos.

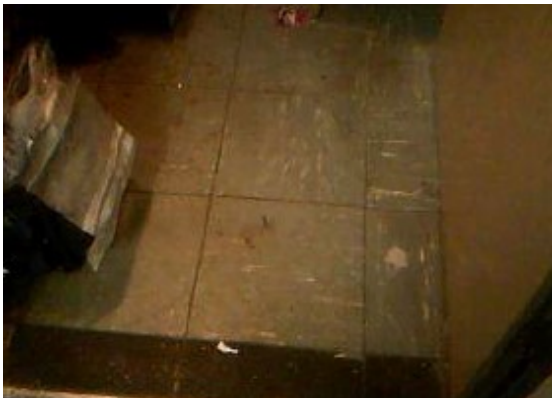
**Item 79 – Ref CB007006**

The Floor tiles (Room 2 Resource cupboard 1) contain asbestos – possibly overlaid

*Further investigation will be required before any work can commence.*

Any change in its appearance should be noted and passed to Property Services.

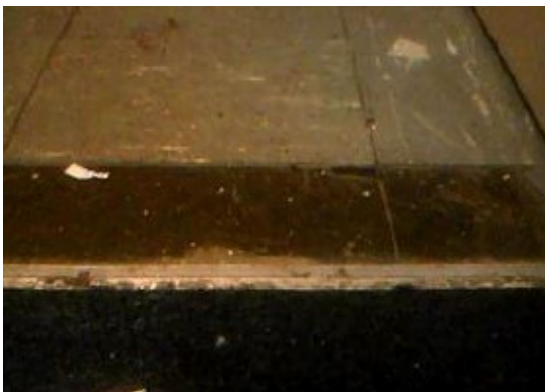
**Item 80 – Ref CB007007**

The Bitumen below floor tiles (Room 2 Resource cupboard 1) contain asbestos – possibly overlaid

*Further investigation will be required before any work can commence.*

Any change in its appearance should be noted and passed to Property Services.

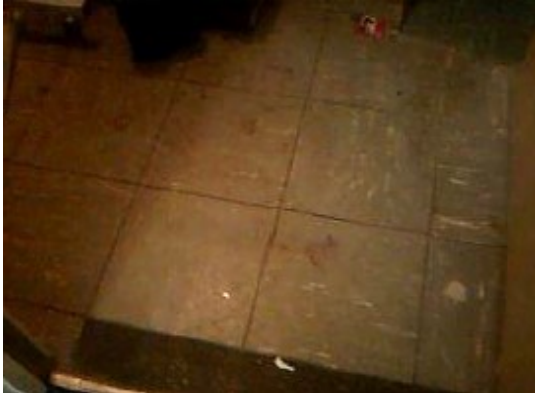
**Item 81 – Ref As CB007005**

The Ashfelt floor (Room 2 Resource cupboard 1) contains asbestos – possibly overlaid

*Further investigation will be required before any work can commence.*

Any change in its appearance should be noted and passed to Property Services.

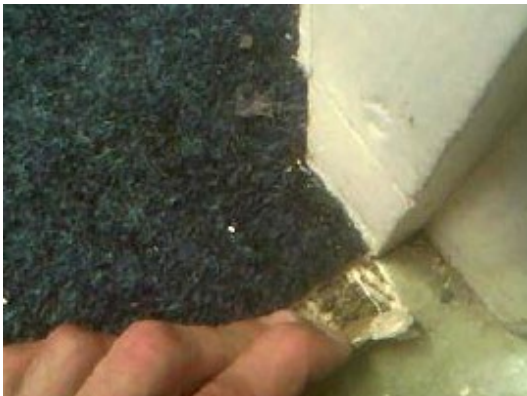
**Item 82 – Ref As CB007004**

The Bitumen adhesive below lino (Room 3 Resource cupboard 2) does not contain asbestos – possibly overlaid

*Further investigation will be required before any work can commence.*

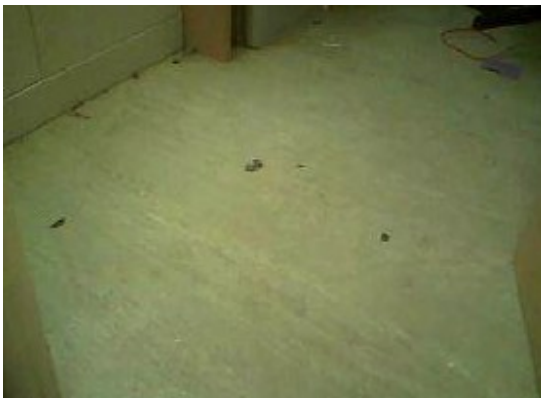
**Item 83 – Ref As CB007005**

The Ashfelt floor (Room 3 Resource cupboard 2) contains asbestos – possibly overlaid

*Further investigation will be required before any work can commence.*

Any change in its appearance should be noted and passed to Property Services.

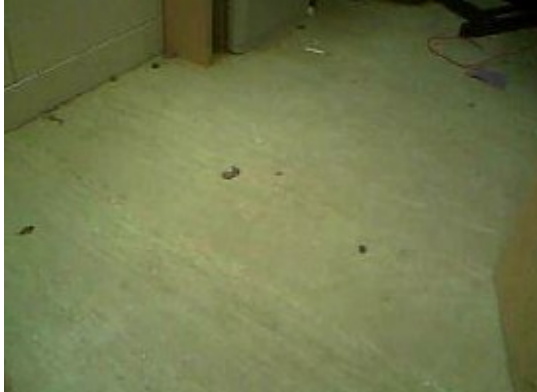
**Item 84 – Ref As CB007003**

The Lino (Room 3 Resource cupboard 2) does not contain asbestos – possibly overlaid

*Further investigation will be required before any work can commence.*

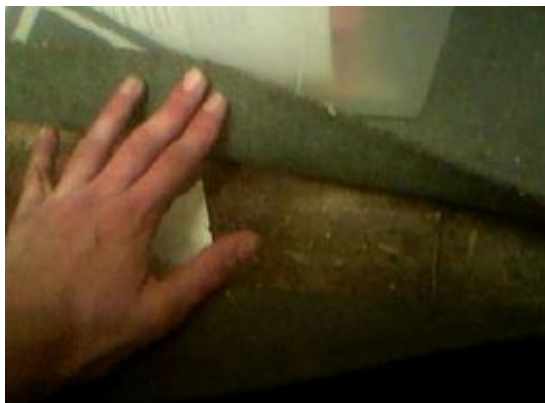
**Item 85 – Ref As CB007006**

The Floor tiles below carpet (Room 4 Resource cupboard 3) contains asbestos – possibly overlaid

*Further investigation will be required before any work can commence.*

Any change in its appearance should be noted and passed to Property Services.

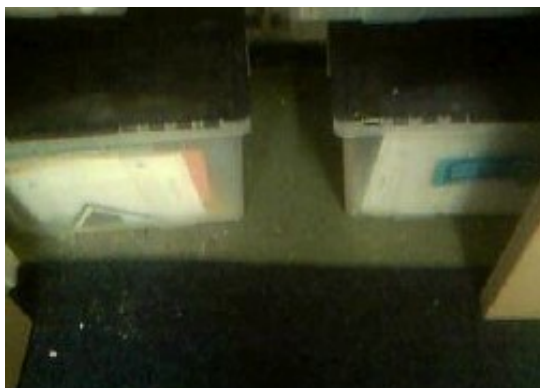
**Item 86 – Ref As CB007007**

The Bitumen below floor tiles (Room 4 Resource cupboard 3) contains asbestos – possibly overlaid

*Further investigation will be required before any work can commence.*

Any change in its appearance should be noted and passed to Property Services.

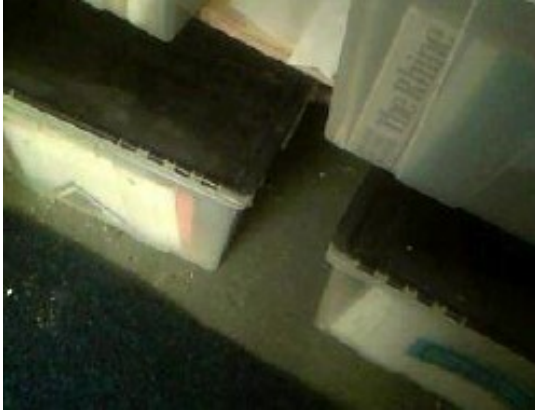
**Item 87 – Ref As CB007005**

The Ashfelt floor (Room 4 Resource cupboard 3) contains asbestos – possibly overlaid

*Further investigation will be required before any work can commence.*

Any change in its appearance should be noted and passed to Property Services.

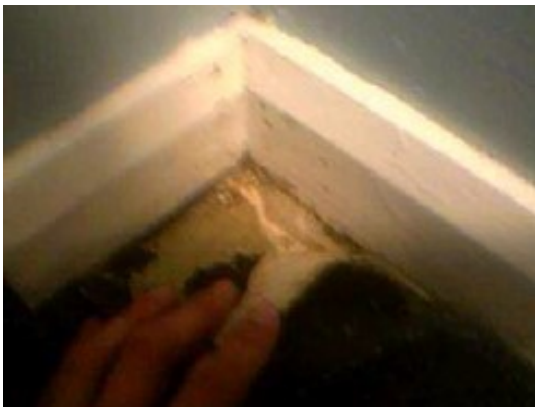
**Item 88 – Ref As CB007003**

The Newly fitted carpet to lino to concrete floor (Room 5 Keystage 2 corridor) does not contain asbestos.

*Further investigation will be required before any work can commence.*

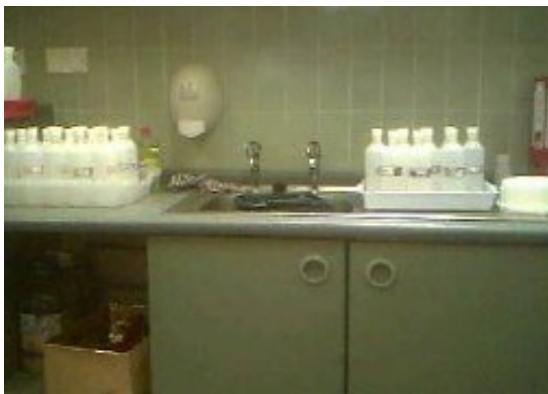
**Item 89 – Ref CB007008**

The Bitumen pads to underside of sink and drainer (Nursery Kitchen) does not contain asbestos.

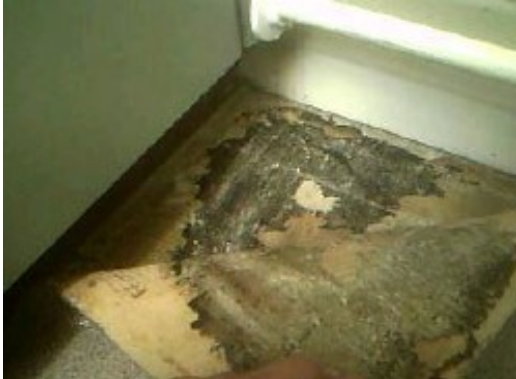
**Item 90 – Ref CB007009**

The Lino to bitumen (Nursery Kitchen) contains asbestos – possibly overlaid

*Further investigation will be required before any work can commence.*

Any change in its appearance should be noted and passed to Property Services.

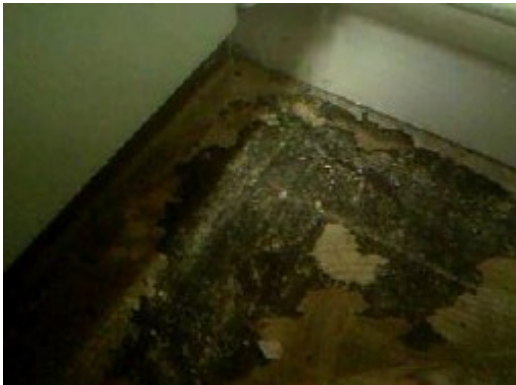
**Item 91 – Ref CB007010**

The Ashfelt floor (Room 6 Nursery Kitchen) contains asbestos – possibly overlaid

*Further investigation will be required before any work can commence.*

Any change in its appearance should be noted and passed to Property Services.

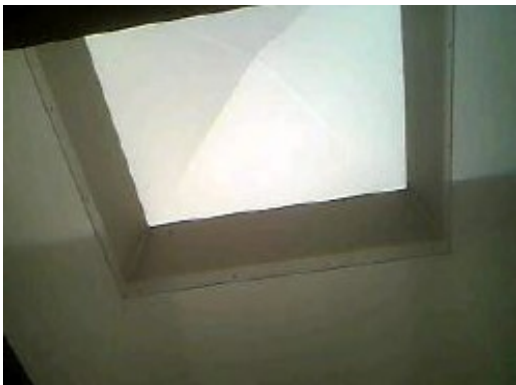
**Item 92 – Ref Presumed**

The Rope seal to skylight (Room 6 Nursery Kitchen) is presumed to contain asbestos.

*Further investigation will be required before any work can commence.*

Any change in its appearance should be noted and passed to Property Services.

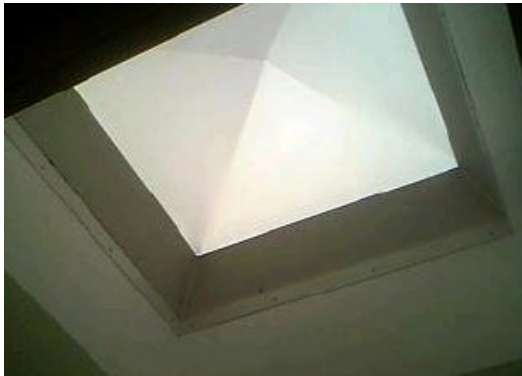
**Item 93 – Ref Presumed**

The rope seal to skylight although not visible limited access without causing possible damage (Room 3 Resource Cupboard 2) is presumed to contain asbestos.

Any change in its appearance should be noted and passed to Property Services.

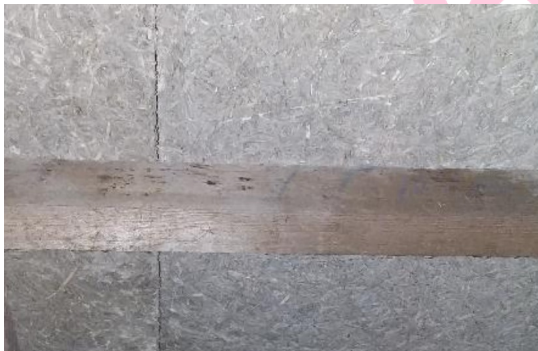
**Item 94 – Ref VK001283**

The strammit board to underside of roof throughout ground floor does not contain asbestos.

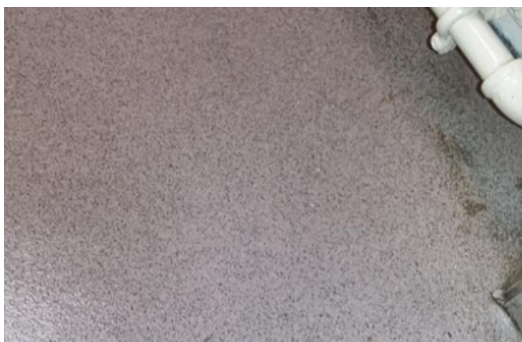
**Item 95 – Ref JS000384**

The Bitumen adhesive to floor beneath screed and modern vinyl floor covering (WC 02) does contain asbestos.

Any change in its appearance should be noted and passed to Property Services.

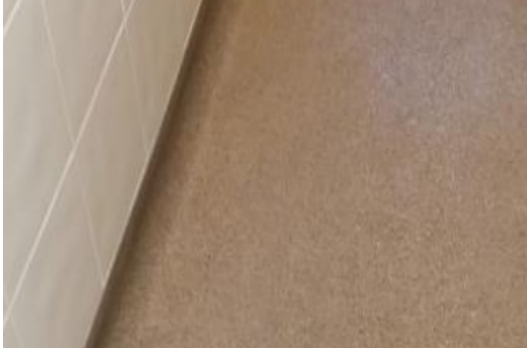
**Item 96 – Ref As JS000384**

The Bitumen adhesive to floor beneath screed and modern vinyl floor covering (WC 01) does contain asbestos.

Any change in its appearance should be noted and passed to Property Services.

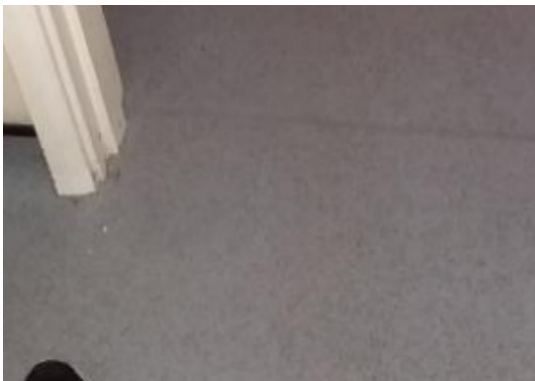
**Item 97 – Ref As JS000384**

The Bitumen adhesive to floor beneath screed and modern vinyl floor covering (WC 05) does contain asbestos.

Any change in its appearance should be noted and passed to Property Services.
