ASBESTOS SURVEY REPORT FOR PLAINS FARM ACADEMY, CARETAKERS HOUSE, SUNDERLAND

Plains Farm Primary School – Caretakers House

**PLAINS FARM ACADEMY
CARETAKERS HOUSE**

Date: 24 July 2024

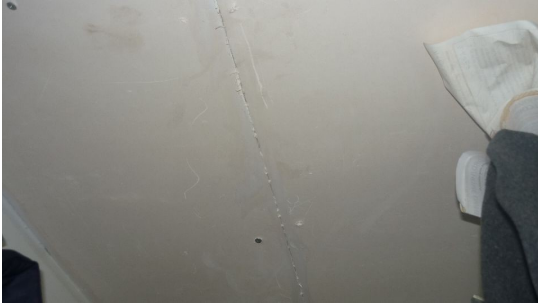
Item 1 Ref: ME1462/10

The ceiling board to the heating cupboard (Rm 0/02) does not contain asbestos.

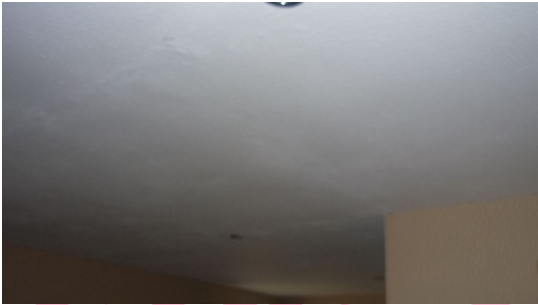
Item 2 - Ref: ME1463/10

The coating to the ceiling in the living room (Rm 0/03) contains asbestos. Any change in its appearance should be recorded, and passed to Property Services.

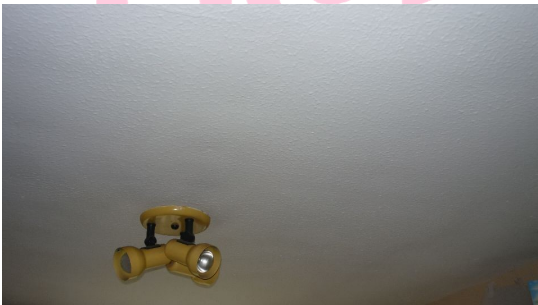
Item 3 – As ME1463/10

The coating to the ceiling in the kitchen (Rm 0/04) contains asbestos. Any change in its appearance should be recorded, and passed to Property Services.

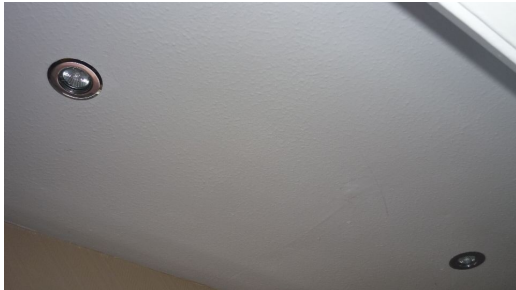
Item 4 –As ME1463/10

The coating to the ceiling in the toilet (Rm 0/05) contains asbestos. Any change in its appearance should be recorded, and passed to Property Services.

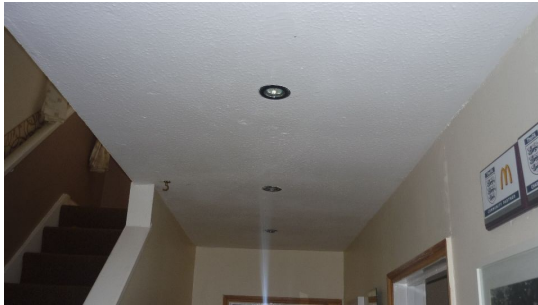
Item 5 – As ME1463/10

The coating to the ceiling to the stairs/hall/landing (Rm 1/01) contains asbestos. Any change in its appearance should be recorded, and passed to Property Services.

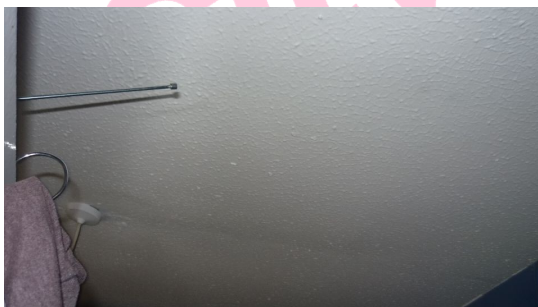
Item 6 – As ME1463/10

The coating to the ceiling in bedroom 1 (Rm 1/02) contains asbestos. Any change in its appearance should be recorded, and passed to Property Services.

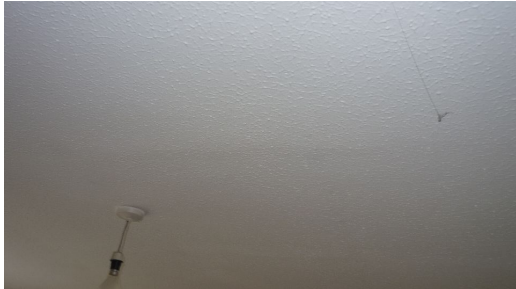
Item 7 – As ME1463/10

The coating to the ceiling in bedroom 2 (Rm 1/03) contains asbestos. Any change in its appearance should be recorded, and passed to Property Services.

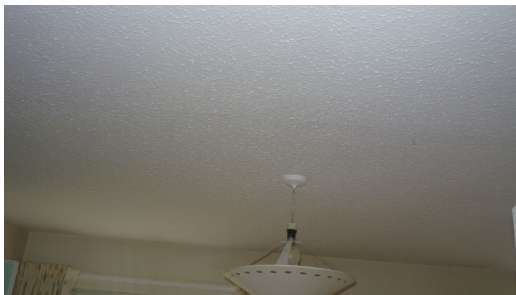
Item 8 – As ME1463/10

The coating to the ceiling in bedroom 3 (Rm 1/07) contains asbestos. Any change in its appearance should be recorded, and passed to Property Services.

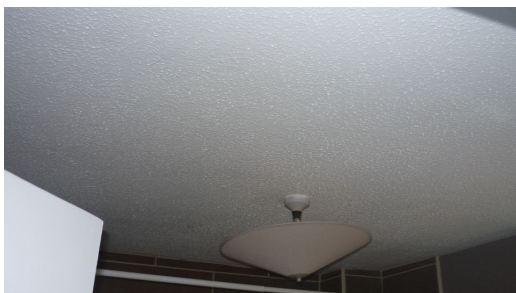
Item 9 - Ref: ME1464/10

The coating to the ceiling in the bathroom (Rm 1/08) contains asbestos. Any change in its appearance should be recorded, and passed to Property Services.

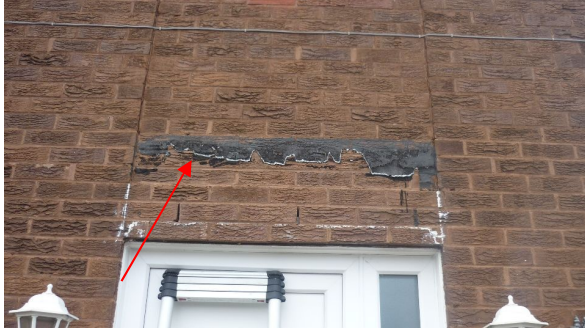
Item 10 - Ref: ME1465/10

The flashing above the front entrance (External) contains asbestos. Any change in its appearance should be recorded, and passed to Property Services.

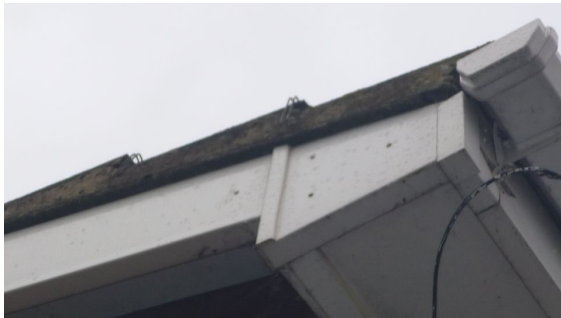
Item 11 - Ref: Presumed

The undercloak to the external of the house is presumed to contain asbestos. Any change in its appearance should be recorded, and passed to Property Services.
