### **ASBESTOS SURVEY REPORT FOR FARRINGDON COMMUNITY ACADEMY, CARETAKERS HOUSE, SUNDERLAND**

**Asbestos Register for**  
**FARRINGDON COMMUNITY ACADEMY**  
**CARETAKERS HOUSE**

**UPRN: - 76709**

**Premises Manager / Samo: - Tenant                      Date: 07 October 2022**

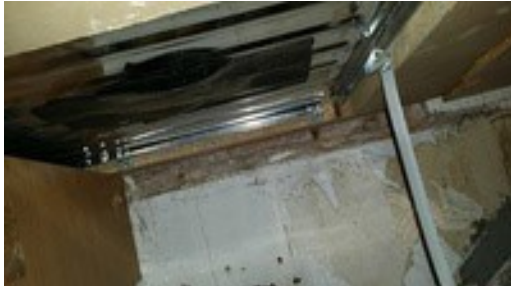
### **Item 1 Ref: 76709-1**

- 76709-1 - Sink Pad (Kitchen) (Item 1) – No Risk
- 76709-2 - Floor covering (Bathroom) (Item 2) – Low Risk
- 76709-3 - Sink Pad (Bathroom) (Item 3) – No Risk

The sink pad in the kitchen does not contain any asbestos.

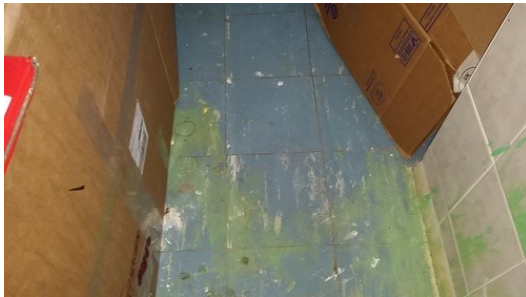
### **Item 2 Ref: 76709-2**

The floor covering in the Bathroom contains asbestos. Any change in its appearance should be recorded, and passed to Property Services.

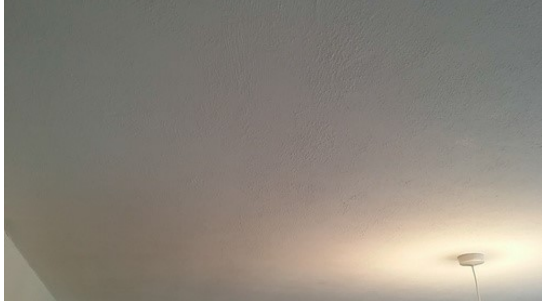
**Item 4 - Ref: 76709-4**

- 76709-4 – Textured coated ceiling (Bedroom) (Item 4) – Low Risk
- As 76709 -4 – Textured coated ceiling (Bedroom) (Item 5) – Low Risk
- As 76709 -4 – Textured coated ceiling (Bedroom) (Item 6) – Low Risk

The textured coated ceiling in the Bedroom contains asbestos. Any change in its appearance should be recorded, and passed to Property Services.

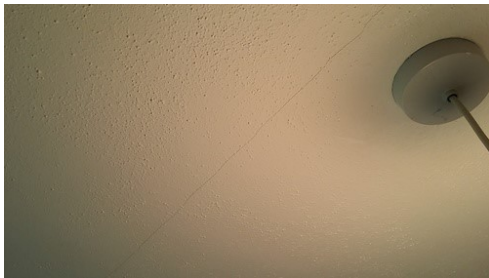
**Item 5 - Ref: As 76709-4**

The textured coated ceiling in the Bedroom contains asbestos. Any change in its appearance should be recorded, and passed to Property Services.

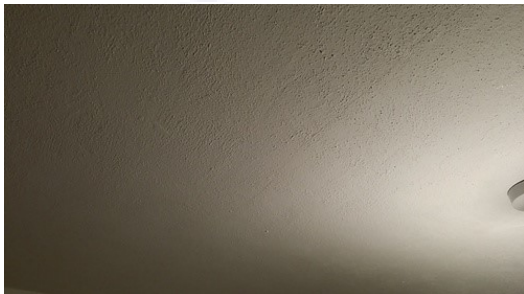
**Item 6 - Ref: As 76709-4**

The textured coated ceiling in the Bedroom contains asbestos. Any change in its appearance should be recorded, and passed to Property Services.

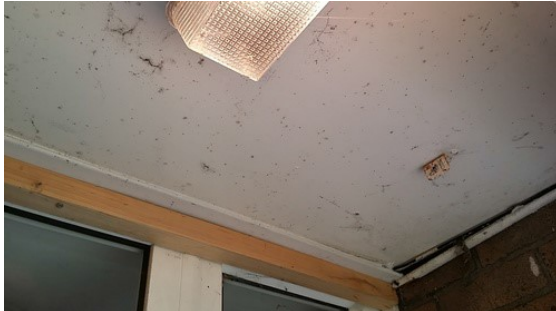
### **Item 7 - Ref: 76709-5**

- 76709-5 – Textured coated ceiling (Front Entrance) (Item 7) – Low Risk
- 76709-6 – Sealant to door frame (Front Entrance) (Item 8) – No Risk
- 76709-7 – Pipe lagging below non asbestos lagging (Loft) (Item 9) – Medium Risk

The textured coated ceiling in the Front Entrance contains asbestos. Any change in its appearance should be recorded, and passed to Property Services.

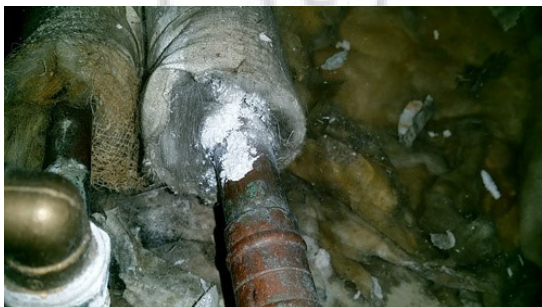
### **Item 9 - Ref: 76709-7**

The pipe lagging below non asbestos lagging in the loft does contain asbestos. Any change in its appearance should be recorded, and passed to Property Services.

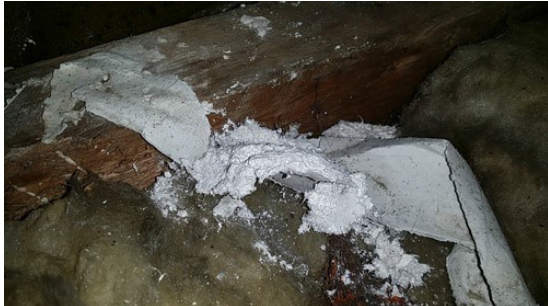
### **Item 10 - Ref: 76709-8**

- 76709-8 – Debris below non asbestos lagging (Loft) (Item 10) –Medium Risk
- 76709-9 – Debris to pipe (Loft) (Item 11) – Medium Risk
- 76709-10 – Debris to wood beams (Loft) (Item 12) – Medium Risk

The debris below non asbestos lagging in the loft does contain asbestos. Any change in its appearance should be recorded, and passed to Property Services. There should be no access to the loft until an environmental clean is carried out.

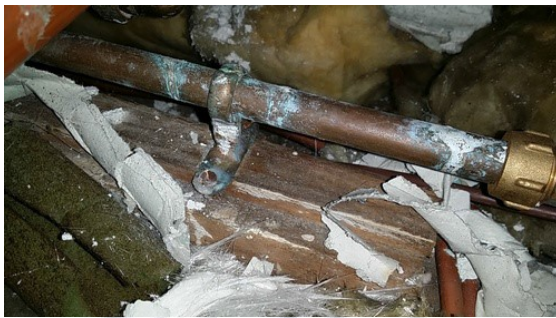
### **Item 11 - Ref: 76709-9**

The debris pipe in the loft does contain asbestos. Any change in its appearance should be recorded, and passed to Property Services. There should be no access to the loft until an environmental clean is carried out.

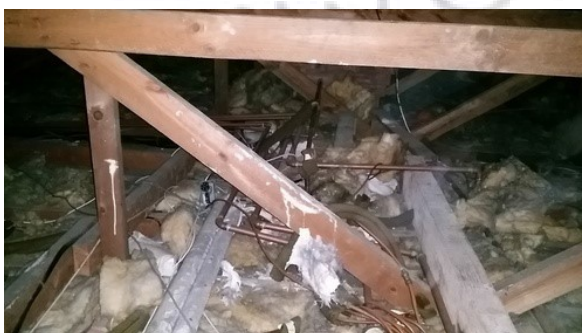
### **Item 12 - Ref: 76709-10**

The debris to the wood beams in the loft does contain asbestos. Any change in its appearance should be recorded, and passed to Property Services. There should be no access to the loft until an environmental clean is carried out.

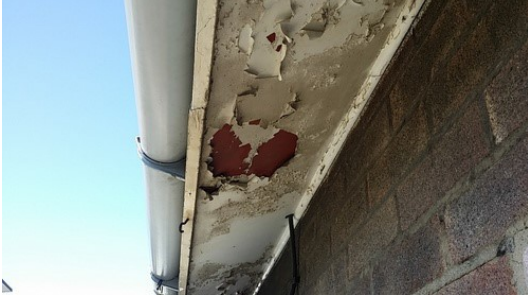
**Item 13 - Ref: 76709-11**

- 76709-11 – Soffit (External) (Item 13) - Very Low Risk
- 76709-12 – Damp Proof Course (External) (Item 14) – No Risk

The soffit contains asbestos. Any change in its appearance should be recorded, and passed to Property Services.
