ASBESTOS SURVEY REPORT FOR MARKET PLACE DEPOT, HOUGHTON LE SPRING,

Asbestos Register for Market Place Depot, Houghton le Spring

Premises Manager / Samo: - Tenant Date: 01 October 2024

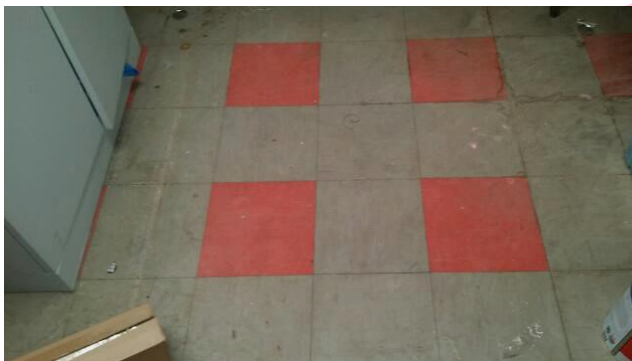
Item 7 Ref: As 02

The floor tiles in the Store Room (Rm 0/14) do not contain asbestos.

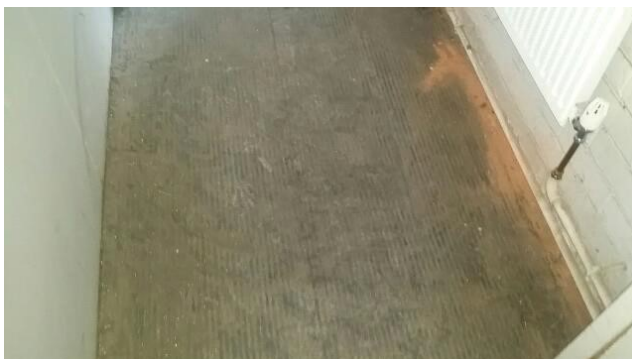
Item 8 Ref: As 02

The floor tiles in the Store Room (Rm 0/14) do not contain asbestos.

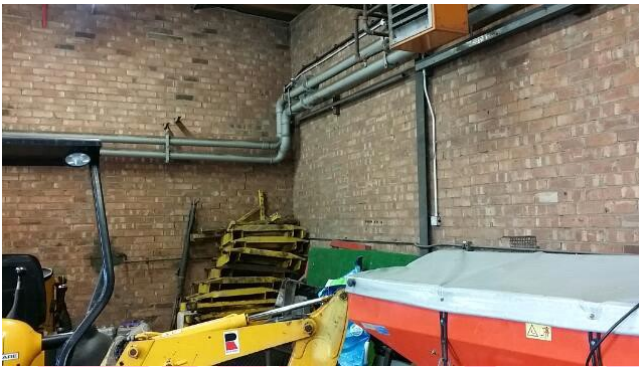
Item 14 Ref: Presumed

The pipework gaskets in the Garage (Rm 0/33) are presumed to contain asbestos.

Any changes in the appearance should be recorded and passed to Property Services.

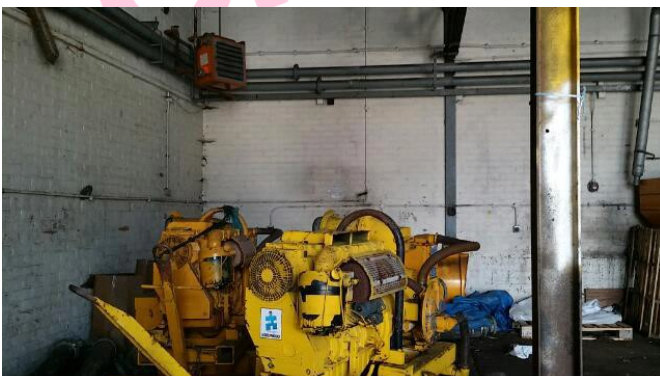
Item 15 Ref: Presumed

The pipework gaskets in the Garage (Rm 0/34) are presumed to contain asbestos.

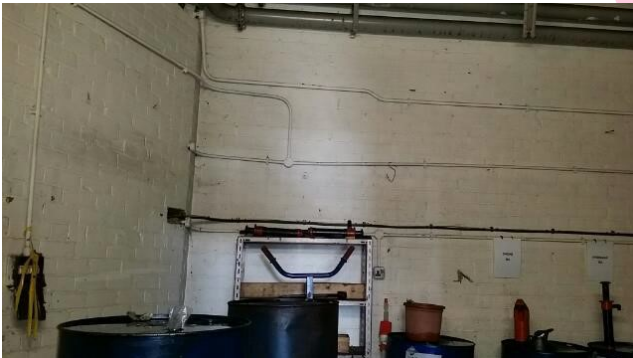
Item 17 Ref: Presumed

The pipework gaskets in the Garage (Rm 0/34) are presumed to contain asbestos.

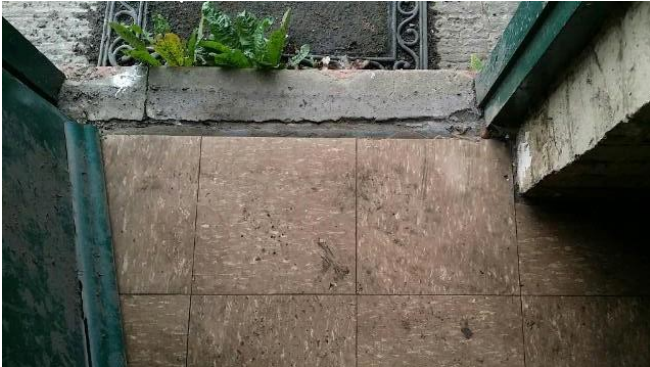
Item 19 Ref: As 07

The floor tiles in the Rest Room (Rm 0/36) contain asbestos.

Any change in the appearance should be recorded and passed to Property Services.

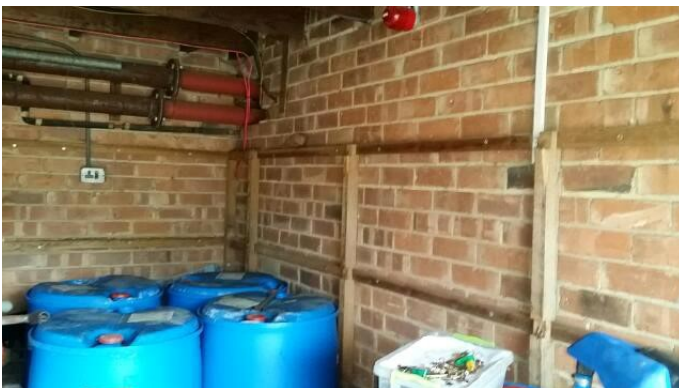
Item 20 Ref: Presumed

The pipework gaskets in the Shed (Rm 0/39) are presumed to contain asbestos.

Removed 2023

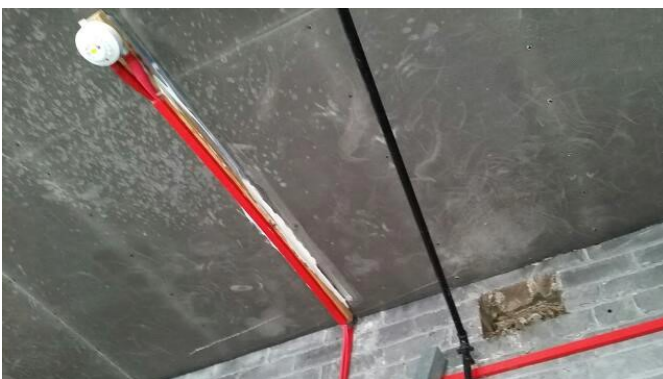
Item 21 Ref: 16

The ceiling in the Boiler Room (Rm 0/40) contained asbestos.

An Environmental clean was carried out in the Boiler Room in October 2016. This has now been removed.

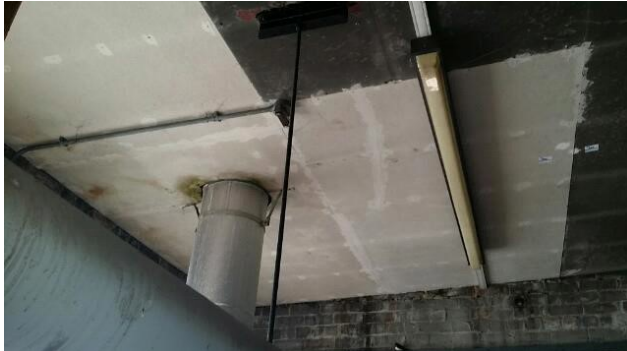
Item 22 Ref: 17

The repair board to ceiling in the Boiler Room (Rm 0/40) do not contain asbestos.

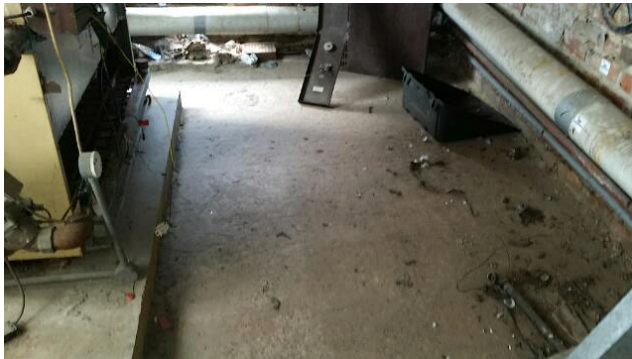
Item 23 Ref: 18

The debris to floor in the Boiler Room (Rm 0/40) contained asbestos.

An Environmental clean was carried out in the Boiler Room in October 2016. This has now been removed.

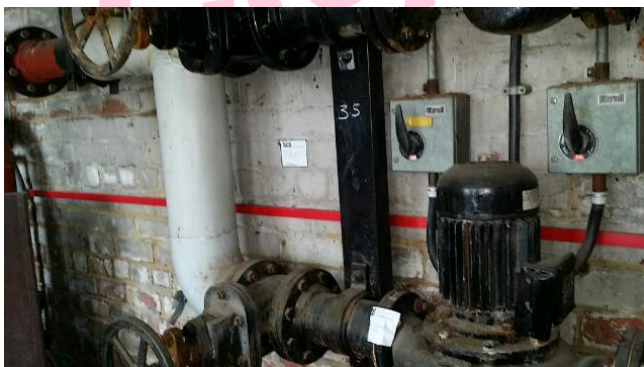
Item 24 Ref: 10

The debris to wall in the Boiler Room (Rm 0/40) contained asbestos.

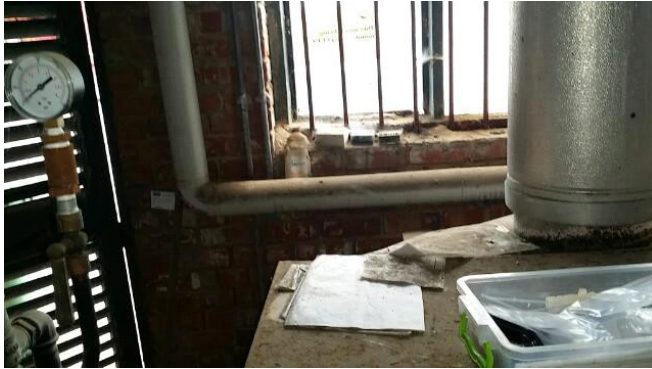
Item 28 Ref: 14

The debris to wall rear of boiler in the Boiler Room (Rm 0/40) does not contain asbestos.

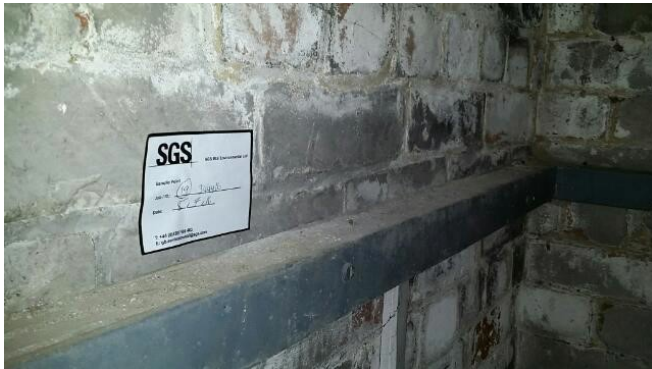
Item 29 Ref: 19

The debris to cable housing in the Boiler Room (Rm 0/40) contained asbestos.

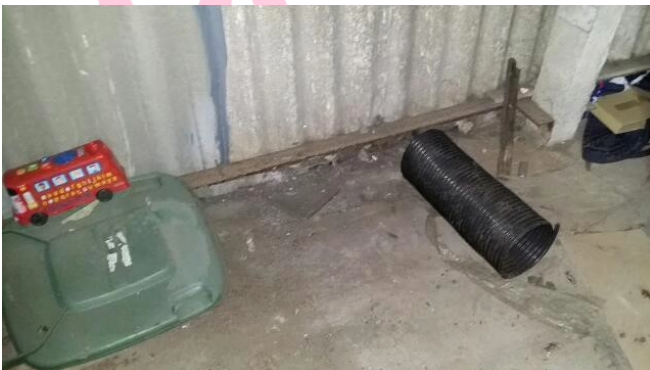
Item 33 Ref: 20

The debris from damaged wall cladding in the Shed (Rm 0/43) contain asbestos.

Item 33	Debris from damaged wall cladding in Shed Room (0/43)	Low Risk	6 monthly	18/02/2025
Item 34	Sheet cladding to wall in Shed Room (0/43)	Low Risk	6 monthly	Removed 2023

Any change in the appearance should be recorded and passed to Property Services.

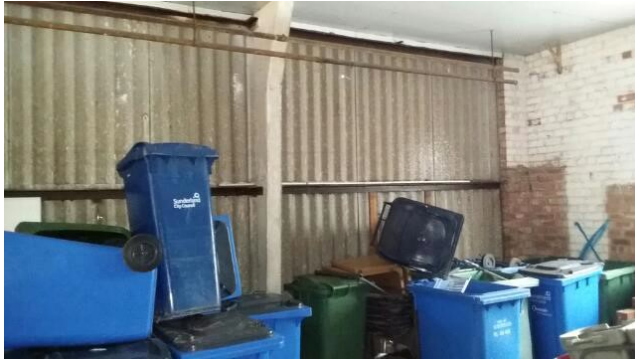
Item 34 Ref: As 20

The sheet cladding to wall in the Shed (Rm 0/43) contains asbestos.

Marked as removed – awaiting paperwork.

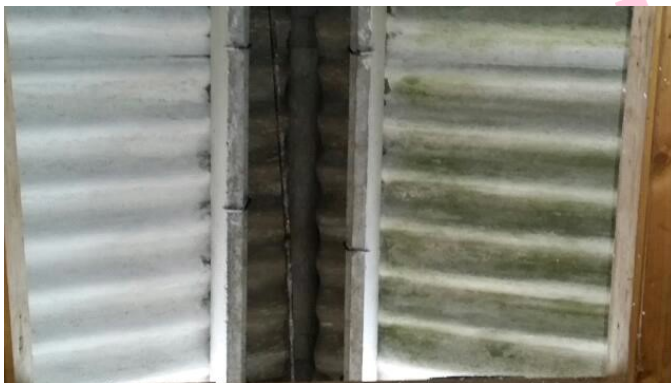
Item 35 Ref: As 21

The sheet cladding to roof in the Shed (Rm 0/43) contains asbestos.

Item 35	Sheet cladding to roof in Shed Room (0/43)	Low Risk	6 monthly	18/02/2025
Item 36	Debris from damaged wall cladding in Salt Shed Room (0/44)	Low Risk	6 monthly	18/02/2025

Any change in its appearance should be recorded and passed to Property Services.

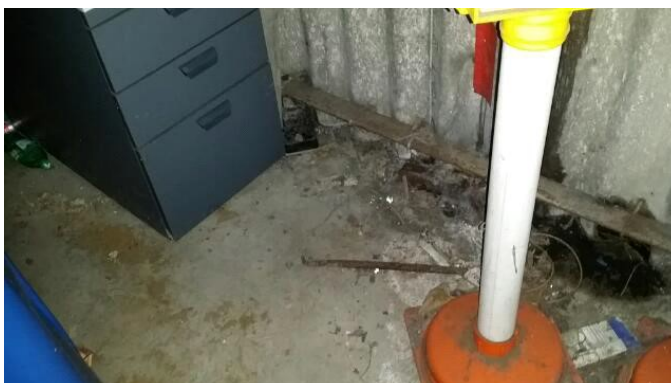
Item 36 Ref: As 20

The debris from wall cladding in Salt Shed (Rm 0/44) contains asbestos.

Any change in its appearance should be recorded and passed to Property Services.

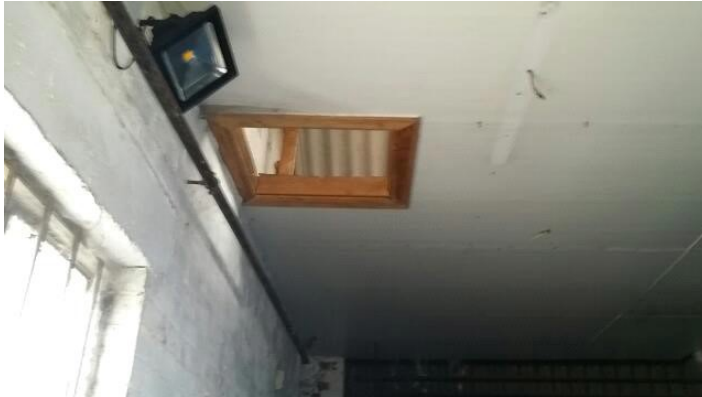
Item 37 Ref: As 21

The roof sheeting in the Salt Shed (Rm 0/44) contains asbestos.

Any change in its appearance should be recorded and passed to Property Services.

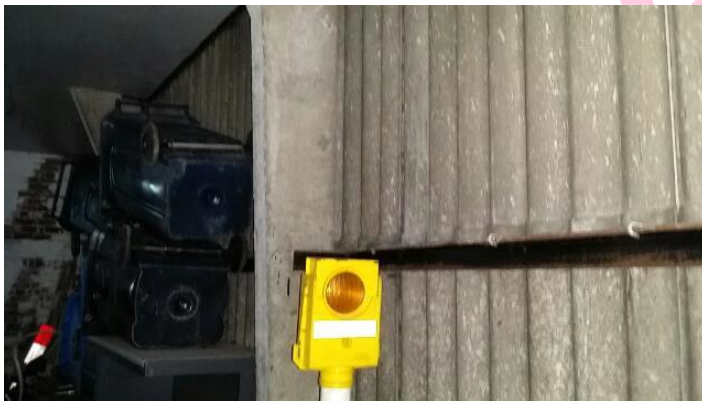
Item 38 Ref: As 20

The wall cladding in the Salt Shed (Rm 0/44) contains asbestos.

Any change in its appearance should be recorded and passed to Property Services.

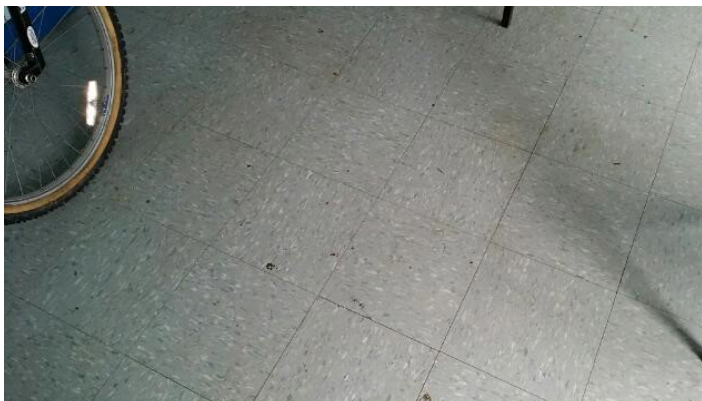
Item 39 Ref: 22

The floor tiles in the Shower Room (Rm 0/46) do not contain asbestos.

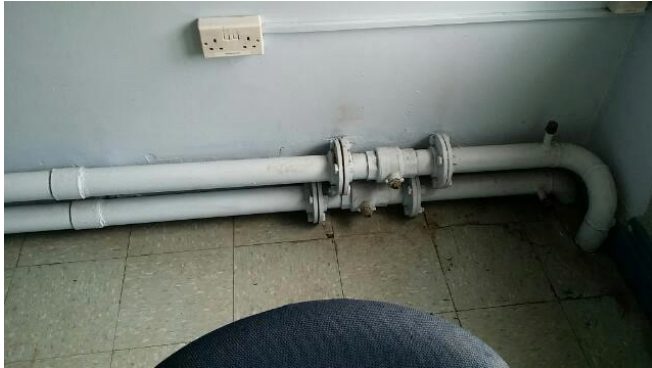
Item 40 Ref: Presumed

The pipework gaskets in the Shower Room (Rm 0/46) contains asbestos.

Any change in its appearance should be recorded and passed to Property Services.

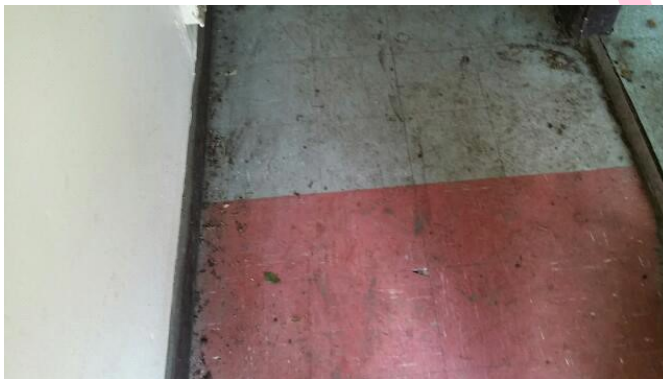
Item 41 Ref: 23

The floor tiles in the Hallway (Rm 0/49) contain asbestos.

Any change in its appearance should be recorded and passed to Property Services.

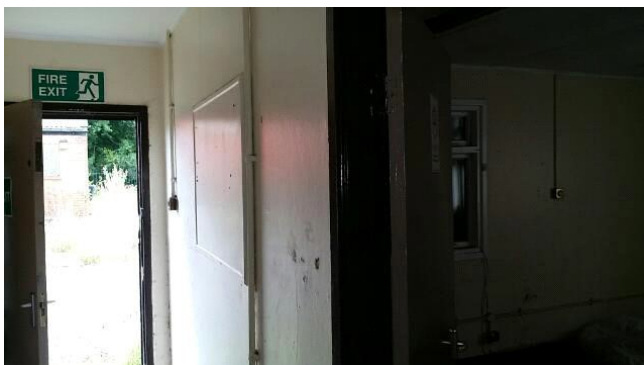
Item 42 Ref: 24

The wall in the Hallway (Rm 0/49) contains asbestos.

Any change in its appearance should be recorded and passed to Property Services.

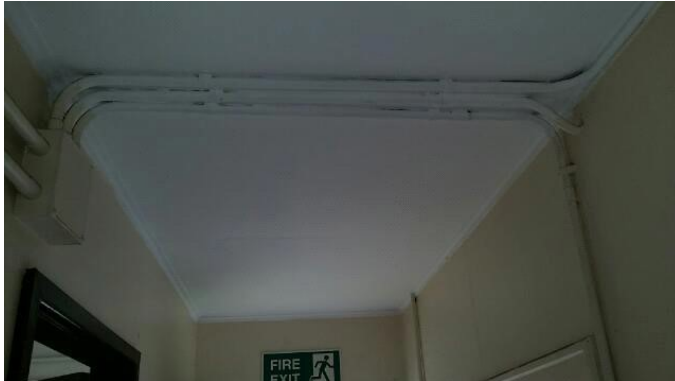
Item 43 Ref: 25

The ceiling in the Hallway (Rm 0/49) contains asbestos.

Any change in its appearance should be recorded and passed to Property Services.

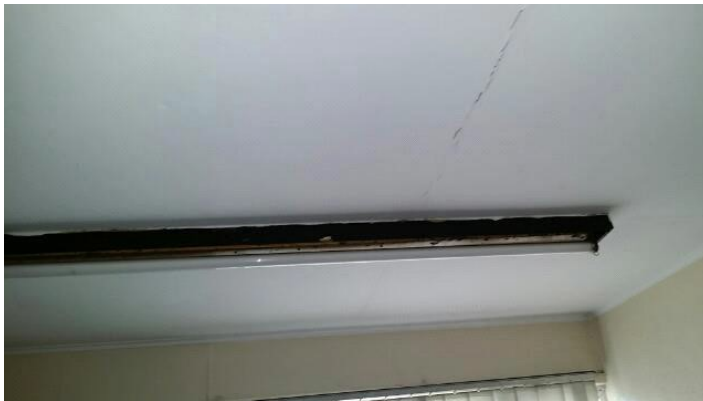
Item 44 Ref: As 25

The ceiling in the Office (Rm 0/50) contains asbestos.

Any change in its appearance should be recorded and passed to Property Services.

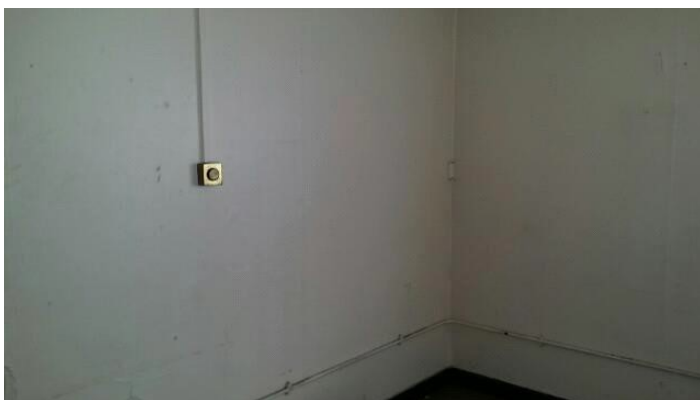
Item 45 Ref: As 24

The wall in the Office (Rm 0/50) contains asbestos.

Any change in its appearance should be recorded and passed to Property Services.

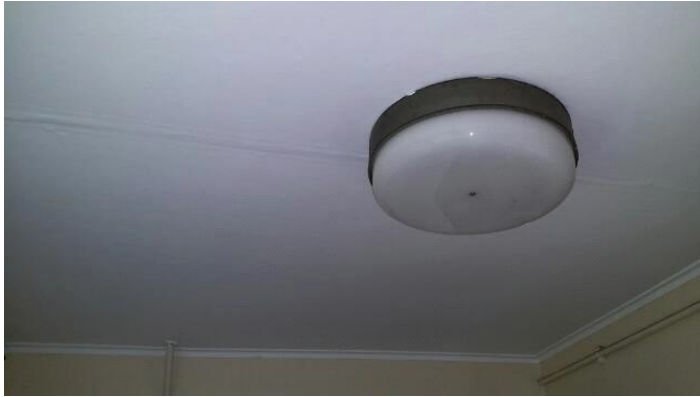
Item 46 Ref: As 25

The ceiling in the Toilets (Rm 0/51) contains asbestos.

Any change in its appearance should be recorded and passed to Property Services.

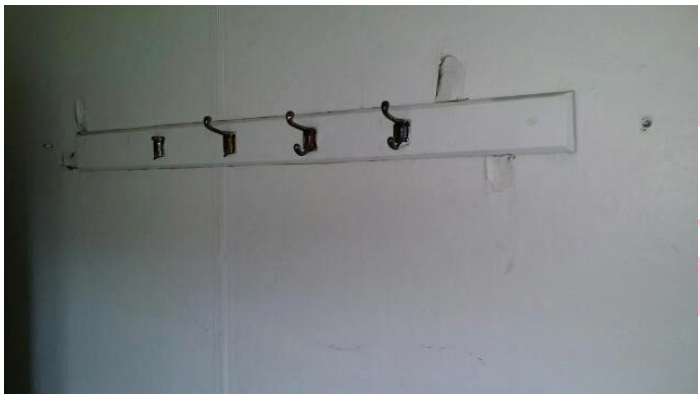
Item 47 Ref: As 24

The wall in the Toilets (Rm 0/51) contains asbestos.

Any change in its appearance should be recorded and passed to Property Services.

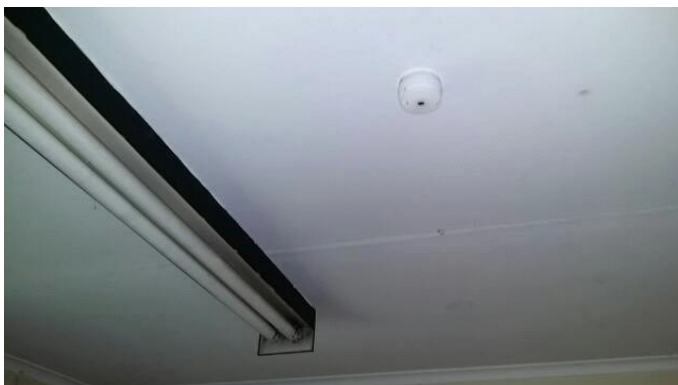
Item 48 Ref: As 25

The ceiling in the Office (Rm 0/52) contains asbestos.

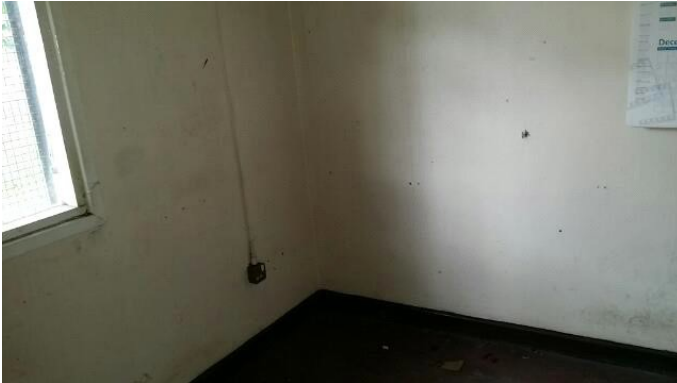
Item 49 Ref: As 24

The wall in the Office (Rm 0/52) contains asbestos.

Any change in its appearance should be recorded and passed to Property Services.

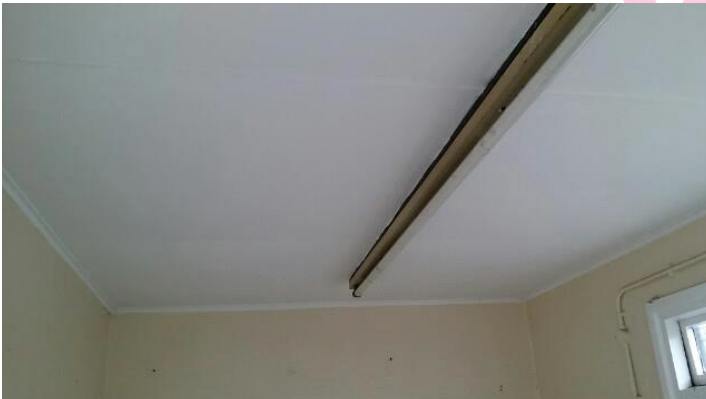
Item 50 Ref: As 25

The ceiling in the Office (Rm 0/53) contains asbestos.

Any change in its appearance should be recorded and passed to Property Services.

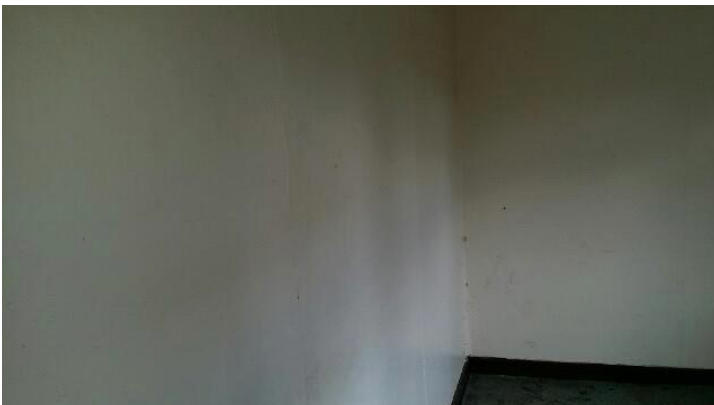
Item 51 Ref: As 24

The wall in the Office (Rm 0/53) contains asbestos.

Any change in its appearance should be recorded and passed to Property Services.

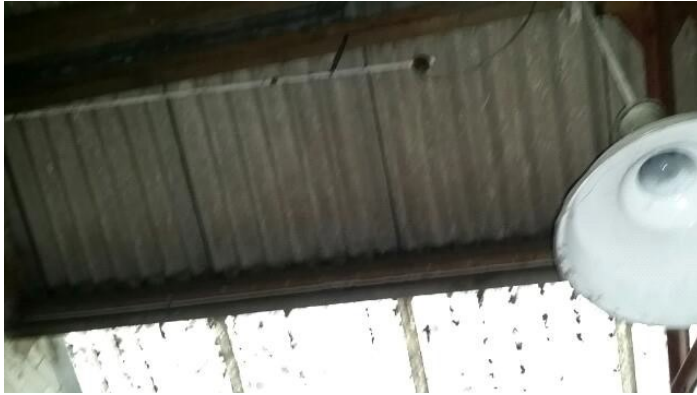
Item 52 Ref: 26

The ceiling in the Shed (Rm 0/54) contains asbestos.

Any change in its appearance should be recorded and passed to Property Services.

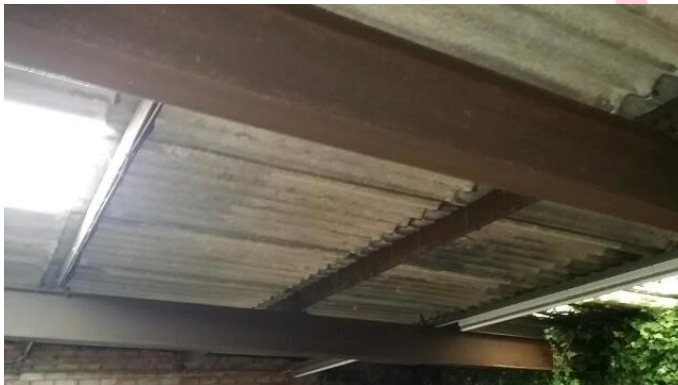
Item 53 Ref: As 26

The ceiling in the Garage (Rm 0/56) contains asbestos.

Any change in its appearance should be recorded and passed to Property Services.

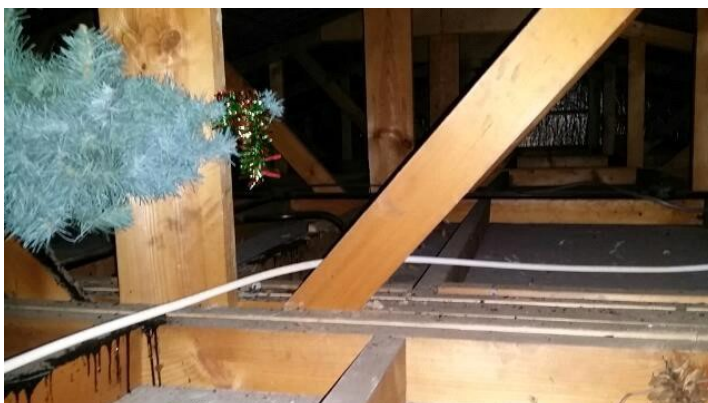
Item 54 Ref: As 25

The ceiling in the Loft Space (Rm L0/5) contains asbestos.

Any change in its appearance should be recorded and passed to Property Services.

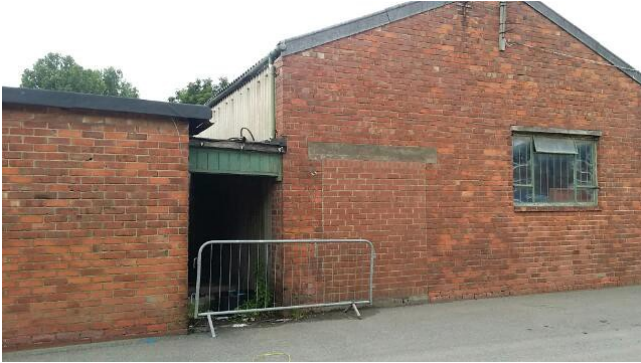
Item 55 Ref: As 20

The wall (External) contains asbestos.

Removed 2023

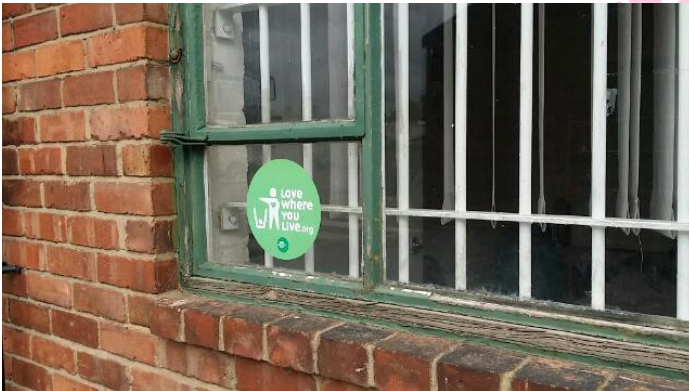
Item 56 Ref: 27

The window putty to the glass (External) does not contain asbestos.

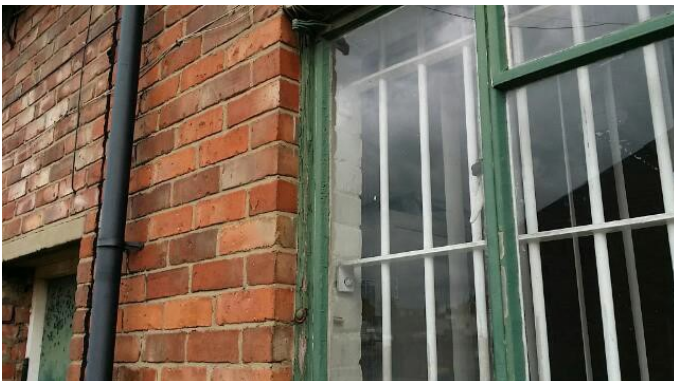
Item 57 Ref: 28

The window putty to the frame (External) contains asbestos.

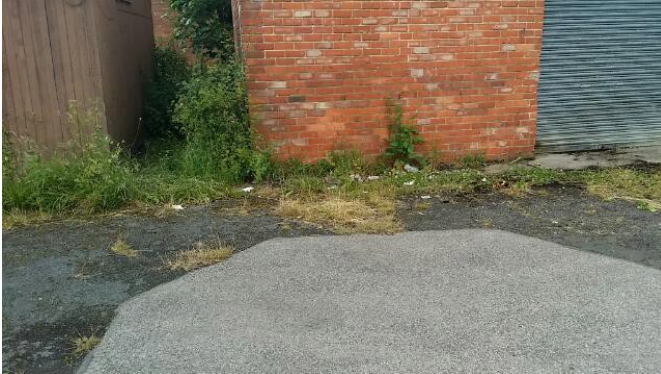
Item 58 Ref: Presumed

The damp proof course
(External) contains asbestos.

Removed 2023

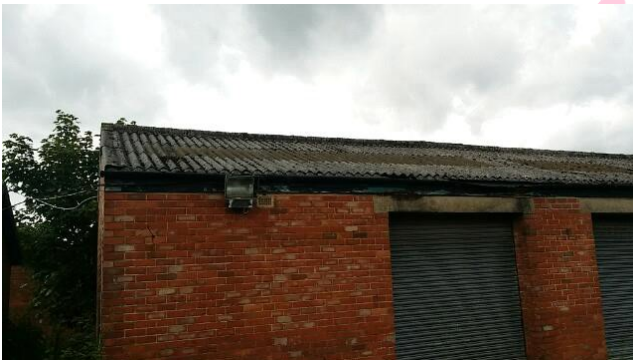
Item 59 Ref: As 26

The roof sheeting (External)
contains asbestos.

Any change in its appearance
should be recorded and
passed to Property Services.

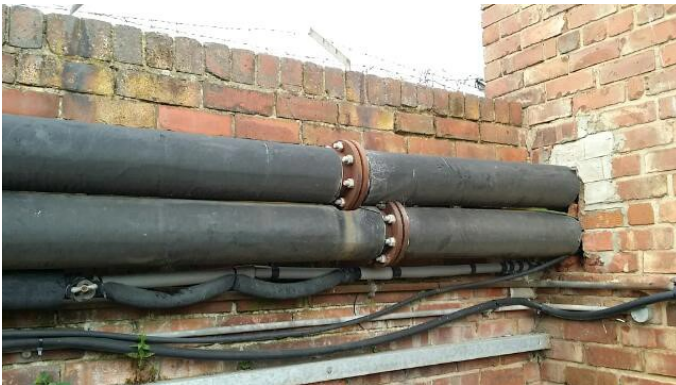
Item 62 Ref: 31

The pipework gaskets (External) do not contain asbestos.

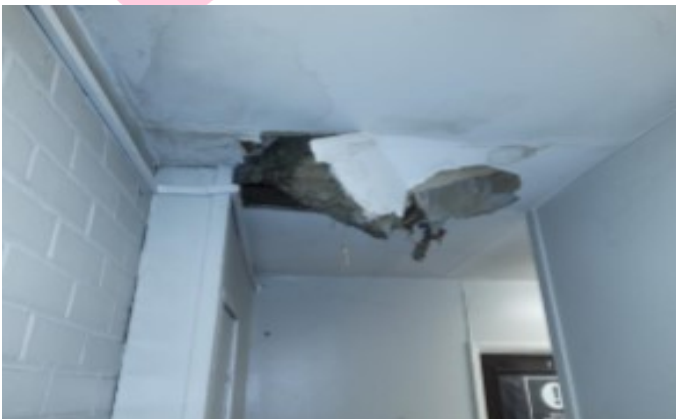
Item 63 Ref: 21-30435-1

The ceiling board in the corridor adjacent to Debra's office does not contain asbestos.

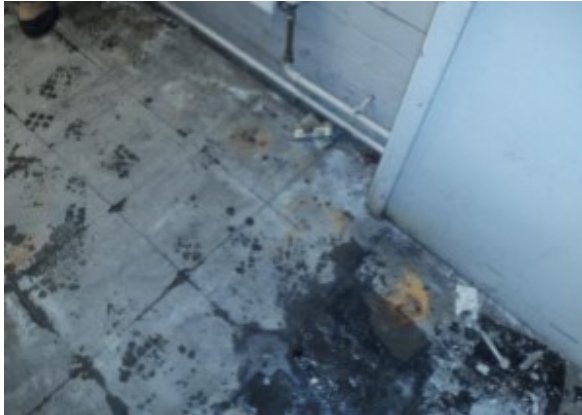
Item 64 Ref: 21-30435-2

The floor tiles and adhesive in the corridor adjacent to Debra's office does not contain asbestos.

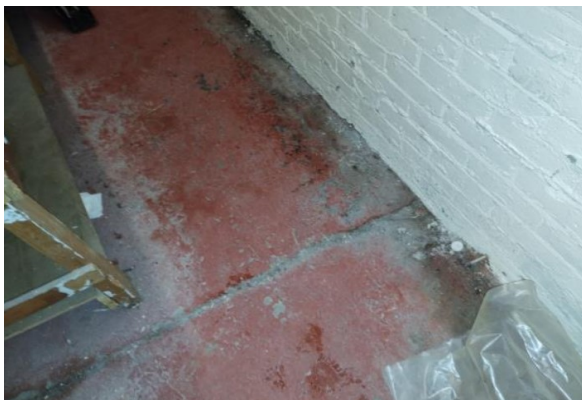
Item 65 Ref: 21-30764-1

The putty to joints in floor in Area 1/Store Room does not contain asbestos.

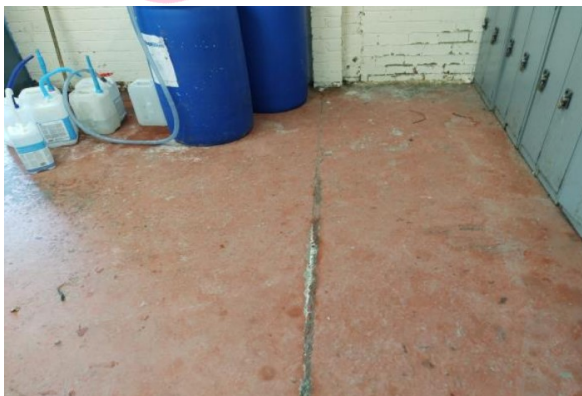
Item 66 Ref: 21-30764-1

The putty on floor in Area 2/Locker Room does not contain asbestos.

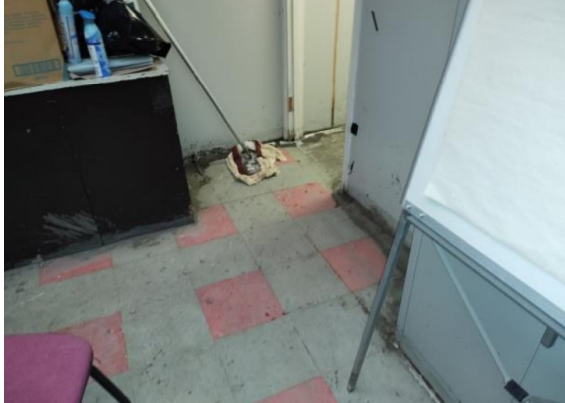
Item 73 Ref: 21-30764-11

The floor tiles and adhesive in Area 14/Mess Room does not contain asbestos.

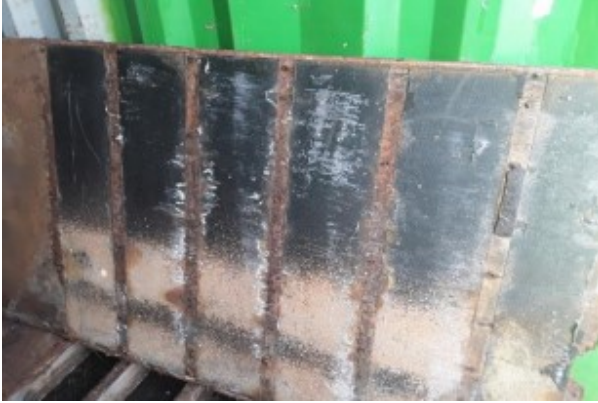
Item 76 Ref: 21-32018-1

The bitumen to the underside of the wood flooring in Container 3 does contain asbestos.

Removed 2023

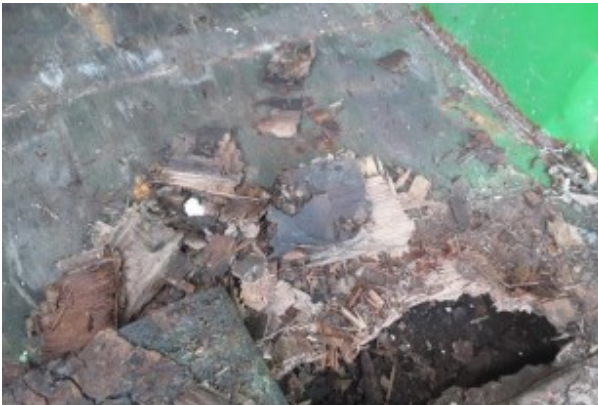
Item 77 Ref: 21-32018-1

The bitumen to the underside of the wood flooring in Container does contain asbestos.

Removed 2023

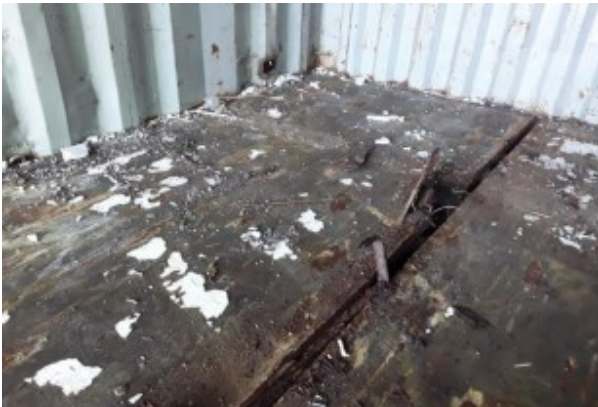
Item 78 Ref: 21-32018-1

The bitumen to the underside of the wood flooring in Container 6 does contain asbestos.

Removed 2023

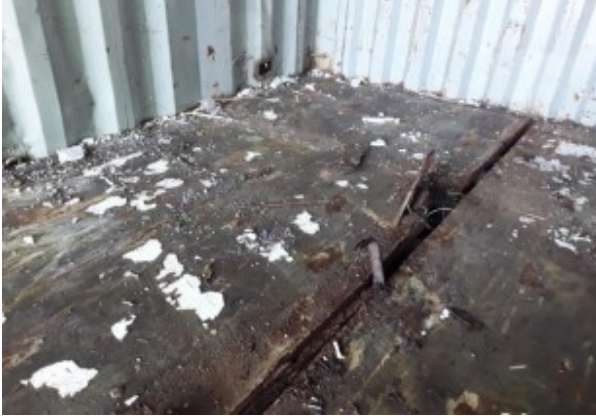
Item 79 Ref: 21-32018-1

The bitumen to the underside of the wood flooring in Container 8 does contain asbestos.

Removed 2023

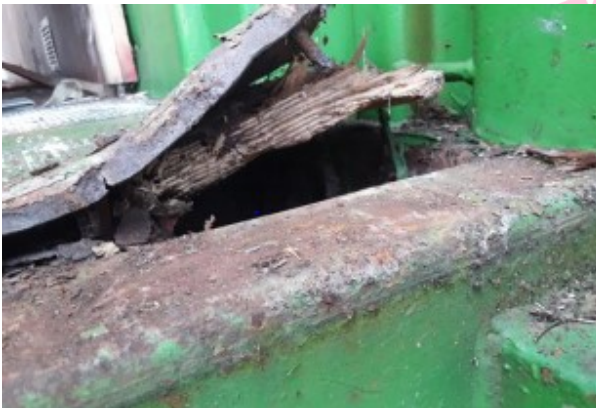
Item 80 Ref: 21-32018-1

The bitumen to the underside of the wood flooring in Container 9 does contain asbestos.

Removed 2023

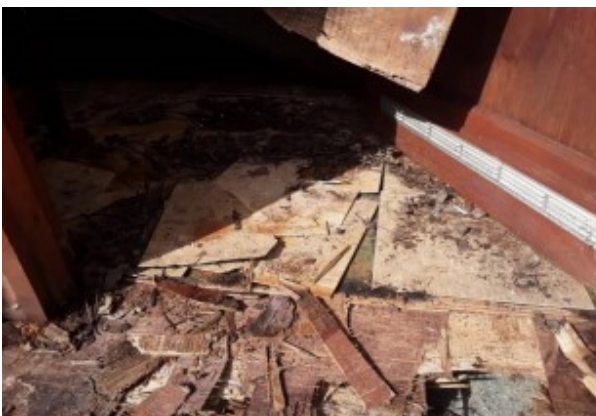
Item 81 Ref: 21-32018-2

The floor tiles in Container 17 do not contain asbestos.

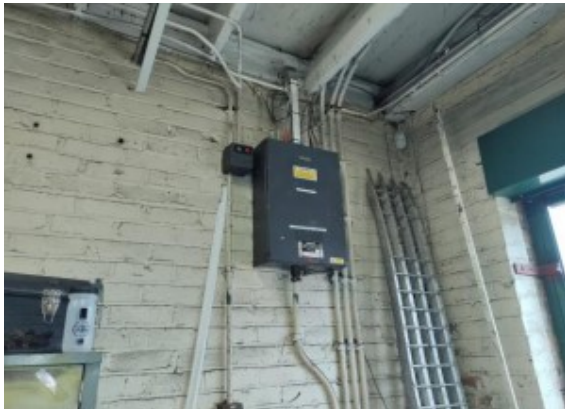
Item 83 Ref: Presumed

The flash guards within live equipment (Tractor Store Wall around DBPL1 and fuse board) is presumed to contain asbestos.

Removed 2023

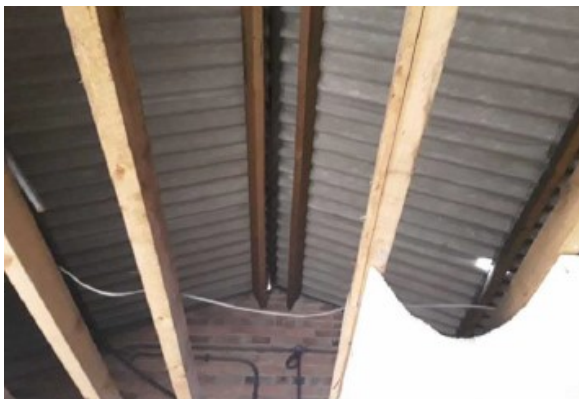
Item 87 Ref: 22-46862-10

The cement ceiling in Warehouse 1 contains asbestos.

Removed 2023

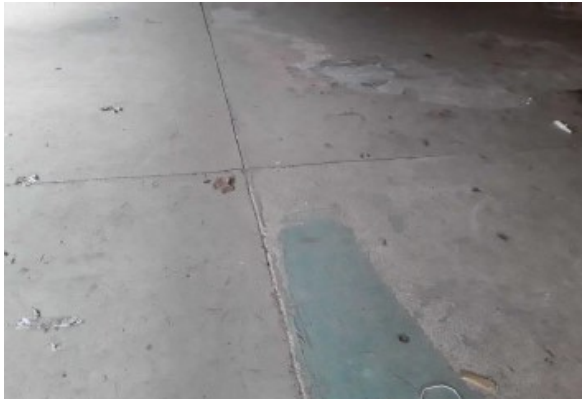
Item 88 Ref: 22-46862-11

The expansion joints to concrete floor slabs in Warehouse 1 contains asbestos.

Removed 2023

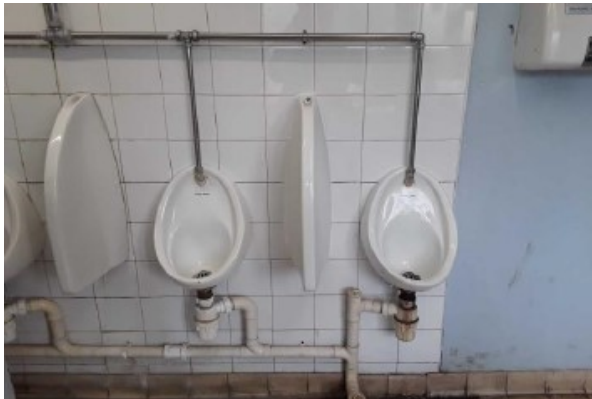
Item 89 Ref: 22-46862-12

The ceramic tile adhesive to walls in Area 4 – Men's Toilets does not contain asbestos.

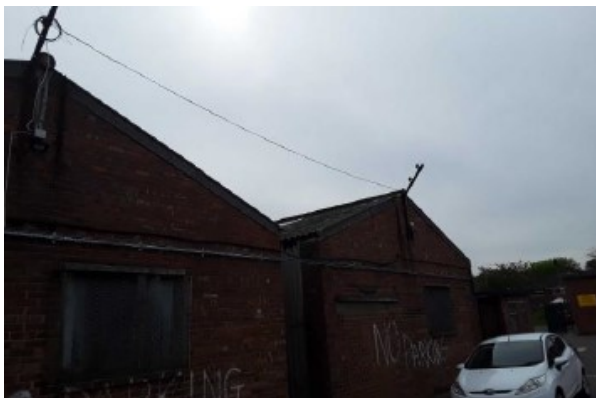
Item 90 Ref: 22-46862-14

The roof cement (External) contains asbestos.

Removed 2023

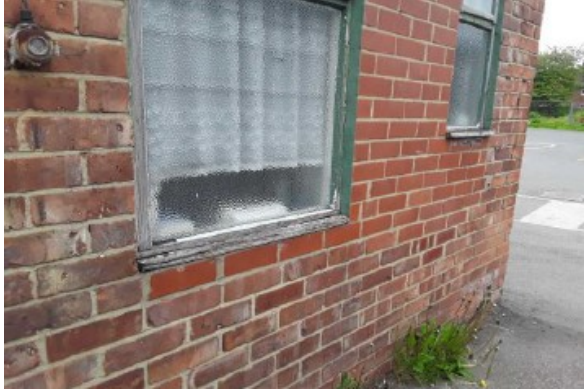
Item 91 Ref: 22-46862-15

The window putty (External) does not contain asbestos.

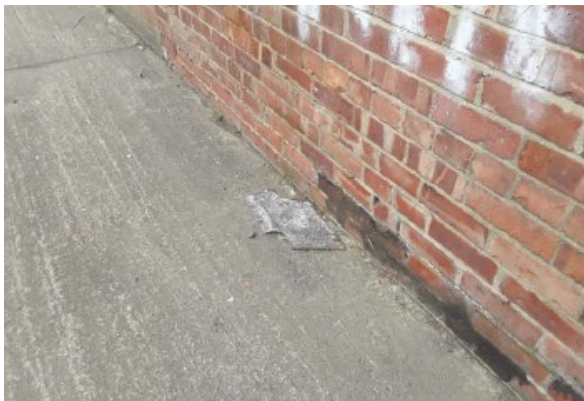
Item 92 Ref: 22-46862-16

The cement debris to floor (External) contains asbestos.

Removed 2023

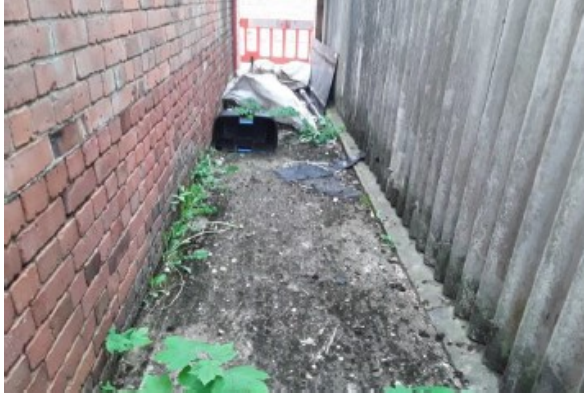
Item 94 Ref: 22-46862-18

The roof felt debris between warehouses (External) contains asbestos.

Removed 2023

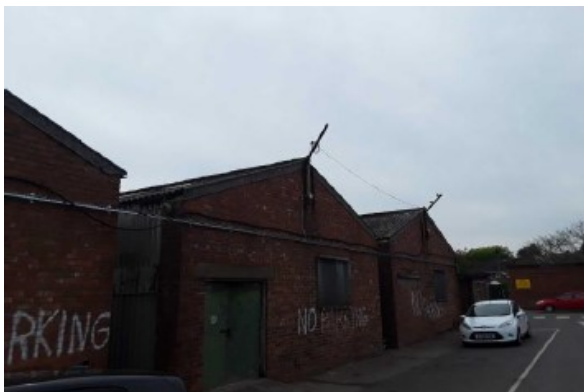
Item 96 Ref: 22-46862-20

The cement roof edging (External) contains asbestos.

Removed 2023

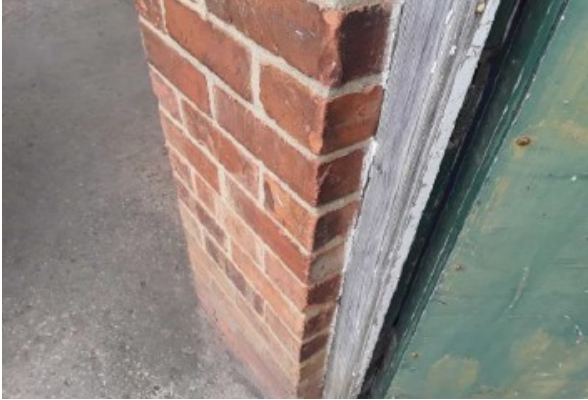
Item 97 Ref: 22-46862-21

The frame sealant to brickwork (External) does not contain asbestos.

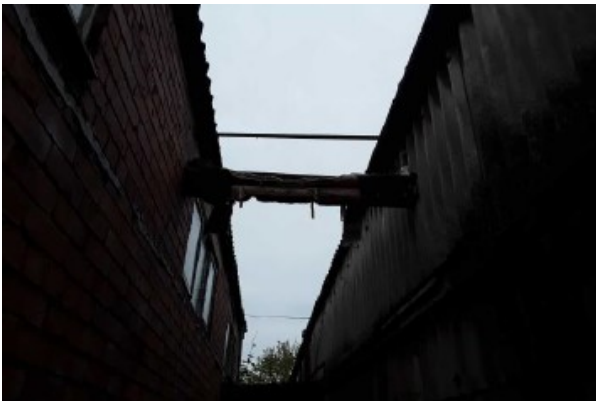
Item 98 Ref: 22-46862-26

The wrap to external pipes (External) contains asbestos.

Removed 2023

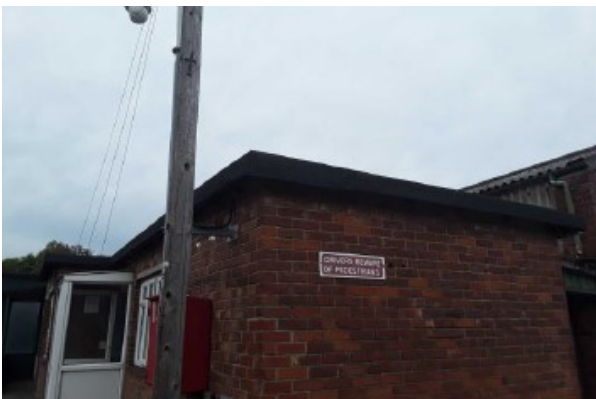
Item 99 Ref: 22-46862-27

The bitumen roof felt (External) does not contain asbestos.

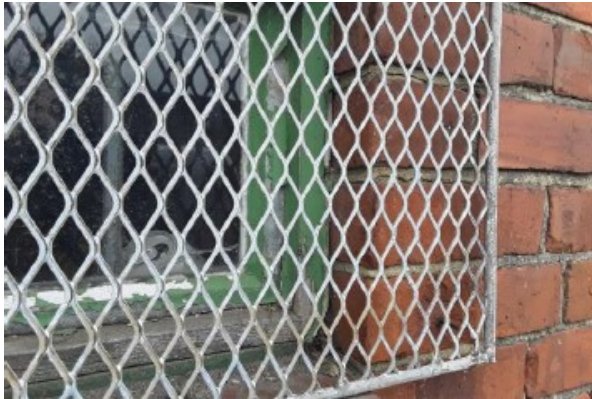
Item 100 Ref: 22-46862-28

The window frame sealant (External) contains asbestos.

Removed 2023

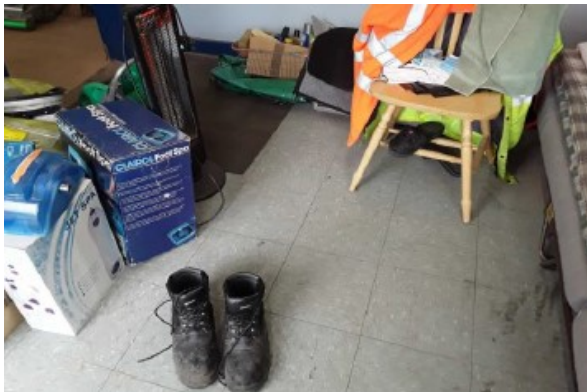
Item 101 Ref: 22-46862-23

The floor tiles & adhesive in Area 7 – Store Room does not contain asbestos.

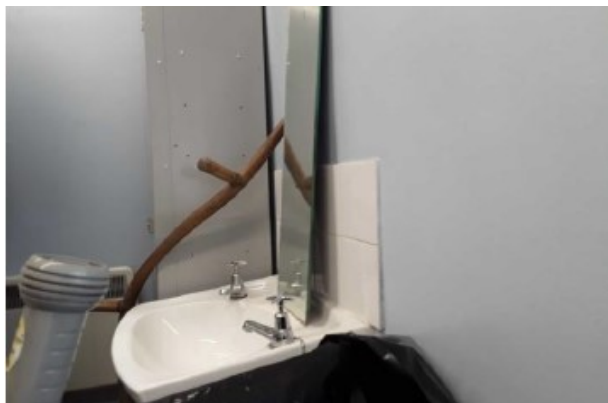
Item 102 Ref: 22-46862-24

The ceramic tile adhesive to walls in Area 8 – Shower Room does not contain asbestos.

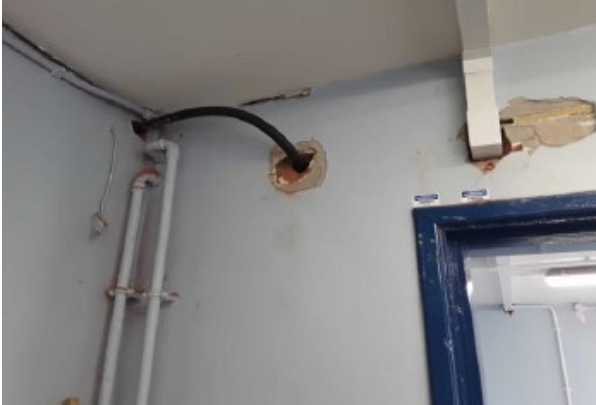
Item 103 Ref: 22-46862-25

The textured coating to walls in Area 8 – Shower Room does not contain asbestos.
