### ASBESTOS SURVEY REPORT FOR ST MARYS CAR PARK, ST MARYS WAY, SUNDERLAND

**Asbestos Register for  
St Marys Car Park, St Marys Way, Sunderland**

**UPRN: - J548565**

**Premises Manager / Samo: - Tenant      Date: 13<sup>th</sup> September 2021**

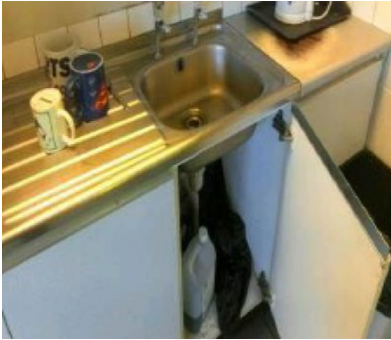
### **Item 1 – EC002219**

The sink pad in the canteen (Room 7) on the Ground Floor does not contain asbestos.

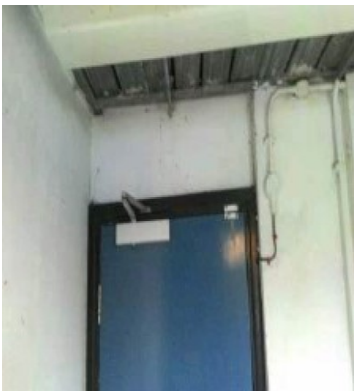
### **Item 2 – As EC002218**

The firebreak above the doors to the car park on ground floor emergency stairwell 1 (Room 15) does not contain asbestos.

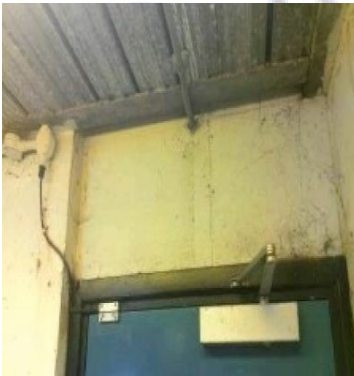
### **Item 3 – As EC002218**

The firebreak above the doors to the car park on ground floor emergency stairwell 2 (Room 16) does not contain asbestos.

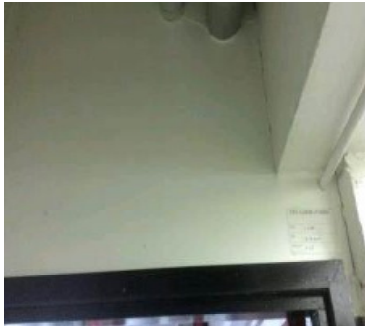
**Item 4 – As EC002218**

Insulating board to the wall in the electrical cupboard on the 1st floor (Room 1) does not contain asbestos.

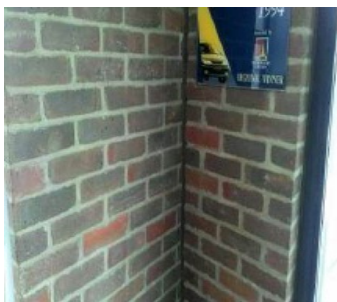
**Item 5 – EC002217**

The sealant to the wall in the 2<sup>nd</sup> Floor lobby (Room 7) does not contain asbestos.

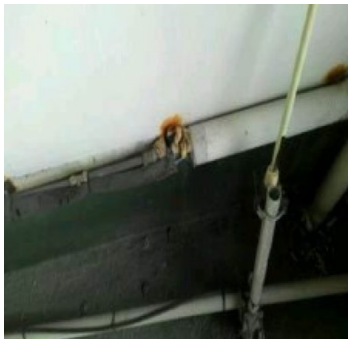
**Item 6 – EC002214**

The pipe lagging in the 3<sup>rd</sup> floor parking area (Room 1) does not contain asbestos.

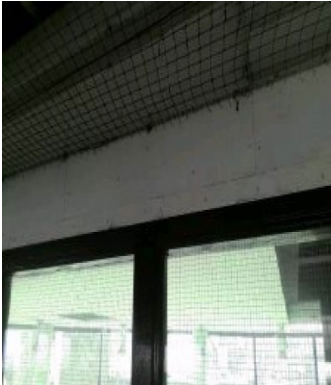
**Item 7 – EC002215**

The cement panel above the windows in the 3<sup>rd</sup> floor parking area (Room 1) do not contain asbestos.

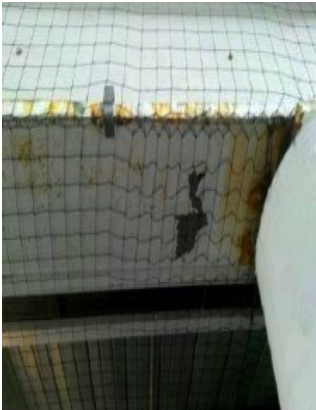
**Item 8 – EC002216**

The coating to the steel beam in the 3<sup>rd</sup> floor parking area (Room 1) does not contain asbestos.

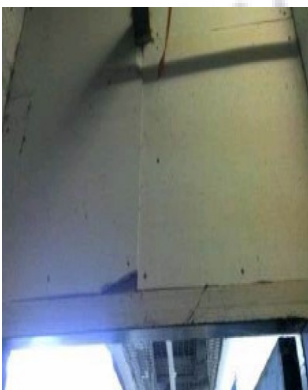
**Item 9 – EC002218**

The insulation board to the 3<sup>rd</sup> floor electrical cupboard (Room 4) does not contain asbestos.

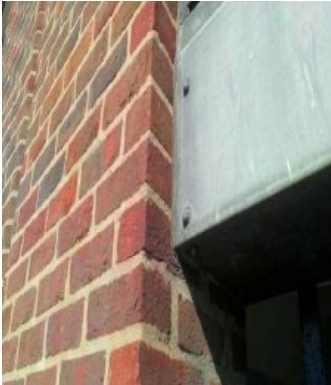
**Item 10 – EC002220**

The wall sealant to the external does not contain asbestos.
