ASBESTOS SURVEY REPORT FOR SILKSWORTH RECREATION PARK,  
BLIND LANE, SUNDERLAND, SR3 1AU.

## **Asbestos Register for**

**Silksworth Recreation Park, Blind Lane,  
Sunderland, SR3 1AU.**

**Date: 13 November 2024**

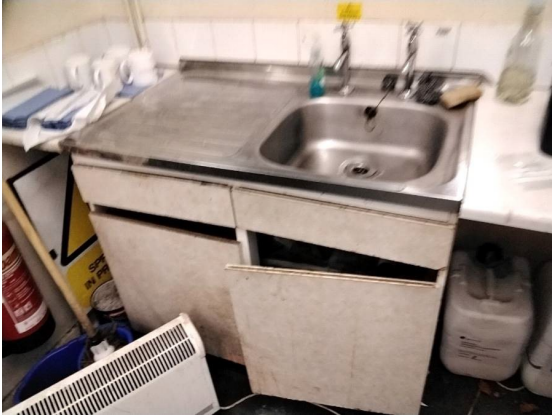
**Item 1 Ref: KX000468**

The Under Sink Mat - Bitumen in Boiler House/Changing Rooms G/001 Staff Room does not contain asbestos.

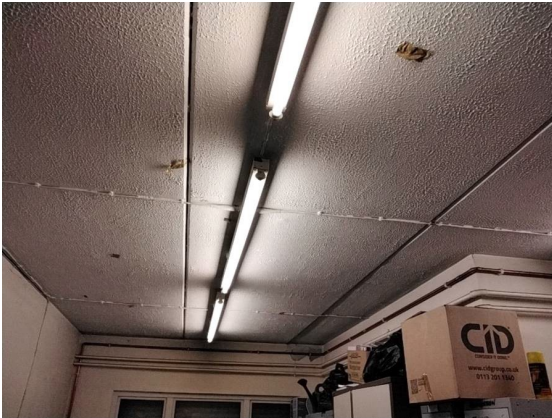
**Item 2 Ref: KX000469**

The Ceiling – Coating – decorative finish in Boiler House/Changing Rooms G/001 Staff Room does not contain asbestos.

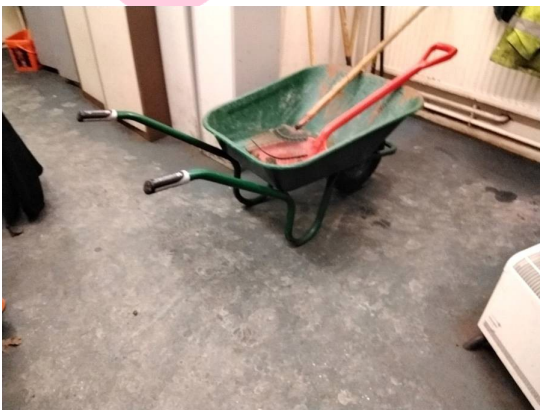
**Item 3 Ref: KX000470**

The Floor – Covering - Vinyl Tile, Vinyl/Lino in Boiler House/Changing Rooms G/001 Staff Room does not contain asbestos.

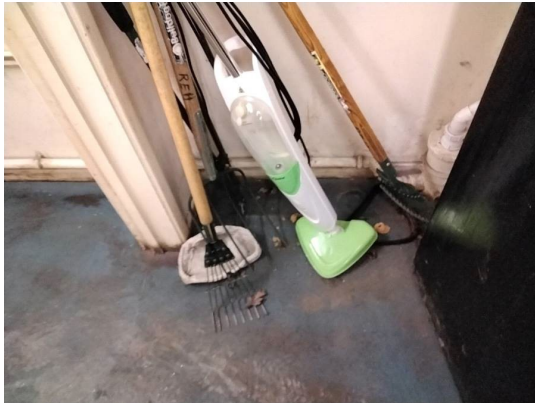
**Item 4 Ref:** As KX000470

The Floor – Covering - Vinyl Tile, Vinyl/Lino in Boiler House/Changing Rooms G/002 Passageway does not contain asbestos.

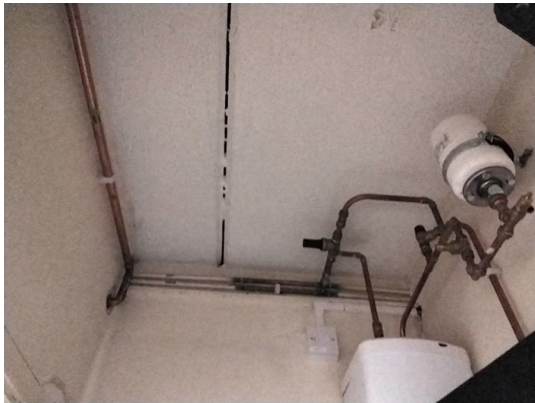
**Item 5 Ref:** As KX000469

The Ceiling – Coating – decorative finish in Boiler House/Changing Rooms G/002 Passageway does not contain asbestos.

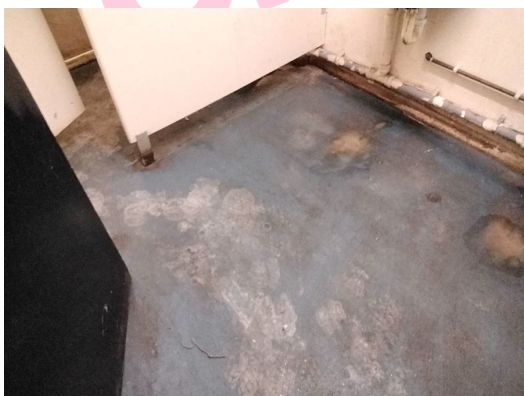
**Item 6 Ref:** As KX000470

The Floor – Covering - Vinyl Tile, Vinyl/Lino in Boiler House/Changing Rooms G/003 Toilets does not contain asbestos.

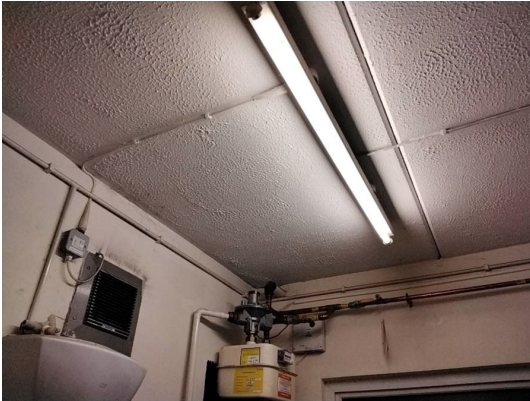
**Item 7 Ref:** As KX000469

The Ceiling – Coating – decorative finish in Boiler House/Changing Rooms G/003 Toilets does not contain asbestos.

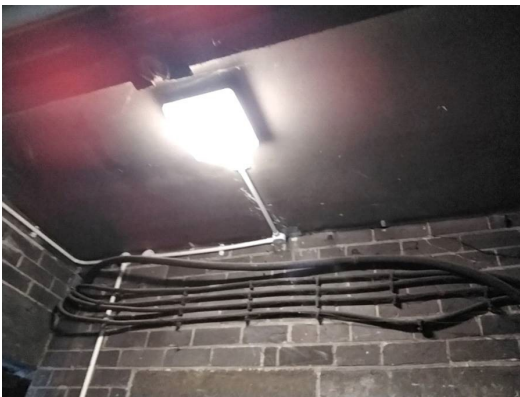
**Item 8 Ref:** KX000471

8.	KX000471	Ceiling - Insulating Board	Boiler House/Changing Rooms G/004 Boiler Room	Low
9.	KX000472	Debris/Residue - to floor	Boiler House/Changing Rooms G/004 Boiler Room	No Risk

The Ceiling - Insulating Board in Boiler House/Changing Rooms G/004 Boiler Room contains asbestos.

Any change in its appearance should be recorded and passed to Property Services.

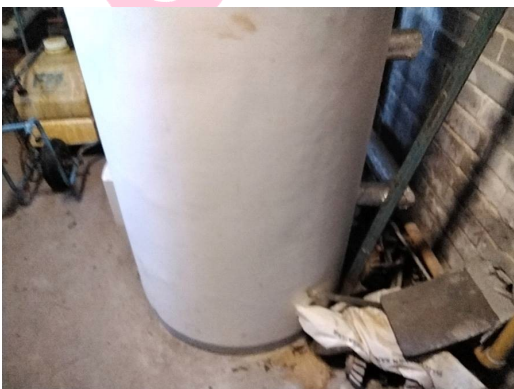
**Item 9 Ref:** KX000472

The Debris/Residue - to floor in Boiler House/Changing Rooms G/004 Boiler Room does not contain asbestos.

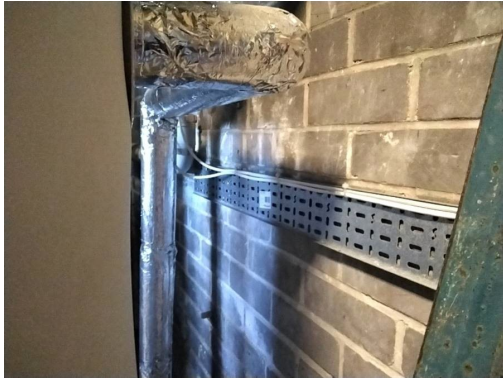
**Item 10 Ref: KX000473**

The Debris/Residue - to walls behind calorifiers - Thermal Insulation Lagging in Boiler House/Changing Rooms G/004 Boiler Room does not contain asbestos.

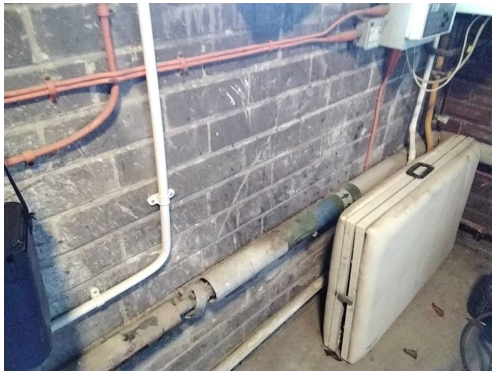
**Item 11 Ref: KX000474**

The Debris/Residue - to walls under window - Thermal Insulation Lagging in Boiler House/Changing Rooms G/004 Boiler Room does not contain asbestos.

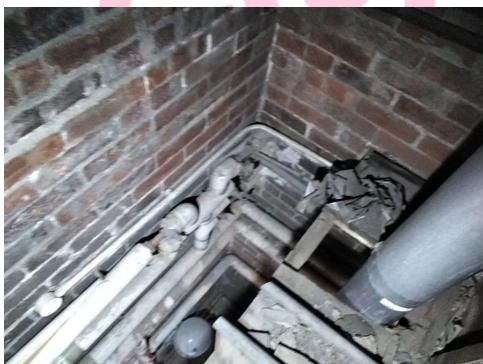
**Item 12 Ref: KX000476**

The Debris/Residue - to pipe penetrations - Thermal Insulation Lagging in Boiler House/Changing Rooms G/004 Boiler Room does not contain asbestos.

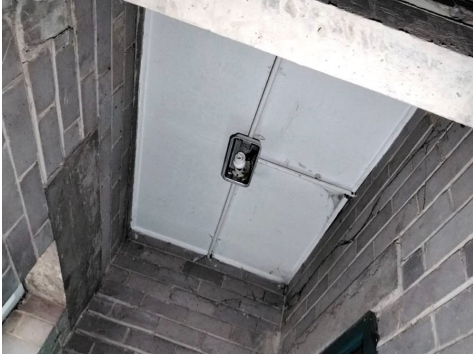
**Item 13 Ref: As KX000471**

The Ceiling - Insulating Board in Boiler House/Changing Rooms G/005 Cupboard-Store contains asbestos.

Any change in its appearance should be recorded and passed to Property Services.

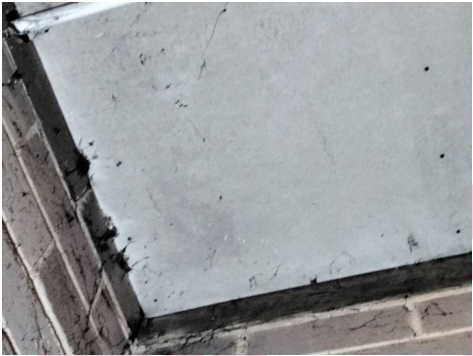
**Item 14 Ref: As KX000471**

The Ceiling - Insulating Board in Boiler House/Changing Rooms G/006 Passageway contains asbestos.

Any change in its appearance should be recorded and passed to Property Services.

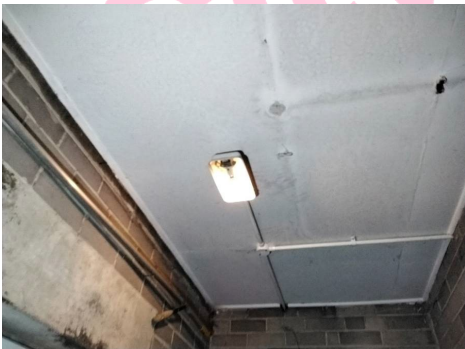
**Item 15 Ref: KX000476**

The Ceiling - Insulating Board in Boiler House/Changing Rooms G/007 Cupboard-Store contains asbestos.

Any change in its appearance should be recorded and passed to Property Services.

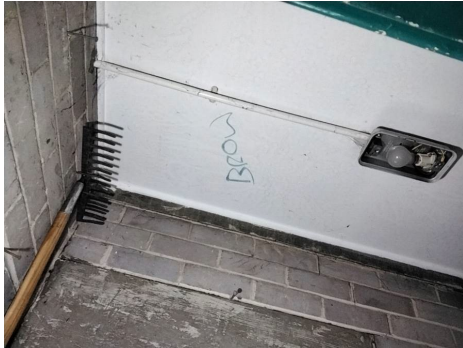
### **Item 16 Ref:** As KX000471

The Ceiling - Insulating Board in Boiler House/Changing Rooms G/008 Cupboard-Store contains asbestos.

Any change in its appearance should be recorded and passed to Property Services.

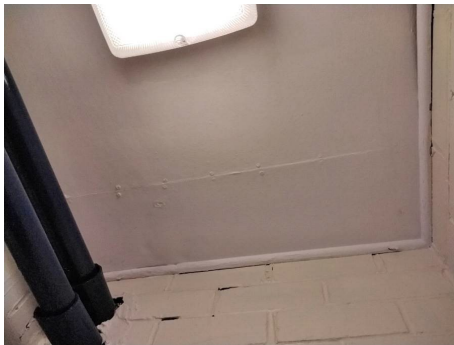
### **Item 17 Ref:** KX000477

The Ceiling - Insulating Board in Boiler House/Changing Rooms G/011 Toilets contains asbestos.

Any change in its appearance should be recorded and passed to Property Services.

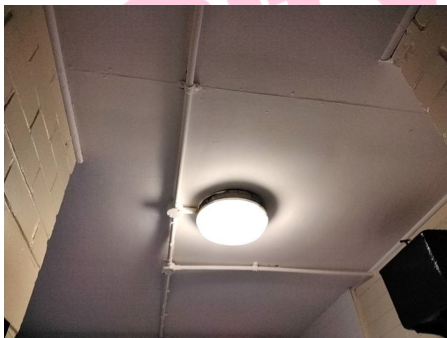
### **Item 18 Ref:** As KX000477

The Ceiling - Insulating Board in Boiler House/Changing Rooms G/012 Shower Room contains asbestos.

Any change in its appearance should be recorded and passed to Property Services.

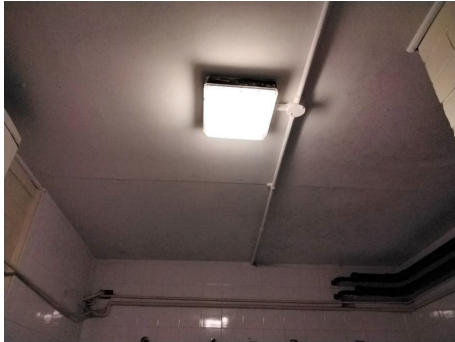
**Item 19 Ref: As KX000477**

The Ceiling - Insulating Board in Boiler House/Changing Rooms G/016 Shower Room contains asbestos.

Any change in its appearance should be recorded and passed to Property Services.

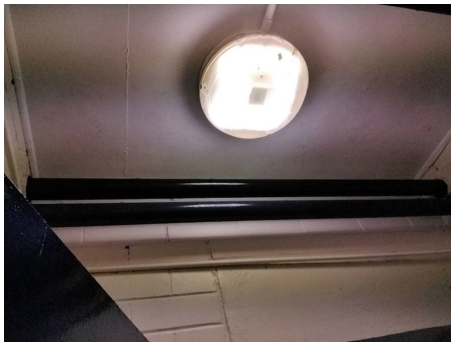
**Item 20 Ref: As KX000477**

The Ceiling - Insulating Board in Boiler House/Changing Rooms G/017 Toilets contains asbestos.

Any change in its appearance should be recorded and passed to Property Services.

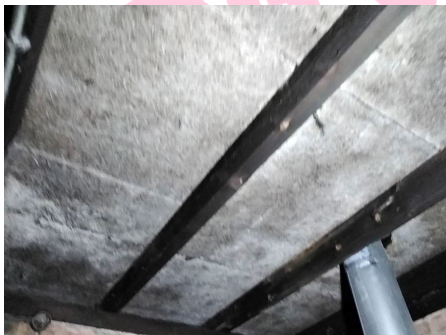
**Item 21 Ref: KX000475**

The Ceiling in Boiler House/ Changing Rooms 1<sup>st</sup> Floor 1/001 Tank Room does not contain asbestos.

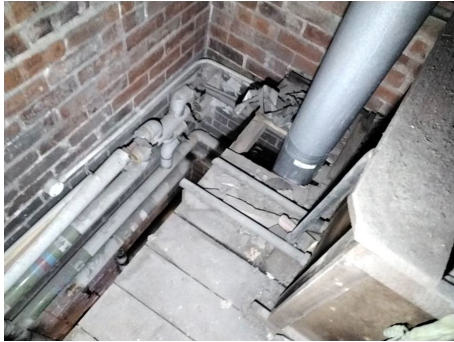
**Item 22 Ref:** As KX000475

The Ceiling in 1<sup>st</sup> Floor 1/001 Tank Room does not contain asbestos.

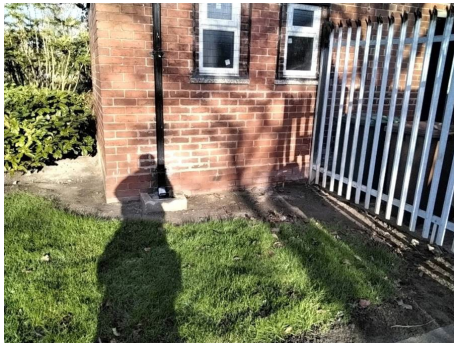
**Item 23 Ref:** KX000478

The Damp Proof Course – bitumen External Boiler House/Changing Rooms contains asbestos.

Any change in its appearance should be recorded and passed to Property Services.

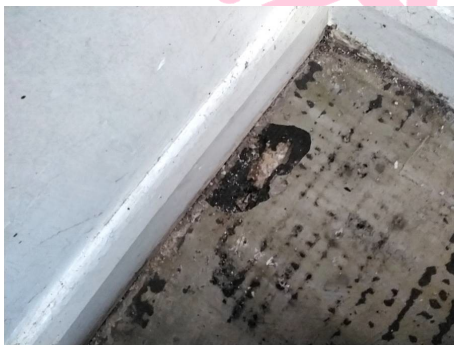
**Item 24 Ref:** KX000479

The Floor - adhesive residue – bitumen in Tea Rooms G/001 Entrance Hall contains asbestos.

Any change in its appearance should be recorded and passed to Property Services.

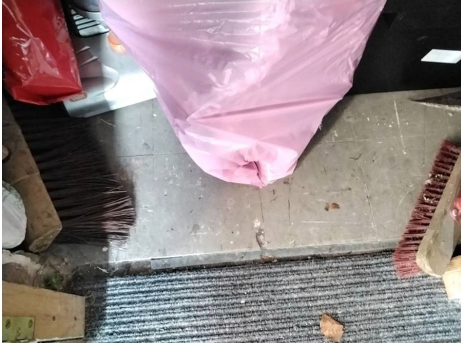
### **Item 25 Ref: KX000480**

The Floor - Tile – green - Composite Vinyl Tile, Vinyl/Lino with adhesive in Tea Rooms G/002 Storeroom (Limited inspection within due to storage) contains asbestos.

Any change in its appearance should be recorded and passed to Property Services.

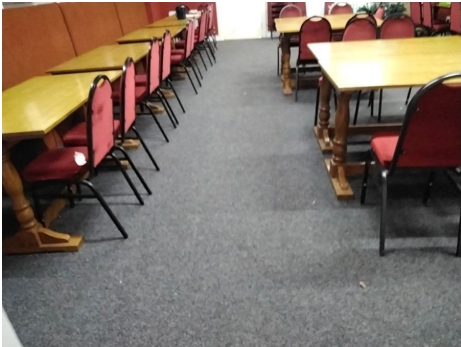
### **Item 26 Ref: As KX000479**

The Floor - adhesive residue – bitumen in Tea Rooms G/003 Dining Hall contains asbestos.

Any change in its appearance should be recorded and passed to Property Services.

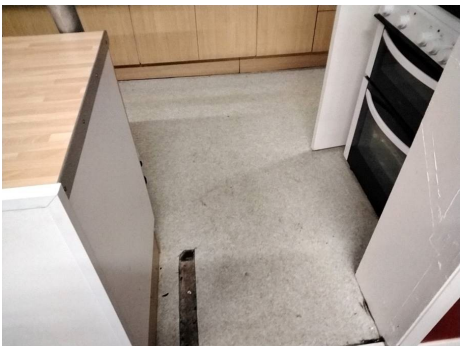
### **Item 27 Ref: As KX000479**

The Floor - adhesive residue – bitumen in Tea Rooms G/004 Kitchen contains asbestos.

Any change in its appearance should be recorded and passed to Property Services.

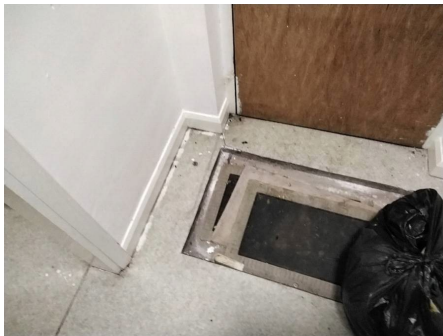
**Item 29 Ref: As KX000479**

The Floor - adhesive residue – bitumen in Tea Rooms G/006 Passageway contains asbestos.

Any change in its appearance should be recorded and passed to Property Services.

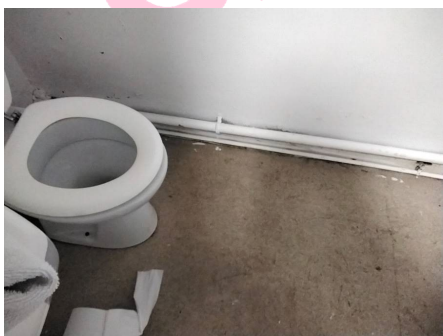
**Item 30 Ref: As KX000479**

The Floor - adhesive residue – bitumen in Tea Rooms G/007 Toilets contains asbestos.

Any change in its appearance should be recorded and passed to Property Services.

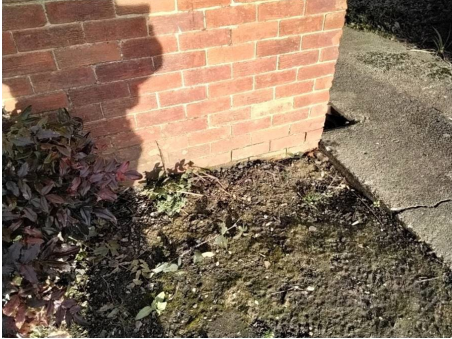
**Item 31 Ref: KX000481**

The Damp Proof Course External Tea Rooms does not contain asbestos.
