ASBESTOS SURVEY REPORT FOR BLOCK 1D – 1E EDWARD THOMPSON SITE, RICHMOND STREET, SUNDERLAND, SR5 1BQ

Asbestos Register for

**BLOCK 1D – 1E EDWARD THOMPSON SITE, RICHMOND
STREET, SUNDERLAND, SR5 1BQ**

Date: 26 October 2022

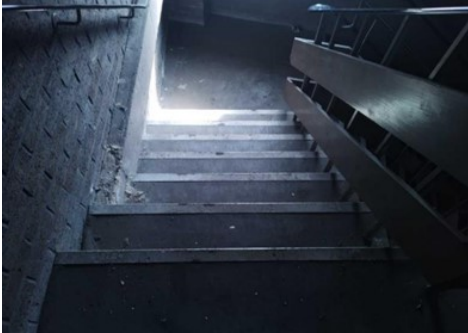
Item 1 Ref: 22-49553-2

The nosing treats to floor in the stairwell (Area 1) does not contain asbestos.

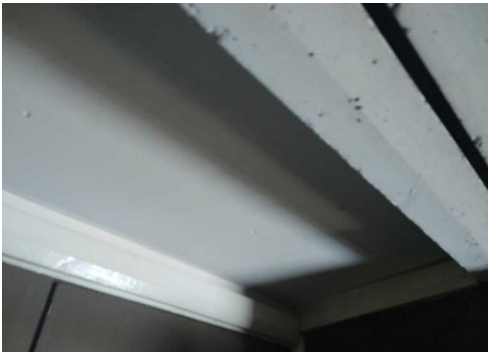
Item 2 Ref: 22-49553-3

The ceiling in the stairwell (Area 1) does not contain asbestos.

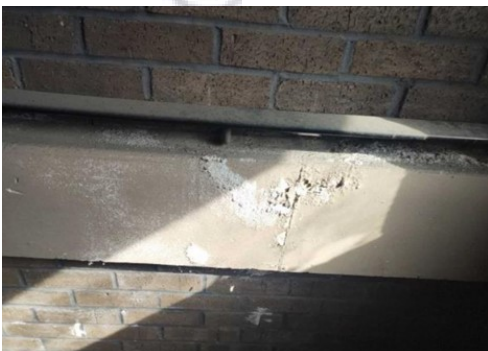
Item 3 Ref: 22-49553-4

The horizontal boxing in the stairwell (Area 1) does not contain asbestos.

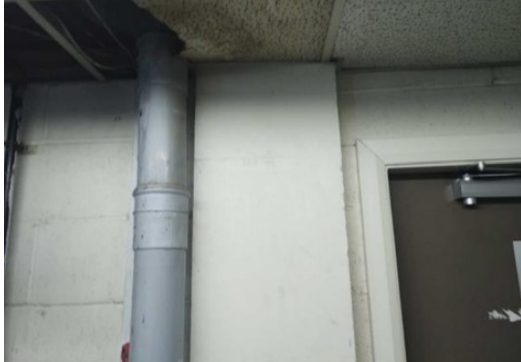
Item 4 Ref: 22-49553-4

The horizontal boxing vessels in the corridor (Area 2) does not contain asbestos.

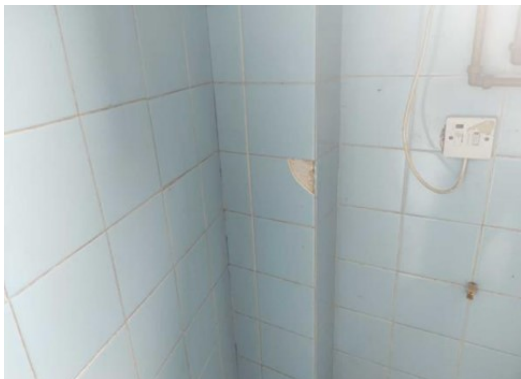
Item 5 Ref: 22-49553-4

The boxing behind ceramic tiles in the male wc (Area 3) does not contain asbestos.

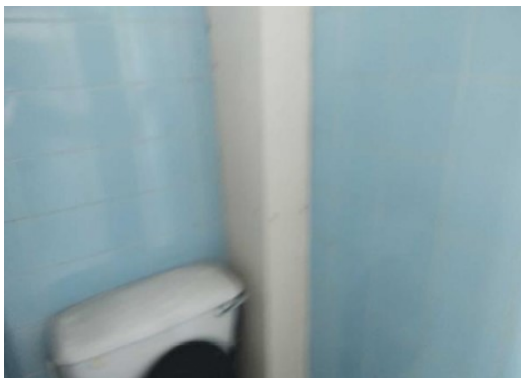
Item 6 Ref: 22-49553-5

The boxing in the male wc (Area 3) does not contain asbestos.

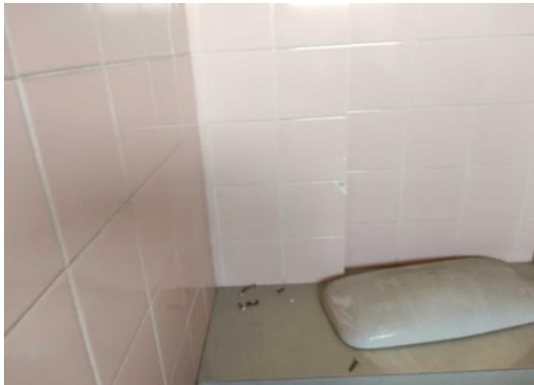
Item 7 Ref: 22-49553-4

The boxing behind the ceramic tiles in the female wc (Area 4) does not contain asbestos.

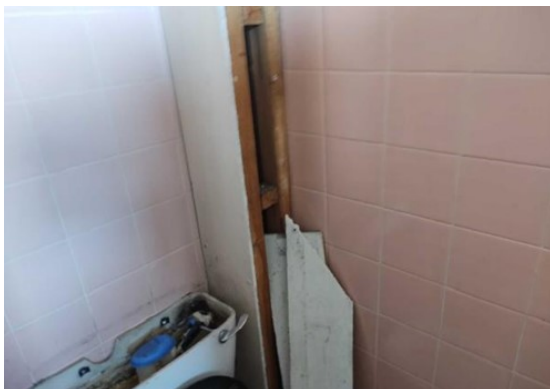
Item 8 Ref: 22-49553-5

The boxing in the female wc (Area 4) does not contain asbestos.

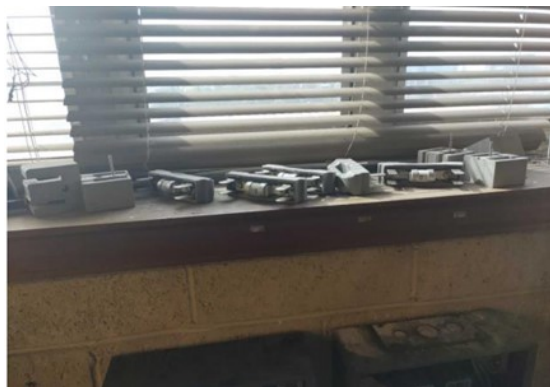
Item 9 Ref: 22-49553-10

The end caps within fuse cartridges in the workshop (Area 5) does not contain asbestos.

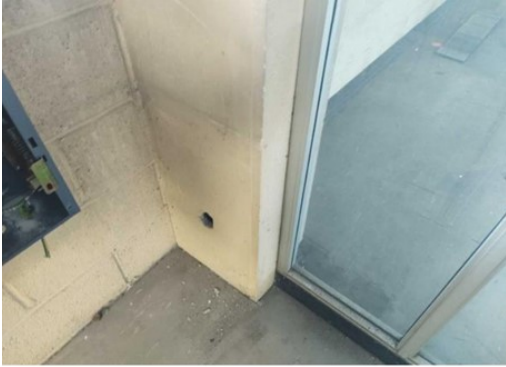
Item 10 Ref: 22-49553-4

The boxing in the workshop (Area 5) does not contain asbestos.

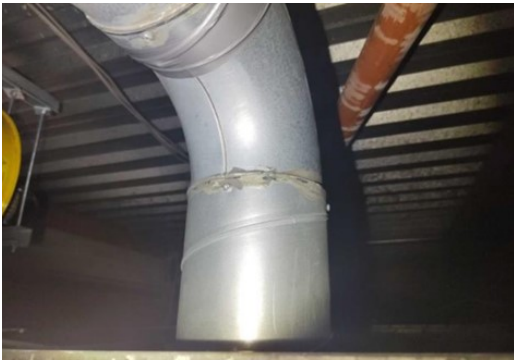
Item 11 Ref: 22-49553-7

The mastic to the duct joints in the workshop (Area 5) does not contain asbestos.

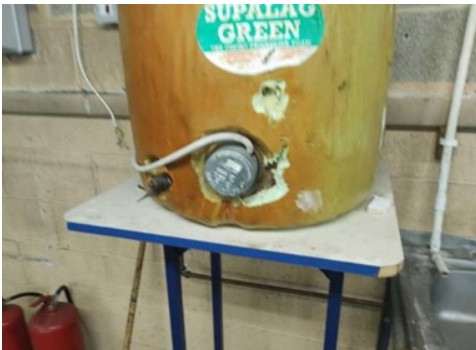
Item 12 Ref: 22-49553-8

- (Item 11) Ref: 22-49553-7 – Mastic to duct joints (Area 5: Workshop) – No Risk
- (Item 12) Ref: 22-49553-8 Gasket to flange on tank (Area 5: Workshop) – Low Risk

The gasket to the flange on tank in the workshop (Area 5) contains asbestos.

Any change in appearance should be reported to Property Services.

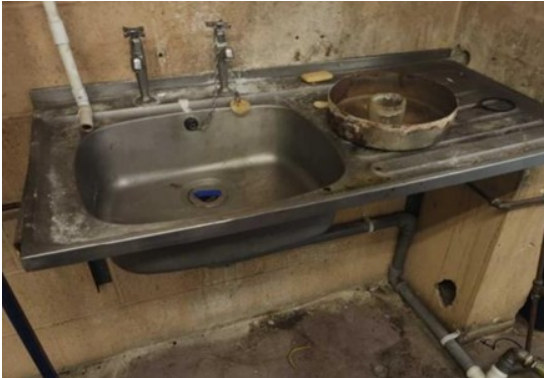
Item 13 Ref: 22-49553-9

The sink pd in the workshop (Area 5) does not contain asbestos.

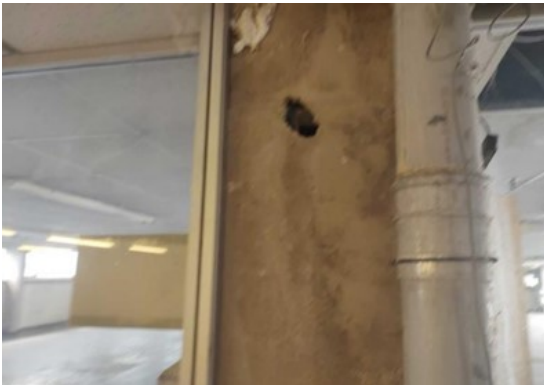
Item 14 Ref: 22-49553-4

The boxing in the office (Area 6) does not contain asbestos.

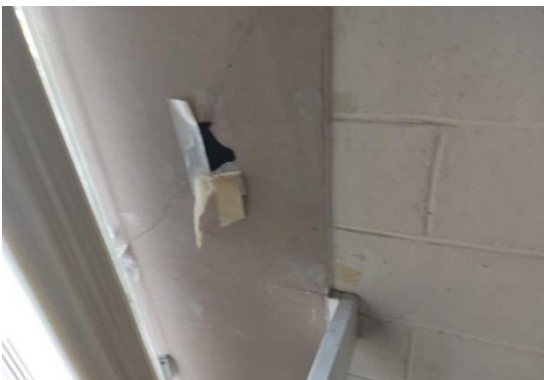
Item 15 Ref: 22-49553-4

The boxing in the comms room (Area 7) does not contain asbestos.

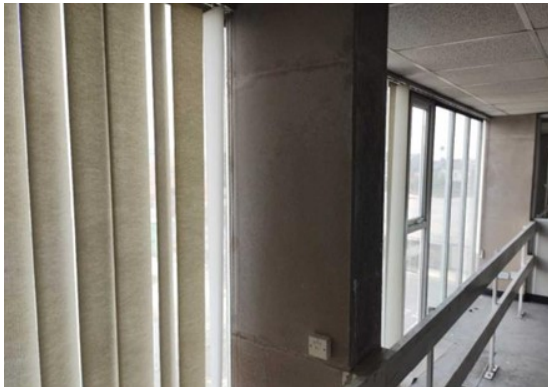
Item 16 Ref: 22-49553-4

The boxing in the office (Area 8) does not contain asbestos.

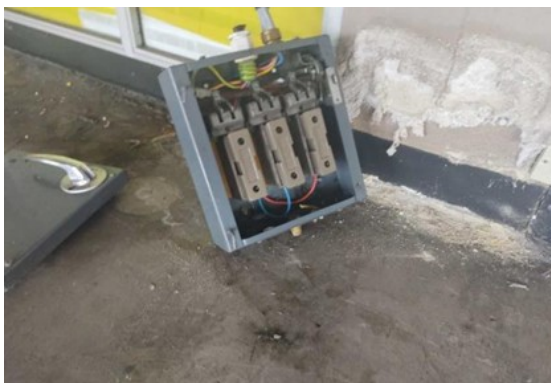
Item 17 Ref: 22-49553-11

- (Item 16) Ref: 22-49553-4 – Boxing (Area 8: Office) – No Risk
- (Item 17) Ref: 22-49553-11 – Residue to fuse cartridges and fuse carriers within MEM isolation box (Area 9: Office) – Low Risk

The residue to fuse cartridges and fuse carriers within MEM isolation box in the Office (Area 9) does contain asbestos.

Any change in appearance should be reported to Property Services.

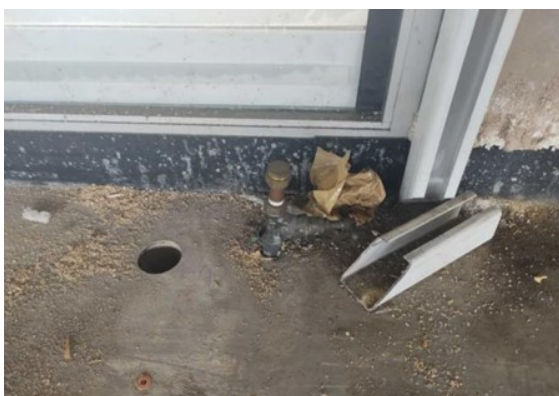
Item 18 Ref: 22-49553-12

The gaskets to the stop taps in the Office (Area 9) does not contain asbestos.

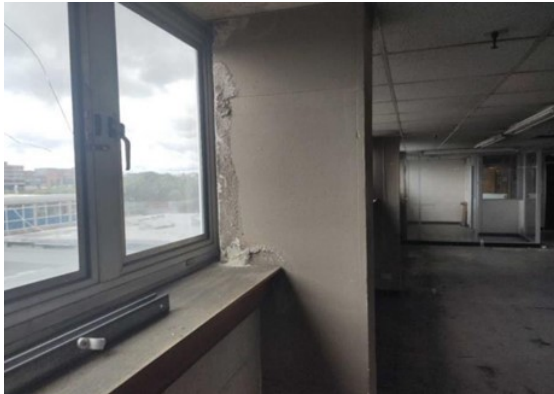
Item 19 Ref: 22-49553-4

The boxing in the office (Area 9) does not contain asbestos.

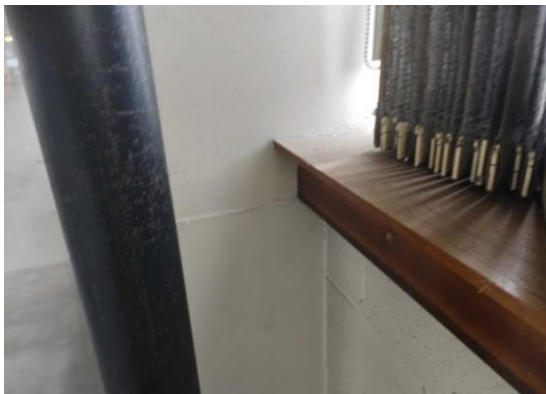
Item 20 Ref: 22-49553-4

The boxing in the store (Area 11) does not contain asbestos.

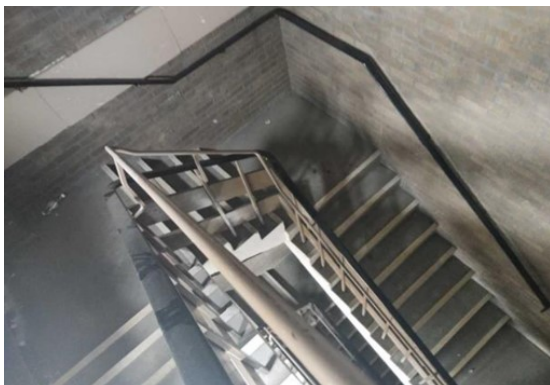
Item 21 Ref: 22-49553-2

The nosing treads in the stairwell (Area 12) does not contain asbestos.

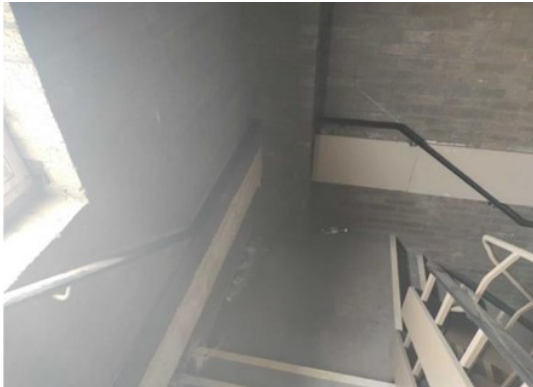
Item 22 Ref: 22-49553-4

The horizontal boxing in the stairwell (Area 12) does not contain asbestos.

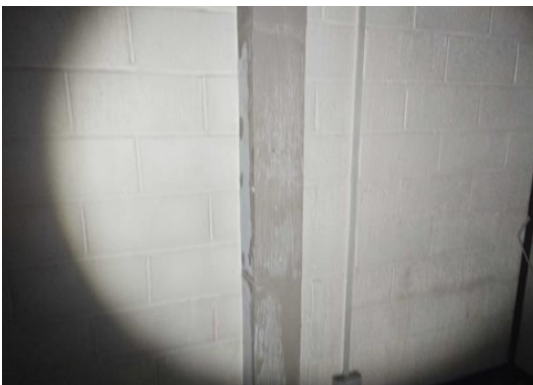
Item 23 Ref: 22-49553-4

The boxing in the store (Area 13) does not contain asbestos.

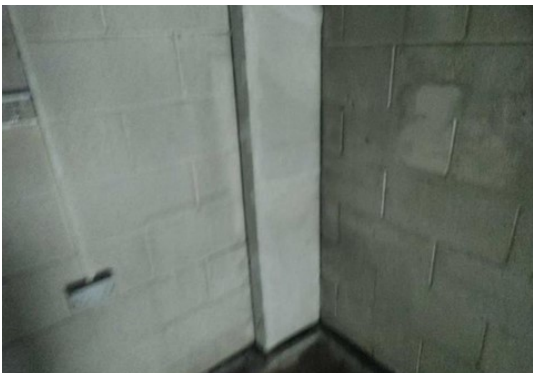
Item 24 Ref: 22-49553-4

The boxing in the store (Area 14) does not contain asbestos.

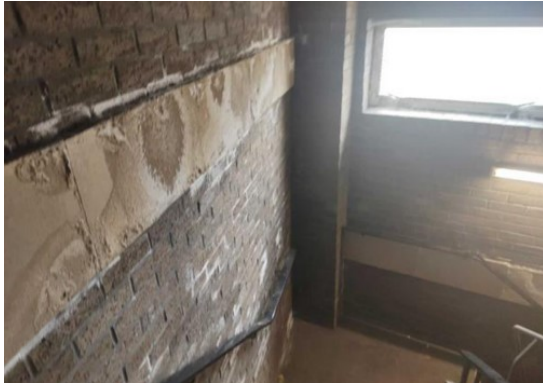
Item 25 Ref: 22-49553-13

The boxing in the landing and stairs (Area 15) does not contain asbestos.

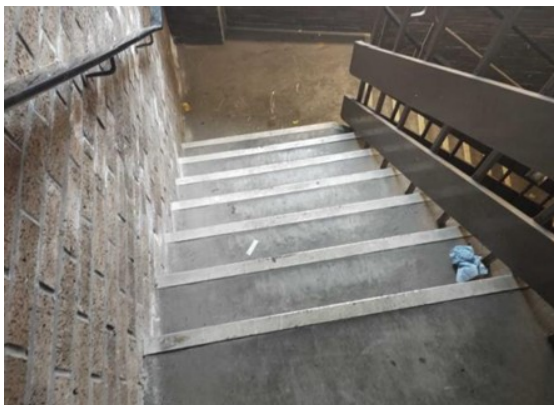
Item 26 Ref: 22-49553-2

The nosing treads to the floor in the Landing and Stairs (Area 15) does not contain asbestos.

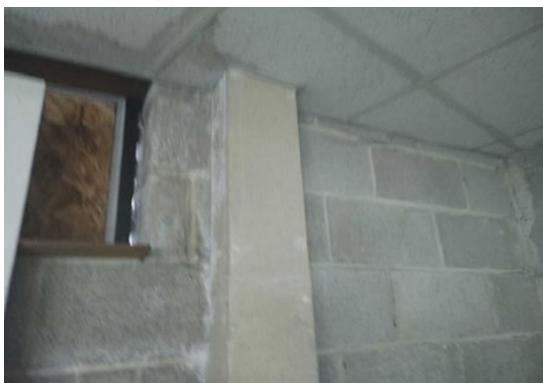
Item 27 Ref: 22-49553-13

The boxing in the Observation Room (Area 16) does not contain asbestos.

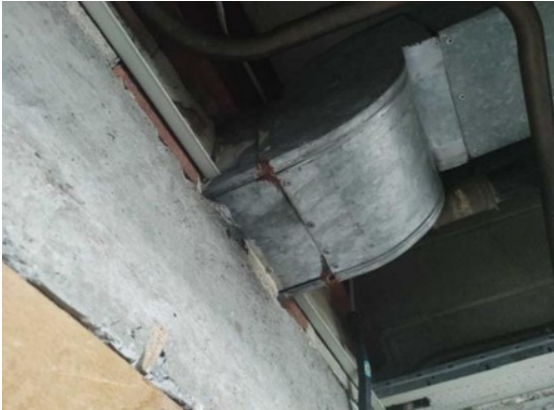
Item 28 Ref: 22-49553-14

- (Item 28) Ref: 22-49553-14 – Mastic to duct joints (Area 16: Observation Room) – Low Risk
- (Item 29) Ref: 22-49553-15 – Boxing (Area 16: Observation Room) – No Risk

The mastic to the duct joints in the Observation Room (Area 16) does contain asbestos.

Any change in appearance should be reported to Property Services.

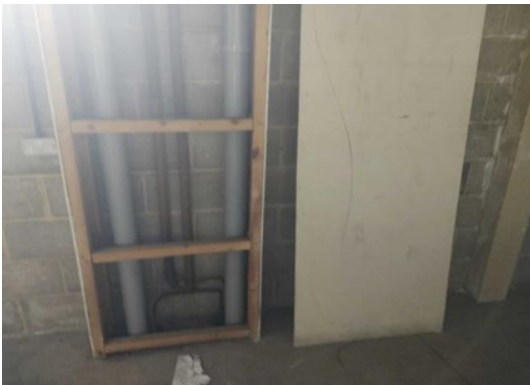
Item 29 Ref: 22-49553-15

The boxing in the Observation Room (Area 16) does not contain asbestos.

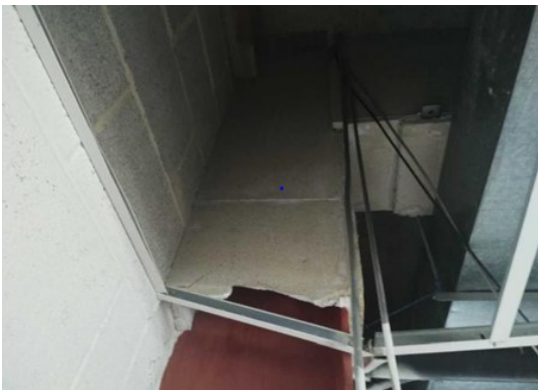
Item 30 Ref: 22-49553-13

The boxing to vertical and horizontal RSJ's in the Mezzanine (Area 17) does not contain asbestos.

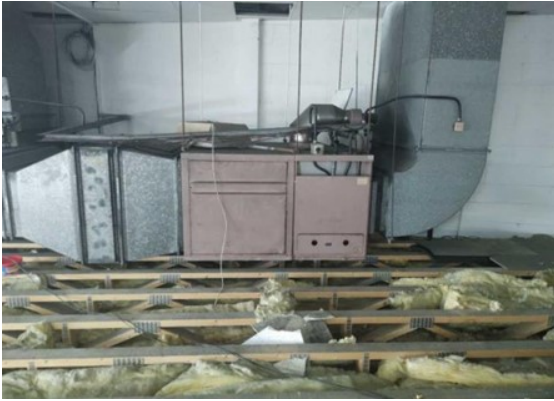
Item 31 Ref: 22-49553-14

- (Item 30) Ref: 22-49553-13 – Boxing to vertical and horizontal RSJs (Area 17: Mezzanine) – No Risk
- (Item 31) Ref: 22-49553-14 – Mastic to duct joints (Area 17: Mezzanine) – Low Risk

The mastic to the duct joints in the Mezzanine (Area 17) does contain asbestos.

Any change in appearance should be reported to Property Services.

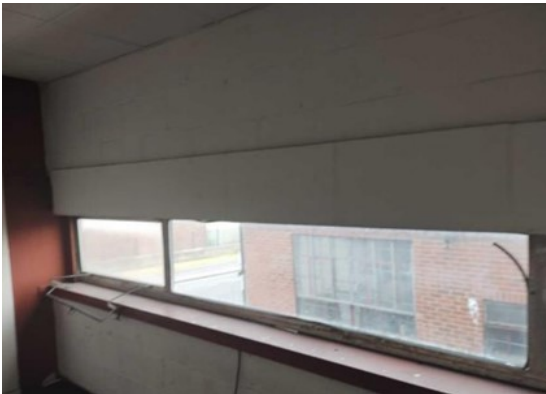
Item 32 Ref: 22-49553-13

The boxing in the office (Area 18) does not contain asbestos.

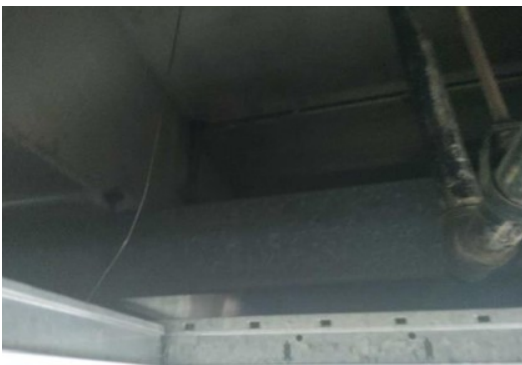
Item 33 Ref: 22-49553-14

- (Item 32) Ref: 22-49553-15 – Boxing (Area 18: Office) – No Risk
- (Item 33) Ref: 22-49553-14 – Mastic to duct joints (Area 18: Office) – Low Risk
- (Item 34) Ref: 22-49553-13 – Boxing to RSJs (Area 19: Office) – No Risk

The mastic to the duct joints in the Office (Area 18) does contain asbestos.

Any change in appearance should be reported to Property Services.

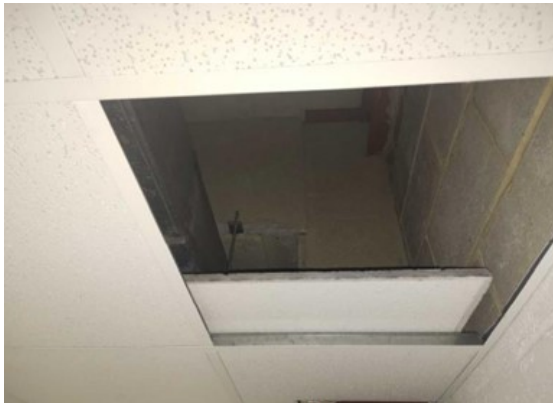
Item 34 Ref: 22-49553-13

The boxing to RSJ's in the Office (Area 19) does not contain asbestos.

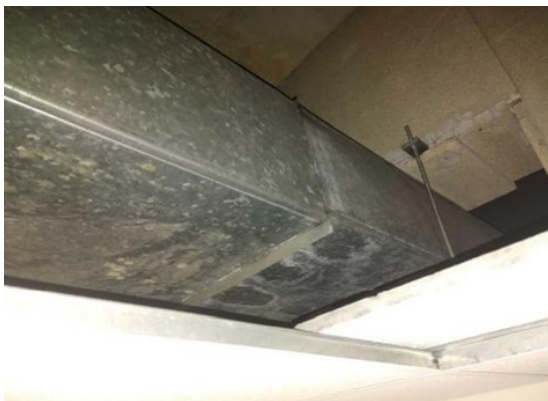
Item 35 Ref: 22-49553-14

- (Item 35) Ref: 22-49553-14 – Mastic to duct joints (Area 19: Office) – Low Risk
- (Item 36) Ref: 22-49553-13 – Boxing to RSJs (Area 20: Office) – No Risk

The mastic to the duct joints in the Office (Area 19) does contain asbestos.

Any change in appearance should be reported to Property Services.

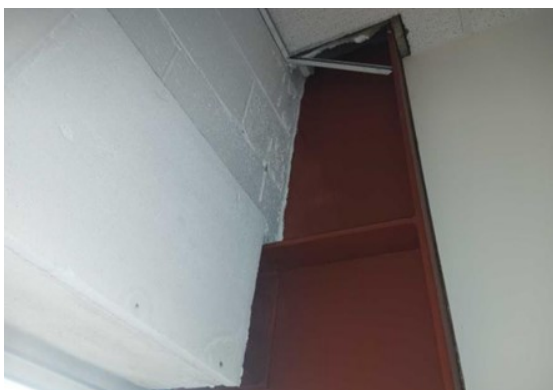
Item 36 Ref: 22-49553-13

The boxing to RSJ's in the Office (Area 20) does not contain asbestos.

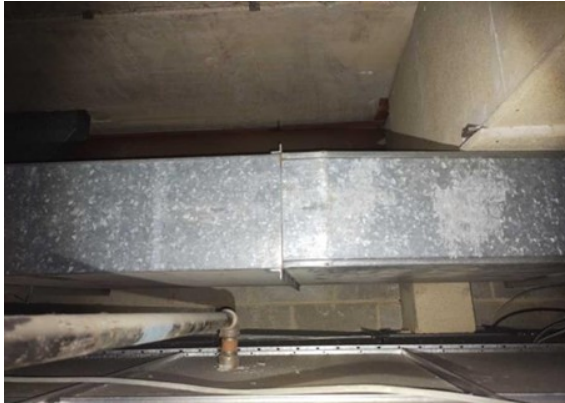
Item 37 Ref: 22-49553-14

- (Item 37) Ref: 22-49553-14 – Mastic to duct joints (Area 20: Office) – Low Risk
- (Item 38) Ref: 22-49553-15 – Ceiling (Area 21: Stairwell) – No Risk
- (Item 39) Ref: 22-49553-16 – Boxing (Area 22: Male WC) – No Risk

The mastic to the duct joints in the Office (Area 20) does contain asbestos.

Any change in appearance should be reported to Property Services.

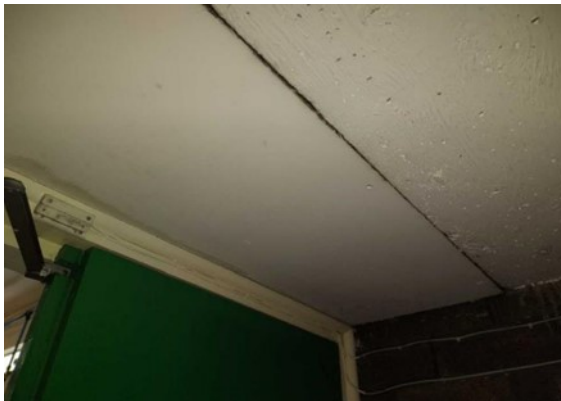
Item 38 Ref: 22-49553-15

The ceiling in the Stairwell (Area 21) does not contain asbestos.

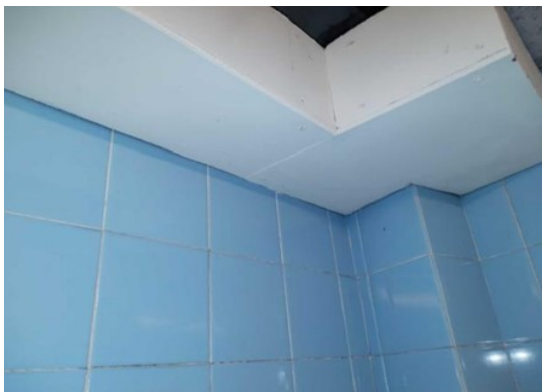
Item 39 Ref: 22-49553-16

The boxing in the Male WC (Area 22) does not contain asbestos.

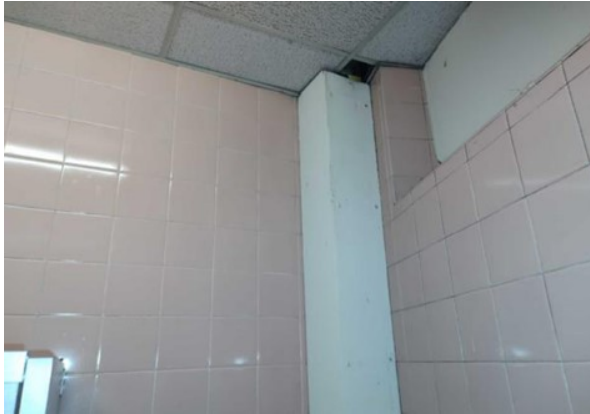
Item 40 Ref: 22-49553-16

The boxing in the female wc (Area 23) does not contain asbestos.

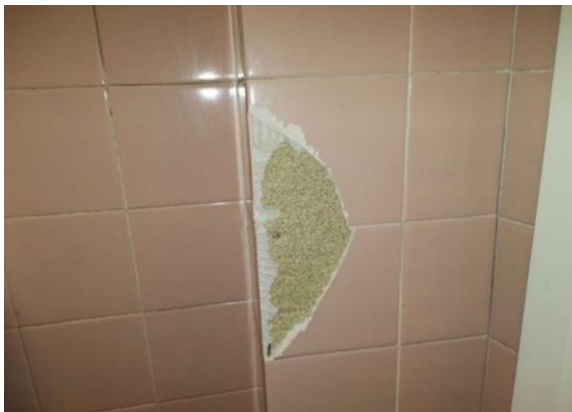
Item 41 Ref: 22-49553-17

The boxing behind the ceramic tiles in the female wc (Area 23) does not contain asbestos.

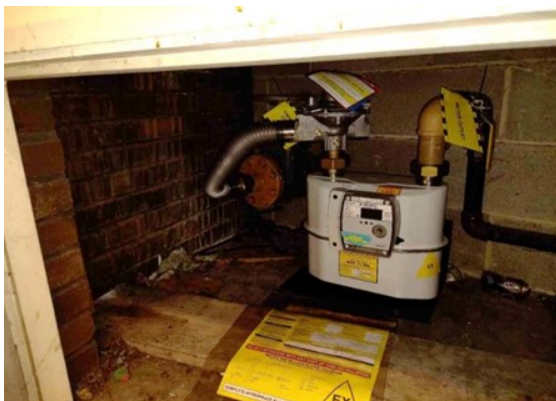
Item 42 Ref: Presumed

- (Item 42) Ref: Presumed – Flange gaskets (Area 24: Gas meter store) – Very Low Risk
- (Item 43) Ref: 22-49553-17 – Boxing behind ceramic tiles (Area 25: Office) – No Risk

The flanges gaskets to the pipes in the gas meter store (Area 24) is presumed to contain asbestos.

Any change in appearance should be reported to Property Services.

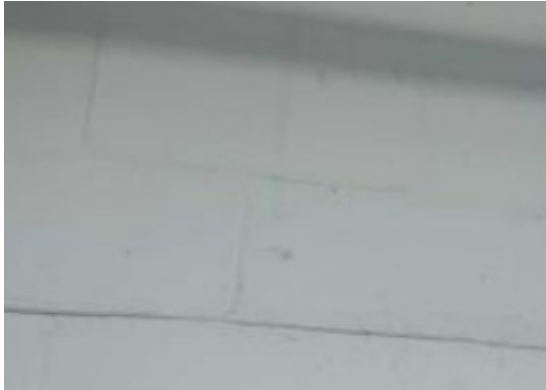
Item 43 Ref: 22-49553-17

The boxing behind the ceramic tiles in the Office (Area 25) does not contain asbestos.

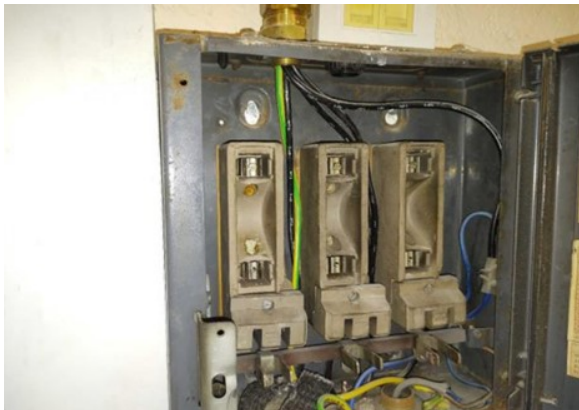
Item 44 Ref: 22-49553-19

- (Item 44) Ref: 22-49553-19 – Mastic to screw holes on fuse carriers (Area 25: Office) – Low Risk
- (Item 45) Ref: 22-49553-17 – Boxing behind plasterboard (Area 26: Print Room) – No Risk

The mastic to screw holes on fuse carriers in the Office (Area 25) does contain asbestos.

Any change in appearance should be reported to Property Services.

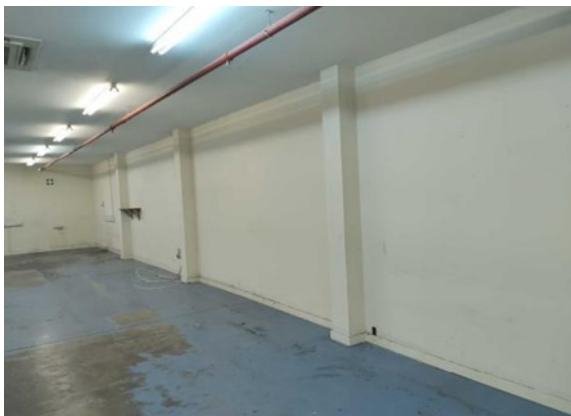
Item 45 Ref: 22-49553-17

The boxing behind the plasterboard in the print room (Area 26) does not contain asbestos.

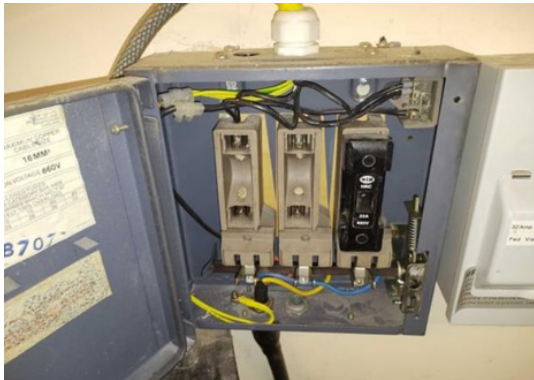
Item 46 Ref: 22-49553-19

- (Item 46) Ref: 22-49553-19 – Mastic to screw holes on fuse carriers, within Bill & MEM isolation boxes (Area 26: Print Room) – Low Risk
- (Item 47) Ref: 22-49553-20 – End cap linings within fuse cartridges, loose lying fuses to top of isolation box (Area 26: Print Room) – Low Risk

The mastic to screw holes on fuse carriers, within Bill and MEM isolation boxes in the Print Room (Area 26) does contain asbestos.

Any change in appearance should be reported to Property Services.

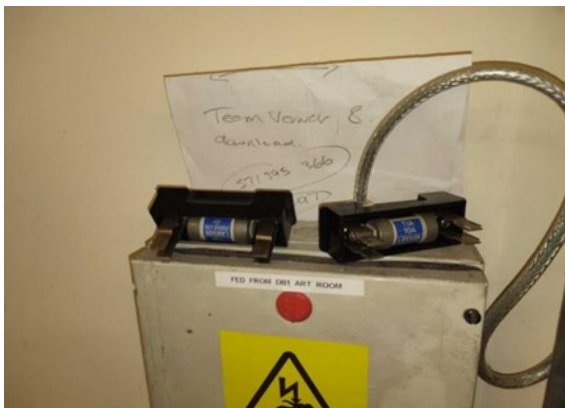
Item 47 Ref: 22-49553-20

The end cap linings within fuse cartridges, loose lying fuses to top of isolation box in the Print Room (Area 26) does contain asbestos.

Any change in appearance should be reported to Property Services.

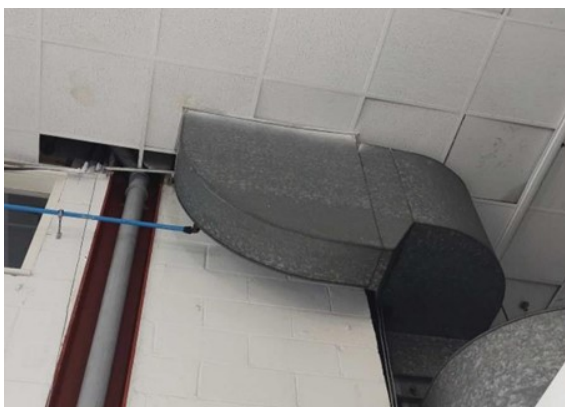
Item 48 Ref: 22-49553-14

- (Item 48) Ref: 22-49553-14 – Mastic to duct joints (Area 27: Main workshop) – Very Low Risk
- (Item 49) Ref: 22-49553-17 – Boxing to RSJs (Area 27: Main workshop) – No Risk

The mastic to the duct joints in the Main workshop (Area 27) does contain asbestos.

Any change in appearance should be reported to Property Services.

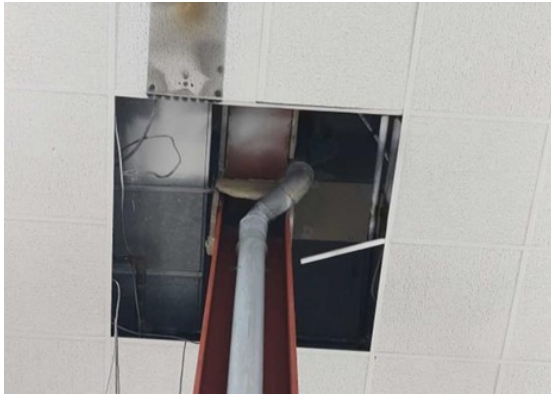
Item 49 Ref: 22-49553-17

The boxing to RSJ's in the main workshop (Area 27) does not contain asbestos.

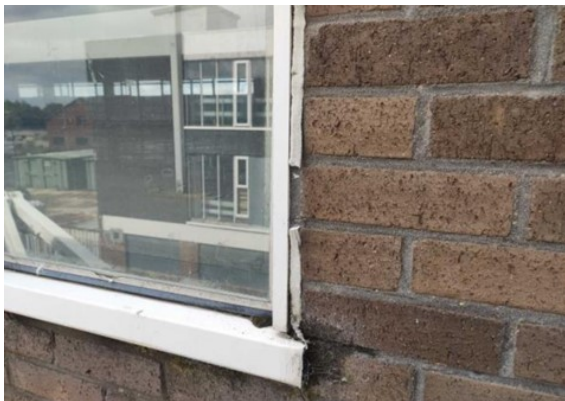
Item 50 Ref: 22-49553-1

The frame sealant between wall and metal frame in the external block 1d (Area 29) does not contain asbestos.

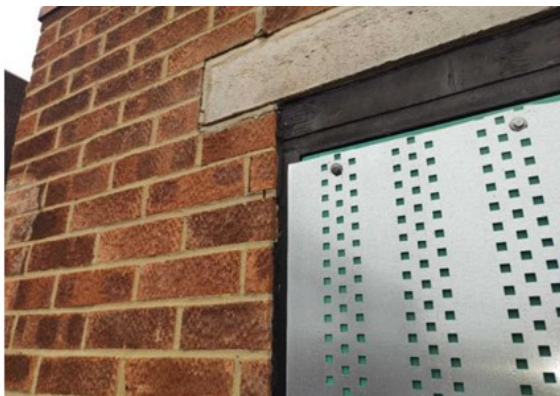
Item 51 Ref: 22-49553-21

The door frame sealant to wood frames in the external block 1d (Area 29) does not contain asbestos.

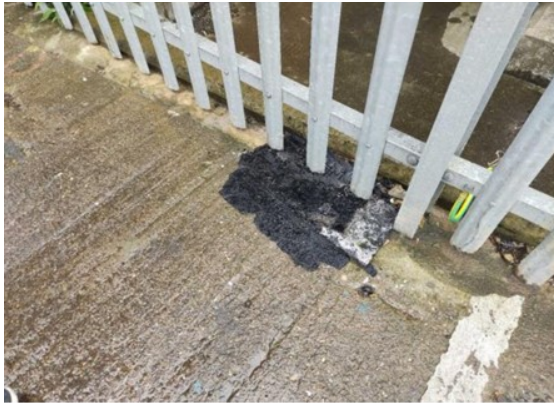
Item 52 Ref: 22-49553-22

The bitumen debris on the floor by the transformers in the external block 1d (Area 29) does not contain asbestos.

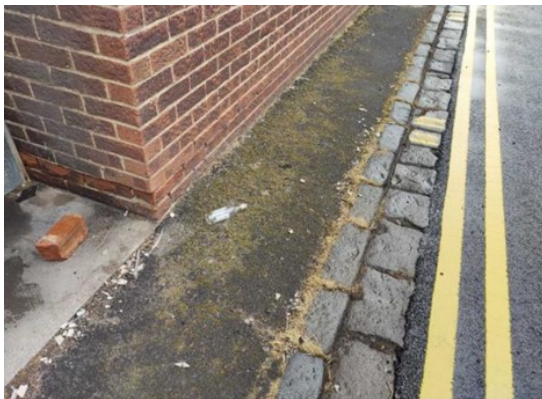
Item 53 Ref: 22-49553-23

- (Item 52) Ref: 22-49553-22 – Bitumen debris to floor by transformers (Area 29: External Block 1d) – No Risk
- (Item 53) Ref: 22-49553-23 – Cement debris to rear elevation path (Area 29: External Block 1d) – Low Risk

The cement debris on the floor to the rear elevation path of external area block 1d (Area 29) does contain asbestos.

Any change in appearance should be reported to Property Services.

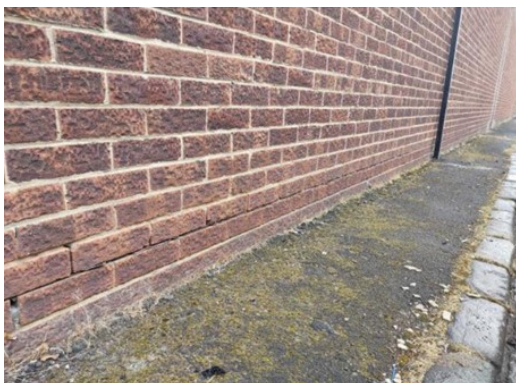
Item 54 Ref: 22-49553-24

- (Item 54) Ref: 22-49553-24 – Damp proof course (Area 29: External Block 1d) – Low Risk
- (Item 55) Ref: 22-49553-25 – Canopies (Area 29: External Block 1d) – No Risk

The damp proof course to the external area block 1d (Area 29) does contain asbestos.

Any change in appearance should be reported to Property Services.

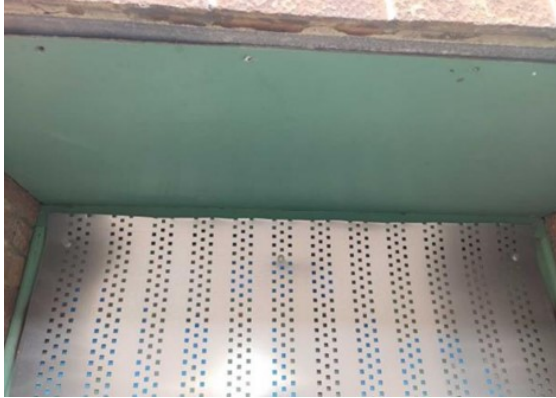
Item 55 Ref: 22-49553-25

The canopies to the external block 1d (Area 29) does not contain asbestos.

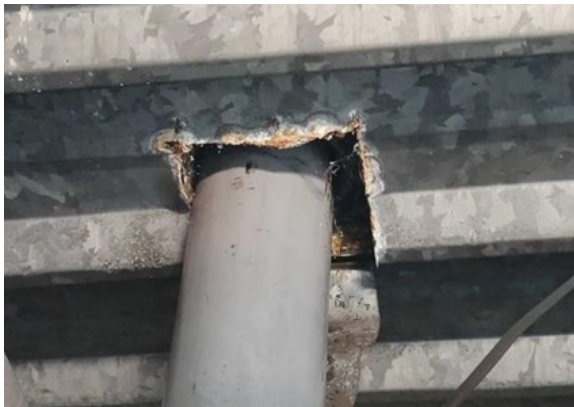
Item 56 Ref: 22-49553-6

The roof to external block 1d (Area 29) does not contain asbestos.

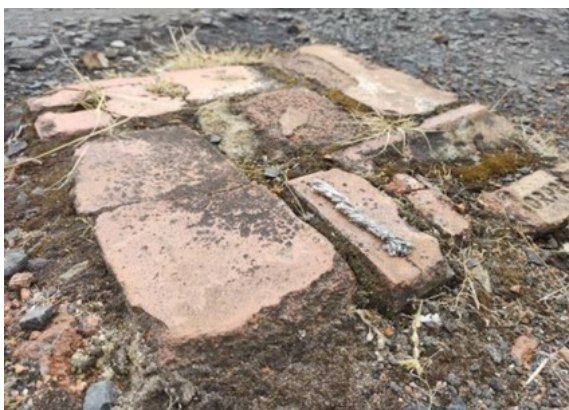
Item 57 Ref: 22-49553-26

- (Item 56) Ref: 22-49553-6 – Roof (Area 29: External Block 1d) – No Risk
- (Item 57) Ref: 22-49553-26 – Loose lying rope to car park (Area 30: Block 1e Waste land) – Low Risk

The loose lying rope on the floor to car park external block 1e waste land (Area 30) does contain asbestos.

Any change in appearance should be reported to Property Services.

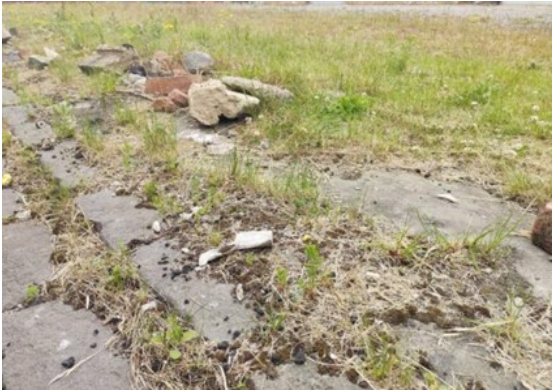
Item 58 Ref: 22-49553-27

- (Item 58) Ref: 22-49553-27 – Cement debris to waste land (Area 30: Block 1e Waste land) – Low Risk
- (Item 59) Ref: 22-49553-28 – Bitumen felt debris to waste land (Area 30: Block 1e Waste land) – No Risk

The cement debris to waste land external block 1e (Area 30) does contain asbestos.

Any change in appearance should be reported to Property Services.

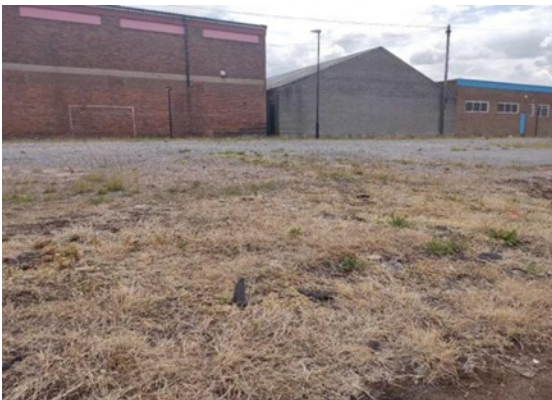
Item 59 Ref: 22-49553-28

The bitumen felt debris to waste land external block 1e (Area30) does not contain asbestos.
