ASBESTOS SURVEY REPORT FOR 18 REVELSTOKE ROAD, SUNDERLAND

Asbestos Register for

18 REVELSTOKE ROAD, SUNDERLAND

Date: 26 September 2024

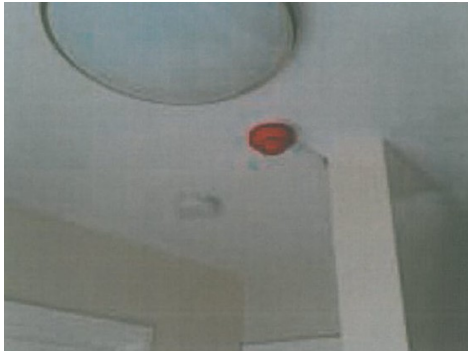
Item 1 Ref: IC10/1643

IC10/1643 – Textured coating (Room 1 Rear Foyer) (Item 1) – Very Low Risk

The textured coating to the ceiling in the foyer and stairs (Room 1) contains asbestos.

Any changes in its appearance should be noted and passed to Property Services.

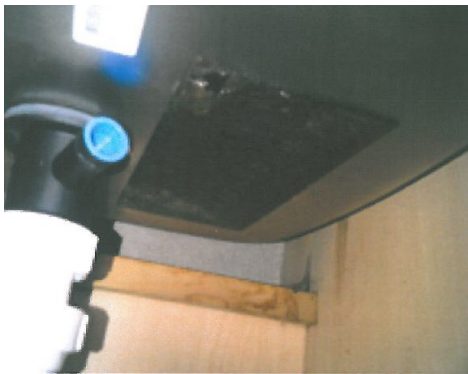
Item 2 - Ref: IC10/1644

The sink pad in the kitchen (Room 3) does not contain asbestos.

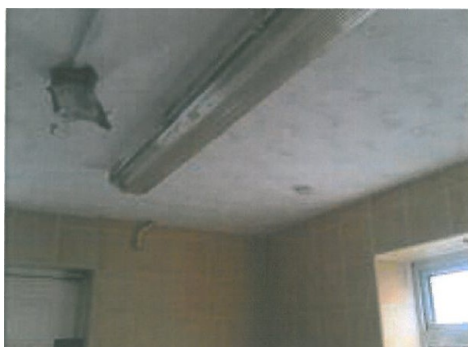
Item 3 - Ref: IC10/1645

The textured coating to the ceiling in the kitchen (Room 6) does not contain asbestos.

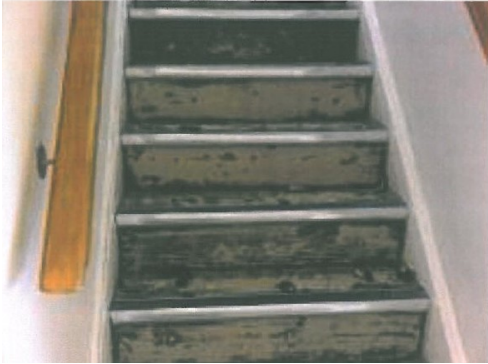
Item 4 Ref: IC10/1648

The stair nosing to the hall and stairs (Room 7) does not contain asbestos.

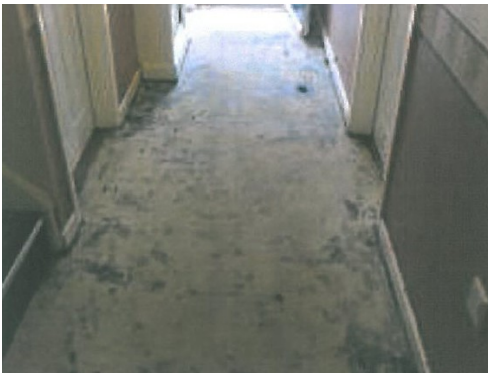
Item 5 - Ref: IC10/1647

IC10/1647 – Floor tiles (Room 7 Front Hall & Stairs) (Item 5) – Very Low Risk

The floor tiles to the hall and stairs (Room 7) contain asbestos. Any changes in its appearance should be noted and passed to Property Services.

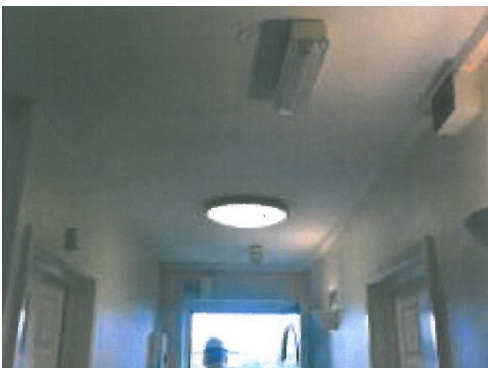
Item 6 - As IC10/1643

The textured coating to the ceiling in the hall and stairs (Room 7) contains asbestos. Any changes in its appearance should be noted and passed to Property Services.

This has been removed and resampled. See Item 24 for evidence.

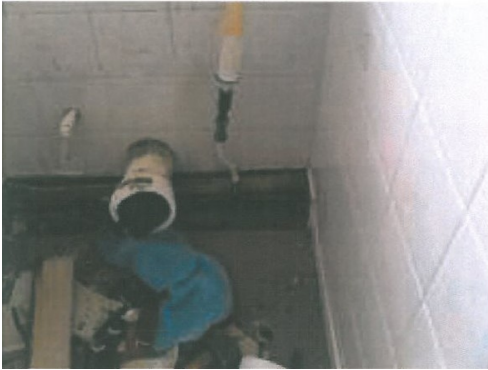
Item 7 Ref: IC10/1649

IC10/1649 – Floor tiles and adhesive (Room 12 WC 2) (Item 7) - Low Risk

The floor tiles and adhesive to WC 2 (Room 12) contain asbestos. Any changes in its appearance should be noted and passed to Property Services.

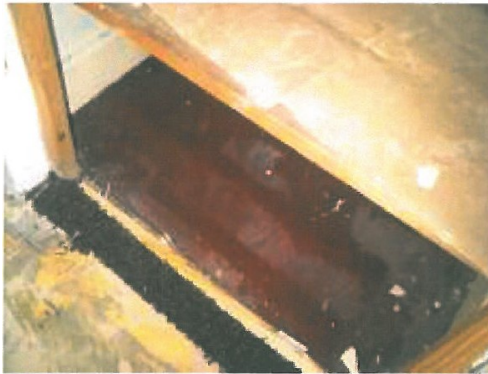
Item 8 - Ref: IC10/1650

The flooring to the landing – Cupboard A (Room 14) does not contain asbestos.

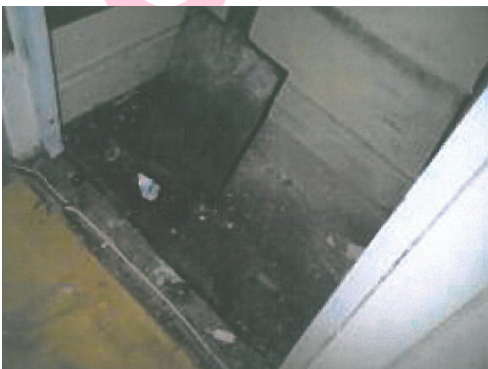
Item 9 - As IC10/1650

The flooring to Landing Cupboard B (Room 15) does not contain asbestos.

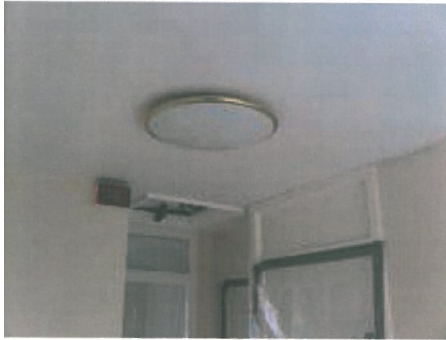
Item 10 As IC10/1643

As IC10/1643 – Textured coating to ceiling (Room 18 Rear Landing) (Item 10) – Very Low Risk

The textured coating to the ceiling in the rear landing (Room 18) contains asbestos. Any changes in its appearance should be noted and passed to Property Services.

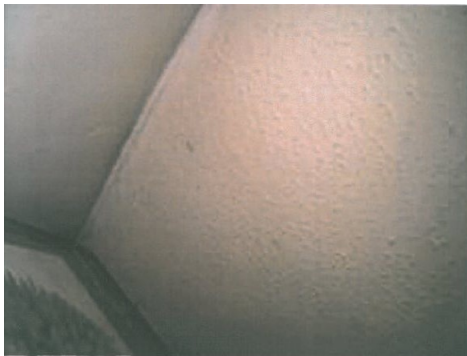
Item 11 – As IC10/1643

As IC10/1643 – Textured coating to ceiling (Room 19 Rear Landing Cupboard) (Item 11) – Very Low Risk

The textured coating to the ceiling in the rear landing cupboard (Room 19) contains asbestos. Any changes in its appearance should be noted and passed to Property Services.

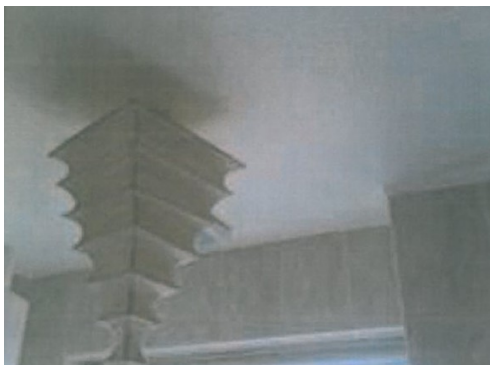
Item 12 - As IC10/1643

As IC10/1643 – Textured coating to ceiling (Room 20 Bathroom 2) (Item 12) – Low Risk

The textured coating to the ceiling in bathroom 2 (Room 20) contains asbestos.

Any changes in its appearance should be noted and passed to Property Services.

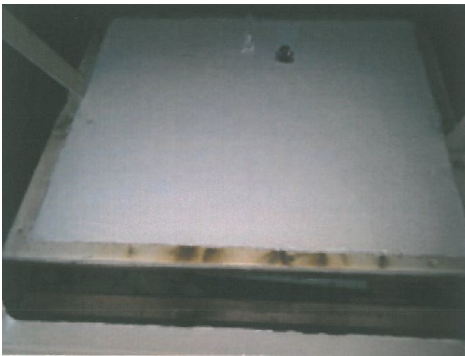
Item 14 – Ref: IC10/1651

The loft hatch board does not contain asbestos.

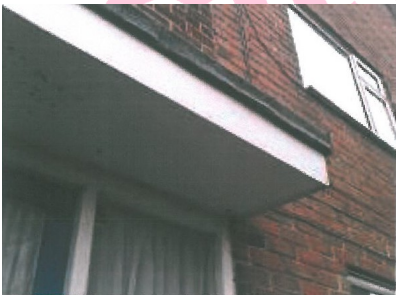
Item 15 Ref: IC10/1653

The canopy to the rear door does not contain asbestos.

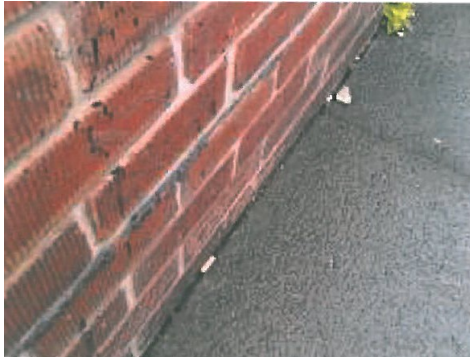
Item 16 Ref: IC10/1654

The damp proof course to the external does not contain asbestos.

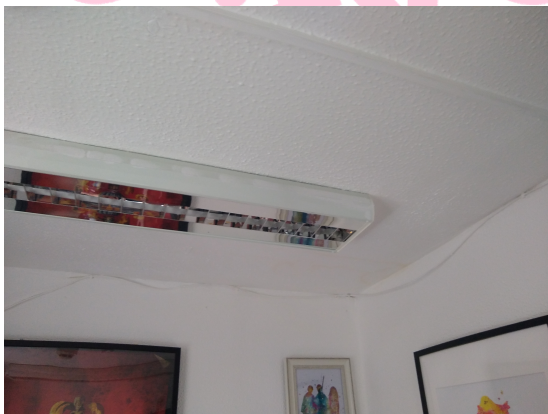
Item 21 Ref: As 340701-2

As 340701-2 – Textured coating to ceiling (Rm 006/ Rear office) (Item 21) – Very Low Risk

The Textured coating to ceiling in Room 006/office contains asbestos.

Any change in appearance should be reported to Property Services.

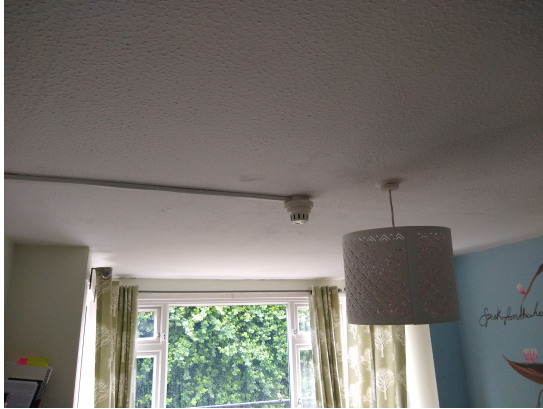
Item 22 Ref: 340701-2

340701-2 – Textured coating to ceiling (Rm 007/ Rear office) (Item 22) – Very Low Risk

The Textured coating to ceiling in Room 007/office contains asbestos.

Any change in appearance should be reported to Property Services.

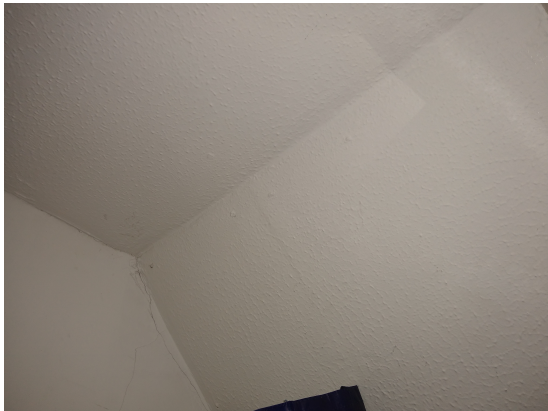
Item 23 Ref: As 340701-2

As 340701-2 – Textured coating to ceiling (Rm 008/Rear under stairs cupboard) (Item 23) – Very Low Risk

The Textured coating to ceiling in Room 008/under stairs cupboard contains asbestos.

Any change in appearance should be reported to Property Services.

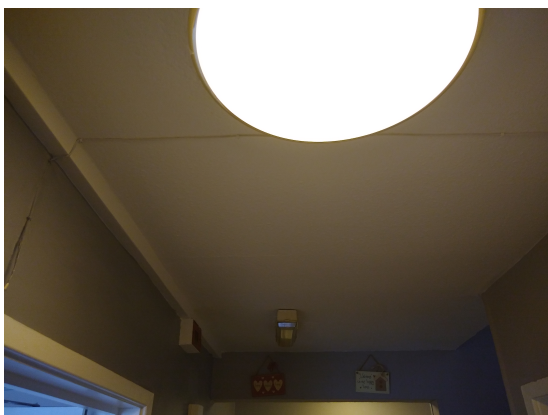
**Item 24 Ref: 340701-3/
22- 53444-1**

The Textured coating to ceiling in Room 010/corridor does not contain asbestos.

Resampled by Pattinsons 2022 – confirmed no asbestos present.

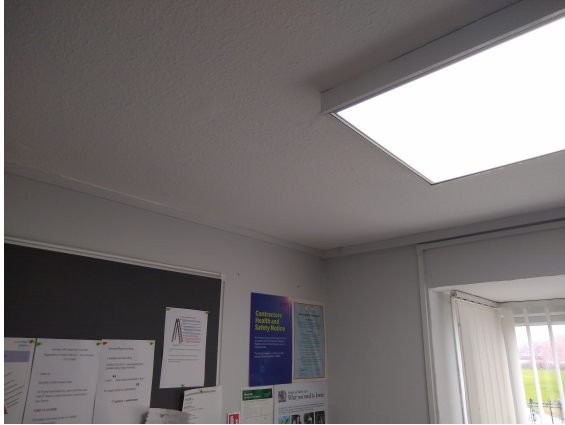
**Item 25 Ref: 340701-7/
22-53444-2**

The Textured coating to ceiling in Room 012/office does not contain asbestos.

Resampled by Pattinsons 2022 – confirmed no asbestos present.

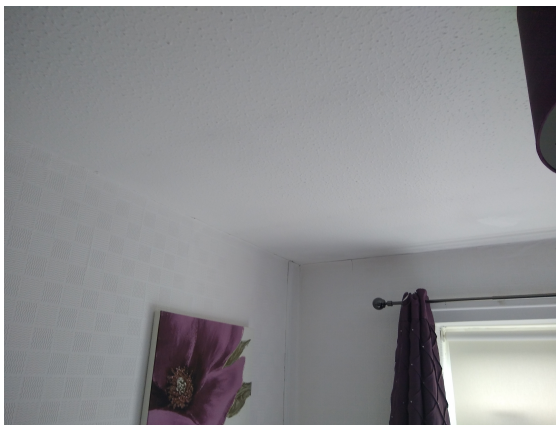
Item 26 Ref: 340701-5

340701-5 – Textured coating to ceiling (Rm 1/004/Rear staff bedroom) (Item 26) – Very Low Risk

The Textured coating to ceiling in Room 004/staff bedroom contains asbestos.

Any change in appearance should be reported to Property Services.

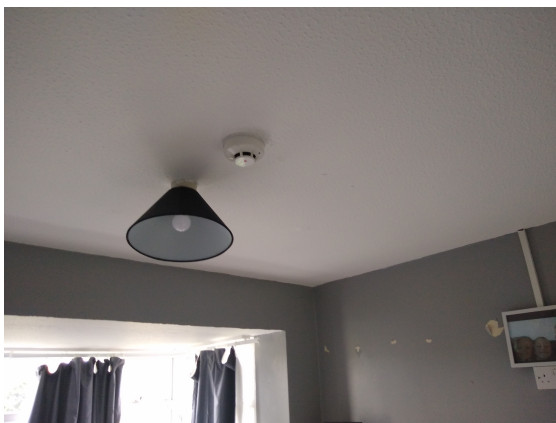
Item 27 Ref: As 340701-5

As 340701-5 – Textured coating to ceiling (Rm 1/005/bedroom 2) (Item 27) – Very Low Risk

The Textured coating to ceiling in Room 005/bedroom 2 contains asbestos.

Any change in appearance should be reported to Property Services.

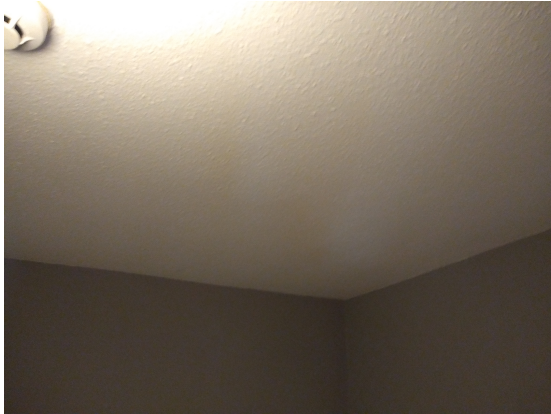
Item 28 Ref: 340701-6

The Textured coating to ceiling in Room 009/bedroom 6 does not contain asbestos.

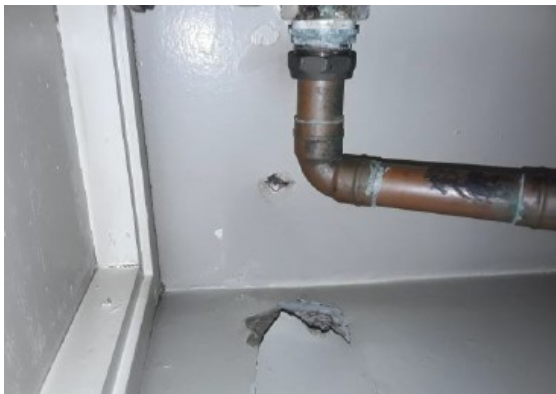
Item 29 Ref: 21-36178-1

The ceiling in the boiler/heating cupboard does not contain asbestos.

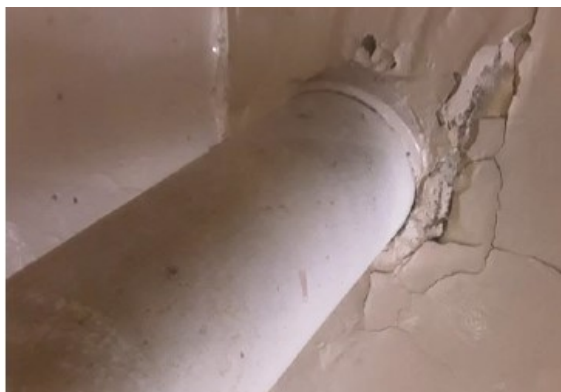
Item 30 Ref: 21-36178-2

The walls in the boiler/heating cupboard does not contain asbestos.

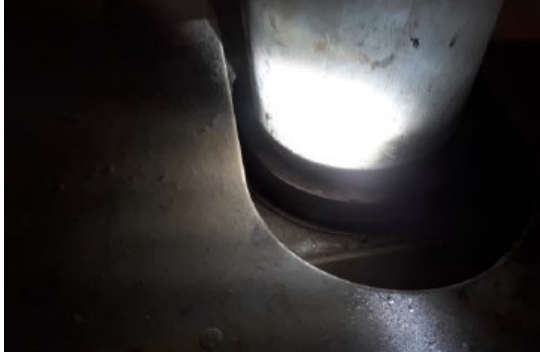
Item 31 Ref: 21-36178-3

The seal to the boiler from the flue in the boiler/heating cupboard does not contain asbestos.

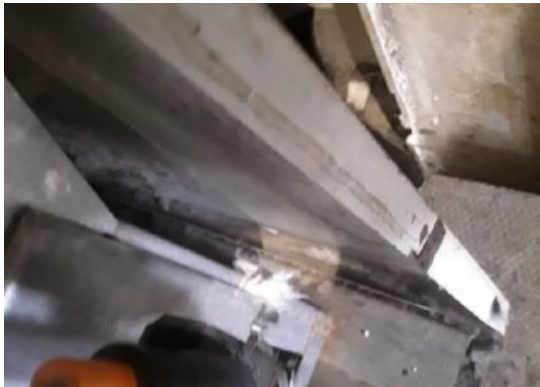
Item 32 Ref: 21-36178-4

The seal to boiler in the boiler/heating cupboard does not contain asbestos.

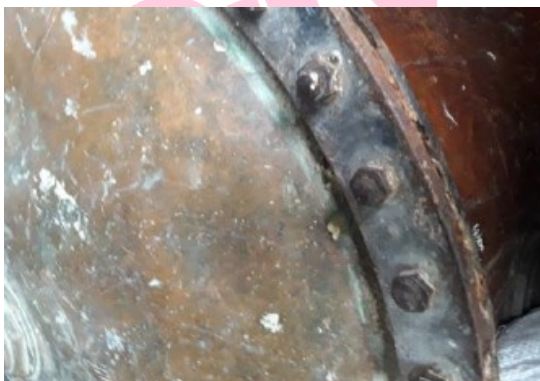
Item 33 Ref: 21-36330-1

The gasket to redundant water tank (External) does not contain asbestos.

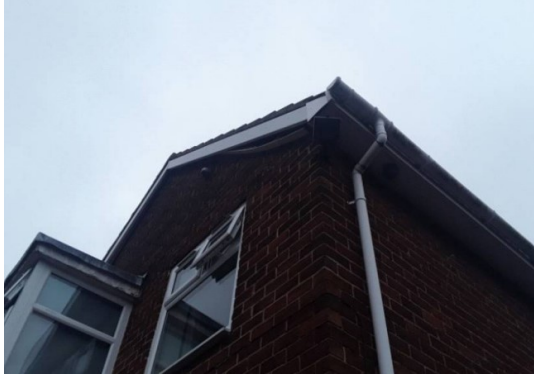
Item 34 Ref: NZ001241

The roof lining (External) does not contain asbestos.

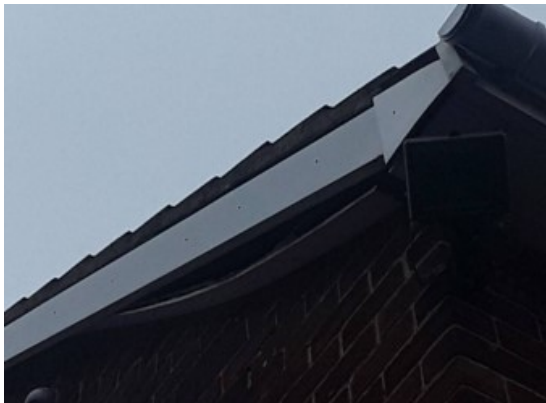
Item 35 Ref: NZ001242

NZ001242 – Undercloak to left hand rear extension (External) (Item 35) – Very Low Risk

The undercloak to left hand rear extension (External) does contain asbestos.

Any changes in appearance should be reported to Property Services.

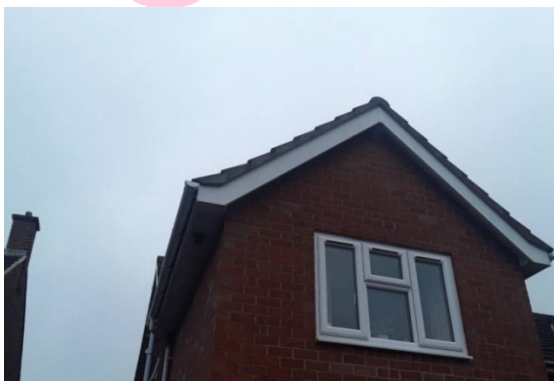
Item 36 Ref: NZ001244

The soffits to right hand rear extension (External) does not contain asbestos.
