ASBESTOS SURVEY REPORT FOR CENTRAL LIBRARY, FAWCETT STREET, SUNDERLAND. SR1 1RE

## **Asbestos Register for**

**Central Library, Fawcett Street, Sunderland. SR1 1RE**

**Date: 14 February 2025**

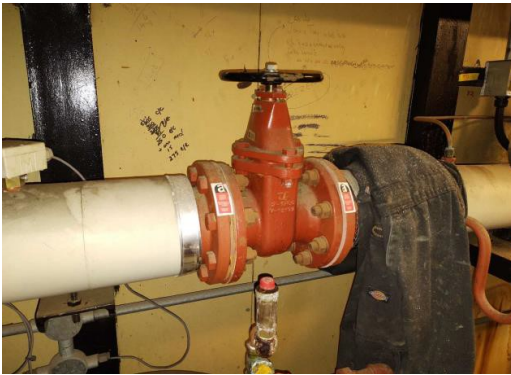
### **Item 1 Ref: 22-42500-22**

The pipe flange gaskets (Area: 04 boiler room) contain asbestos.

Any change in its appearance should be recorded and passed to Property Services.

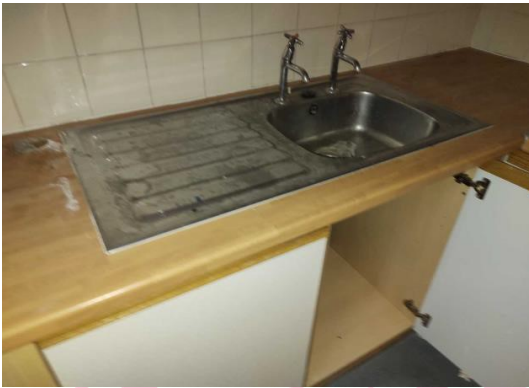
### **Item 2 Ref: 22-42500-10**

The sink pad (Area: 3/25 staff room) does not contain asbestos.

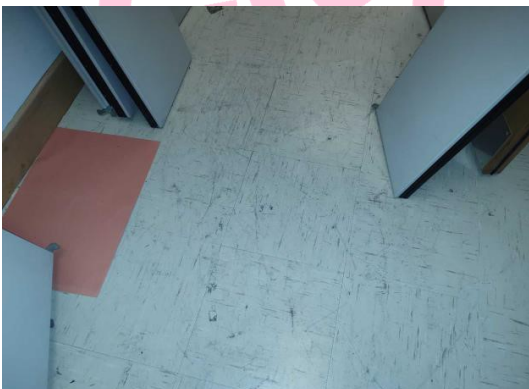
### **Item 3 Ref: 22-42500-8**

The floor (tiles & adhesive) (Area: 3/32 cupboard) does not contain asbestos.

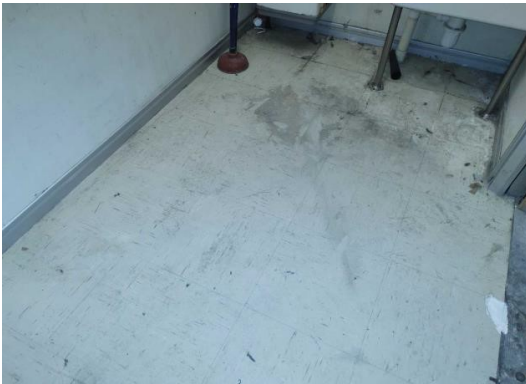
### **Item 4 Ref: 22-42500-9**

The floor (tiles & adhesive)  
(Area: 3/34 store cupboard)  
does not contain asbestos.

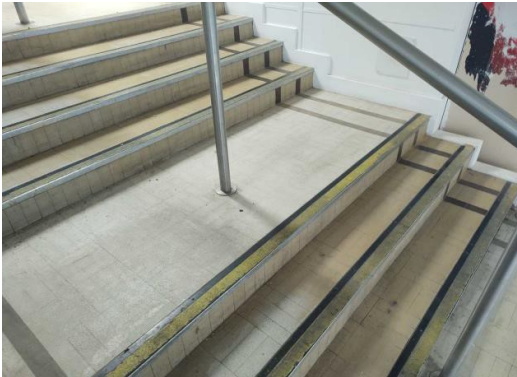
### **Item 5 Ref: 22-42500-4**

The floor (stair nosing treads)  
(Area: 3/36 foyer) does not  
contain asbestos.

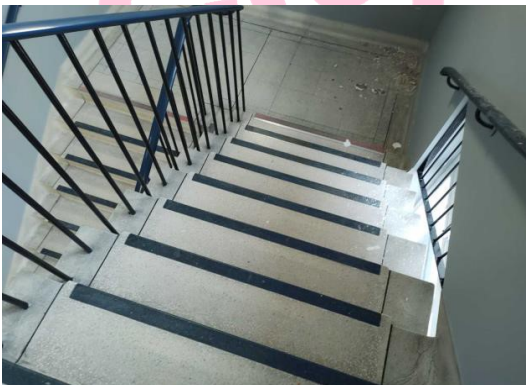
### **Item 6 Ref: 22-42500-5**

The floor (stair nosing treads)  
(Area: 3/40 stairwell) does not  
contain asbestos.

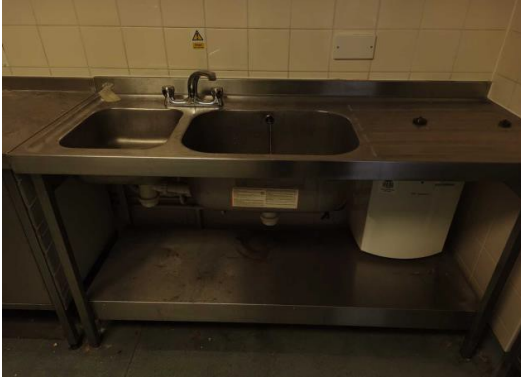
### **Item 7 Ref: 22-42500-1**

The sink pad (Area: 3/42 kitchen) does not contain asbestos.

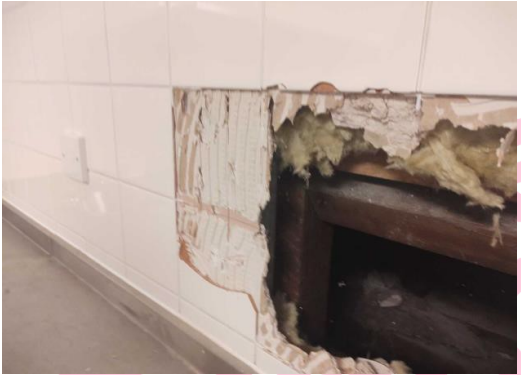
### **Item 8 Ref: 22-42500-2**

The walls (ceramic wall tiles adhesive) (Area: 3/42 kitchen) do not contain asbestos.

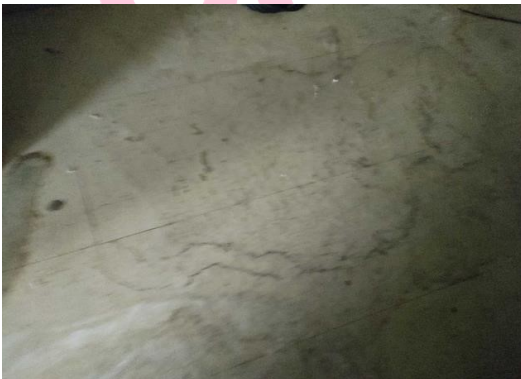
### **Item 9 Ref: 22-42500-3**

The floor (tiles & adhesive) (Area: 3/46 electrical cupboard) does not contain asbestos.

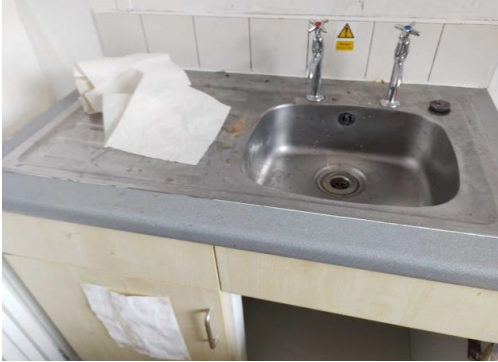
### **Item 10 Ref: 22-42500-6**

The sink pad (Area: 3/48 meeting room & stores) does not contain asbestos.

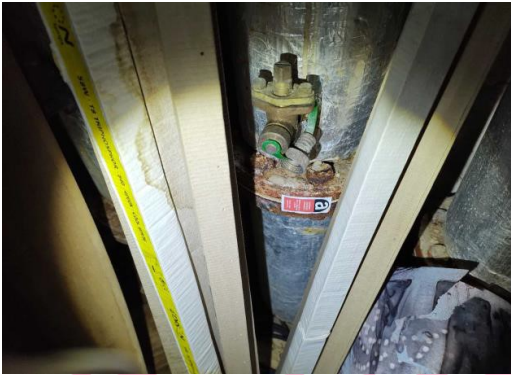
### **Item 11 Ref: 22-42500-7**

The pipe flange gaskets (Area: 3/51 service riser) contain asbestos.

Any change in its appearance should be recorded and passed to Property Services.

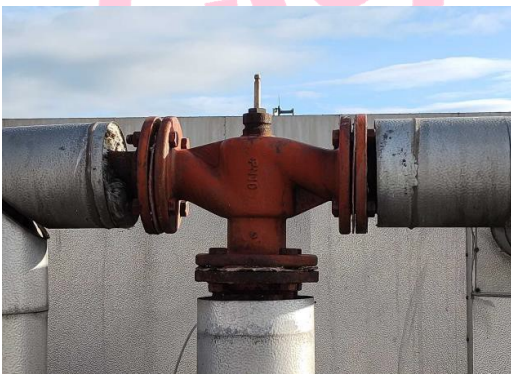
### **Item 12 Ref: 22-42500-22**

- (Item 11) Ref: 22-42500-7 – Pipe flange gaskets (Area: 3/51 service riser) – Very Low Risk
- (Item 12) Ref: 22-42500-22 – Pipe flange gaskets (Area: 02 roof top externals) – Very Low Risk (**repair then monitor**)

The pipe flange gaskets (Area: 02 roof top externals) contain asbestos.

Any change in its appearance should be recorded and passed to Property Services.

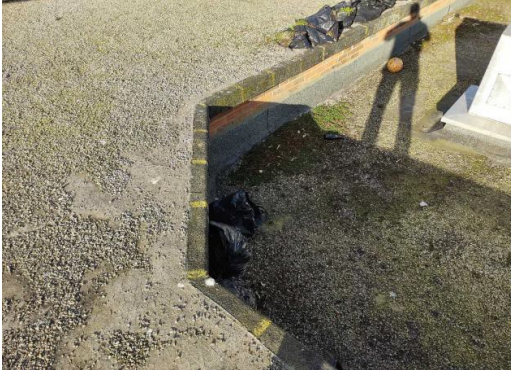
### **Item 13 Ref: 22-42500-23**

The floor (bitumen) (Area: 02 roof top externals) does not contain asbestos.

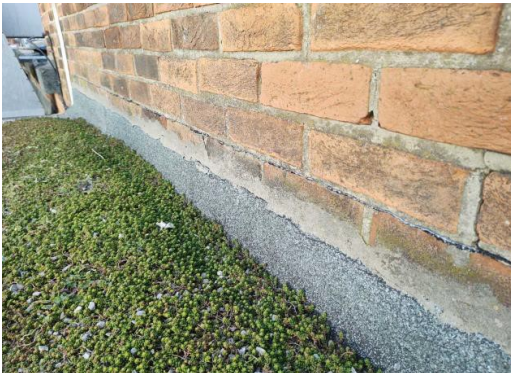
### **Item 14 Ref: 22-42500-24**

The damp proof course (Area: 02 roof top externals) does not contain asbestos.

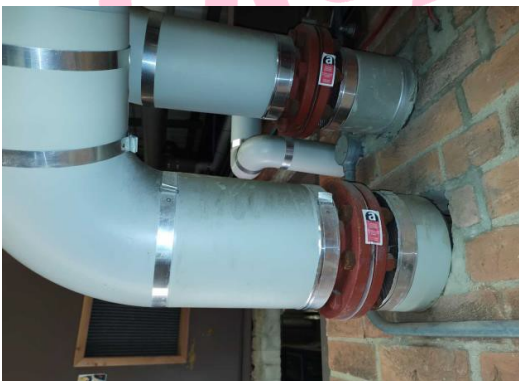
### **Item 15 Ref: 22-42500-22**

The pipe flange gaskets (Area: 03 air handling room) contain asbestos.

Any change in its appearance should be recorded and passed to Property Services.

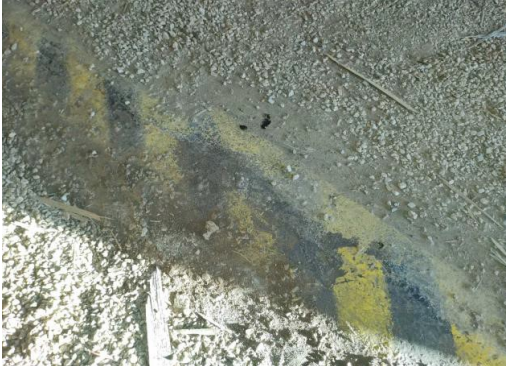
### **Item 16 Ref: 22-42500-23**

The floor (asphalt floor) (Area: 03 air handling room) does not contain asbestos.

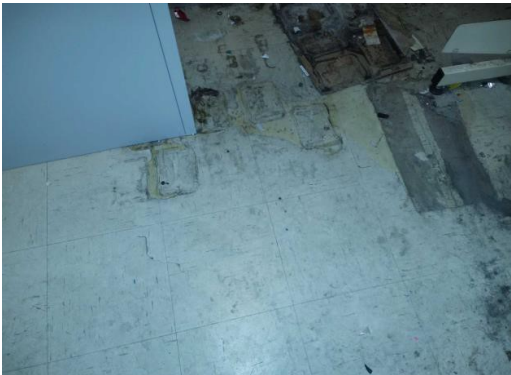
### **Item 17 Ref: 22-42500-27**

The floor (tiles & adhesive) (Area: 1-004 switch room) does not contain asbestos.

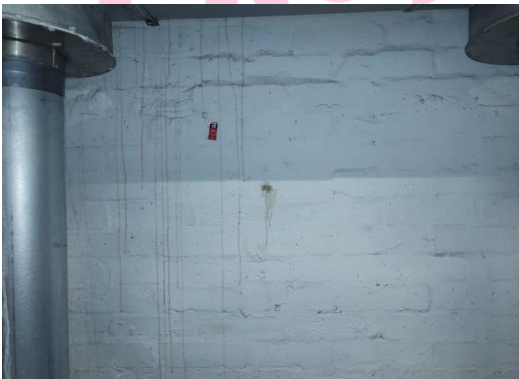
### **Item 18 Ref: 22-42500-13**

The walls (residue to walls - insulation) (Area: 05 boiler room) contain asbestos.

Any change in its appearance should be recorded and passed to Property Services.

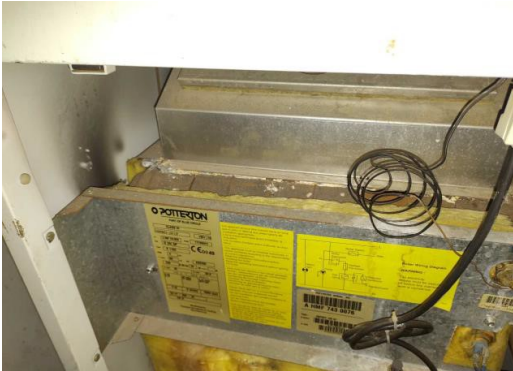
### **Item 19 Ref: 22-42500-14**

The sealant to floor standing boilers (mastic) (Area: 05 boiler room) does not contain asbestos.

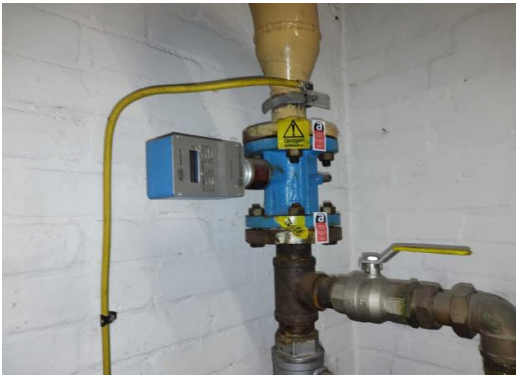
### **Item 20 Ref: 22-42500-15**

The pipe flange gaskets (Area: 05 boiler room) contain asbestos.

Any change in its appearance should be recorded and passed to Property Services.

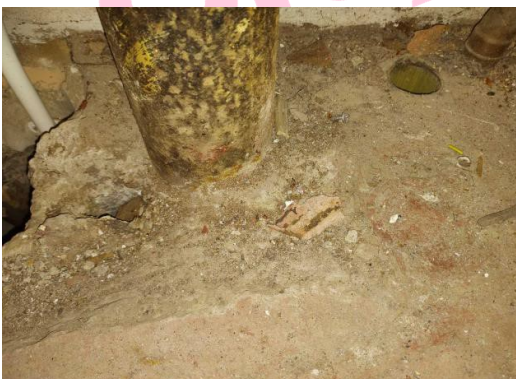
### **Item 21 Ref: 22-42500-16**

- (Item 21) Ref: 22-42500-16 – Gasket debris to floor beneath modern fuse board & by cast iron down pipe (Area: 05 boiler room) – Low Risk (**Rhodar to remove**)

The gasket debris to floor beneath modern fuse board & by cast iron down pipe (Area: 05 boiler room) contains asbestos.

Any change in its appearance should be recorded and passed to Property Services.

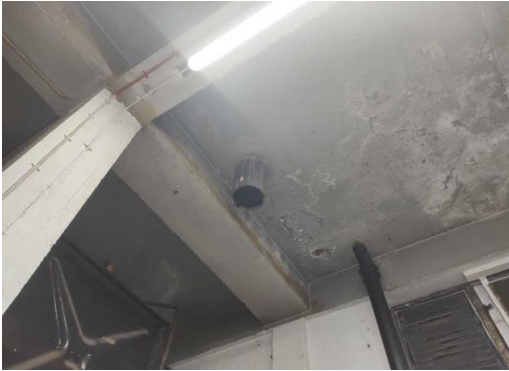
### **Item 22 Ref: Presumed**

The redundant flue penetrating ceiling (cement) (Area: 05 boiler room) is presumed to contain asbestos.

Any change in its appearance should be recorded and passed to Property Services.

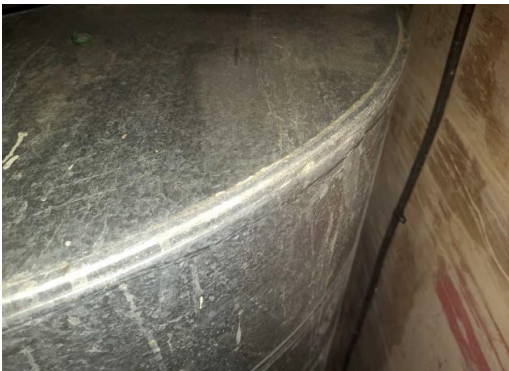
### **Item 23 Ref: 22-42500-37**

The ductwork joint mastic (Area: 05 boiler room) does not contain asbestos.

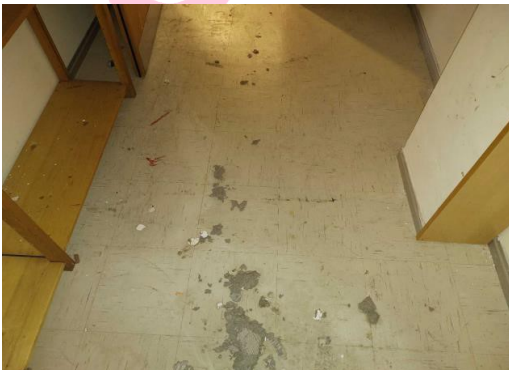
### **Item 24 Ref: 22-42500-27**

The floor (tiles & adhesive) (Area: 2/009 store cupboard) does not contain asbestos.

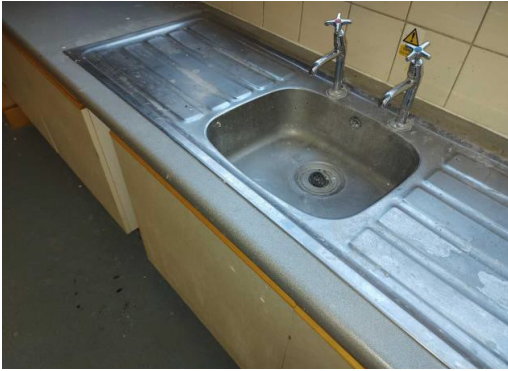
### **Item 25 Ref: 22-42500-28**

The sink pad (Area: 2/01 staff room) does not contain asbestos.

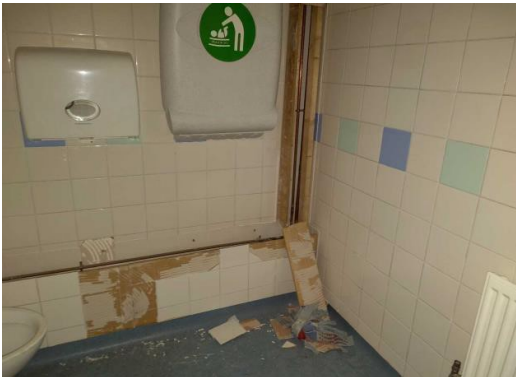
### **Item 26 Ref: 22-42500-26**

The walls (adhesive) (Area: 2/012 baby care rom) do not contain asbestos.

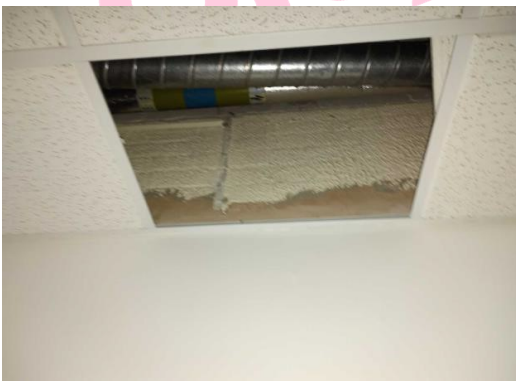
### **Item 27 Ref: 22-42500-29**

The walls (textured coating) (Area: 2/015 office) contain asbestos.

Any change in its appearance should be recorded and passed to Property Services.

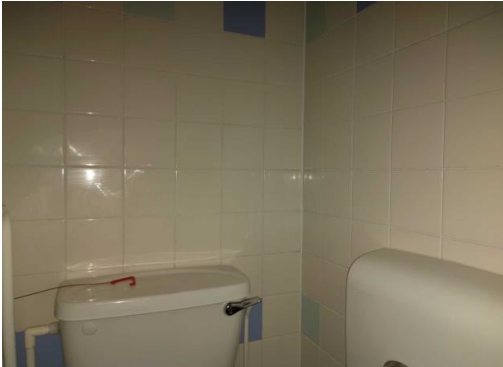
### **Item 28 Ref: 22-42500-26**

The walls (ceramic tile adhesive) (Area: 2/018 accessible wc) do not contain asbestos.

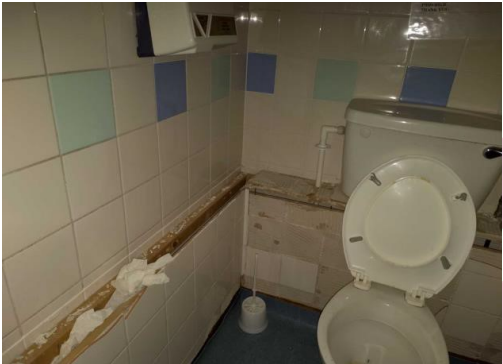
### **Item 29 Ref: 22-42500-26**

The walls (ceramic tile adhesive) (Area: 2/02 staff wc) do not contain asbestos.

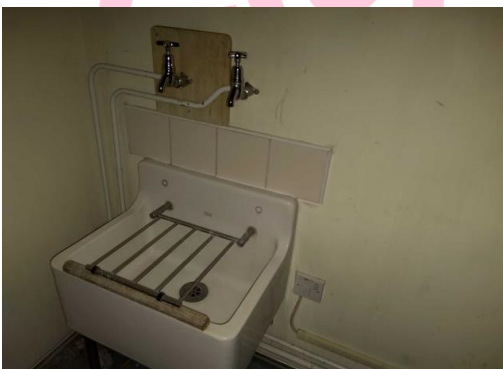
### **Item 30 Ref: 22-42500-26**

The walls (ceramic tile adhesive) (Area: 2/021 cleaners cupboard) do not contain asbestos.

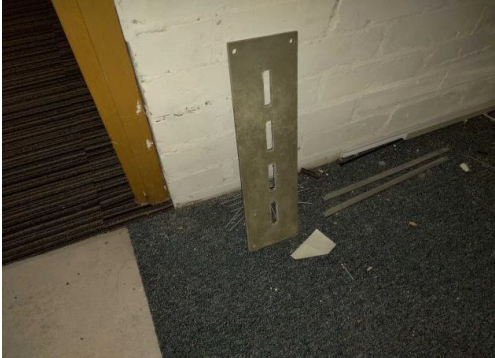
### **Item 31 Ref: 22-42500-30**

- (Item 31) Ref: 22-42500-30 – Loose lying cement arc chute (cement) (Area: 2/022 electrical cupboard) – Very Low Risk (**Rhodar to remove**)
- (Item 32) Ref: 22-42500-25 – Sink pad (Area: 2/027 kitchen) – No Risk

The loose lying cement arch chute (cement) (Area: 2/022 electrical cupboard) contains asbestos.

Any change in its appearance should be recorded and passed to Property Services.

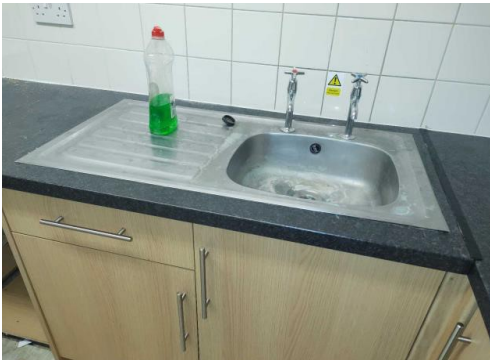
### **Item 32 Ref: 22-42500-25**

The sink pad (Area: 2/027 kitchen) does not contain asbestos.

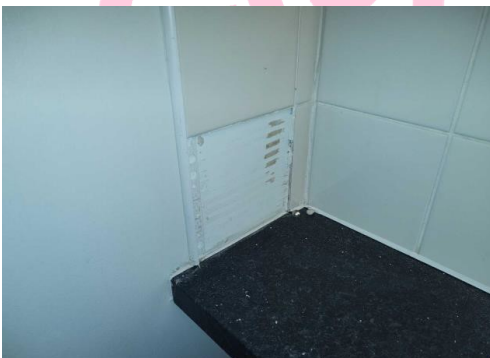
### **Item 33 Ref: 22-42500-26**

The walls (ceramic tile adhesive) (Area: 2/027 kitchen) do not contain asbestos.

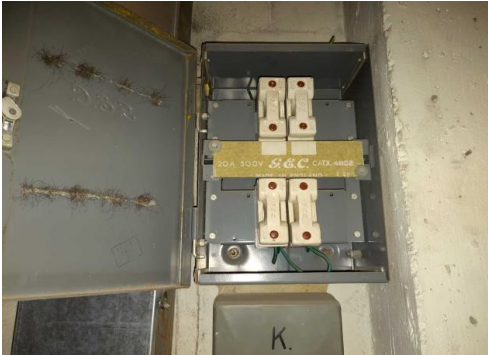
### **Item 34 Ref: 22-42500-11**

The flash guards within redundant GEC electric box (woven) (Area: 3/01D electrical cupboard) contain asbestos.

Removed according to reinspection survey J248418.

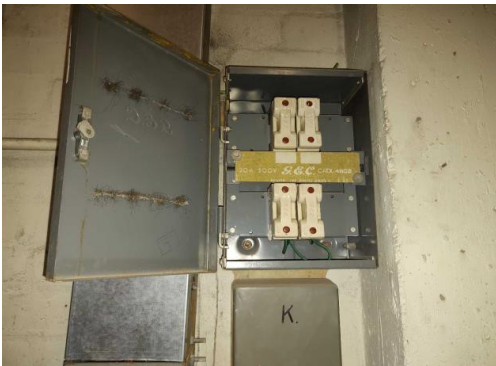
### **Item 35 Ref: 22-42500-12**

The cement arc chute within redundant GEC electric box (Area: 3/01D electrical cupboard) contain asbestos.

Any change in its appearance should be recorded and passed to Property Services.

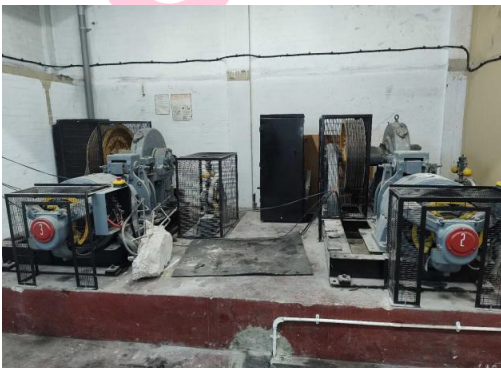
### **Item 36 Ref: Presumed**

The brake shoes to lift machinery (cement) (Area: 04A lift motor room) are presumed to contain asbestos.

Any change in its appearance should be recorded and passed to Property Services.

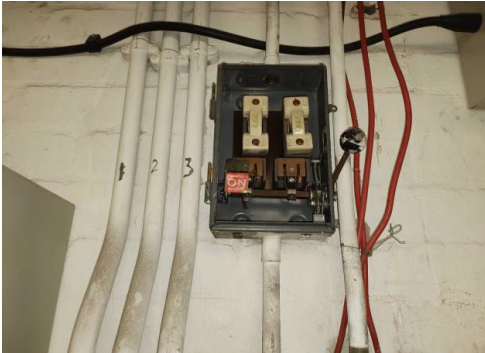
### **Item 37 Ref: 22-42500-11**

The flash guards within electrical equipment (woven) (Area: 05A corridor) contain asbestos.

Any change in its appearance should be recorded and passed to Property Services.

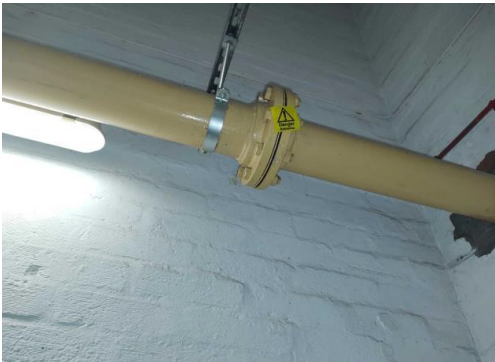
### **Item 38 Ref: Presumed**

The pipe flange gasket (Area: 05A corridor) is presumed to contain asbestos.

Any change in its appearance should be recorded and passed to Property Services.

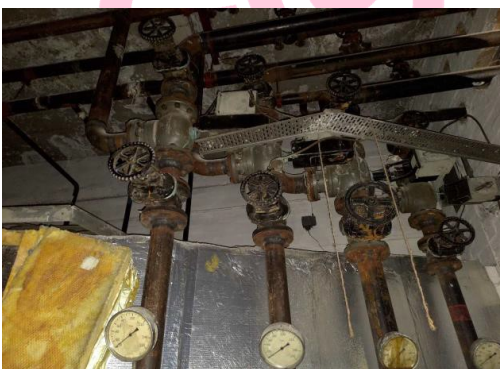
### **Item 39 Ref: Presumed**

The pipe flange gaskets (Area: 05E ventilation rooms) are presumed to contain asbestos.

Any change in its appearance should be recorded and passed to Property Services.

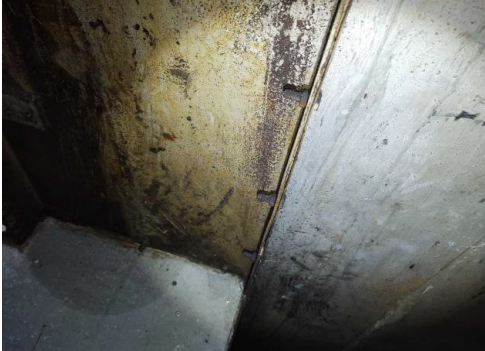
### **Item 40 Ref: 22-42500-19**

The ductwork joint sealants (mastic) (Area: 05E ventilation rooms) do not contain asbestos.

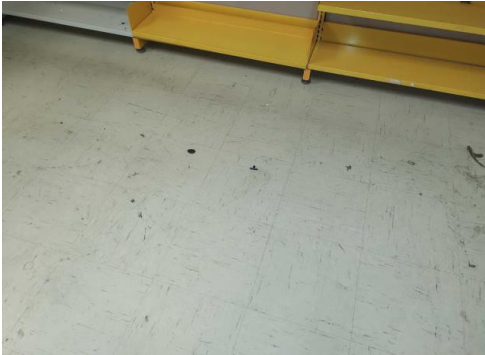
### **Item 41 Ref: 22-42500-27**

The floor (tiles & adhesive) (Area: 2/02 store room) does not contain asbestos.

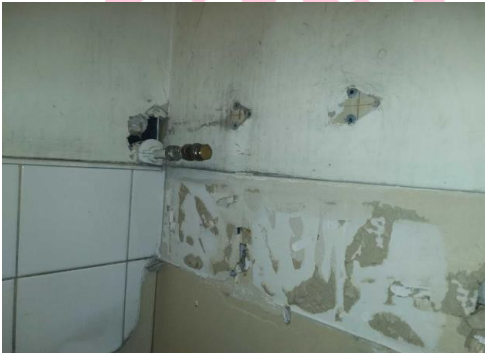
### **Item 42 Ref: 22-42500-26**

The walls (ceramic tile adhesive) (Area: 2/04 electrical cupboard) do not contain asbestos.

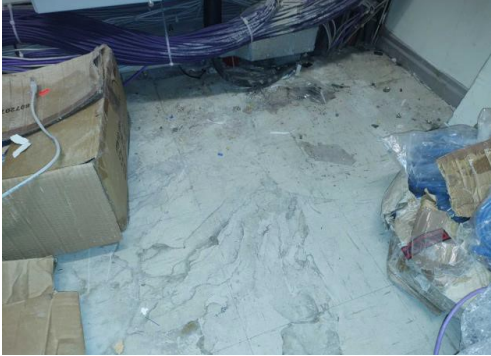
### **Item 43 Ref: 22-42500-27**

The floor (tiles & adhesive) (Area: 2/04 electrical cupboard) does not contain asbestos.

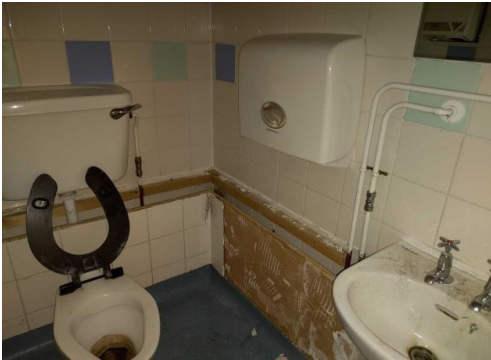
### **Item 44 Ref: 22-42500-26**

The walls (ceramic tile adhesive to walls & MDF boxing) (Area: 2/11 WC) do not contain asbestos.

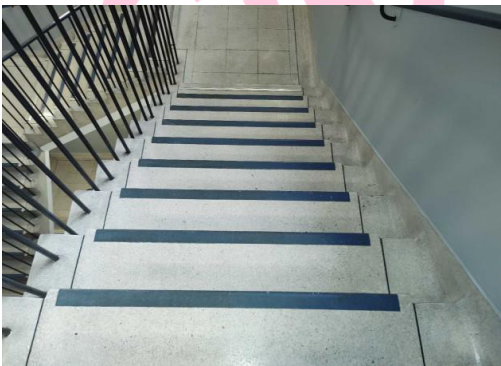
### **Item 45 Ref: 22-42500-5**

The floor stair nosing (Area: 1/35 stairwell) does not contain asbestos.

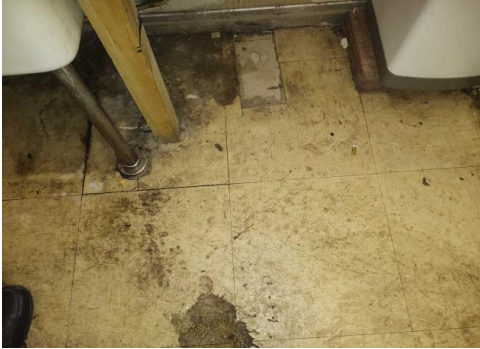
### **Item 46 Ref: 22-42500-27**

The floor (tiles & adhesive)  
(Area: 1/01 switch room) does  
not contain asbestos.

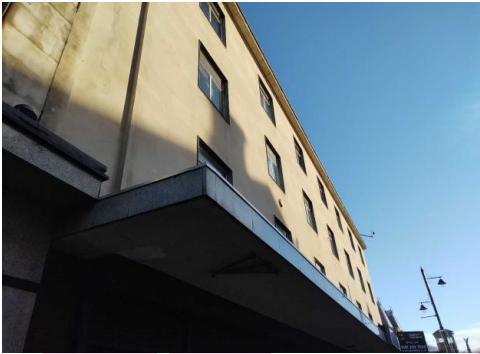
### **Item 47 Ref: Presumed**

The felt to canopy (bitumen)  
(Area: 06 building externals) is  
presumed to contain  
asbestos.

Any change in its appearance  
should be recorded and  
passed to Property Services.

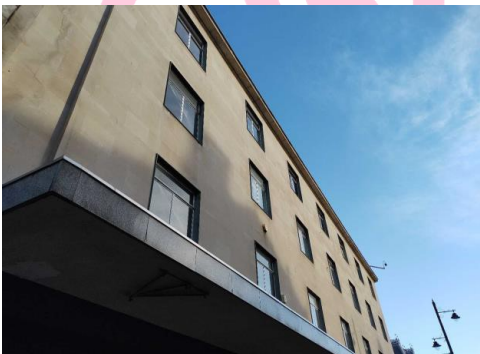
### **Item 48 Ref: Presumed**

The window putty to front &  
side elevation (putty) (Area:  
06 building externals) is  
presumed to contain  
asbestos.

Any change in its appearance  
should be recorded and  
passed to Property Services.

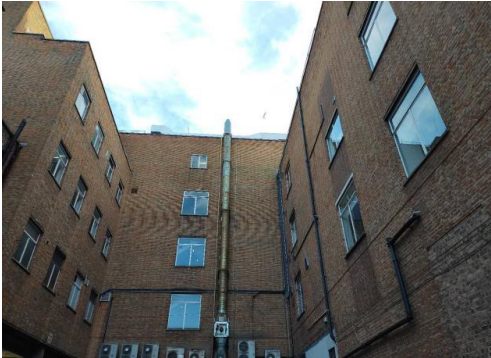
### **Item 49 Ref: Presumed**

The window putty to rear elevation windows (putty) (Area: 06 building externals) is presumed to contain asbestos.

Any change in its appearance should be recorded and passed to Property Services.

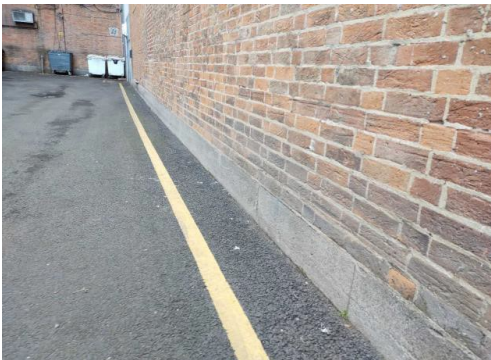
### **Item 50 Ref: 22-42500-35**

The damp proof course (bitumen) (Area: 06 building externals) does not contain asbestos.

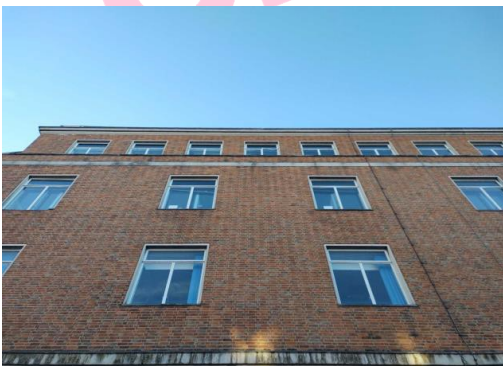
### **Item 51 Ref: Presumed**

The windows to side elevation on John Street (putty) (Area: 06 building externals) are presumed to contain asbestos.

Any change in its appearance should be recorded and passed to Property Services.

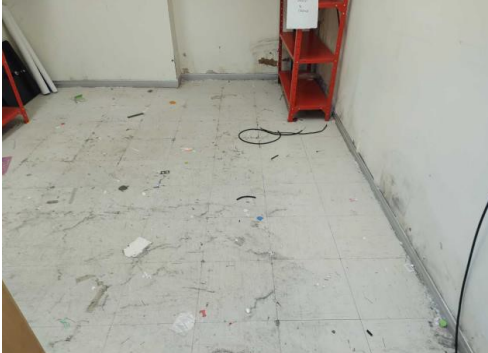
### **Item 52 Ref: 22-42500-35**

The floor (tiles & adhesive) (Area: B/03 basement cupboard) does not contain asbestos.

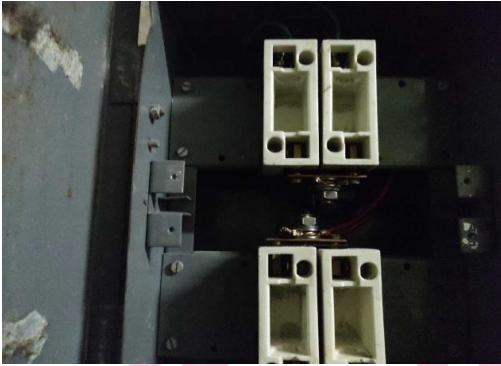
### **Item 53 Ref: Presumed**

The flash guard residue within GEC isolation box to wall 4 no. fuses (woven) (Area: B/02 switch room) is presumed to contain asbestos.

Any change in its appearance should be recorded and passed to Property Services.

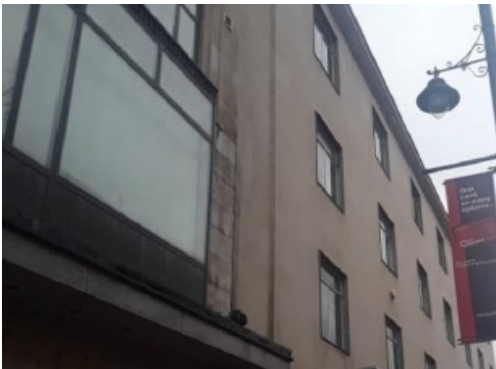
### **Item 54 Ref: NZ000576**

The window putty/seal to glass on the third floor (External) does not contain asbestos.
