ASBESTOS SURVEY REPORT FOR HENDON HEALTH CENTRE, MEABURN TERRACE, SUNDERLAND, SR1 2RN

## Asbestos Register for

**Hendon Health Centre, Meaburn Terrace, Sunderland**

**Date: 19 December 2024**

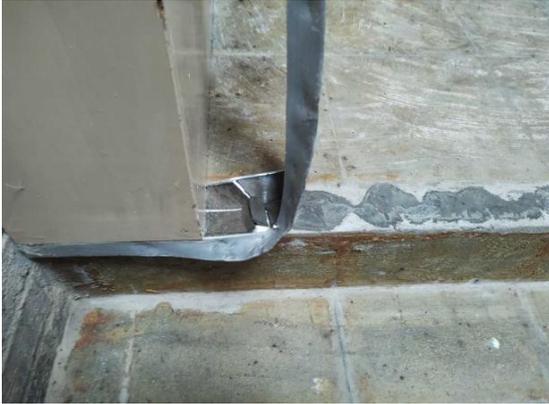
### **Item 1 Ref: 21-40548-1**

- (Item 1) Ref: 21-40548-1 Remaining noising treads to floor (Area 4/Landing and Stairs) – Low Risk
- (Item 2) Ref: 21-40548-2 – Sink pad (Area 20/Kitchen and Cupboard) – No Risk

The remaining noising treats to floor (Area 4/Landing and Stairs) contain asbestos.

Any change in its appearance should be recorded and passed to Property Services.

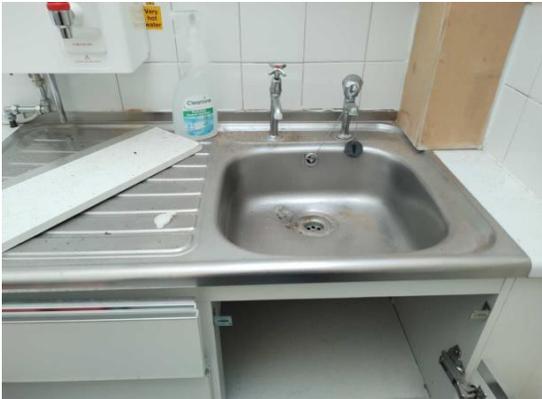
### **Item 2 Ref: 21-40548-2**

The sink pad (Area 20/Kitchen and Cupboard) does not contain asbestos.

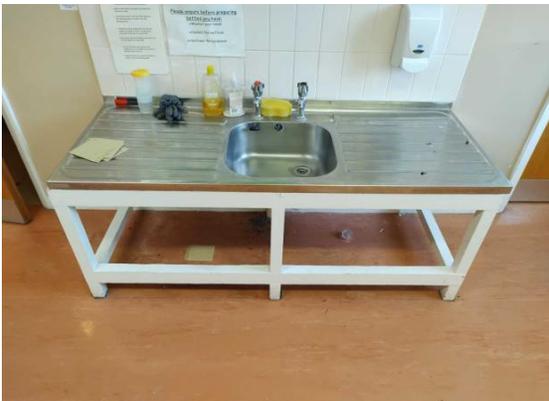
### **Item 3 Ref: 21-40548-3**

The sink pad (Area 22/Playroom) does not contain asbestos.

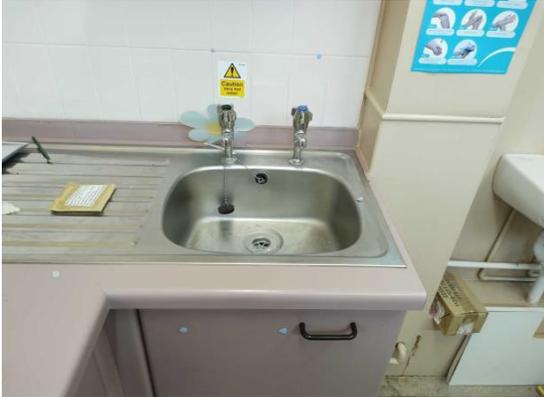
**Item 4 Ref: 21-40548-4**

The sink pad (Area 23/Children's WC) does not contain asbestos.

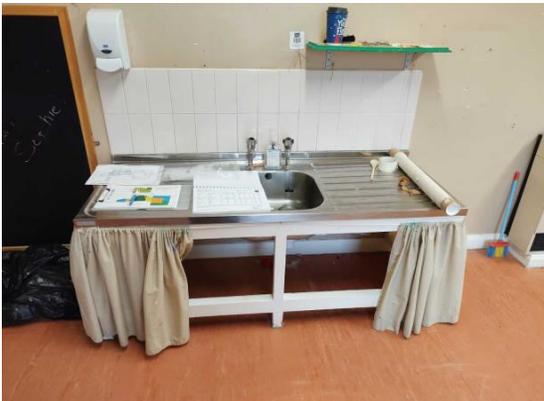
**Item 5 Ref: 21-40548-4**

The sink pad (Area 25/Playroom 2) does not contain asbestos.

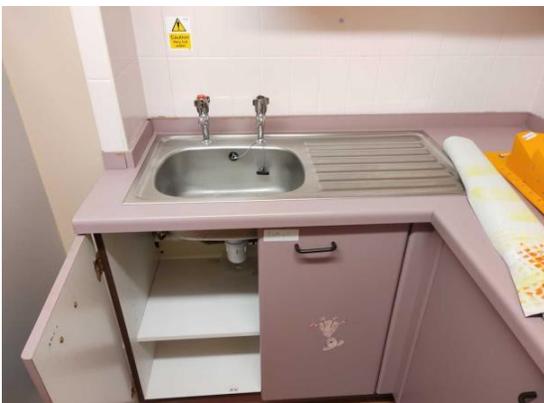
**Item 6 Ref: 21-40548-4**

The sink pad (Area 27/Children's WC 2) does not contain asbestos.

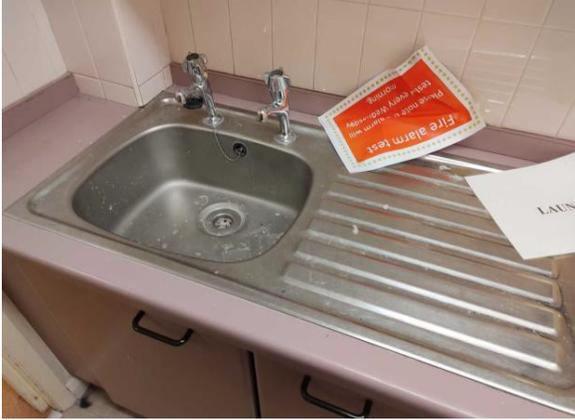
**Item 7 Ref: 21-40548-5**

The sink pad (Area 29/Laundry) does not contain asbestos.

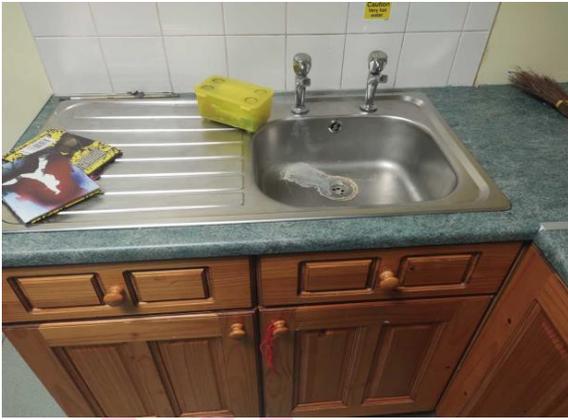
**Item 8 Ref: 21-40548-6**

The sink pad (Area 35/Family Room) does not contain asbestos.

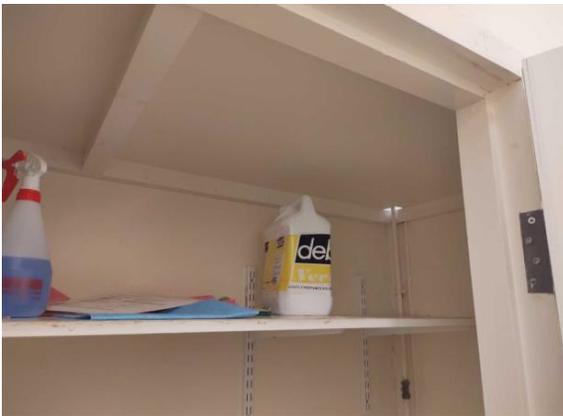
**Item 9 Ref: 21-40548-7**

The cupboard ceiling (Area 42/Male WC and Cupboard) does not contain asbestos.

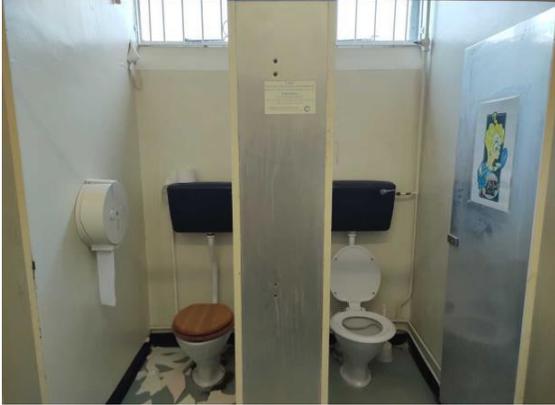
### **Item 10 Ref: 21-40548-8**

The toilet (Area 43/Female WC) does not contain asbestos.

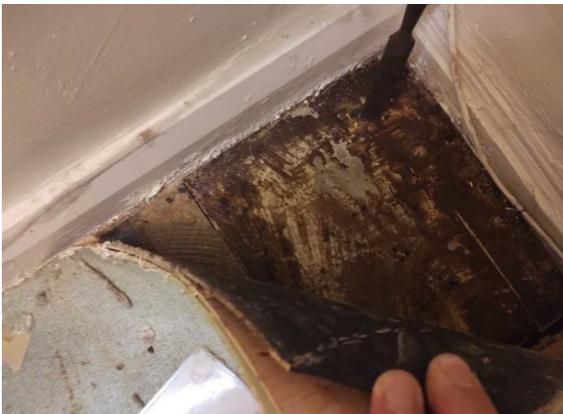
### **Item 11 Ref: 21-40548-9**

The floor tiles and adhesive (Area 44/Store Cupboard) does not contain asbestos.

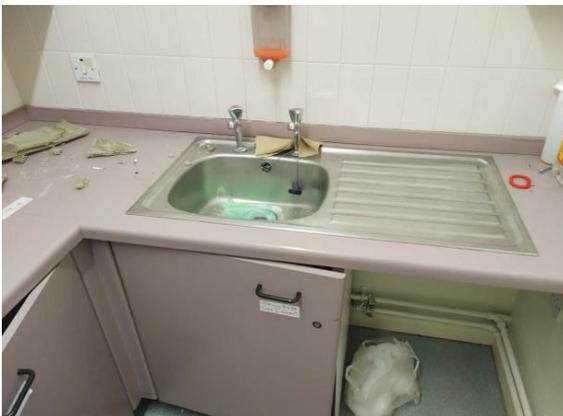
### **Item 12 Ref: 21-40548-10**

The sink pad (Area 48/Kitchen young mums) does not contain asbestos.

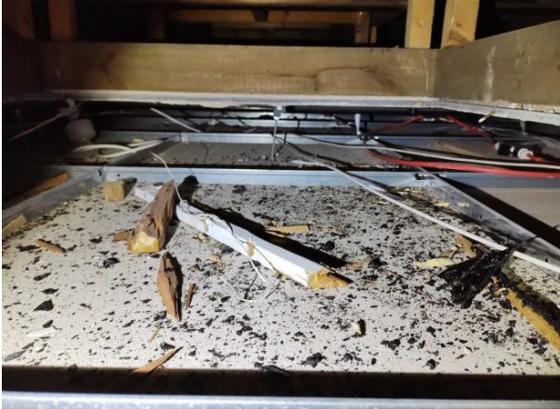
### **Item 13 Ref: 21-40548-11**

The debris to tops of suspended ceiling tiles from flat roof above (Area 56/Cloaks) contains asbestos.

Removed February 2022

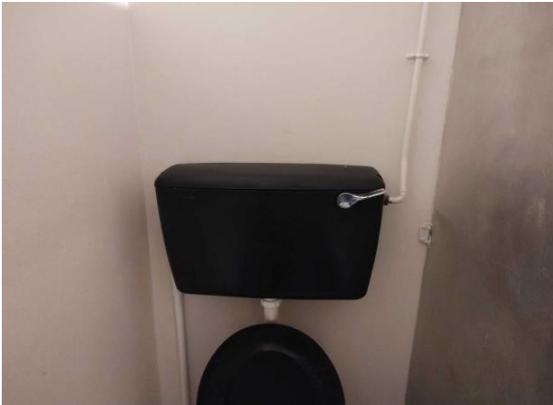
### **Item 14 Ref: 21-40548-8**

The toilet (Area 58/Male WC) does not contain asbestos.

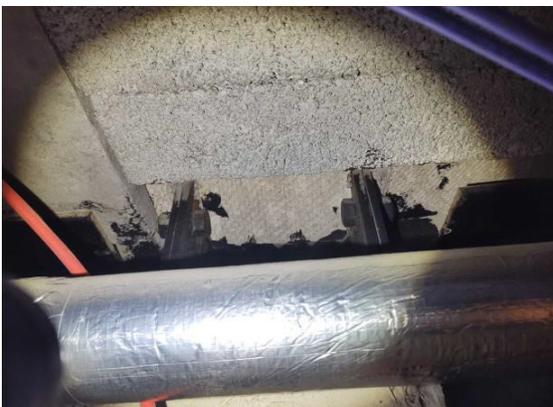
### **Item 15 Ref: Presumed**

The cement shuttering within ceiling void (Area 62/Corridor 2) is presumed to contain asbestos.

Any change in its appearance should be recorded and passed to Property Services.

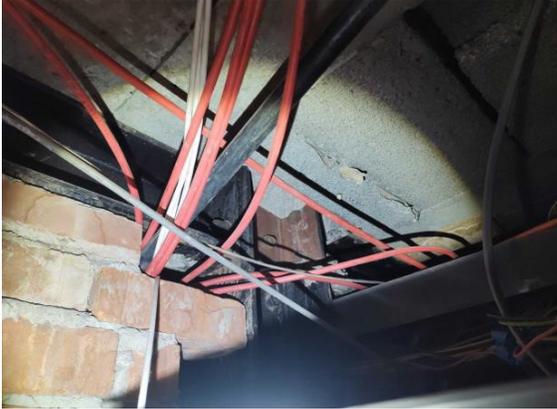
### **Item 16 Ref: Presumed**

The ceiling (Area 64/Main entrance) is presumed to contain asbestos.

Any change in its appearance should be recorded and passed to Property Services.

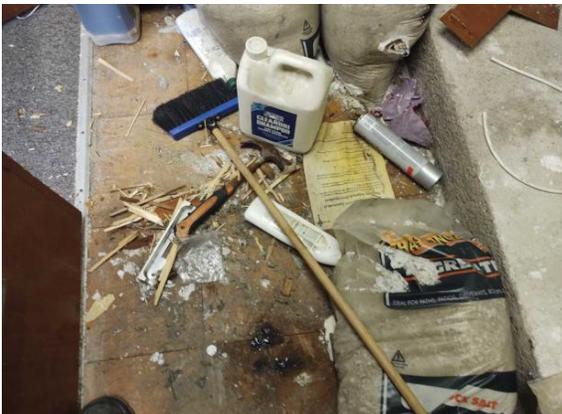
### **Item 17 Ref: 21-40548-13**

The floor tiles and adhesive (Area 65/Switch Room) do not contain asbestos.

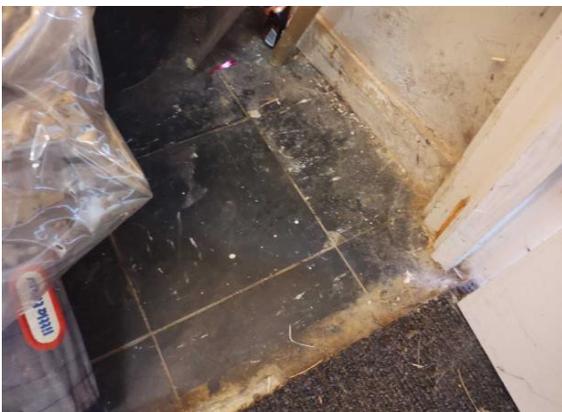
### **Item 18 Ref: 21-40548-14**

The floor tiles and adhesive (Area 66/Main Entrance Store) do not contain asbestos.

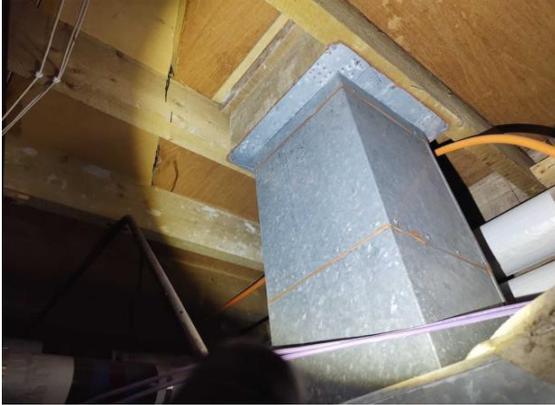
### **Item 19 Ref: 21-40548-15**

The sealant to duct joints (Area 67/Foyer 2 and Cupboard) contains asbestos.

Any change in its appearance should be recorded and passed to Property Services.

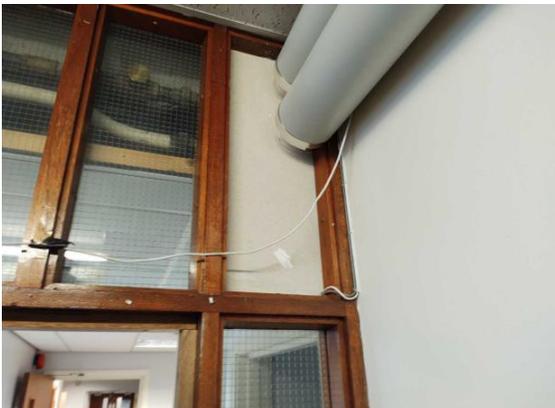
### **Item 20 Ref: 21-40548-16**

The infill panels (Area 73/Stairwell) do not contain asbestos.

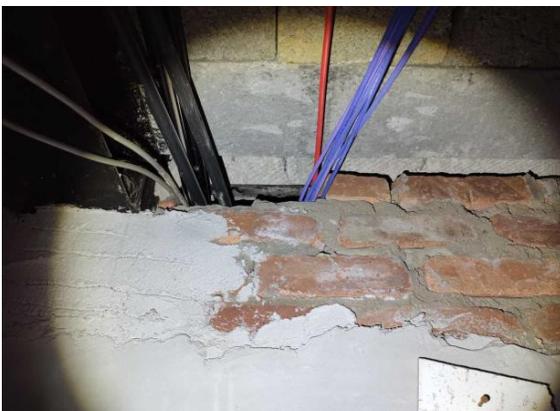
### **Item 21 Ref: Presumed**

The shuttering within ceiling void (Area 75/Corridor 3) is presumed to contain asbestos.

Any change in its appearance should be recorded and passed to Property Services.

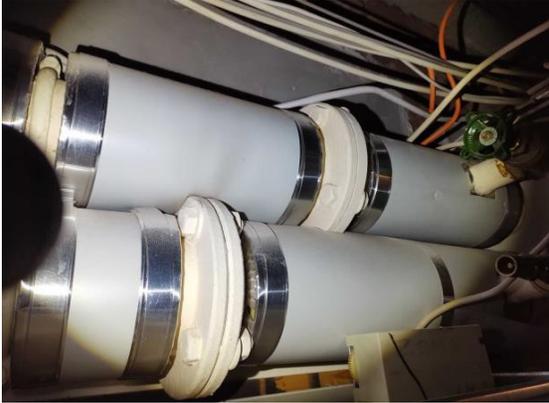
### **Item 22 Ref: Presumed**

The gasket to close coupled pipe flanges (Area 75/Corridor 3) is presumed to contain asbestos.

Any change in its appearance should be recorded and passed to Property Services.

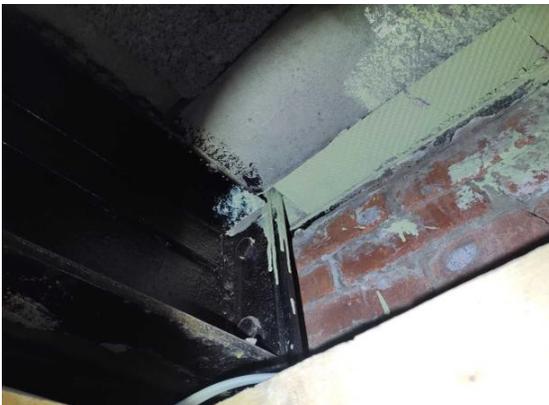
### **Item 23 Ref: Presumed**

The cement shuttering within ceiling void (Area 79/Office 10) is presumed to contain asbestos.

Any change in its appearance should be recorded and passed to Property Services.

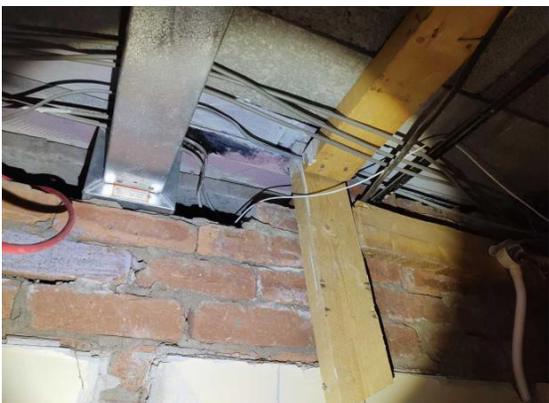
### **Item 24 Ref: Presumed**

The cement shuttering within ceiling void (Area 80/WC accessible) is presumed to contain asbestos.

Any change in its appearance should be recorded and passed to Property Services.

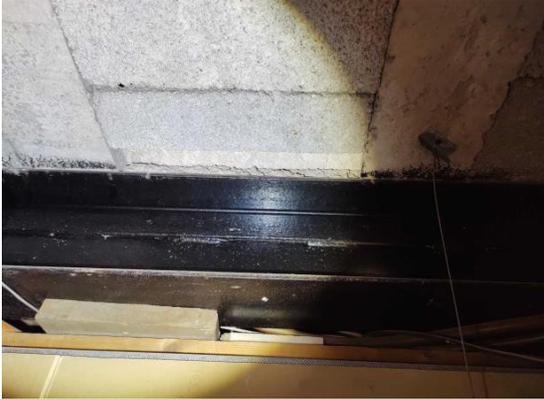
### **Item 25 Ref: Presumed**

The cement shuttering within ceiling void (Area 85/Kitchen 2) is presumed to contain asbestos.

Any change in its appearance should be recorded and passed to Property Services.

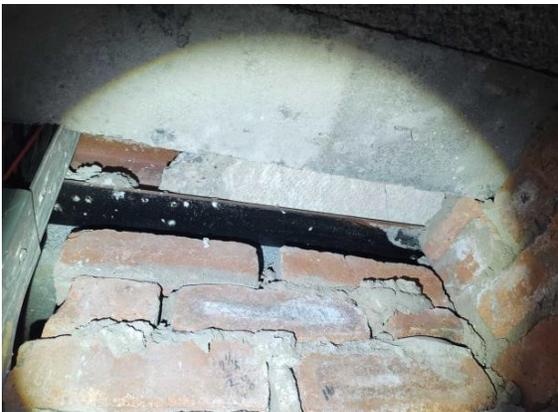
### **Item 26 Ref: Presumed**

The ceiling (Area 88/Office and Cupboard) is presumed to contain asbestos.

Any change in its appearance should be recorded and passed to Property Services.

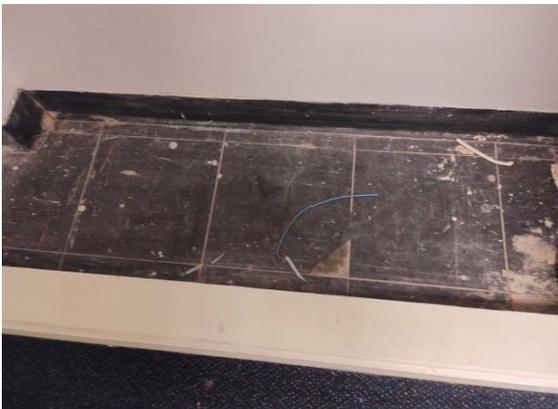
### **Item 27 Ref: 21-40548-14**

The floor tiles and adhesive (Area 88/Office and Cupboard) do not contain asbestos.

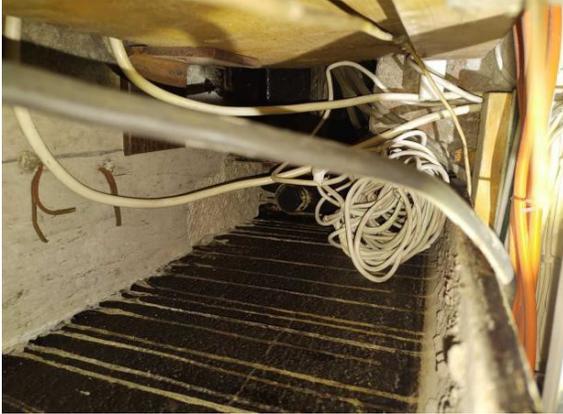
### **Item 28 Ref: Presumed**

The cement shuttering within ceiling void (Area 89/Office 14) is presumed to contain asbestos.

Any change in its appearance should be recorded and passed to Property Services.

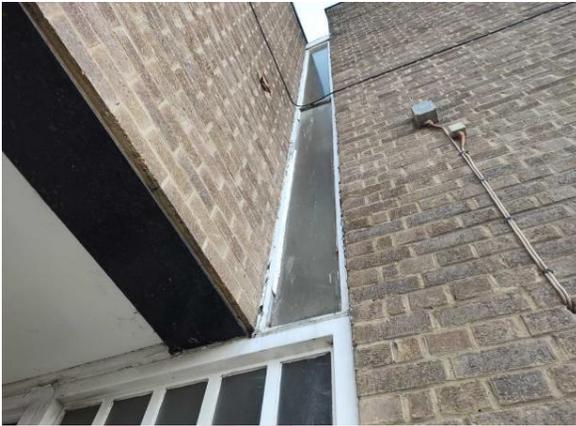
### **Item 29 Ref: 21-40548-18**

The sealant to metal window frames (Area 95/External) contains asbestos.

Any change in its appearance should be recorded and passed to Property Services.

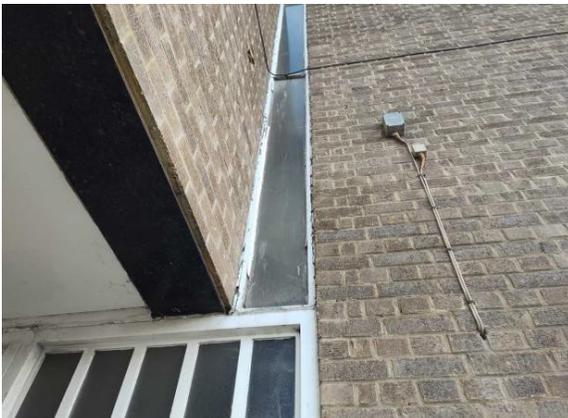
### **Item 30 Ref: 21-40548-19**

The sealant to glazing on metal frames (Area 95/External) contains asbestos.

Any change in its appearance should be recorded and passed to Property Services.

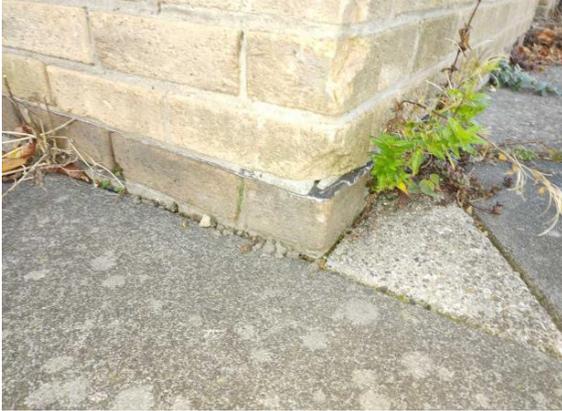
### **Item 31 Ref: 21-40548-20**

The damp proof course (Area 95/External) contains asbestos.

Any change in its appearance should be recorded and passed to Property Services.

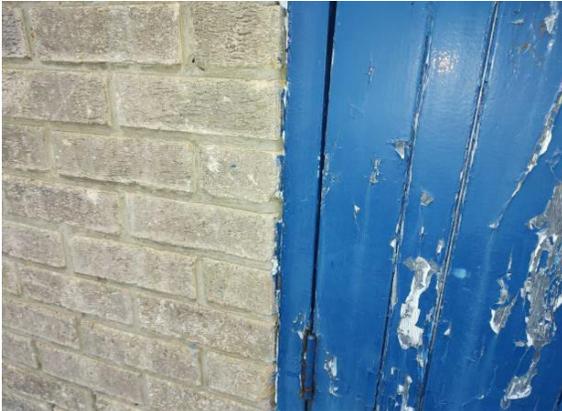
### **Item 32 Ref: 21-40548-21**

The sealant to timber external door frame (Area 95/External) contains asbestos.

Any change in its appearance should be recorded and passed to Property Services.
