ASBESTOS SURVEY REPORT FOR SUNDERLAND CREMATORIUM,  
CHESTER ROAD, SUNDERLAND, SR4 7RS.

## Asbestos Register for

**Sunderland Crematorium, Chester Road, Sunderland,  
SR4 7RS**

**Date: 27 November 2024**

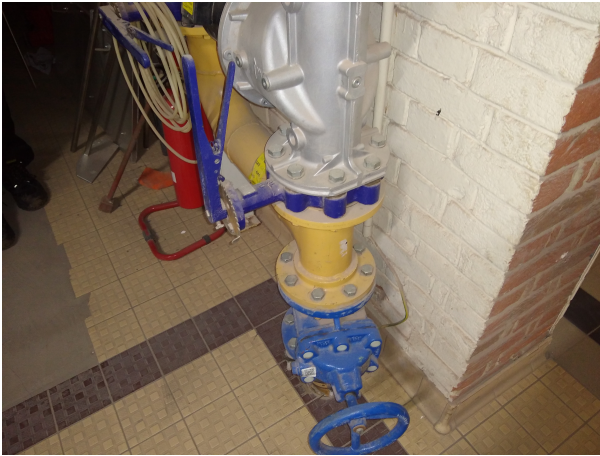
### **Item 1 Ref: As 411588-6**

The pipework flange gasket (0/001/Cremator room 1) does not contain asbestos.

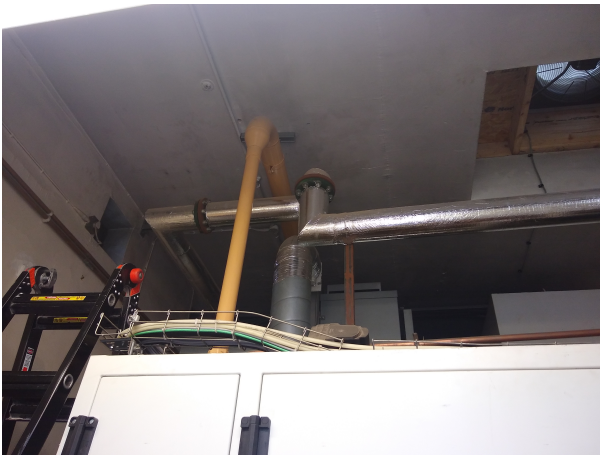
### **Item 2 Ref: 411588-12**

The pipework flange gasket (0/002/Cremator room 2) does not contain asbestos.

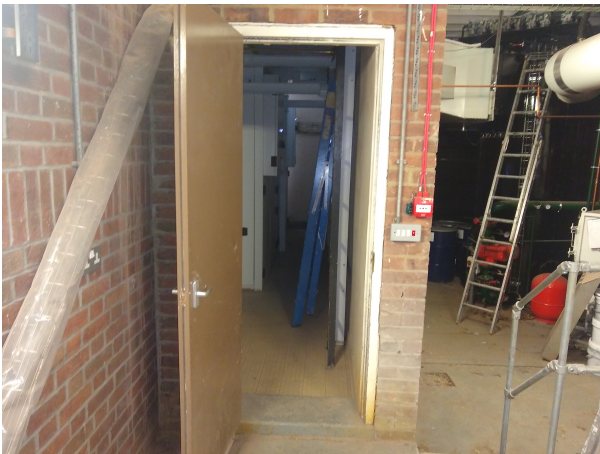
### **Item 3 Ref: 411588-15**

The sealant to door frame (0/003/Plant room containing mercury abatement system) does not contain asbestos.

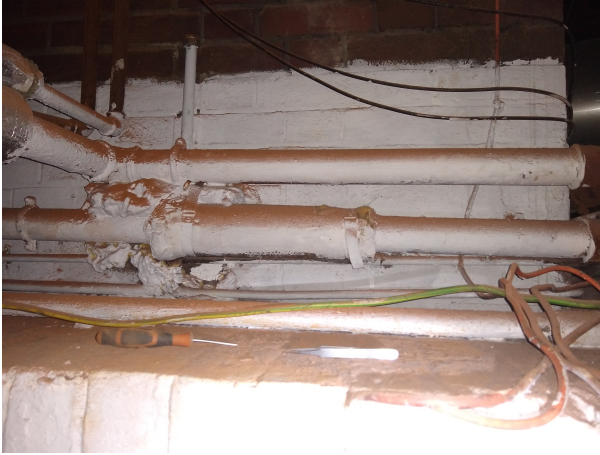
### **Item 4 Ref: 411588-10**

The loose debris behind high level pipework/cable conduits above ledge, partially encapsulated (0/004/Boiler room) contains asbestos.

Removed May 2020.

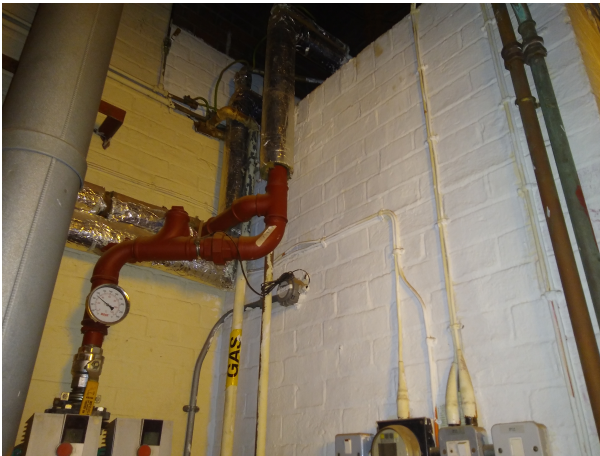
### **Item 5 Ref: 411588-11**

The debris to walls encapsulated (0/004/Boiler room) contain asbestos.

Any change in its appearance should be recorded and passed to Property Services.

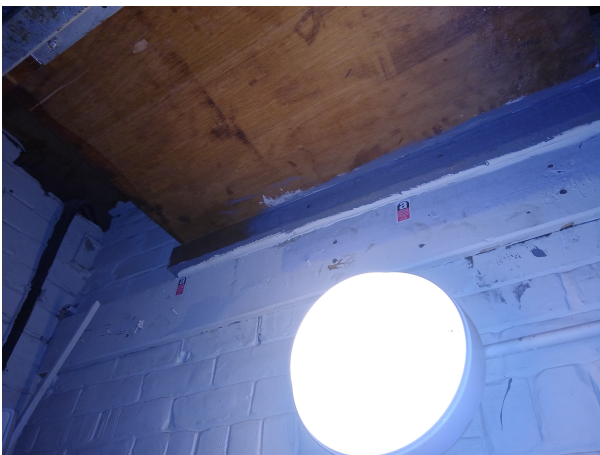
### **Item 6 Ref: Presumed**

The thin fillet above door above wooden fascia (0/004/Boiler Room) is presumed to contain asbestos.

Any change in its appearance should be recorded and passed to Property Services.

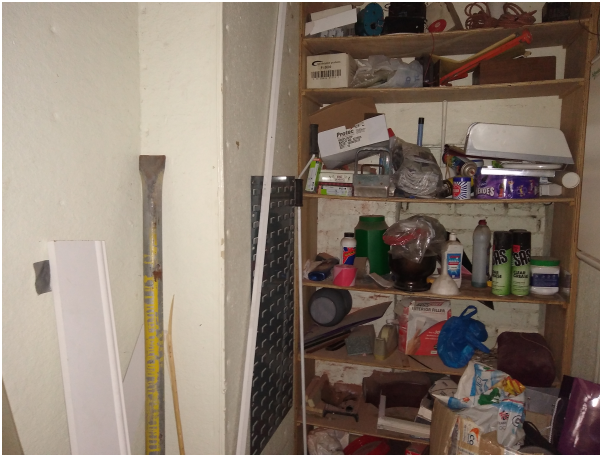
### **Item 7 Ref: 411588-13**

The panels to walls (0/007/Store room) do not contain asbestos.

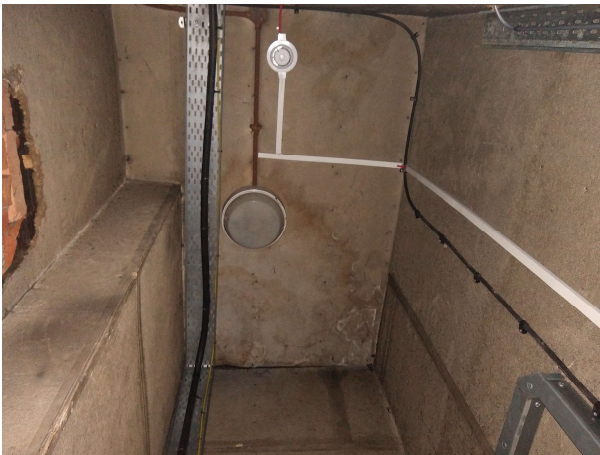
### **Item 8 Ref: As 411588-13**

The panels to ceiling (0/007/Store room) does not contain asbestos.

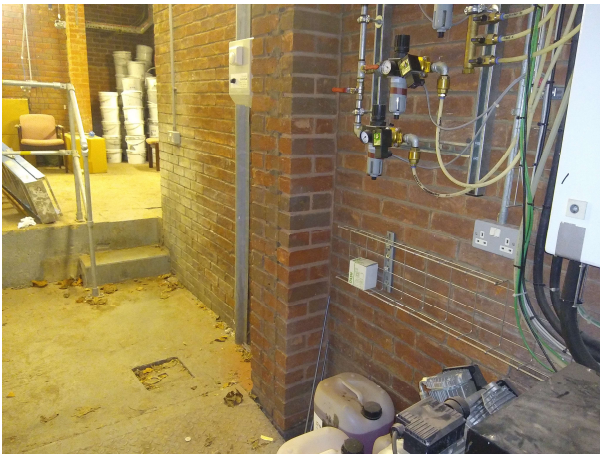
### **Item 9 Ref: 411588-14**

The remnant sealant to brick pillars (0/008/Plant Room) do not contain asbestos.

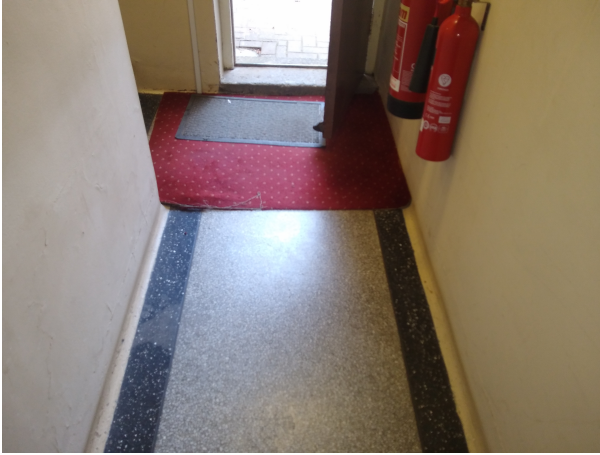
### **Item 10 Ref: 411588-5**

The floor covering (0/009/Corridor) does not contain asbestos.

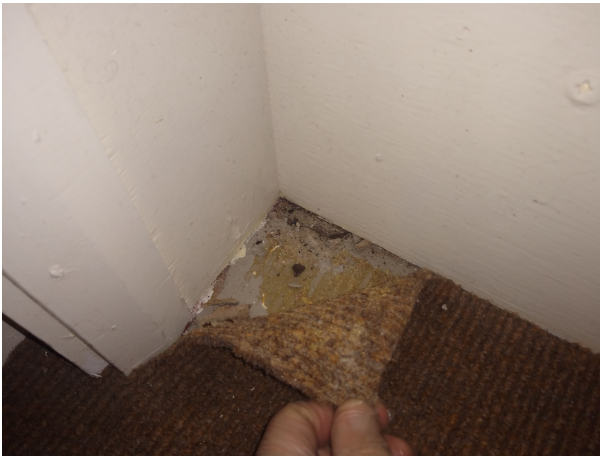
### **Item 11 Ref: 411588-3**

The remnant floor tiles beneath skirting (0/010/Office) contain asbestos.

Any change in its appearance should be recorded and passed to Property Services.

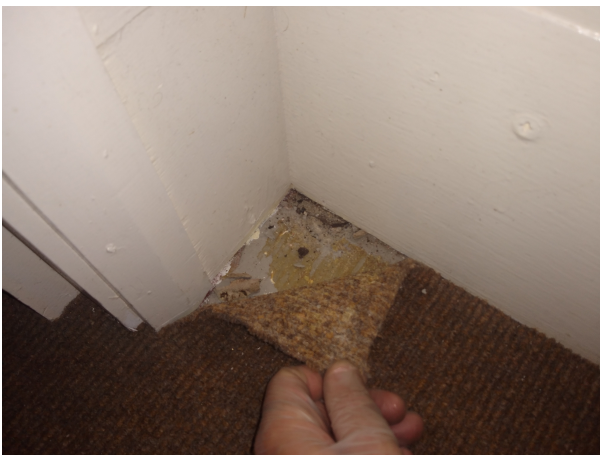
### **Item 12 Ref: 411588-4**

The remnant adhesive to floor beneath screed (0/010/Office) contains asbestos.

Any change in its appearance should be recorded and passed to Property Services.

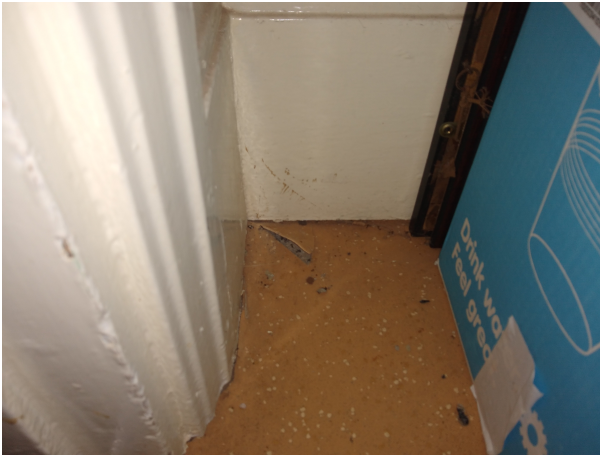
### **Item 13 Ref: 411588-4**

The remnant adhesive to floor beneath screed (0/012/Office store) contains asbestos.

Any change in its appearance should be recorded and passed to Property Services.

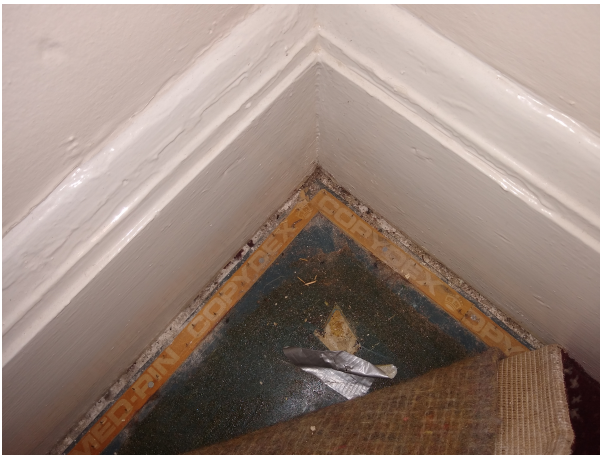
### **Item 14 Ref: 411588-16**

The subfloor (0/017/Waiting room) contains asbestos.

Any change in its appearance should be recorded and passed to Property Services.

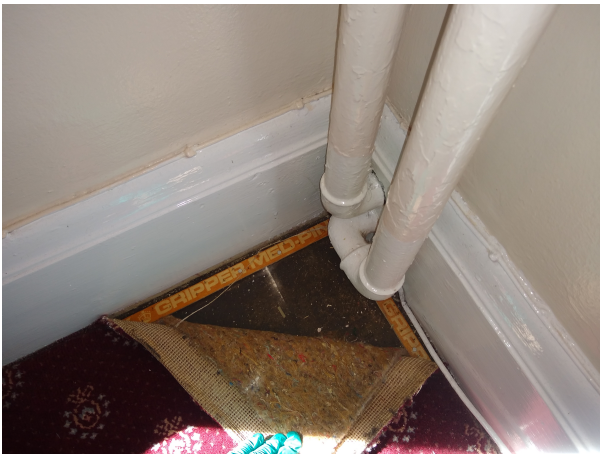
### **Item 15 Ref: As 411588-2**

The subfloor (0/019/Lobby) contains asbestos.

Any change in its appearance should be recorded and passed to Property Services.

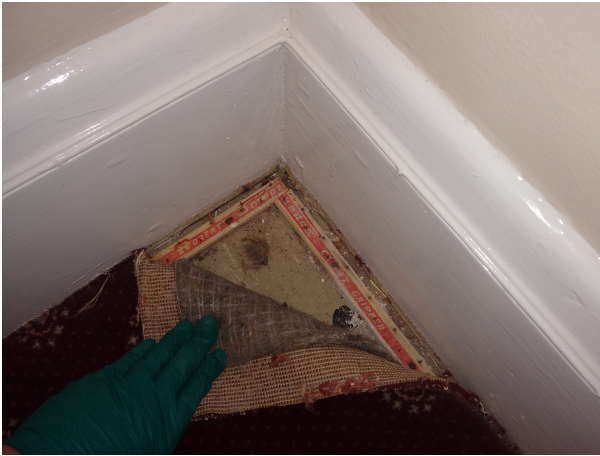
### **Item 16 Ref: 411588-17**

The subfloor (0/21/  
Remembrance corridor)  
contains asbestos.

Any change in its appearance  
should be recorded and  
passed to Property Services.

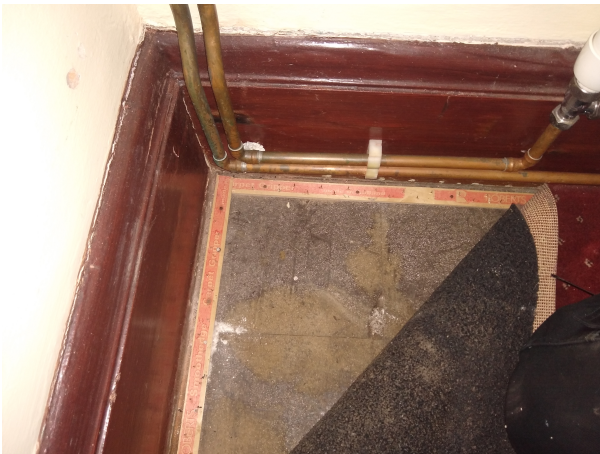
### **Item 18 Ref: 411588-2**

The subfloor (0/025/Lobby)  
contains asbestos.

Any change in its appearance  
should be recorded and  
passed to Property Services.

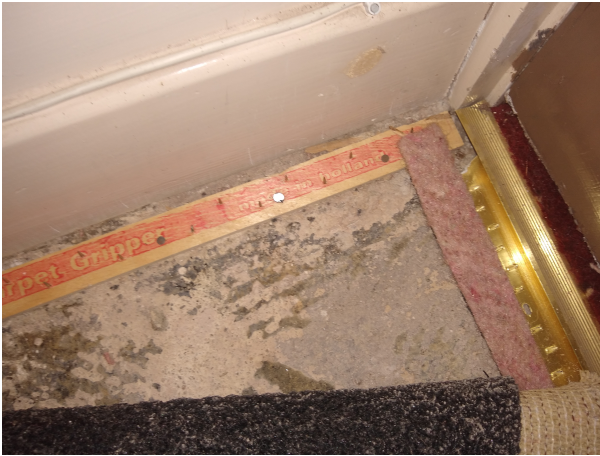
### **Item 19 Ref: As 411588-1**

The remnant adhesive to floor (0/031/Records room) contains asbestos.

Any change in its appearance should be recorded and passed to Property Services.

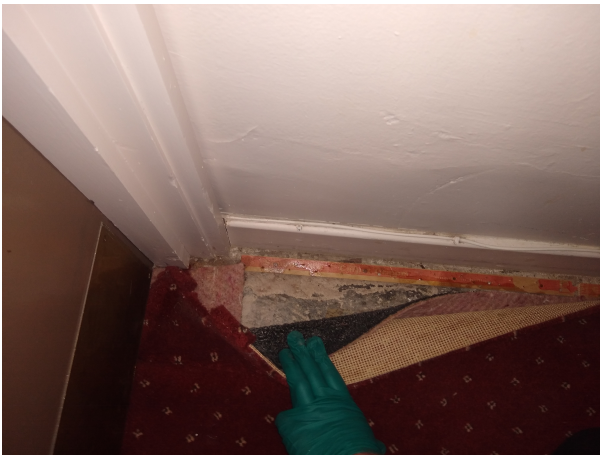
### **Item 20 Ref: As 411588-1**

The remnant adhesive to floor (0/032/Records lobby) contains asbestos.

Any change in its appearance should be recorded and passed to Property Services.

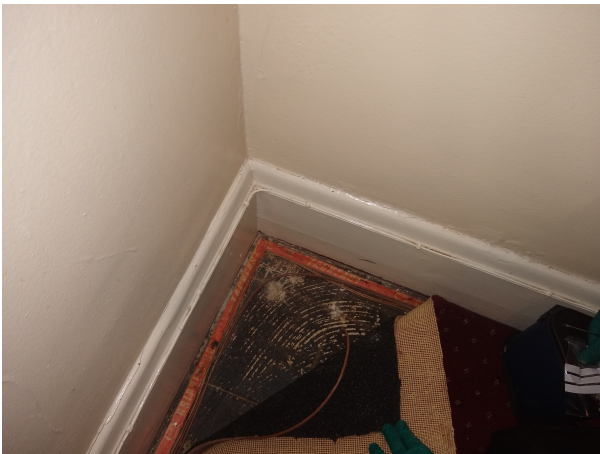
### **Item 21 Ref: 411588-1**

The remnant adhesive to floor (0/033/Lobby) contains asbestos.

Any change in its appearance should be recorded and passed to Property Services.

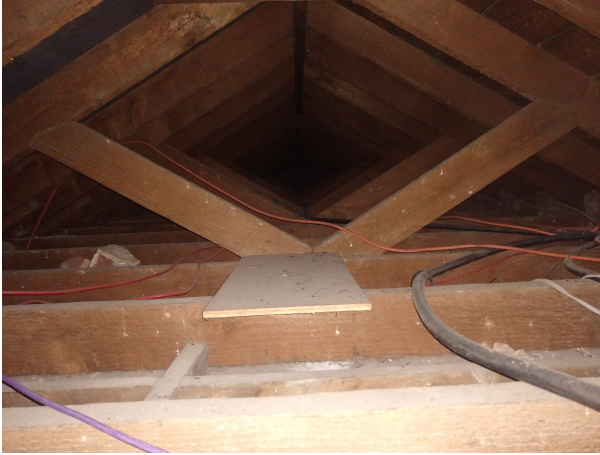
### **Item 22 Ref: 139184-2**

The general debris to top side of ceiling below (1/001/Loft void above lobby 0/033) does not contain asbestos.

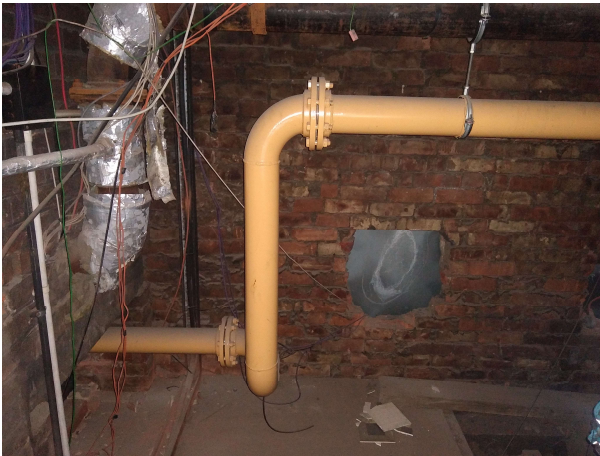
### **Item 23 Ref: 411588-6**

The gas pipework flange gaskets (1/003/loft void) does not contain asbestos.

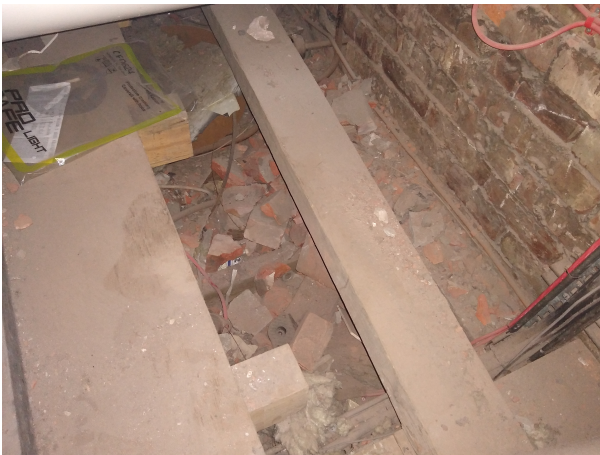
### **Item 24 Ref: 411588-7**

The remnant floor beneath timber flooring (1/003/loft void) contains asbestos.

Any change in its appearance should be recorded and passed to Property Services.

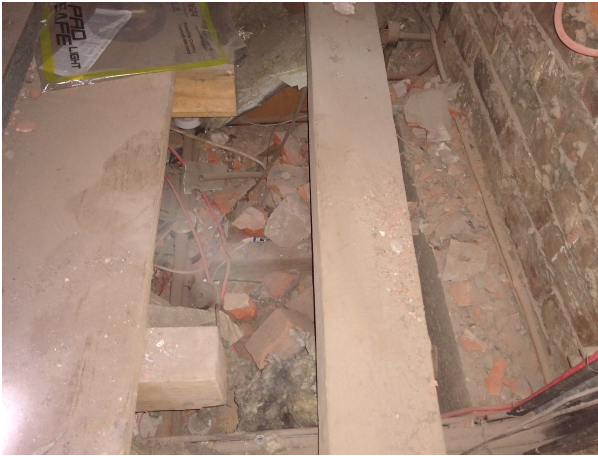
### **Item 25 Ref: 411588-8**

The debris beneath timber floor (1/003/loft void) contains asbestos.

Any change in its appearance should be recorded and passed to Property Services.

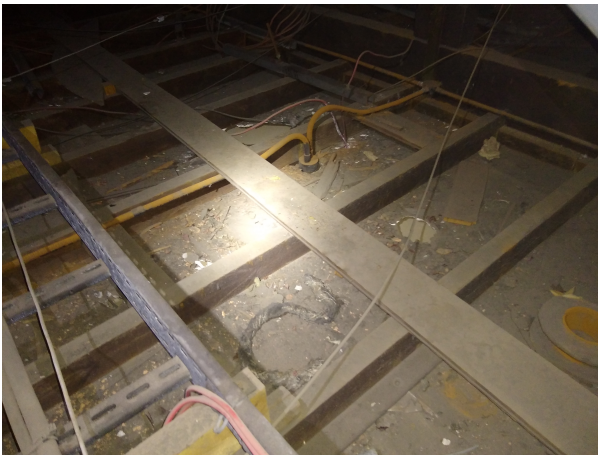
### **Item 26 Ref: 411588-9**

The debris to top side of ceiling below 0/005 (1/003/loft void) contains asbestos.

Any change in its appearance should be recorded and passed to Property Services.

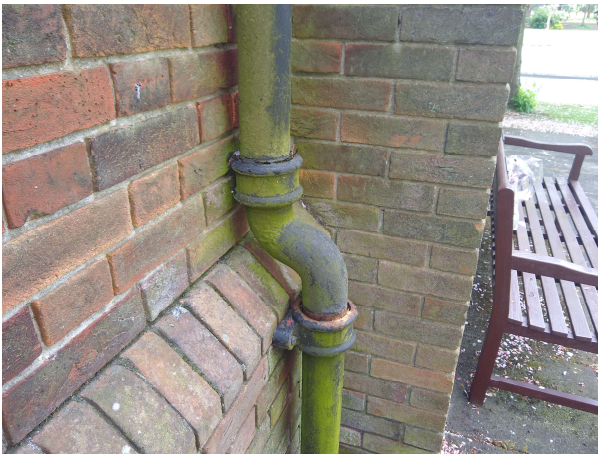
### **Item 27 Ref: 411588-19**

The sealant to downpipe collars (External) does not contain asbestos.

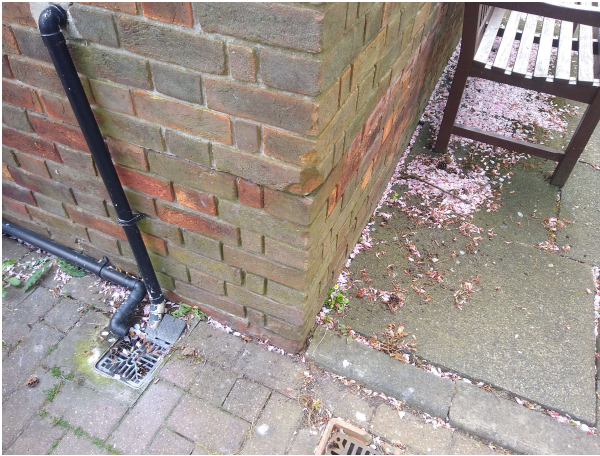
### **Item 28 Ref: 411588-20**

The damp proof course  
(External) contains asbestos.

Any change in its appearance  
should be recorded and  
passed to Property Services.

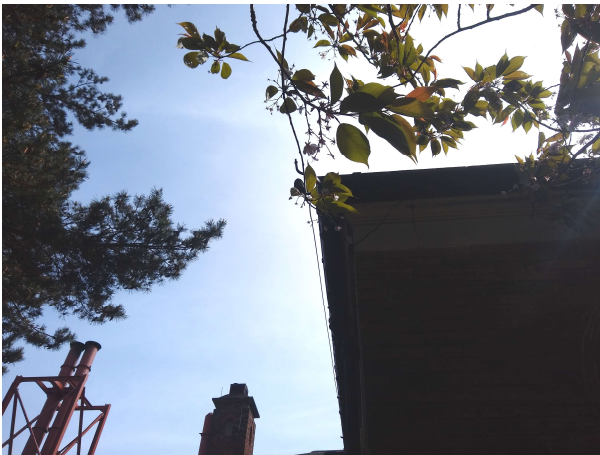
### **Item 29 Ref: 411588-21**

The telephone insulator  
(External) contains asbestos.

Any change in its appearance  
should be recorded and  
passed to Property Services.

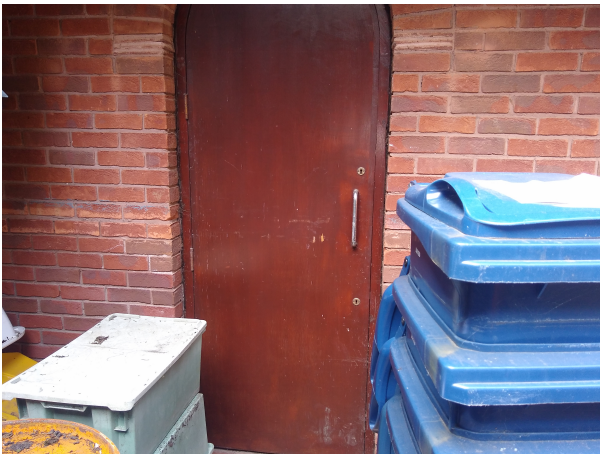
### **Item 30 Ref: 411588-22**

The sealant to door frame  
0/011 (External) does not  
contain asbestos.

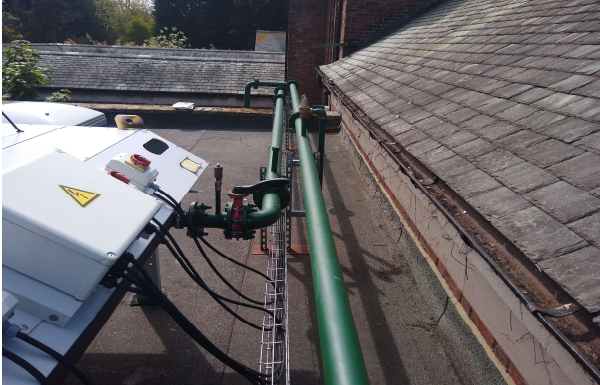
### **Item 31 Ref: 411588-22**

The pipework flange gaskets to flat roof top (External) does not contain asbestos.

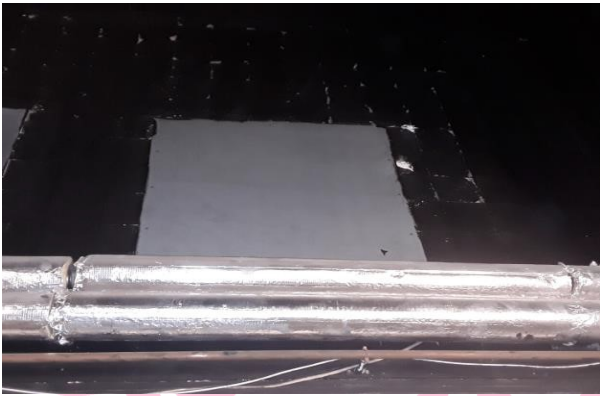
### **Item 32 Ref: 20-28162-1**

The walls (tiles & adhesive) in the Cremator Room do not contain asbestos.

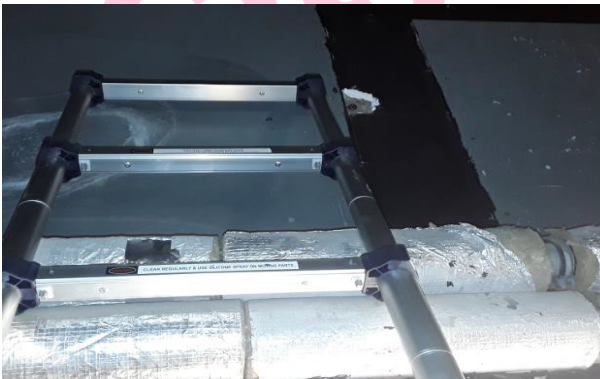
### **Item 33 Ref: 20-28162-2**

The walls (tiles & adhesive) in the Cremator Room do not contain asbestos.

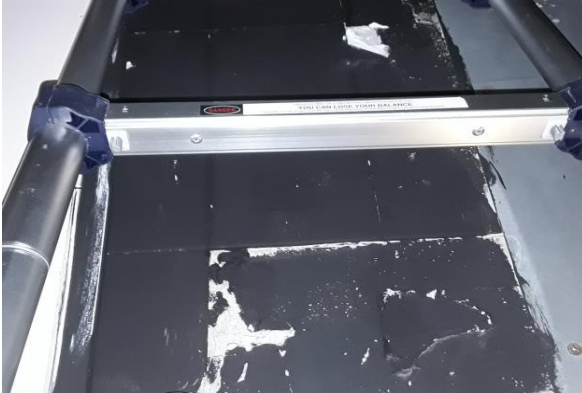
### **Item 34 Ref: 20-28162-3**

The walls (tiles & adhesive) in the Cremator Room do not contain asbestos.

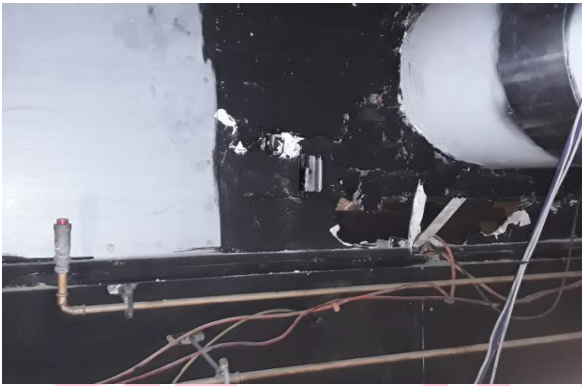
### **Item 35 Ref: 20-28162-4**

The walls (plaster) in the Cremator Room do not contain asbestos.

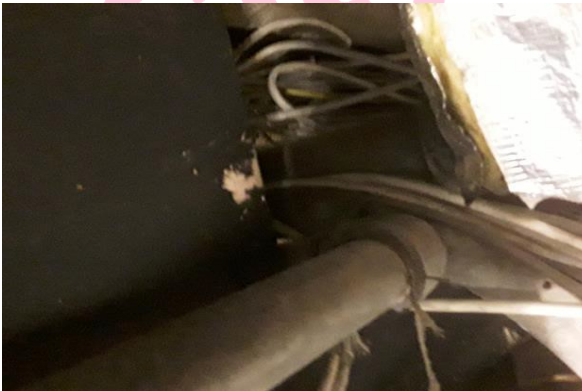
### **Item 36 Ref: 20-28162-5**

The walls – cable tray intrusion (debris) in the Cremator Room does not contain asbestos.

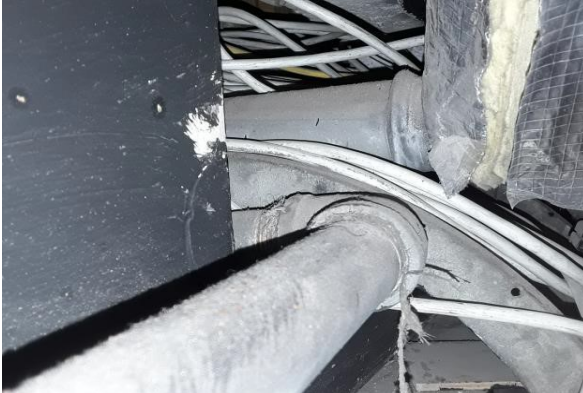
**Item 37 Ref: 20-28162-5**

The walls – cable tray intrusion (debris) in the Cremator Room does not contain asbestos.
