ASBESTOS SURVEY REPORT FOR 20 VILLIERS STREET, SUNDERLAND, SR1 1EJ

## *Control of Asbestos Regulations 2012*

**20 Villiers Street, Sunderland, SR1 1EJ**

**Date: 17 October 2024**

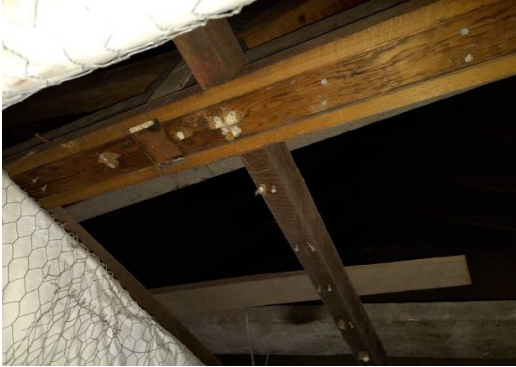
### **Item 1 Ref: 22-53656-1**

The ceiling – fibre board  
(Room/Area: 1 Loft Space)  
does not contain asbestos.

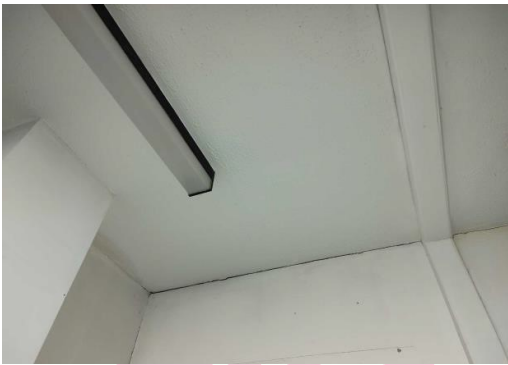
### **Item 2 Ref: 22-53656-2**

The ceiling – textured coating  
(Room/Area: 2 Studio)  
does not contain asbestos.

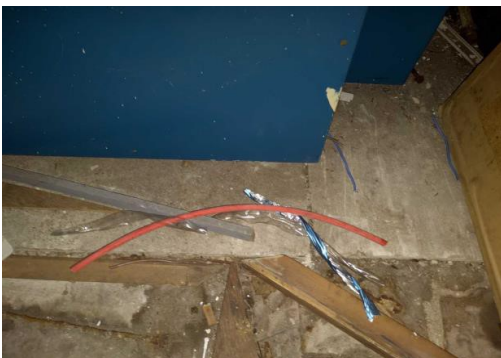
### **Item 3 Ref: 22-53656-3**

The floor – insulating board  
(Room/Area: 3 Boiler  
Cupboard)  
does not contain  
asbestos.

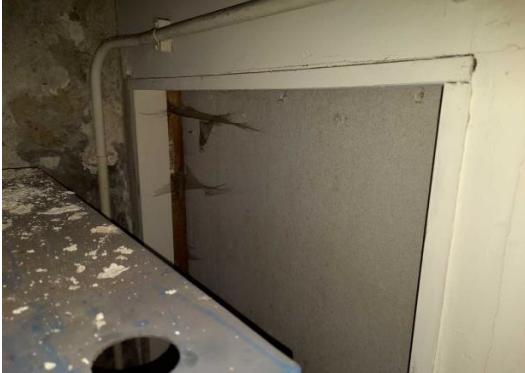
**Item 4 Ref: 22-53656-3**

The floor – infill panels  
(Room/Area: 3 Boiler  
Cupboard) does not contain  
asbestos.

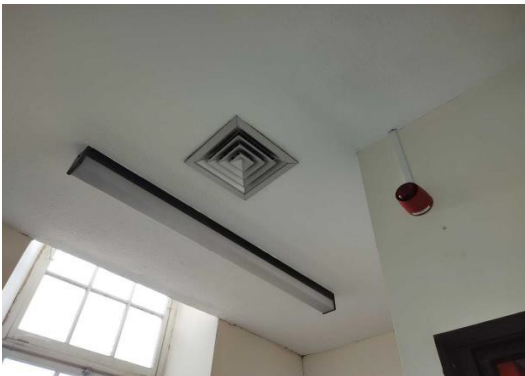
**Item 5 Ref: 22-53656-2**

The ceiling – textured coating  
(Room/Area: 4 WC & Lobby)  
does not contain asbestos.

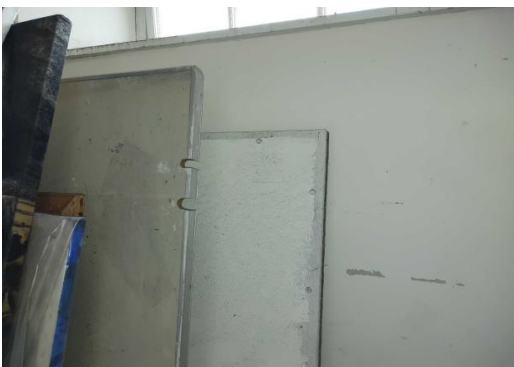
**Item 6 Ref: 22-53656-3**

The panel – insulating board  
(Room/Area: 4 WC & Lobby)  
does not contain asbestos.

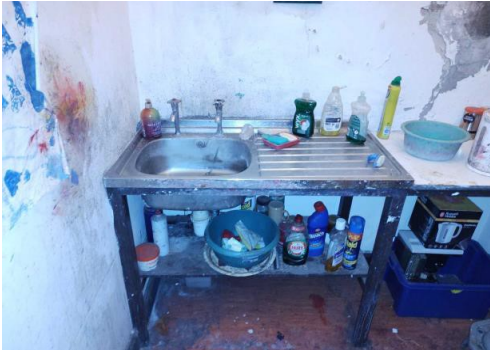
**Item 7 Ref: 22-53656-4**

5.	22-53656-2	Ceiling – textured coating	Room/Area: 4 WC & Lobby	No Risk
6.	22-53656-3	Panel – insulating board	Room/Area: 4 WC & Lobby	No Risk
7.	22-53656-4	Sink Pad – bitumen	Room/Area: 5 Beverage Bay	Low Risk – To be checked every 6 months

The sink pad – bitumen  
(Room/Area: 5 Beverage Bay)  
contains asbestos.

Any change in its appearance  
should be recorded and  
passed to Property Services.

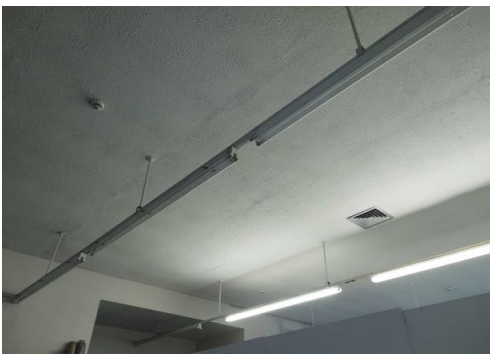
**Item 8 Ref: 22-53656-2**

The ceiling – textured coating  
(Room/Area: 8 Main Studio)  
does not contain asbestos.

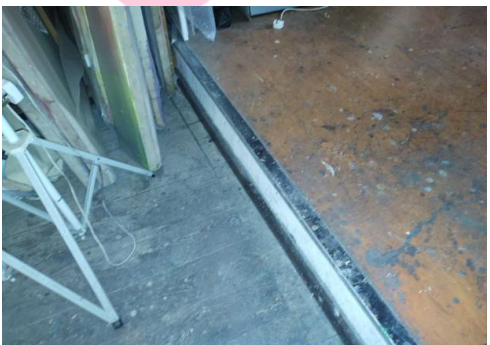
**Item 9 Ref: 22-53656-5**

The floor – composite  
(Room/Area: 8 Main Studio)  
does not contain asbestos.

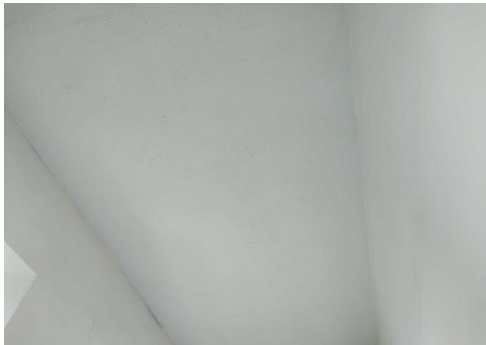
**Item 10 Ref: 22-53656-2**

The ceiling – textured coating (Room/Area: 9 Landing & Stairs) does not contain asbestos.

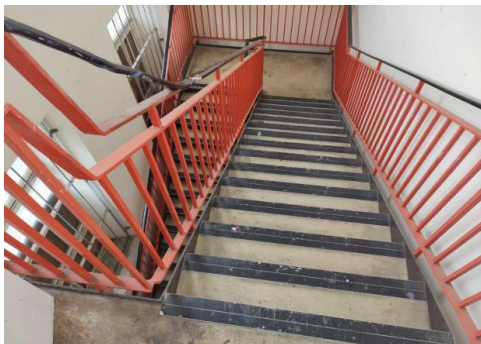
**Item 11 Ref: 22-53656-6**

The floor – stair nosing composite (Room/Area: 9 Landing & Stairs) does not contain asbestos.

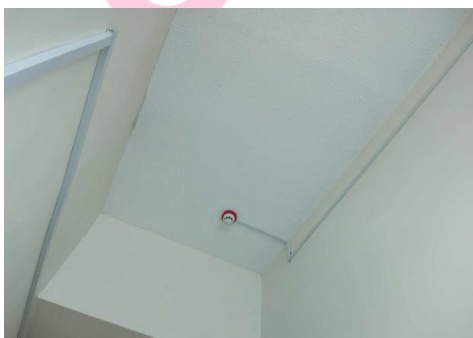
**Item 12 Ref: 22-53656-7**

The ceiling – textured coating (Room/Area: 11 Entrance Hall) does not contain asbestos.

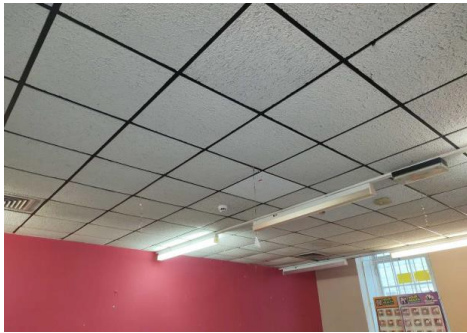
**Item 13 Ref: 22-53656-8**

The ceiling - suspended ceiling tiles insulating board (Room/Area: 12 Large Storeroom 1) does not contain asbestos.

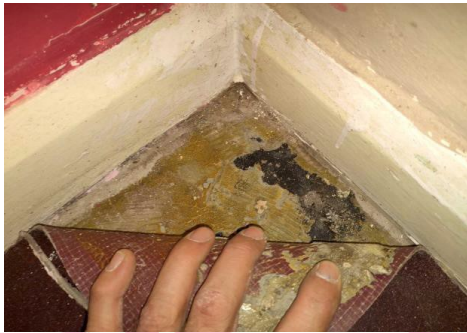
**Item 14 Ref: 22-53656-9**

The floor – asphalt bitumen (Room/Area: 12 Large Storeroom 1) does not contain asbestos.

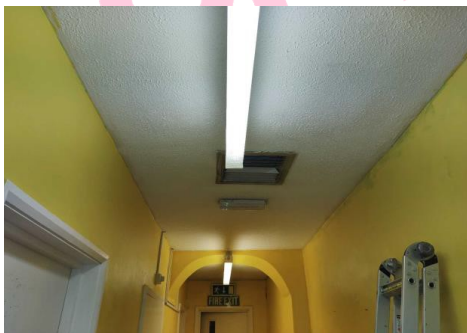
**Item 15 Ref: 22-53656-7**

The ceiling – textured coating (Room/Area: 15 Corridor) does not contain asbestos.

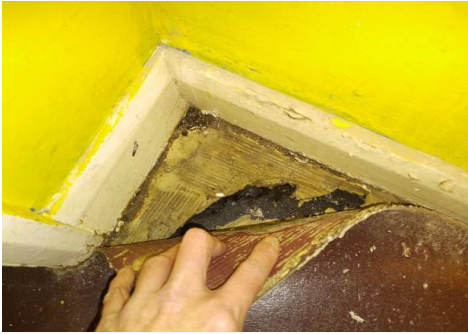
**Item 16 Ref: 22-53656-9**

The floor – asphalt bitumen  
(Room/Area: 15 Corridor)  
does not contain asbestos.

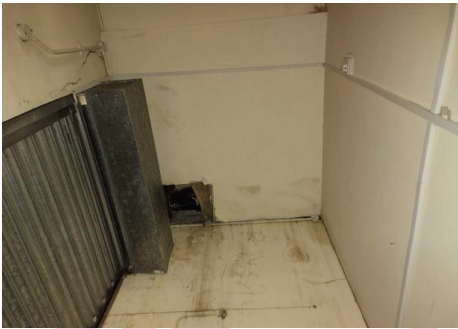
**Item 17 Ref: 22-53656-7**

The ceiling – textured coating  
(Room/Area: 16 Fire Exit)  
does not contain asbestos.

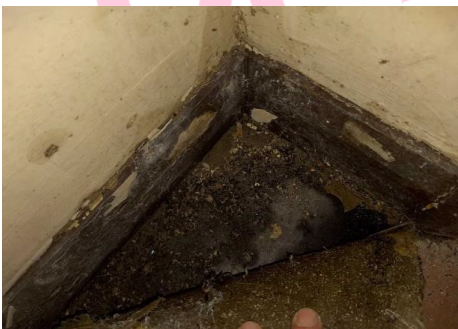
**Item 18 Ref: 22-53656-9**

The floor – asphalt bitumen  
(Room/Area: 16 Fire Exit)  
does not contain asbestos.

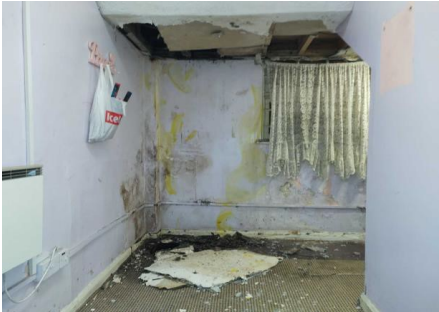
### **Item 19 Ref: 22-53656-10**

The ceiling – textured coating ceiling & debris to floor (textured coating) (Room/Area: 17 First Aid Room) does not contain asbestos.

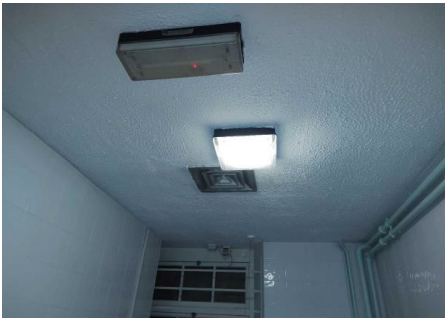
### **Item 20 Ref: 22-53656-7**

The ceiling – textured coating (Room/Area: 18 Accessible WC) does not contain asbestos.

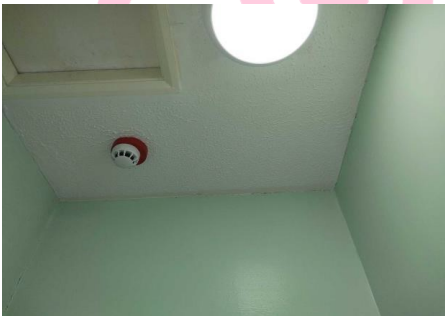
### **Item 21 Ref: 22-53656-7**

The ceiling – textured coating (Room/Area: 19 Female WC) does not contain asbestos.

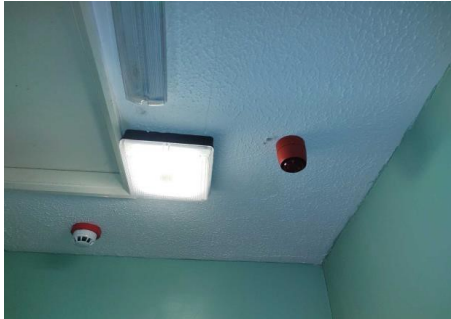
**Item 22 Ref: 22-53656-7**

The ceiling – textured coating (Room/Area: 21 Male WC & Lobby) does not contain asbestos.

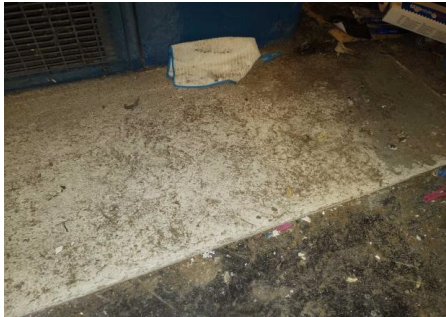
**Item 23 Ref: 22-53656-3**

The floor – insulating board (Room/Area: 23 Boiler Cupboard) does not contain asbestos.

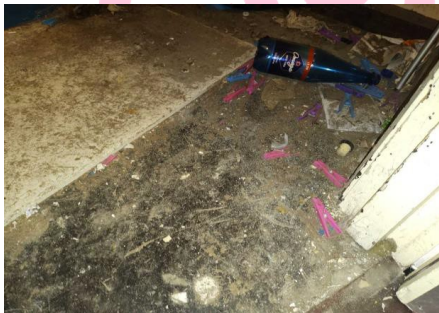
**Item 24 Ref: 22-53656-9**

The floor – asphalt bitumen (Room/Area: 23 Boiler Cupboard) does not contain asbestos.

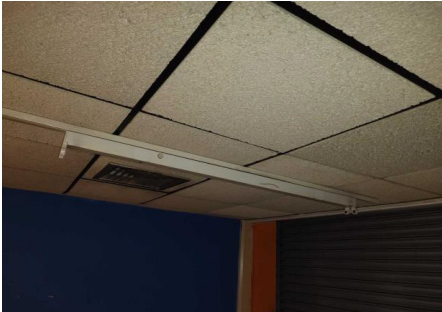
### **Item 25 Ref: 22-53656-8**

The ceiling – suspended ceiling tiles insulating board (Room/Area: 24 Storage Room 2) does not contain asbestos.

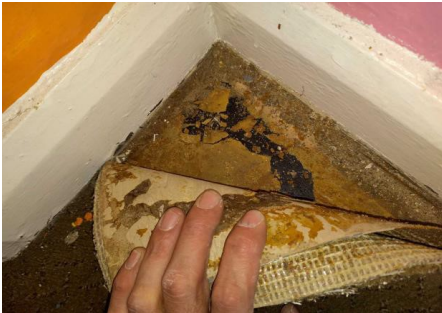
### **Item 26 Ref: 22-53656-9**

The floor – asphalt bitumen (Room/Area: 24 Storage Room 2) does not contain asbestos.

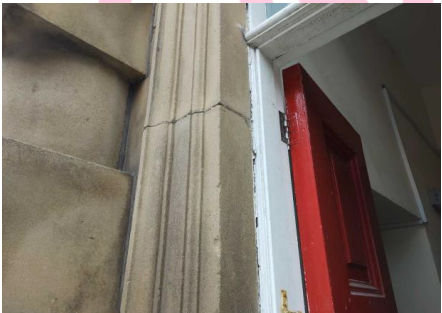
### **Item 27 Ref: 22-53656-11**

The door – frame sealant mastic (Room/Area: 25 External) does not contain asbestos.

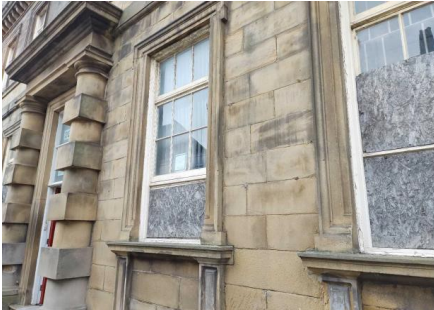
**Item 28 Ref: 22-53656-12**

The windows – frame sealant mastic (Room/Area: 25 External) contains asbestos.

Any change in its appearance should be recorded and passed to Property Services.

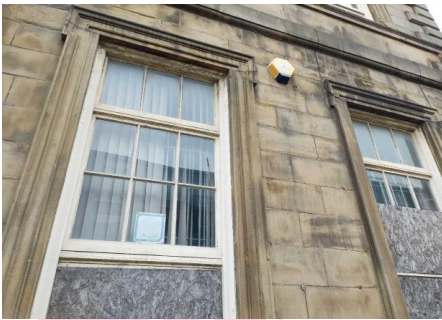
**Item 29 Ref: 22-53656-13**

The windows – glazing putty (Room/Area: 25 External) does not contain asbestos.
