ASBESTOS SURVEY REPORT FOR ILLUSIONS NIGHTCLUB, 43  
HOLMESIDE, SUNDERLAND SR1 3JE

### **Asbestos Register for Illusions Nightclub, 43 Holmeside, Sunderland, SR1 3JE**

**Date: 17 November 2022**

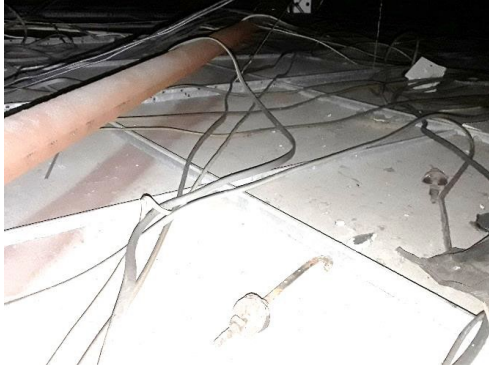
### **Item 1 Ref: 20-28415-10**

- (Item 1) Ref: 20-28415-10 – Ceiling – debris to the rear of suspended ceiling tiles & metal ducting (cement) (Area 3 ceiling void 1) – Low Risk
- (Item 2) Ref: 20-28415-11 – Ceiling – debris to the rear of suspended ceiling tiles & metal ducting (cement) (Area 3 ceiling void 1) – Low Risk

The ceiling – debris to the rear of suspended ceiling tiles & metal ducting (cement) in Area 3 ceiling void 1 contains asbestos.

Any change in its appearance should be recorded and passed to Property Services.

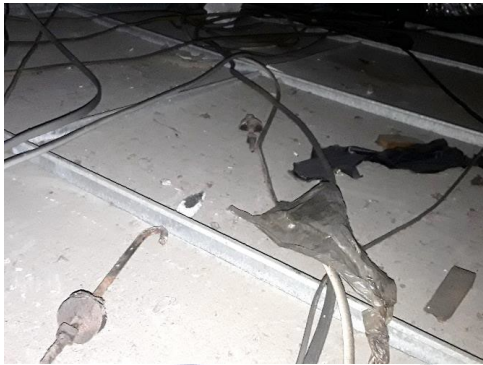
### **Item 2 Ref: 20-28415-11**

The ceiling – debris to the rear of suspended ceiling tiles & metal ducting (cement) in Area 3 ceiling void 1 contains asbestos.

Any change in its appearance should be recorded and passed to Property Services.

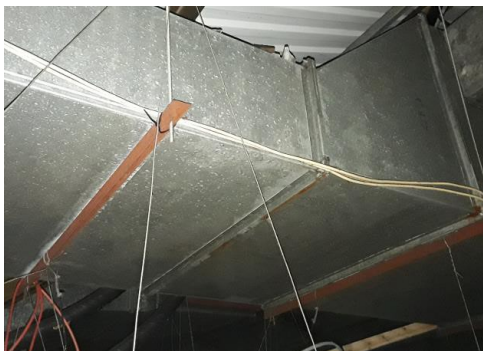
### **Item 3 Ref: 20-28415-12**

The vessels – metal ducting (mastic) in Area 3 ceiling void 1 does not contain asbestos.

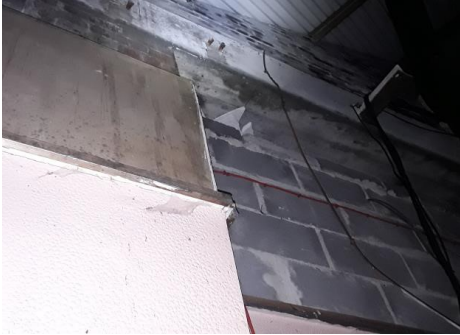
### **Item 4 Ref: 20-28415-13**

- (Item 3) Ref: 20-28415-12 – Vessels – metal ducting (mastic) (Area 3 ceiling void) – No Risk
- (Item 4) Ref: 20-28415-13 – Walls – packing to concrete pillar (insulation board) (Area 3 ceiling void 1) – Low Risk

The walls – packing to concrete pillar (insulation board) in Area 3 ceiling void 1 contain asbestos.

Any change in its appearance should be recorded and passed to Property Services.

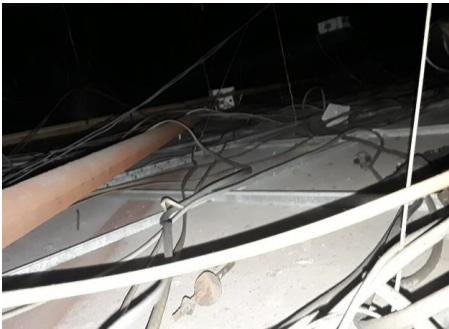
### **Item 5 Ref: 20-28415-13**

The floor – washer debris (bitumen) in Area 3 ceiling void 1 does not contain asbestos.

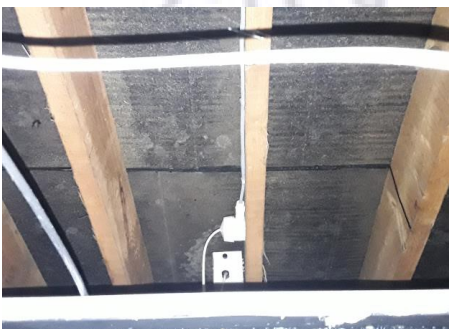
### **Item 6 Ref: 20-28415-23**

The ceiling – jointing compound between wood, weyroc deck below offices (Bitumen) in Area 3 ceiling void 1 does not contain asbestos.

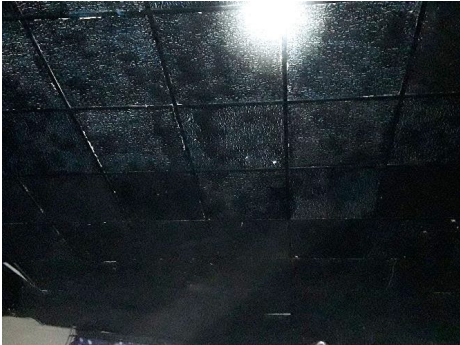
### **Item 7 Ref: 20-28415-4**

The ceiling (insulating board) in Area 3 ceiling void 1 does not contain asbestos.

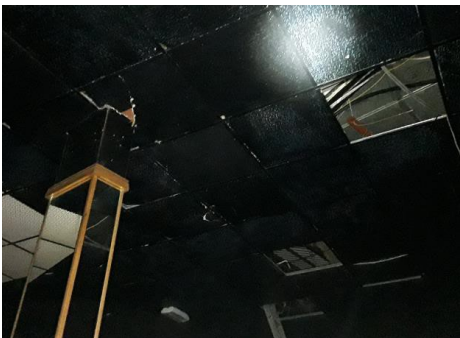
### **Item 8 Ref: 20-28415-6**

The ceiling (insulating board) in Area 3 ceiling void 1 does not contain asbestos.

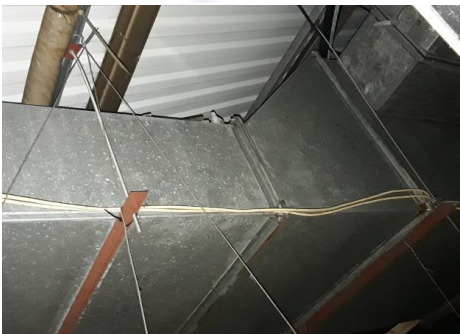
### **Item 9 Ref: 20-28415-7**

The ceiling – debris to the rear of suspended ceiling tiles & metal ducting (cement) in Area 3 ceiling void 1 contains asbestos.

Any change in its appearance should be recorded and passed to Property Services.

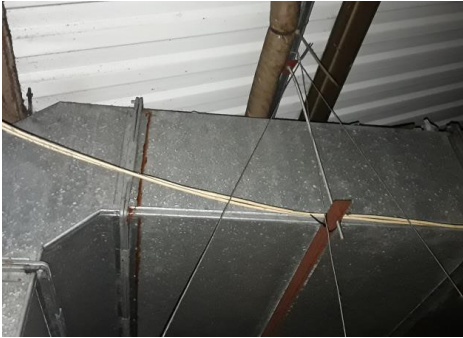
### **Item 10 Ref: 20-28415-8**

The ceiling – debris to the rear of suspended ceiling tiles & metal ducting (cement) in Area 3 ceiling void 1 contains asbestos.

Any change in its appearance should be recorded and passed to Property Services.

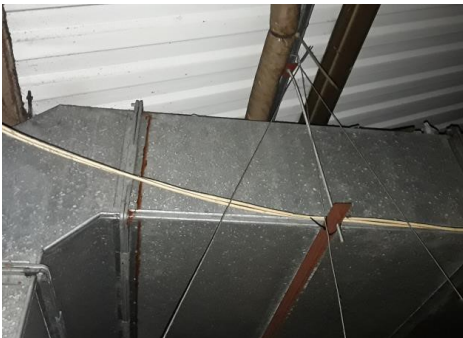
### **Item 11 Ref: 20-28415-9**

The ceiling – debris to the rear of suspended ceiling tiles & metal ducting (cement) in Area 3 ceiling void 1 contains asbestos.

Any change in its appearance should be recorded and passed to Property Services.

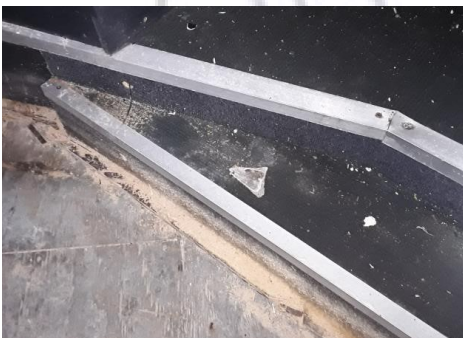
### **Item 12 Ref: 20-28415-1**

The floor – floor debris (cement) in Area 4 main nightclub & dance floor area contains asbestos.

Any change in its appearance should be recorded and passed to Property Services.

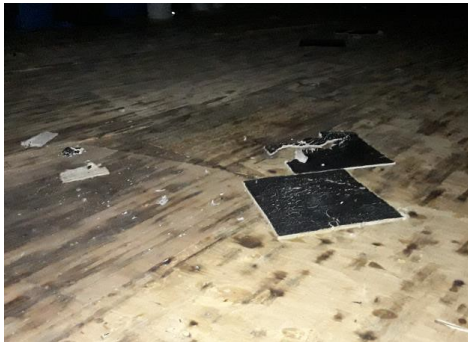
**Item 13 Ref: 20-28415-2**

The floor – tile debris (insulating board) in Area 4 main nightclub & dance floor area does not contain asbestos.

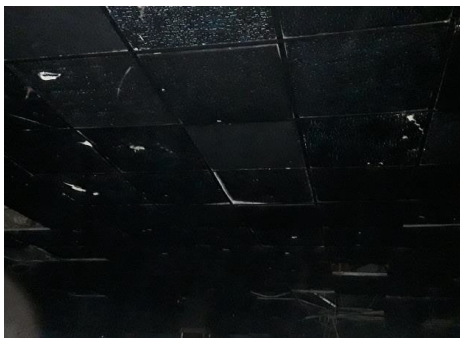
**Item 14 Ref: 20-28415-3**

The ceiling – suspended ceiling tiles (insulating board) in Area 4 main nightclub & dance floor area does not contain asbestos.

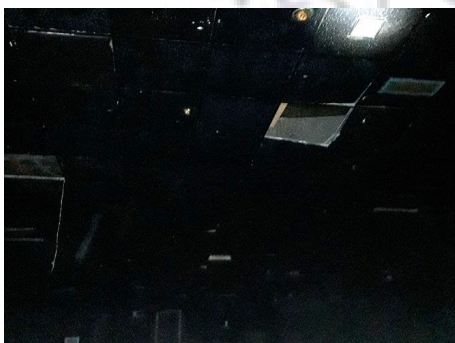
**Item 15 Ref: 20-28415-5**

The floor – suspended ceiling tiles (insulating board) in Area 4 main nightclub & dance floor area does not contain asbestos.

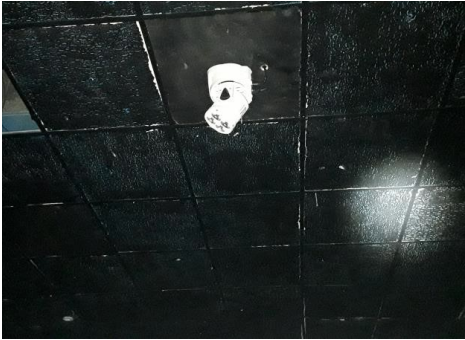
### **Item 16 Ref: As 20-28415-5**

The floor – suspended ceiling tiles (insulating board) in Area 4 main nightclub & dance floor area does not contain asbestos.

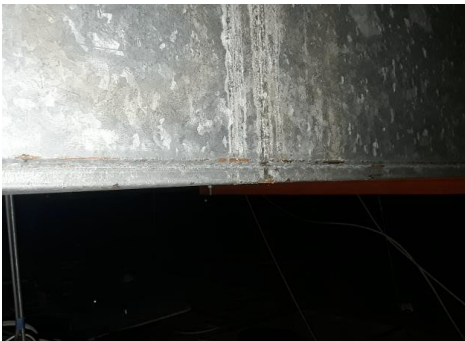
### **Item 17 Ref: 20-28415-12**

The vessels (mastic) in Area 5 ceiling void 2 do not contain asbestos.

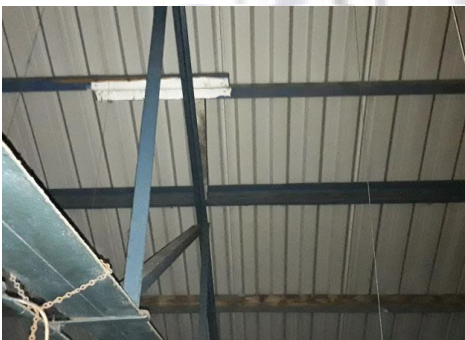
### **Item 18 Ref: 20-28415-14**

- (Item 17) Ref: 20-28415-12 – Vessels (mastic) (Area 5 ceiling void 2) – No Risk
- (Item 18) Ref: 20-28415-14 – Ceiling – Residual corrugated cement (cement) (Area 5 ceiling void 2) – Very Low Risk

The ceiling – residual corrugated cement (cement) in Area 5 ceiling void 2 contains asbestos.

Any change in its appearance should be recorded and passed to Property Services.

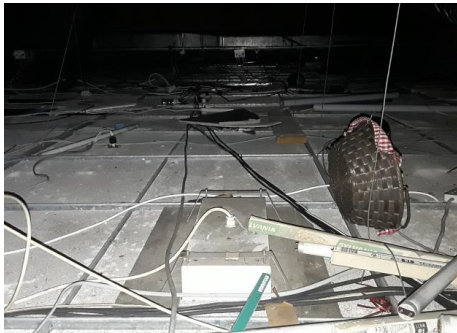
**Item 19 Ref: 20-28415-15**

The floor – suspended ceiling tiles to floor (insulating board) in Area 5 ceiling void 2 does not contain asbestos.

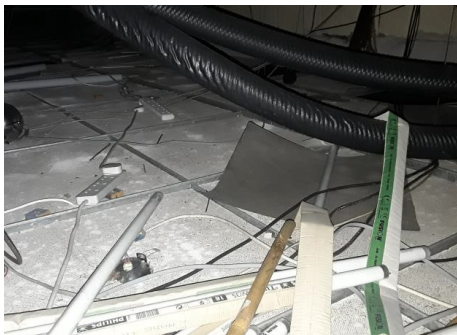
**Item 20 Ref: 20-28415-16**

The floor (insulating board) in Area 5 ceiling void 2 does not contain asbestos.

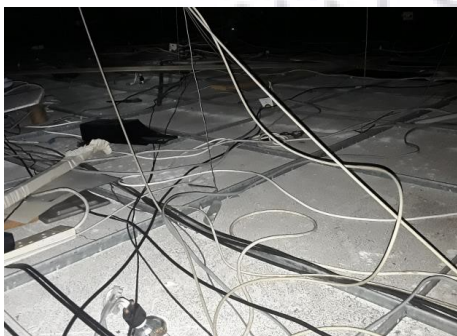
**Item 21 Ref: 20-28415-17**

The floor (insulating board) in Area 5 ceiling void 2 does not contain asbestos.

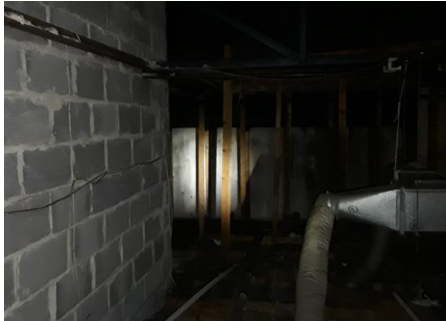
**Item 22 Ref: 20-28415-18**

The walls – insulation board above front elevation (insulating board) in Area 5 ceiling void 2 do not contain asbestos.

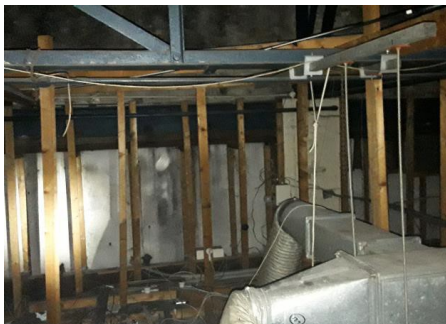
**Item 23 Ref: 20-28415-19**

The walls – insulation board above front elevation (insulating board) in Area 5 ceiling void 2 do not contain asbestos.

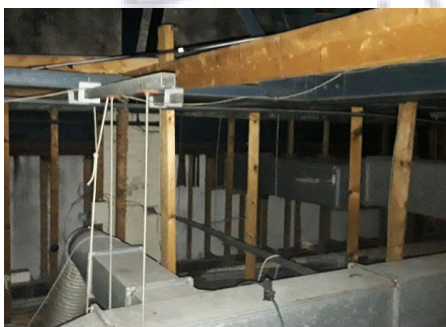
**Item 24 Ref: 20-28415-20**

The walls – insulation board above front elevation (insulating board) in Area 5 ceiling void 2 do not contain asbestos.

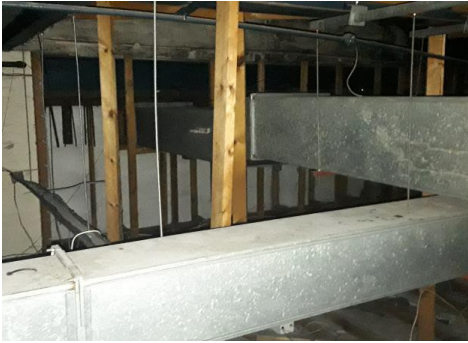
### **Item 25 Ref: 20-28415-21**

The walls – insulation board above front elevation (insulating board) in Area 5 ceiling void 2 do not contain asbestos.

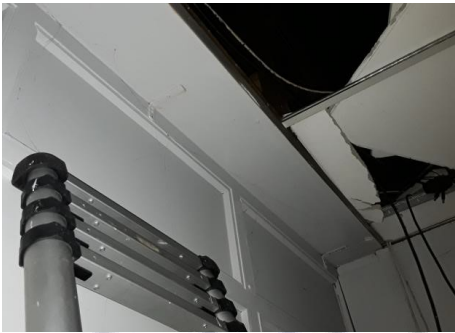
### **Item 26 Ref: 20-28415-24**

The soffits – internal soffit above window (insulating board) in Area 24 security office do not contain asbestos.

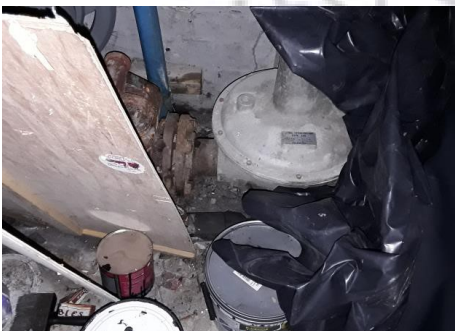
### **Item 27 Ref: 20-28415-25**

- (Item 26) Ref: 20-28415-24 – Soffits – internal soffit above window (insulating board) (Area 24 security office) – No Risk
- (Item 27) Ref: 20-28415-25 – Pipes – pipe flanges (gaskets) (Area 29 store cupboard) – Low Risk

The pipes – pipe flanges (gaskets) in Area 29 store cupboard contain asbestos.

Any change in its appearance should be recorded and passed to Property Services.

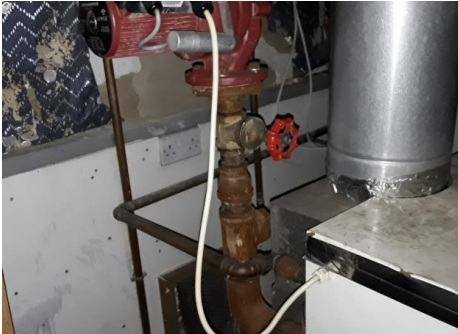
**Item 28 Ref: 20-28415-26**

The pipes – pipe flanges (gaskets) in Area 33 hall stores & boiler room do not contain asbestos.

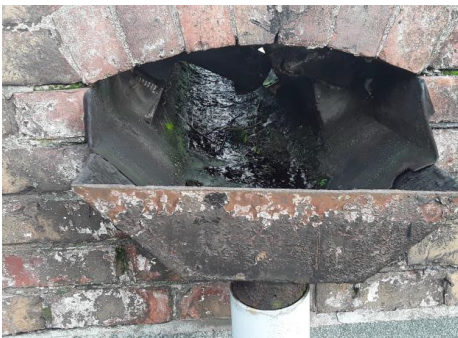
**Item 29 Ref: 20-28415-27**

The rainwater goods – lining to metal guttering (bitumen) in Area 43 External do not contain asbestos.

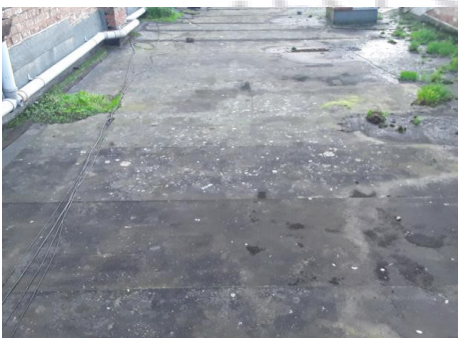
**Item 30 Ref: 20-28415-28**

The roof – felt to concrete & wood roof decks (bitumen) in Area 43 External does not contain asbestos.

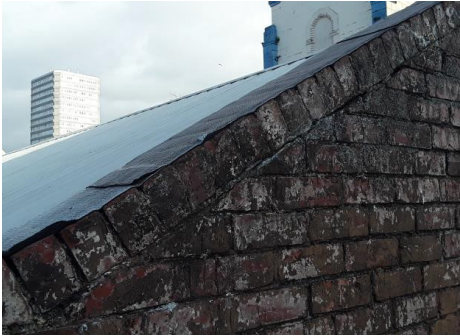
**Item 31 Ref: 20-28415-29**

The roof – flashing to brickwork (bitumen) in Area 43  
External do not contain asbestos.
