ASBESTOS SURVEY REPORT FOR SUNDERLAND CEMETERY, SUNDERLAND

**Asbestos Register for
Sunderland Cemetery**

Date: 17 November 2022

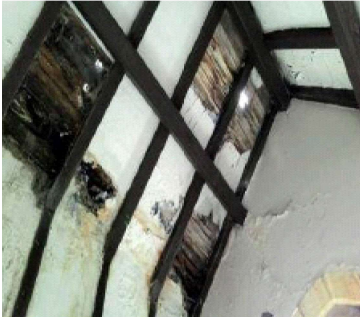
Item 1 Ref: EA003337

EA003337 – Plaster (Room 1) (Item 1) – No Risk

The plaster to the ceiling in the Narthex (Room 1) does not contain asbestos.

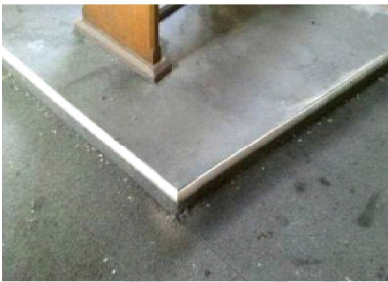
Item 2 Ref: EA003338

EA003338 – Blue Flooring (Room 2) (Item 2) - No Risk

The blue floor covering to the main worship area (Room 2) does not contain asbestos.

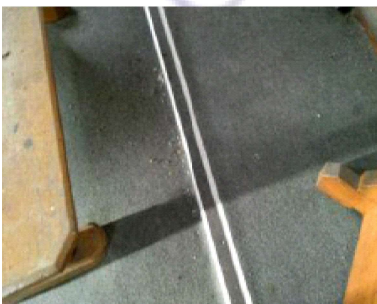
Item 3 Ref: EA003339

EA003339 – Step nosing (Room 2) (Item 3) – No Risk

The step nosing to the main worship area (Room 2) does not contain asbestos.

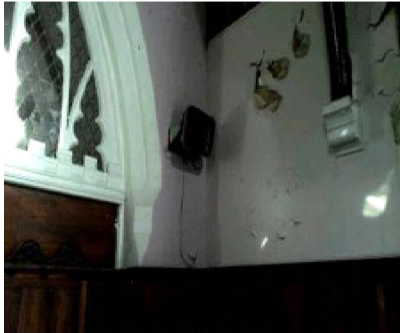
No access to gas heater in Room 2 further investigation is required

There was no access within the gas heaters in the main worship area (Room 2). Further investigation may be required.

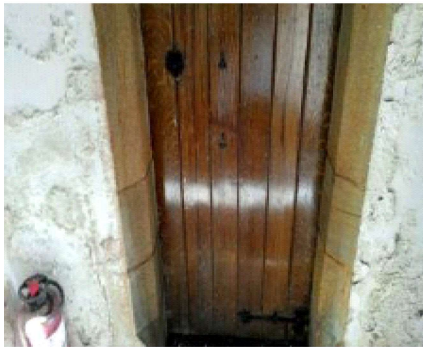
No access to Vestry (Room 3) further investigation is required

Room 3 (Vestry) was inaccessible as the door was jammed shut and no handle on the door. Further investigation may be required.

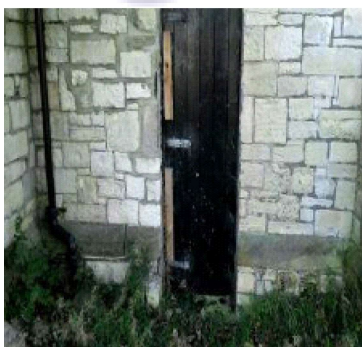
No access to Room at rear (Room 4) further investigation is required

Room 4 (Room to the rear) could not be accessed as the door was bolted shut. Further investigation may be required.

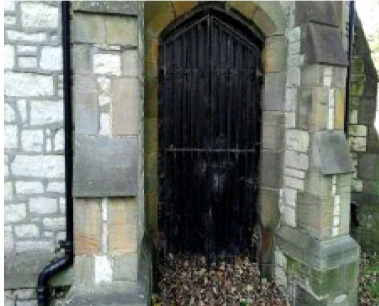
No access to Room at rear (Room 5) further investigation is required

Room 5 (room to rear) could not be accessed as the door was bolted shut. Further investigation may be required

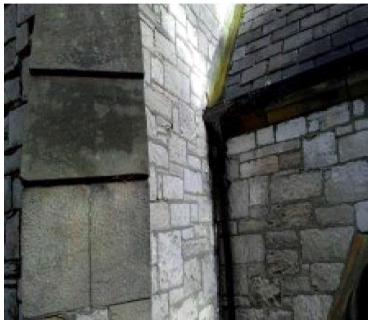
The external to the chapel was accessed and no suspect materials were found.

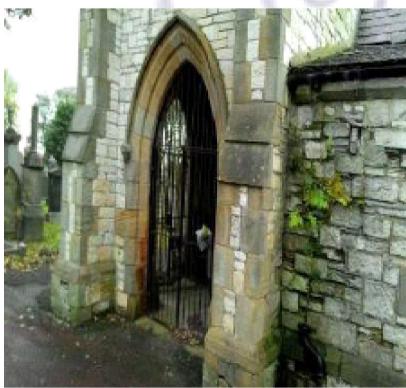
No access to Church (Unsafe structure) therefore further investigation is required

The internal area of the south church was not accessible as it was deemed an unsafe structure. Further investigation may be required.

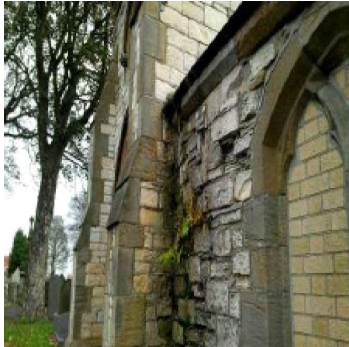
The external to the South Church was accessed and no suspect materials were found.

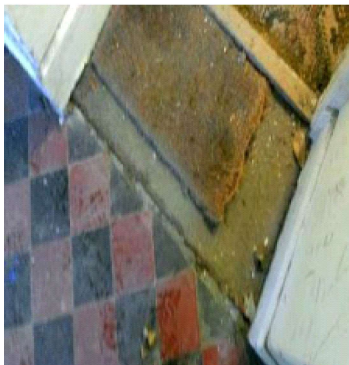
Item 4 Ref: EA003340

EA003340 – Floor covering (Room 1) (Item 4) – No Risk

The floor covering to the porch (Room 1) does not contain asbestos.

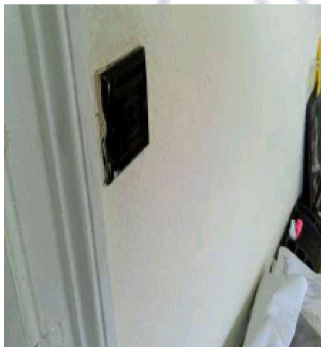
Item 5 Ref: EA003341

EA003341 – Switch Casing (Room 2) (Item 5) – No Risk

The light switch casing to the office (Room 2) does not contain asbestos.

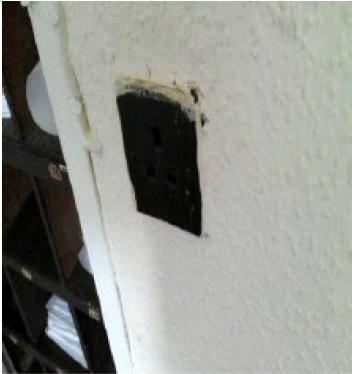
Item 6 Ref: EA003342

EA003342 – Plug socket (Room 2) (Item 6) - No Risk

The plug socket to the office (Room 2) does not contain asbestos.

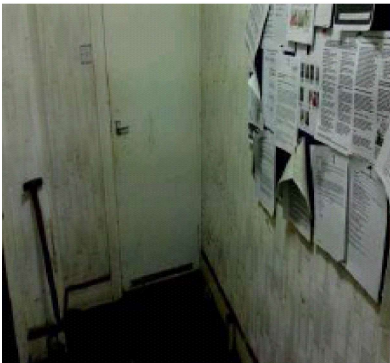
Room 3 (corridor) was accessed and no suspect materials were found.

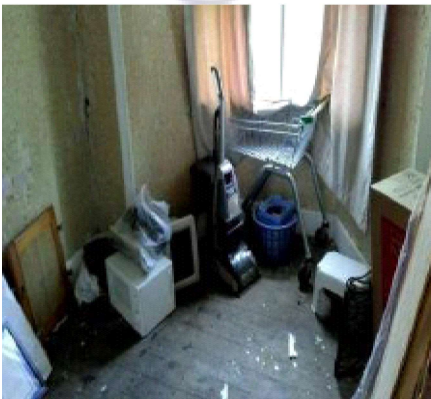
Room 4 (store) was accessed and no suspect materials were found.

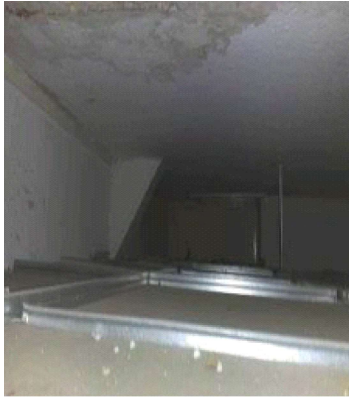
Room 5 (staff room) was accessed and no suspect materials were found.

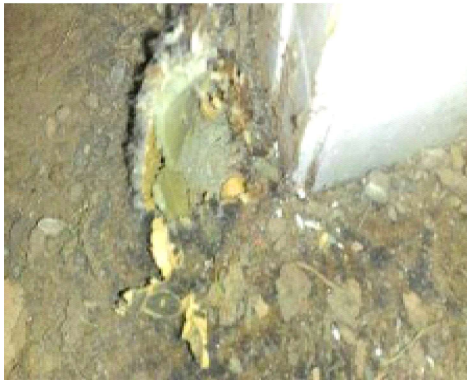
Item 7 Ref: EA003343

EA003343 – Vinyl flooring (Room 6) (Item 7) - Very Low Risk

The grey vinyl floor tiles and adhesive to the hall (Room 6) contains asbestos. Any change in its appearance should be noted and passed to Property Services.

| Picture | Location | Risk | Inspection Frequency | Date of return |
|---|--|---|---|---|
| Item 7 | South Lodge -- Vinyl flooring to room 6 | Very Low | Tenants Responsibility | Do Not Inspect |

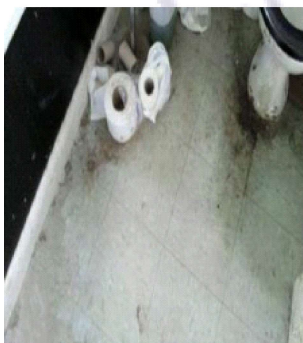
Item 8 Ref: EA003344

EA003344 – Vinyl flooring (Room 7) (Item 8) - No Risk

The green vinyl floor tiles to the bathroom (Room 7) do not contain asbestos.

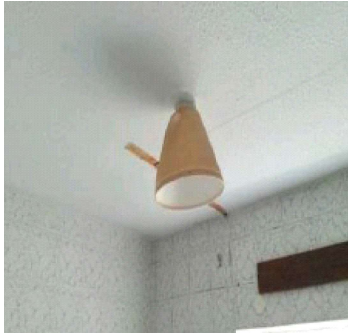
Item 9 Ref: EA003345

EA003345 – Textured coating (Room 7) (Item 9) - No Risk

The textured coating to the ceiling in the bathroom (Room 7) does not contain asbestos.

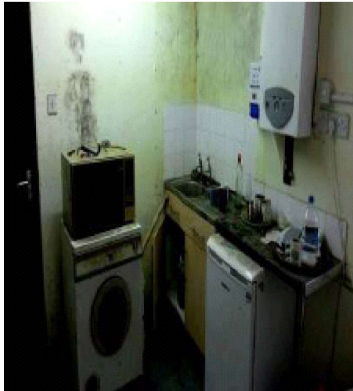
Room 8 (Kitchen) was accessed and no suspect materials were found.

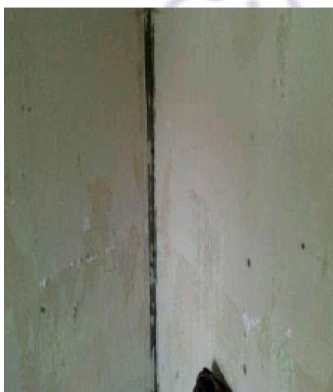
Item 10 Ref: EA003346

EA003346 – Wall panels (Room 9) (Item 10) – No Risk

The fibreboard wall panels to the store room (Room 9) do not contain asbestos.

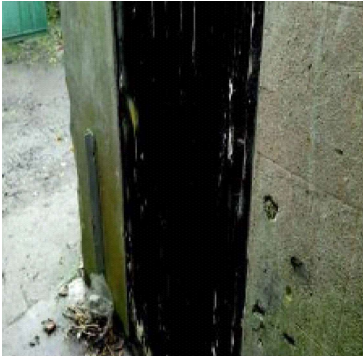
No access to the external WC (Room 10) further investigation is required

Room 10 (External WC) was inaccessible as the door was nailed shut. Further investigation may be required.

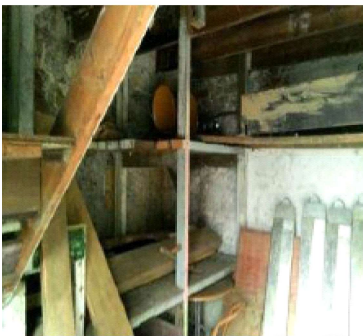
Room 11 (Stores) was accessed and no suspect materials were found.

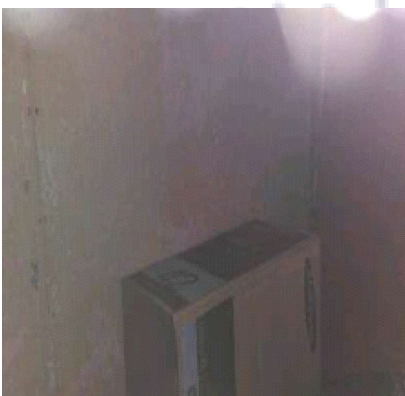
Item 11 Ref: EA003346

As EA003346 – Wall panels (Room 12) (Item 11) – No Risk

Room 12 (Store room) was accessed and no suspect materials were found.

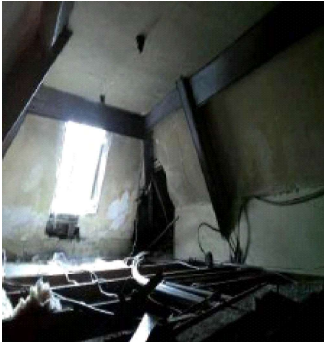
Room 1 (Attic Room) was accessed and no suspect materials were found.

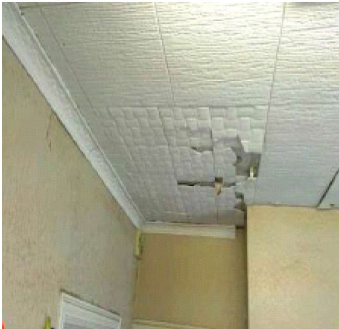
No access to the roof void (Room 2) further investigation is required

The large loft (Room 2) was inaccessible due to being above a fixed ceiling. Further investigation may be required.

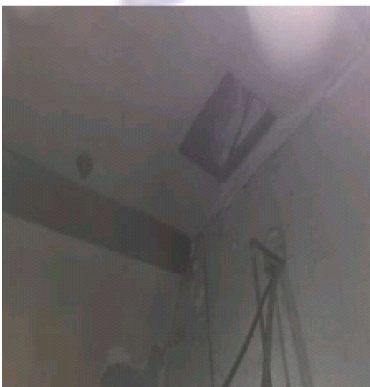
No access to the roof void (Room 3) further investigation is required

The small loft (Room 3) was inaccessible as the hatch was above an unstable ceiling. Further investigation may be required.

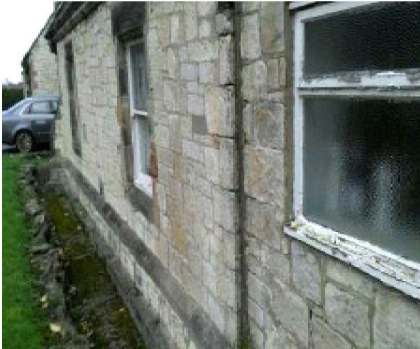
Item 12 Ref: EA003347

EA003347 – Window Putty (External) (Item 12) - No Risk

The window putty to the external of the South Lodge does not contain asbestos.
