### ASBESTOS SURVEY REPORT FOR PARCELFORCE DEPOT, WASHINGTON

**Asbestos Register for**  
**PARCELFORCE DEPOT, WASHINGTON**

**UPRN: - 39099**

**Premises Manager / Samo: - Tenant                      Date: 17 November 2022**

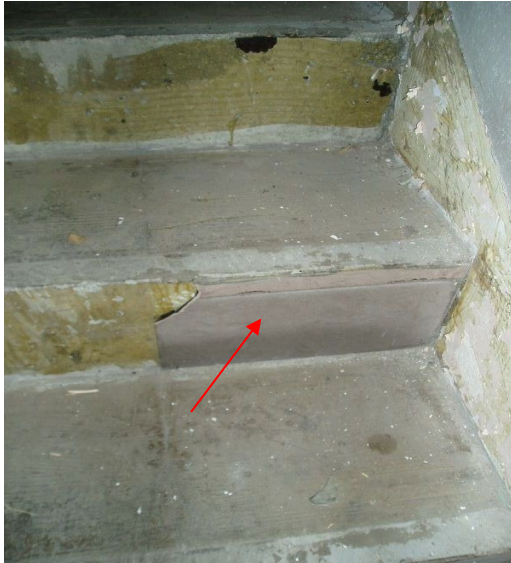
### **Item 2 - Ref: JJ0339/07**

The vinyl floor covering to the vertical stair rises (Room 0/59) does not contain asbestos.

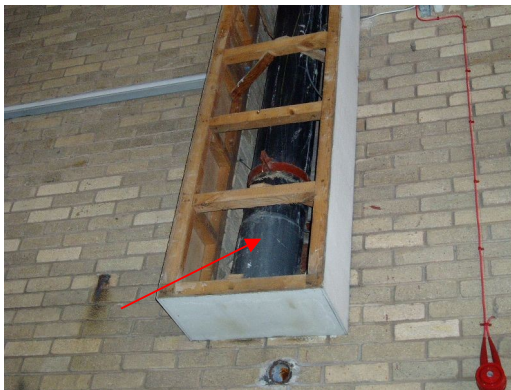
### **Item 3 - Ref: JJ0224/07**

The vertical Pipework inside the boxing in mowers storage area (Room 0/59a) does not contain asbestos.

Similar pipework is located in room 0/52. **(Item 1)**

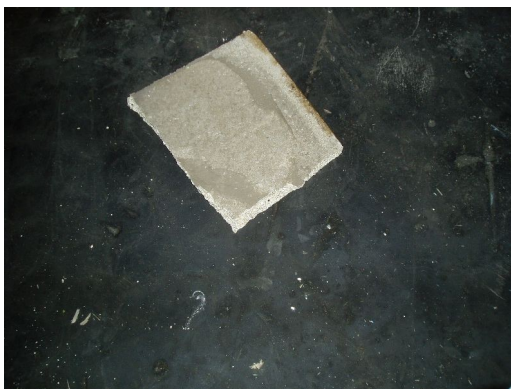
### **Item 4 - Ref: JJ0338//07**

The debris to the floor in storage area 2 (Room 0/60) does not contain asbestos.

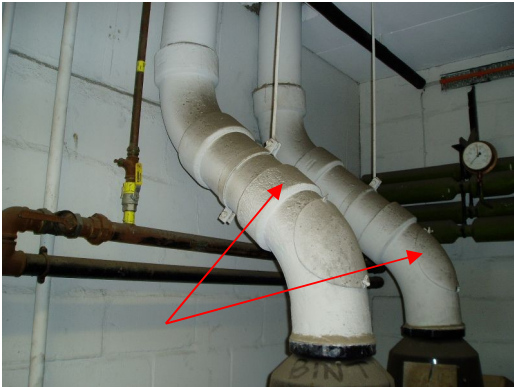
### **Item 6 - Ref: JJ0218/07**

The flue pipe in the boiler room (Room 0/64) contains asbestos.

Any change in its appearance should be recorded and passed to Property Services.

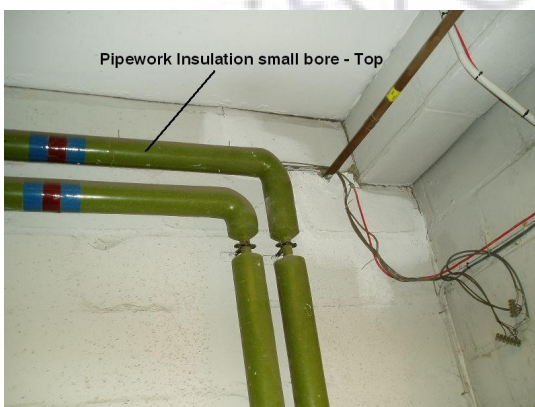
### **Item 7 - Ref: JJ0225/07**

The small bore insulation to the pipework in the boiler room (Room 0/64) does not contain asbestos.

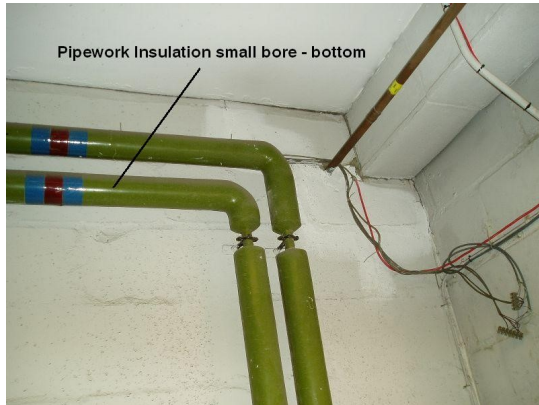
### **Item 8 - Ref: JG0226/07**

The small bore insulation to the pipework in the boiler room (Room 0/64) does not contain asbestos.

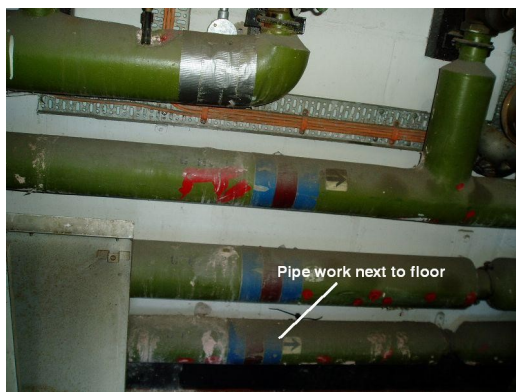
### **Item 9 – Ref: JJ0222/07**

The pipework next to the floor in the boiler room (Room 0/64) does not contain asbestos.

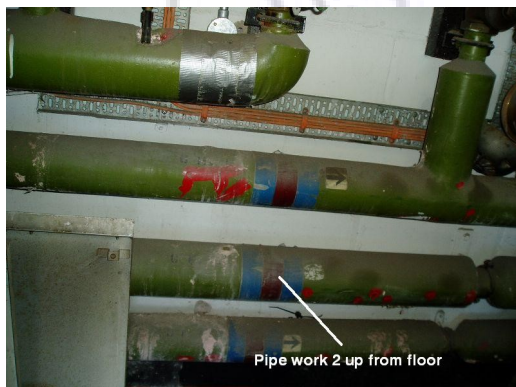
### **Item 10 - Ref: JJ0221/07**

The pipework (2<sup>nd</sup> up from floor) in the boiler room (Room 0/64) does not contain asbestos.

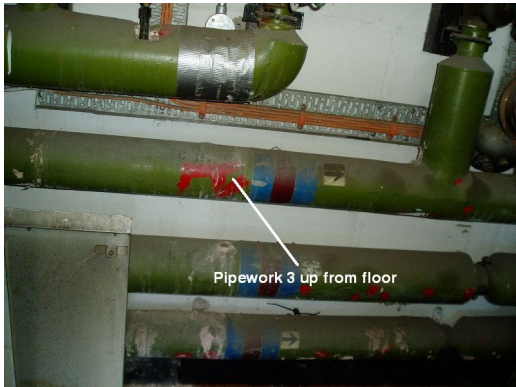
#### **Item 11 - Ref: JJ0220/07**

The pipework (3rd from the floor) in the boiler room (Room 0/64) does not contain asbestos.

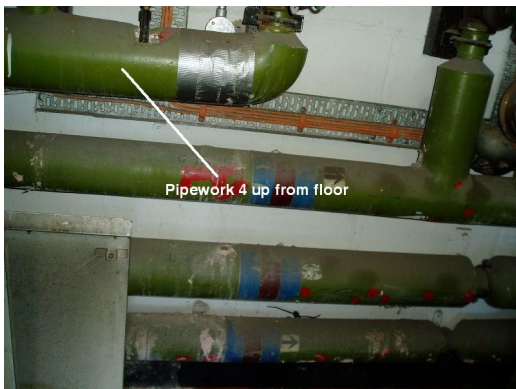
#### **Item 12 - Ref: JJ0219/07**

The pipework (4<sup>th</sup> from the floor) in the boiler room (Room 0/64) does not contain asbestos.

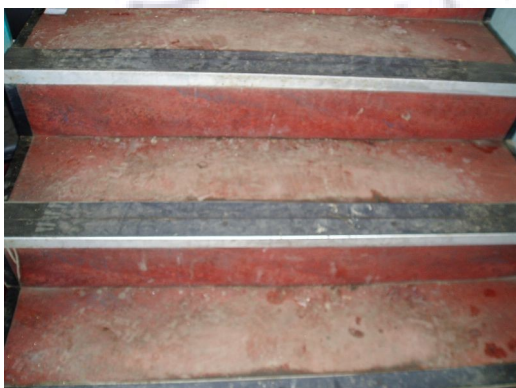
#### **Item 13 - Ref: JJ0212/07**

The covering lino to the stairs in the entrance hall (Room 0/65) does not contain asbestos.

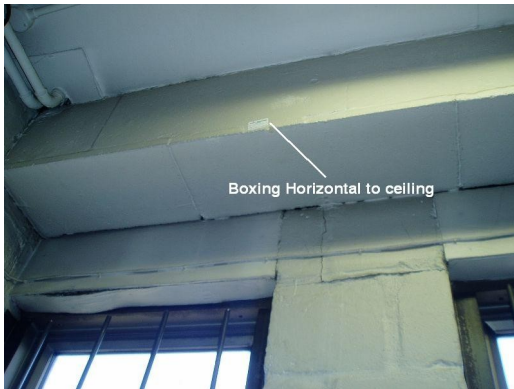
### **Item 14 - Ref: JJ0214/07**

The horizontal boxing to the ceiling in the workshop stores (Room 0/66) does not contain asbestos.

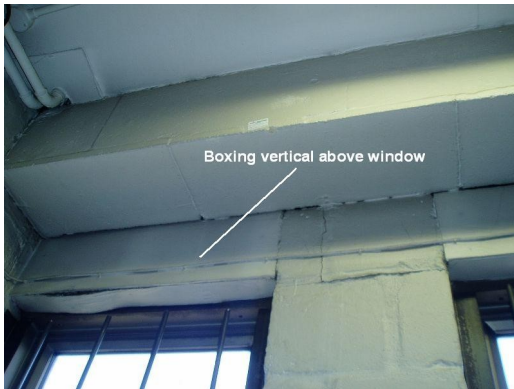
### **Item 15 - Ref: JJ0213/07**

The horizontal boxing above the window in the workshop stores (Room 0/66) does not contain asbestos.

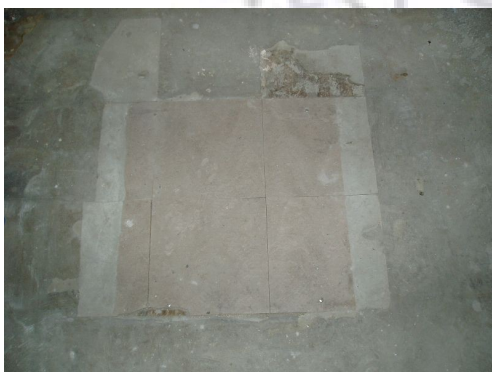
### **Item 16 - Ref: JJ0209/07**

The grey floor tiles to room 1/2 do not contain asbestos.

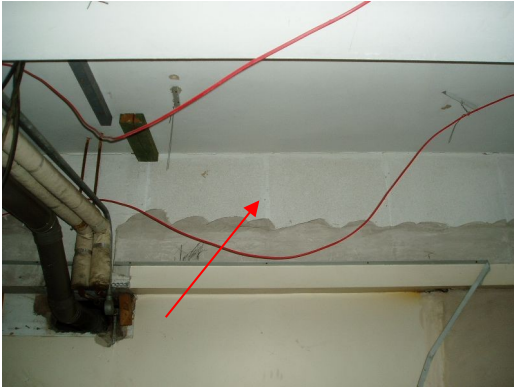
**Item 17 - Ref: JJ0223/07**

The wall upper in Room 1/2 does not contain asbestos.

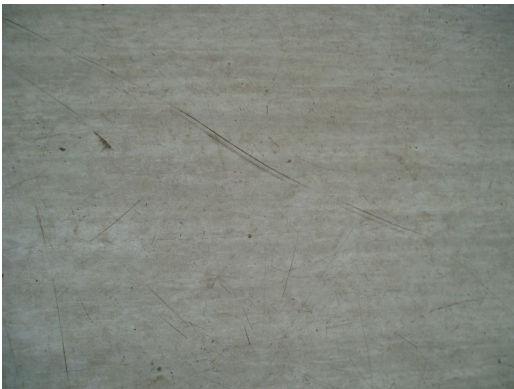
**Item 18 - Ref: JJ0215/07**

The cream floor covering to the lock room pool (Room 1/5) does not contain asbestos.

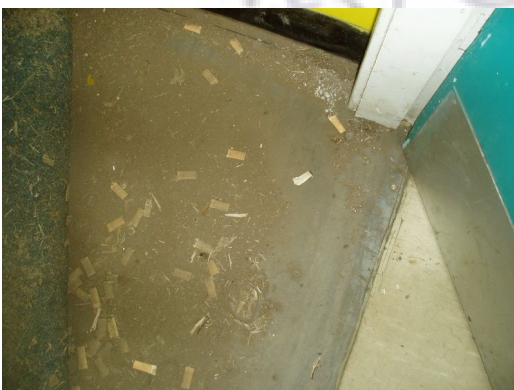
**Various - Ref: JJ0216/07**

The dark floor covering to the office (Room 1/6) does not contain asbestos. **(Item 19)**

Similar flooring is located in room 1/7. **(Item 20)**

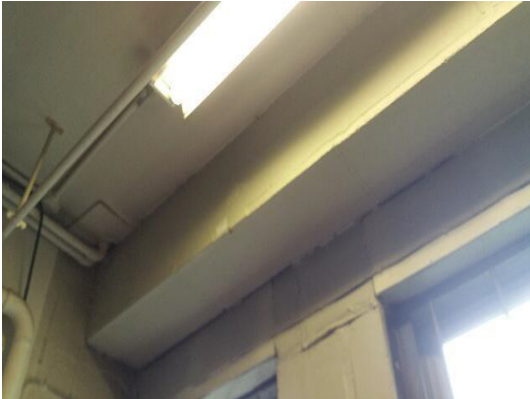
**Item 21 - Ref: 389139-03**

The beam cladding in ground floor stairwell (0/068) does not contain asbestos.

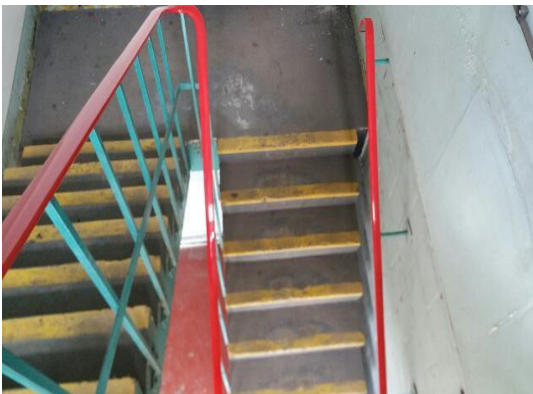
**Item 22 - Ref: 389139-04**

The grey tiles in ground floor stairwell (0/068) do not contain asbestos.

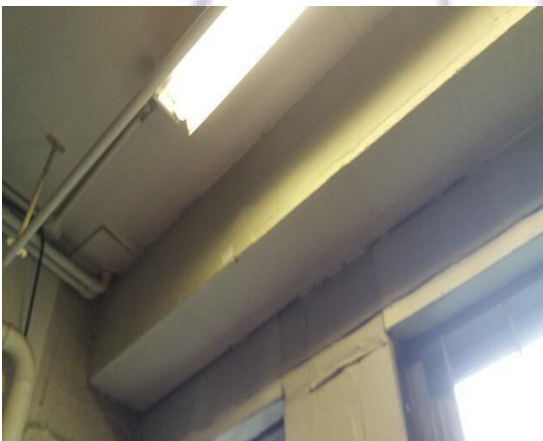
**Item 23 - Ref: As 389139-03**

The boxing in the store room transport and cupboard (Rm 0/073) does not contain asbestos.

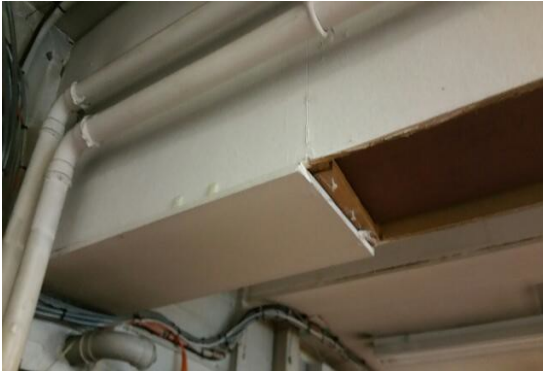
**Item 24 - Ref: 389139-23**

The boxing in the store room transport and cupboard (Rm 0/073) does not contain asbestos.

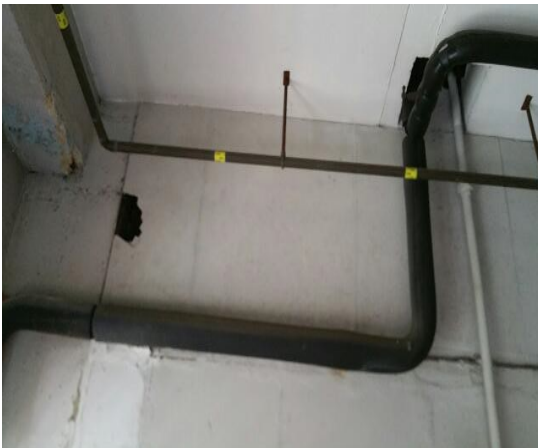
**Item 25-Ref:As389139-10**

The beam cladding in boiler room (0/076) does not contain asbestos.

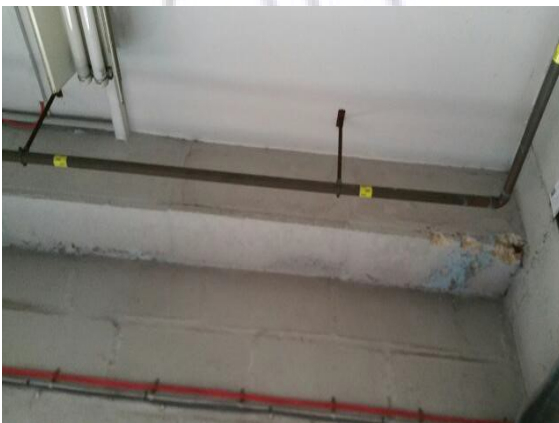
**Item 26 - Ref: 389139-10**

The beam cladding above doorway in boiler room (0/076) does not contain asbestos.

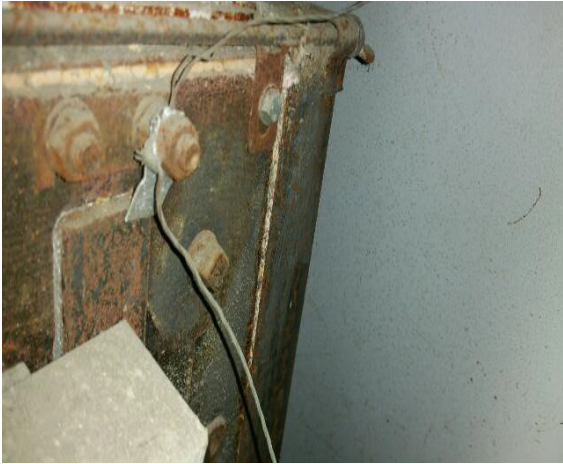
**Item 27 - Ref: 389139-17**

The boiler lining in boiler room (0/076) does contain asbestos.

Any change in its appearance should be recorded and passed to Property Services.

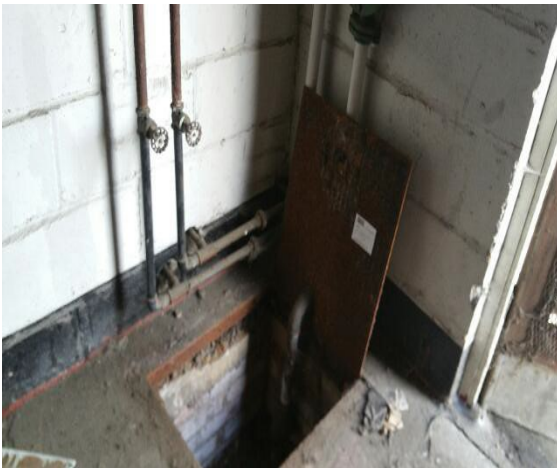
**Item 28 - Ref: 389139-06**

The debris to floor in boiler room (0/076) does not contain asbestos.

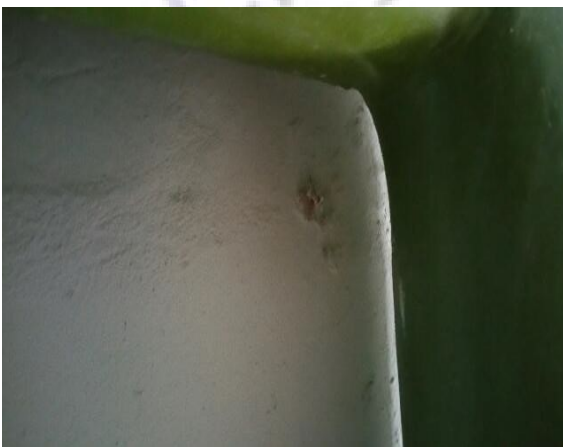
**Item 29 - Ref: 389139-18**

The debris to walls adj to pipes in boiler room (0/076) does not contain asbestos.

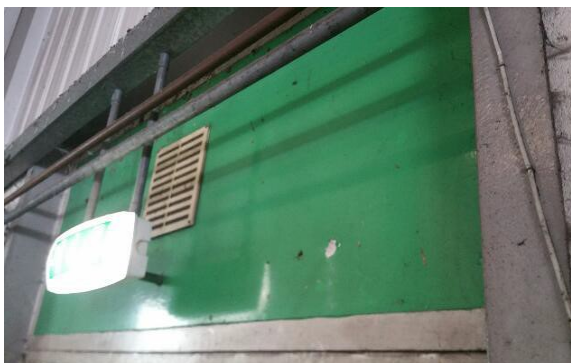
**Item 32 - Ref: 389139-16**

The door header panel in the garage (0/077) does not contain asbestos.

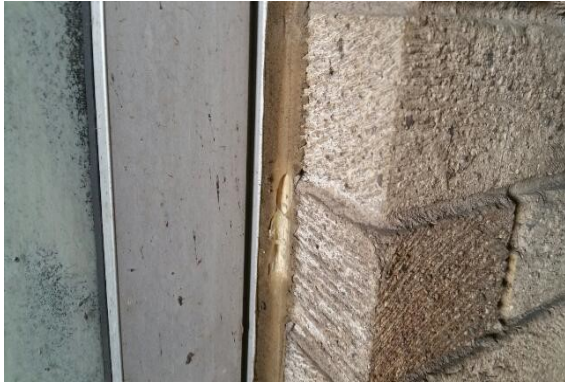
### **Item 33 - Ref: 389139-01**

The mastic to the window in the garage (Rm 0/077) does not contain asbestos.

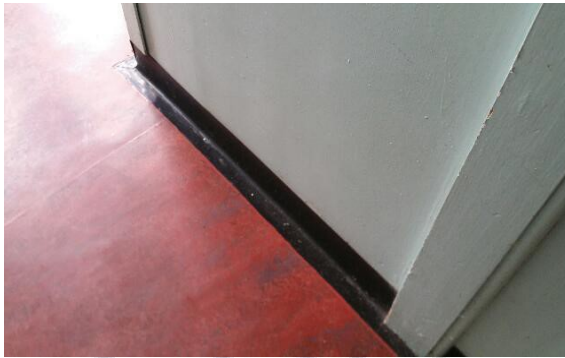
### **Item 34 - Ref: 389139-22**

The wall skirting (Black) in the corridor in the workshop /garage block (Rm 1/083) does not contain asbestos.

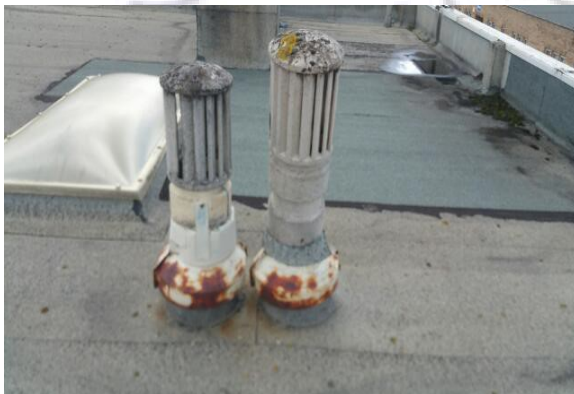
### **Item 35 - Ref: Presumed**

The cowl and flue pipe to the roof (external) is presumed to contain asbestos.  
(Asbestos confirmed in Survey 21-41309)

Any change in appearance should be reported to Property Services.

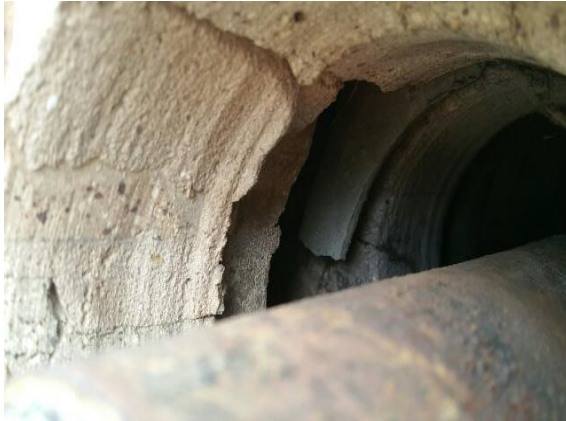
**Item 36 - Ref: 389139-05**

The damp proof course (externally) does contain asbestos.  
(Also extends around doors/windows in wall cavity)

Any change in appearance should be reported to Property Services.

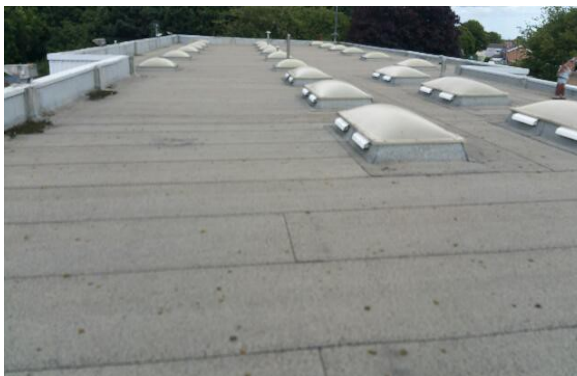
**Item 37 - Ref: 389139-20**

The roof felt (externally) does not contain asbestos.

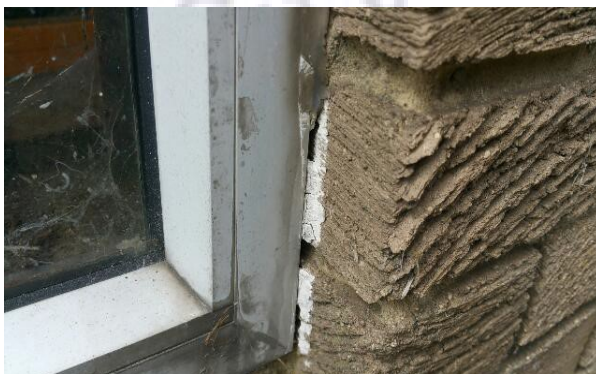
**Item 38 - Ref: 389139-25**

The window putty seal – white (Externally) does not contain asbestos.

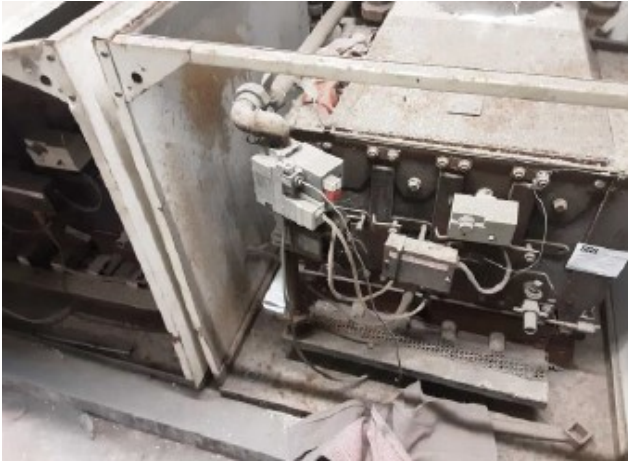
**Item 39 - Ref: 389139-17**

The vessel - rope seal gasket to boiler joints does contain asbestos.

Any change in appearance should be reported to Property Services.

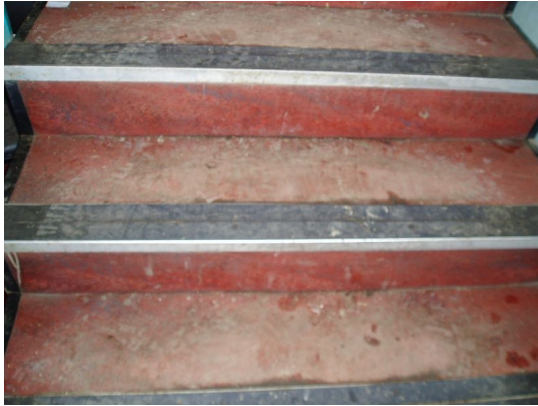
**Ref: JJ0210/07**

*The nosing to the stairs on the stairwell to mezzanine (Room 0/55) contained asbestos. This has since been removed.*

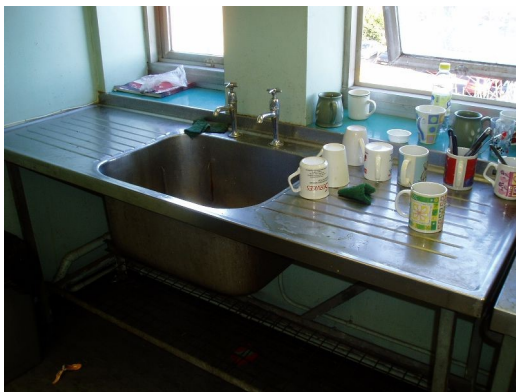
**Ref: JJ0217/07**

*The sink pad in the rest room (Room 1/7) contained asbestos. This has since been removed.*
