ASBESTOS SURVEY REPORT FOR NOOK LODGE, NOOKSIDE, SUNDERLAND

Asbestos Register for

NOOK LODGE, NOOKSIDE, SUNDERLAND

Date: 17th January 2025

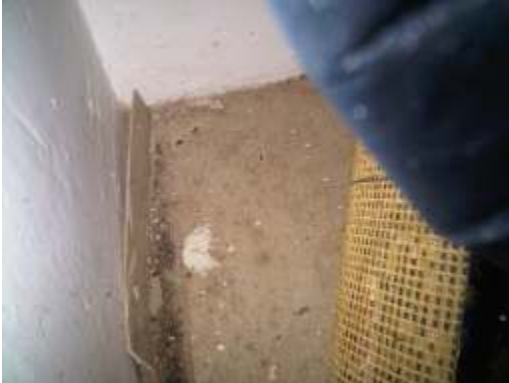
Item 1 Ref: IC10/2002

IC10/2002 – Floor tiles and adhesive (cross ref: 385803-5) (Dining Rm Cupbd)
(Item 1) Very Low Risk

The beige floor tiles and adhesive to the dining room cupboard (Games) contains asbestos.

Cross referenced with sample 385803-5

Any change in its appearance should be recorded and passed to Property Services.

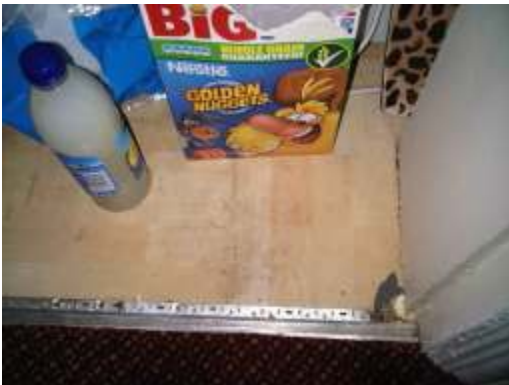
Item 2 - Ref: IC10/2003

IC10/2003 – Floor tiles and adhesive (cross ref: 385803-4) (Dining Rm Cupbd)
(Item 2) Very Low Risk

The flooring and adhesive to the dining room cupboard (Window) contains asbestos.

Cross referenced with sample 385803-4

Any change in its appearance should be recorded and passed to Property Services.

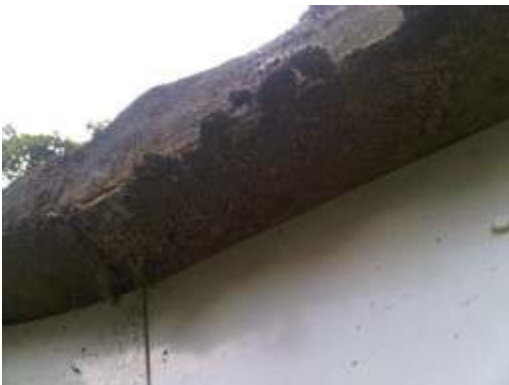
Item 3 - Ref: IC10/2005

IC10/2005 – Fillet board to gable end (External) (Item 3) Very Low Risk

The fillet board to the gable end (external) contains asbestos.

Any change in its appearance should be recorded and passed to Property Services.

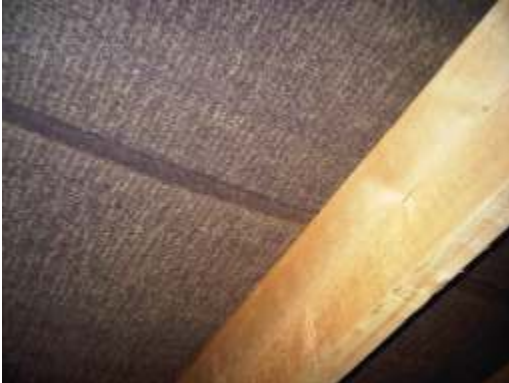
Item 4 - Ref: IC10/2001

The sarking felt to loft hatch 2 does not contain asbestos.

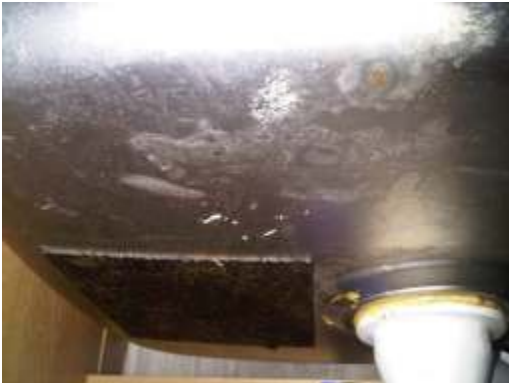
Item 5 - Ref: IC10/2004

The sink pad to the sink in the kitchen does not contain asbestos.

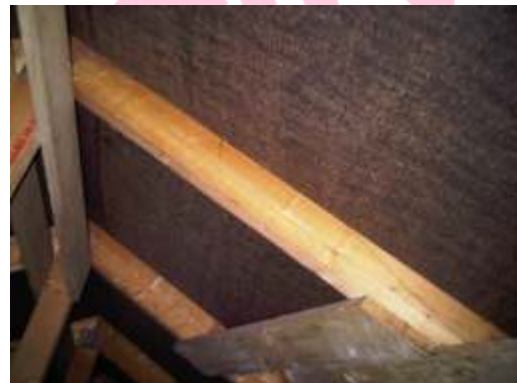
Item 6 - Ref: As IC10/2001

The sarking felt to loft hatch 4 does not contain asbestos.

Cross referenced with sample 385803-6

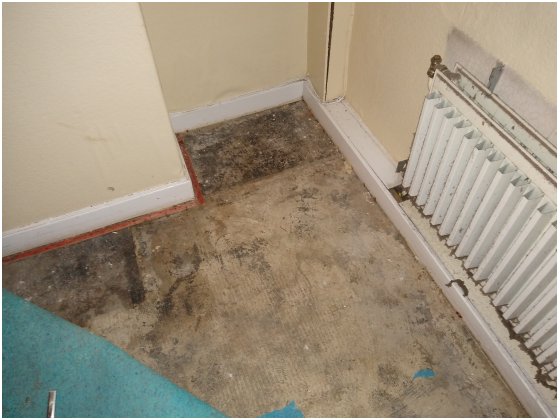
Item 7 - Ref: 385803-3

The old tile adhesive in Rm 008/Dining Room does not contain asbestos.

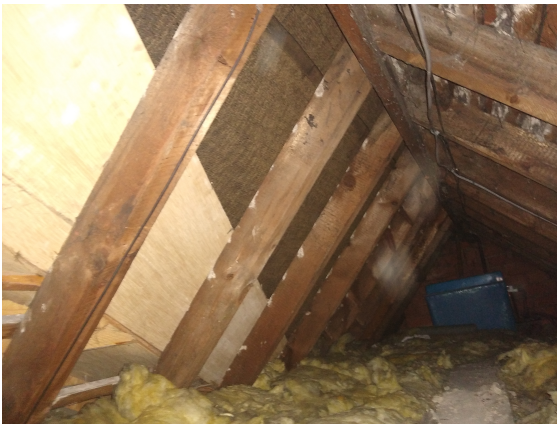
Item 8 - Ref: 385803-1

The sarking in Rm 001/Original Loft Space does not contain asbestos.

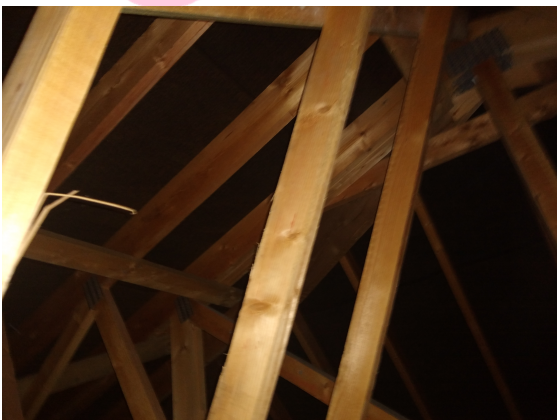
Item 9 - Ref: 385803-2

The sarking in Rm 002/Extension Loft Space does not contain asbestos.

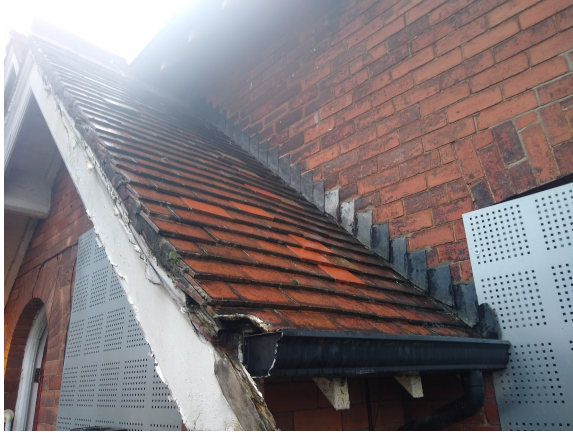
Item 10 - Ref: 385803-7

385803-7 – Pitched roof flashing (External) (Item 10) Low Risk

The pitched roof flashing
(External) contains asbestos.

Any change in its appearance
should be recorded, and
passed to Property Services.

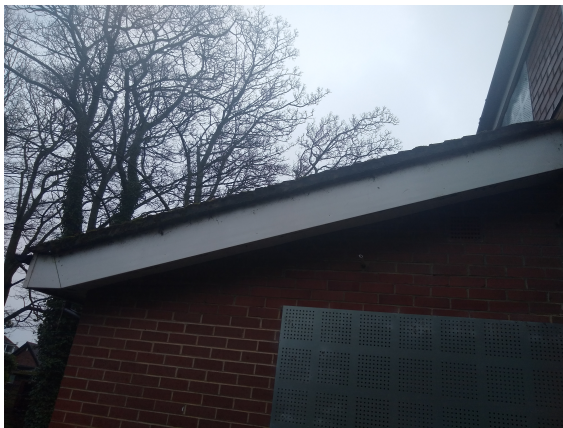
Item 11 - Ref: 385803-8

385803-8 – Extension undercloaks (External) (Item 11) Very Low Risk

The extension undercloaks
(External) contain asbestos.

Any change in its appearance
should be recorded, and
passed to Property Services.

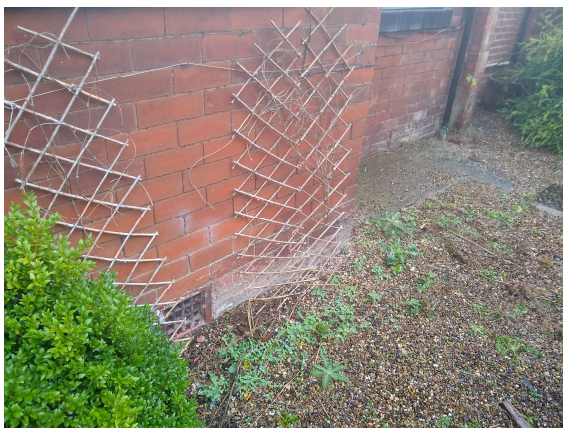
Item 12 - Ref: 385803-9

The Damp proof course to
original building (External)
does not contain asbestos.

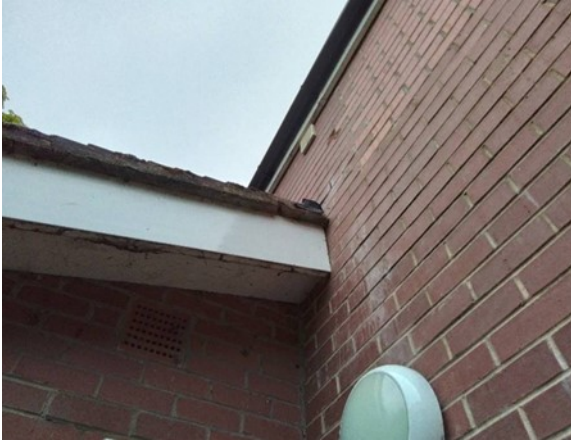
Item 13 - Ref: KN001533

The roof felt flashing (External)
does not contain asbestos.
