### ASBESTOS SURVEY REPORT FOR MOWBRAY PARK, BURDON ROAD, SUNDERLAND

**Asbestos Register for**  
**MOWBRAY PARK, SUNDERLAND**

**Date: 30<sup>th</sup> January 2023**

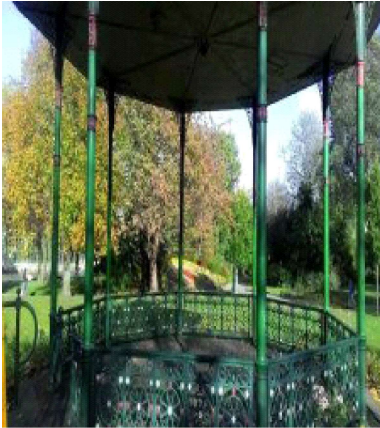
The bandstand was accessed and no suspect material was found.

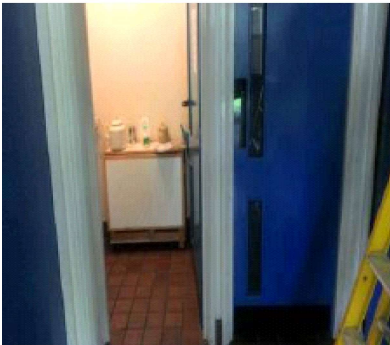
The lobby to the bowls pavilion (Room 1) was accessed and no suspect materials were found.

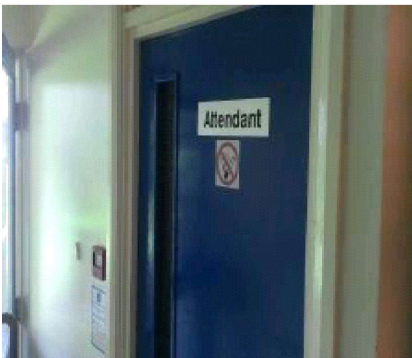
The attendants office was inaccessible at the time of the survey. This requires further investigation.

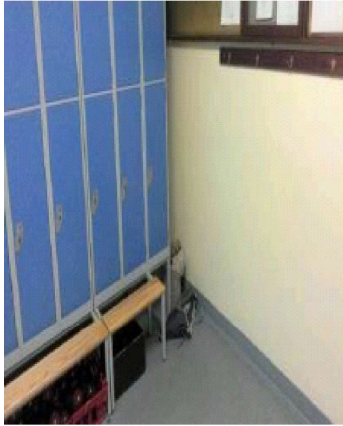
The home changing area to the pavilion (Room 3) was accessed and no suspect materials were found.

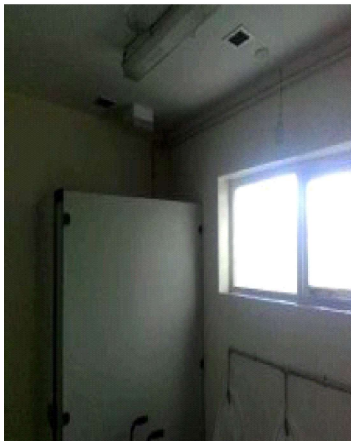
Toilet 1 to the pavilion (Room 4) was accessed and no suspect materials were found.

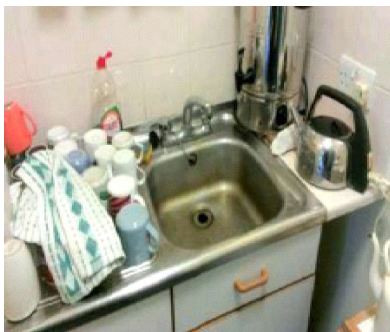
**Item 1 Ref:EC002470**

EC002470 – Sink pad (Room 5) (Item 1) - No Risk

The sink pad to the kitchen in the pavilion (Room 5) does not contain asbestos.

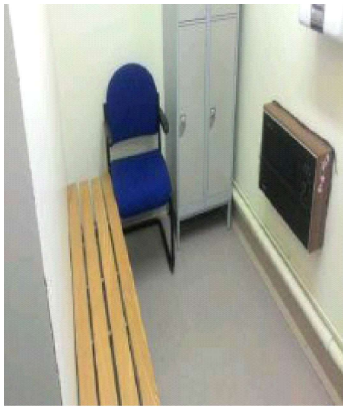
The ladies wc (Room 6) to the pavilion was accessed and no suspect materials were found.

There was no access to the storage heater however, as it was live.

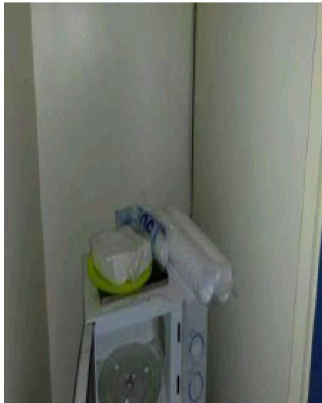
The cupboard to the pavilion (Room 7) was accessed and no suspect materials were found.

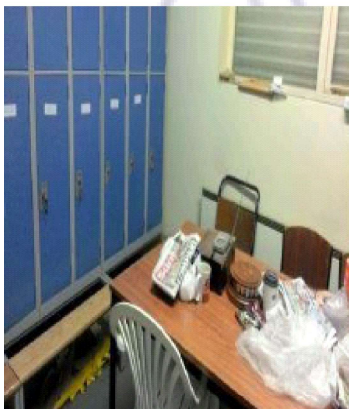
The visitors changing area to the pavilion (Room 8) was accessed and no suspect materials were found.

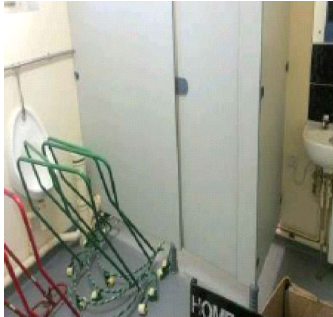
Toilet 2 in the pavilion (Room 9) was accessed and no suspect materials were found.

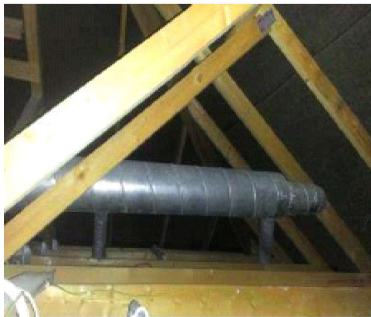
The roof void to the pavilion was accessed and no suspect materials were found.

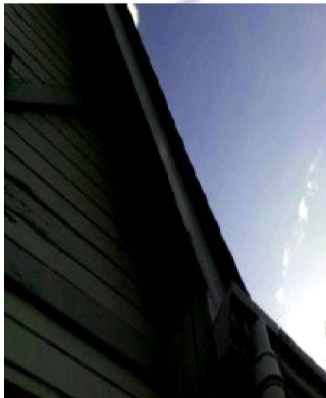
**Item 2 Ref: - EC002471**

EC002471 – Cement Verge (External) (Item 2) - No Risk

The cement verge edging to the external does not contain asbestos.

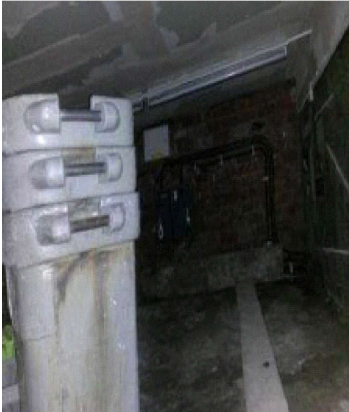
The basement store to the mess room was accessed and no suspect materials were found.

However there was no access to the electrics as they were ..

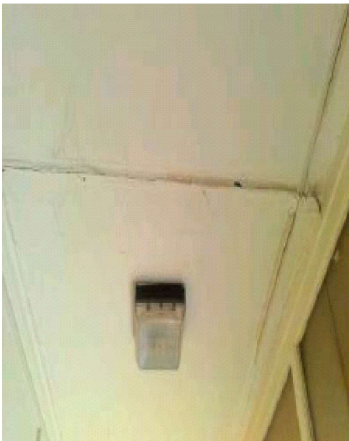
#### **Item 3 Ref: - EC002465**

EC002465 – Ceiling (Room 1) (Item 3) - No Risk

The ceiling to the hall in the mess room (Room 1) does not contain asbestos.

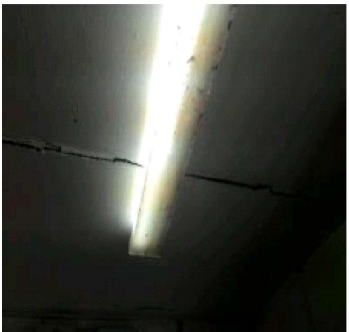
#### **Item 4 As EC002465**

As EC002465 – Ceiling (Room 2) (Item 4) - No Risk

The ceiling to the office (Room 2) in the mess room does not contain asbestos.

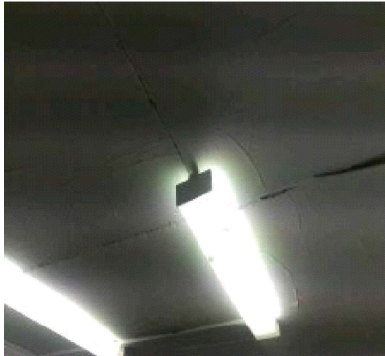
**Item 5 As EC002465**

As EC002465 – Ceiling (Room 3) (Item 5) – No Risk

The ceiling to the mess room (Room 3) does not contain asbestos.

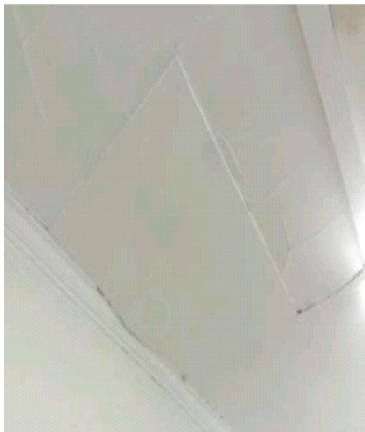
**Item 6 Ref: EC002466**

EC002466 – Ceiling (Room 3) (Item 6) – No Risk

The ceiling to the mess room (Room 3) does not contain asbestos.

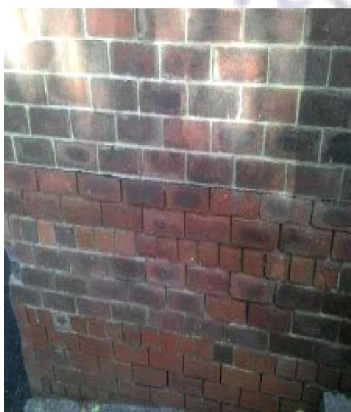
**Item 7 Ref: - EC002467**

EC002467 – Damp proof course (Item 7) - No Risk

The damp proof course to the external of the mess room does not contain asbestos.

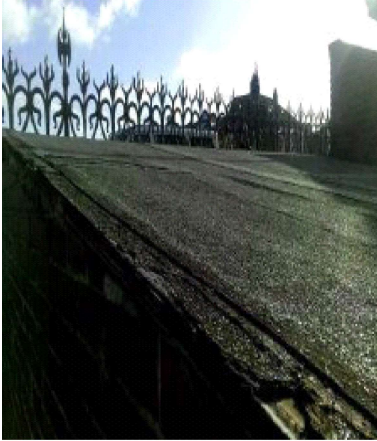
**Item 8 As EC002469**

EC002469 – Garage Roof (External) (Item 8) - No Risk

The bitumen roof felt to the garages does not contain asbestos.

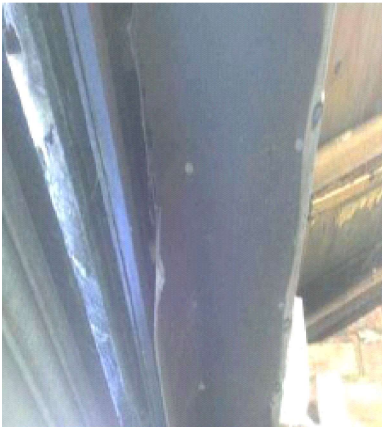
**Item 9 Ref: EC002468**

EC002468 – Damp proof course (External) (item 9) – No Risk

The damp proof course to garage 1 does not contain asbestos.

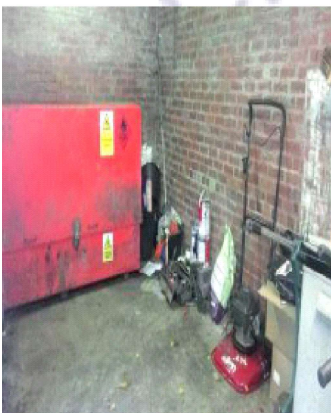
Garage 2 was accessed and no suspect materials were found.

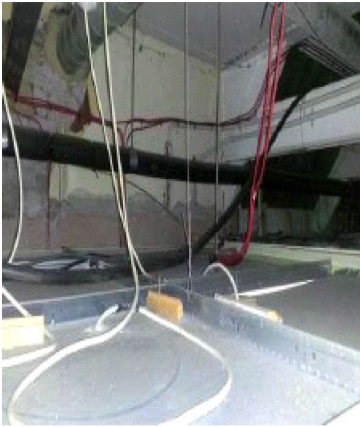
The lobby to the base (Room 1) was accessed and no suspect materials were found.

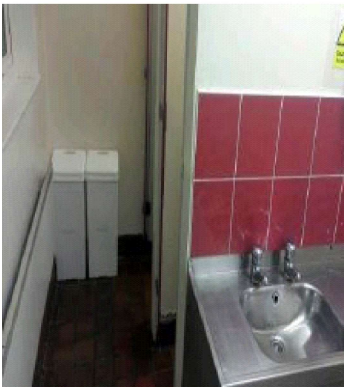
The ladies wc to the base (Room 2) was accessed and no suspect materials were found.

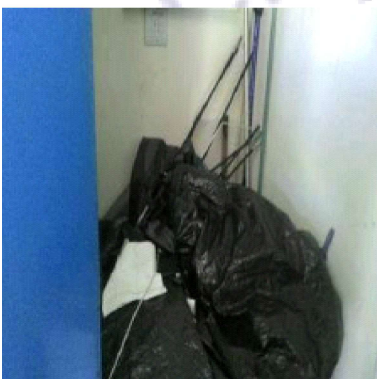
The cupboard (Room 3) was accessed and no suspect materials were found.

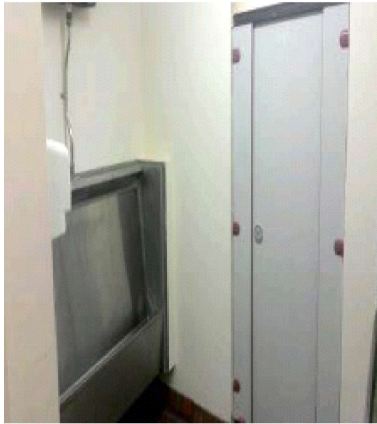
The mens wc (Room 4) was accessed and no suspect materials were found.

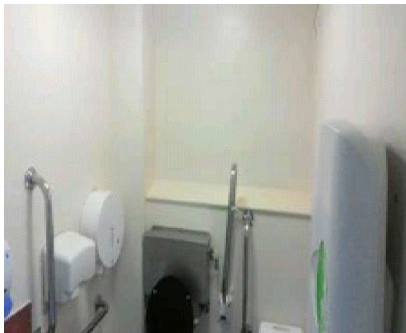
The disabled wc to the base (Room 5) was accessed and no suspect materials were found.

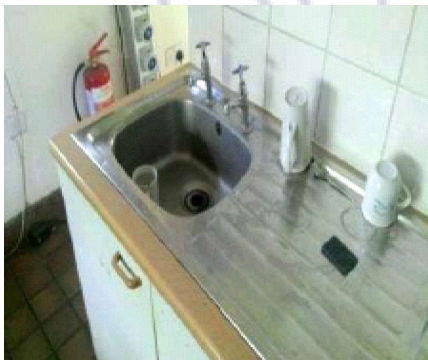
**Item 10 Ref: EC002473**

EC002473 – Sink pad (Room 6) (Item 10) - No Risk

The sink pad to the Park rangers office (Room 6) does not contain asbestos.

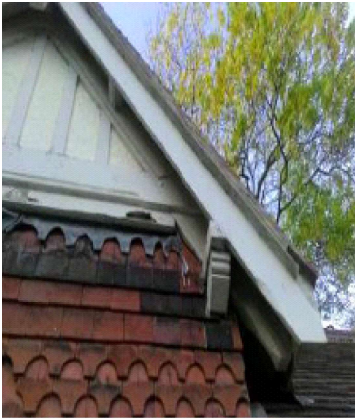
**Item 11 Ref: EC002472**

EC002472 – Cement Verge (External) (Item 11) - No Risk

The verge tiles and the cement sheet to the external do not contain asbestos.
