ASBESTOS SURVEY REPORT FOR HERRINGTON COUNTRY PARK, SUNDERLAND

**Asbestos Register for
Herrington Country Park, Sunderland**

Date: 22 November 2022

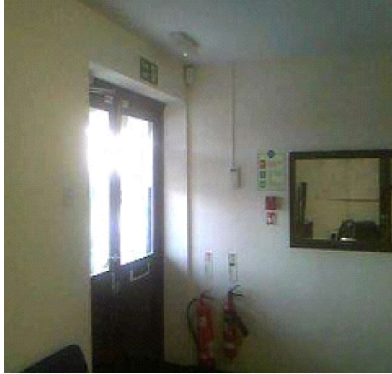
Room 1 (Lobby) was accessed and no suspect materials were found.

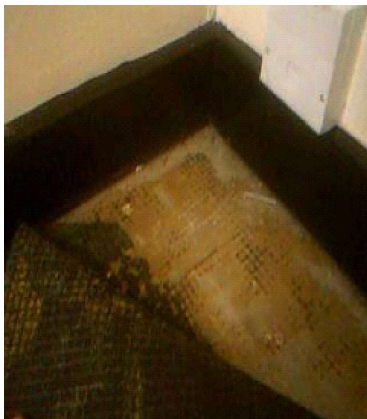
Item 1 Ref: CB008847

The floor tiles beneath the carpet in the classroom (Room 2) do not contain asbestos.

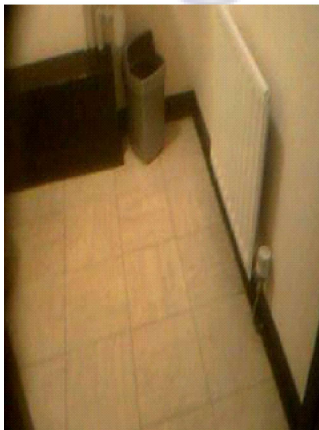
Item 2 As CB008847

The floor tiles to the female WC (Room 3) do not contain asbestos.

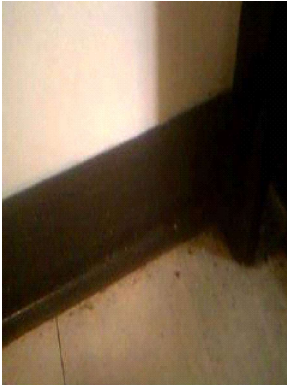
Item 3 Ref: CB008848

The skirting to the female WC (Room 3) does not contain asbestos.

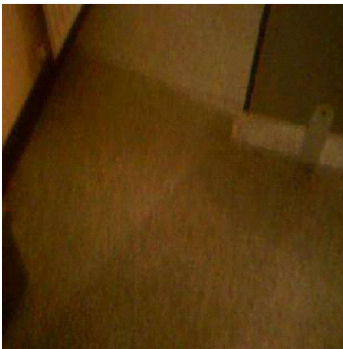
Item 4 As CB008847

The floor tiles beneath the modern lino in the male wc (Room 4) are presumed not to contain asbestos.

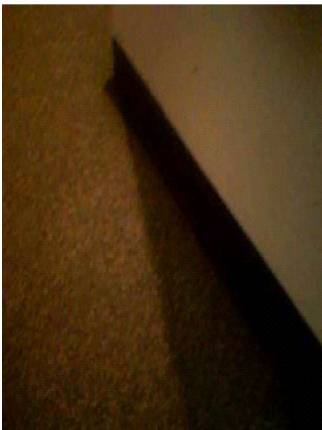
Item 5 As CB008848

The skirting to the male WC (Room 4) does not contain asbestos.

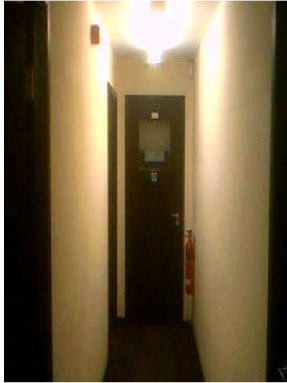
The corridor (Room 5) was accessed and no suspect materials were found.

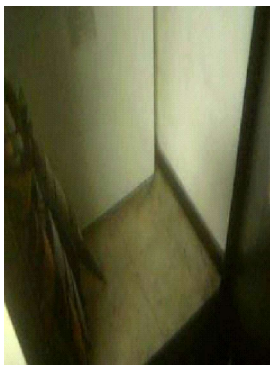
Item 7 As CB008847

The floor tiles to the boiler cupboard (Room 7) do not contain asbestos.

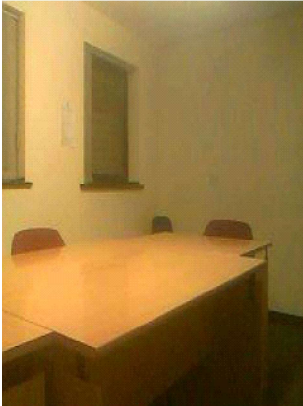
Room 8 (Meeting Room 1) was accessed and no suspect materials were found.

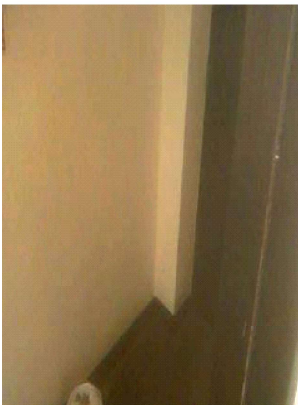
Room 9 (Corridor) as accessed and no suspect materials were found.

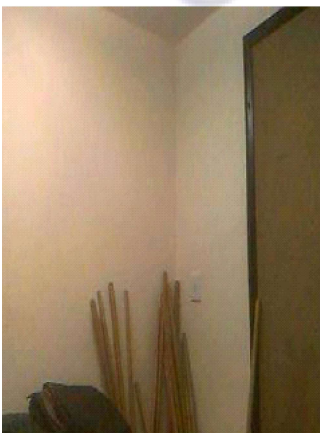
Room 10 (Cleaners Store) was accessed and no suspect materials were found.

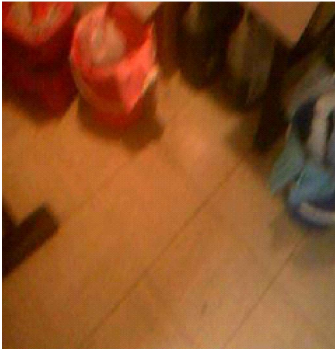
Item 8 As CB008847

The floor tiles to the shower room (Room 11) do not contain asbestos.

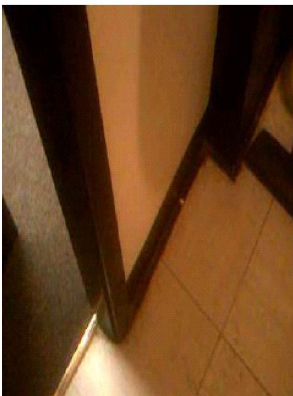
Item 9 As CB008848

The skirting to the shower room (Room 11) does not contain asbestos.

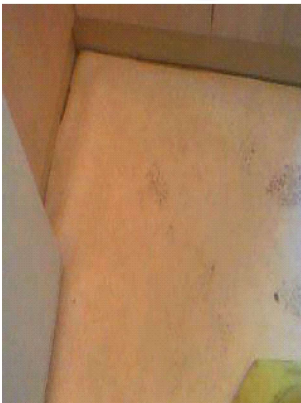
Item 10 As CB008847

The floor tiles to the kitchen (Room 12) do not contain asbestos.

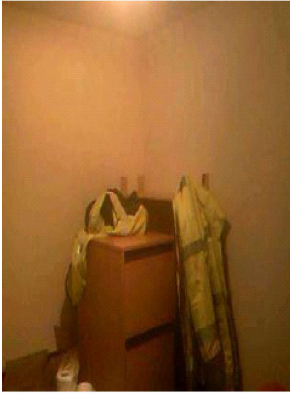
Room 13 (Store) was accessed and no suspect materials were found.

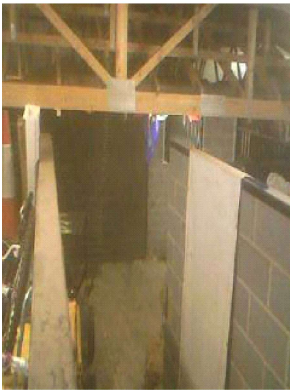
Room 15 (Garage) was accessed and no suspect materials were found.

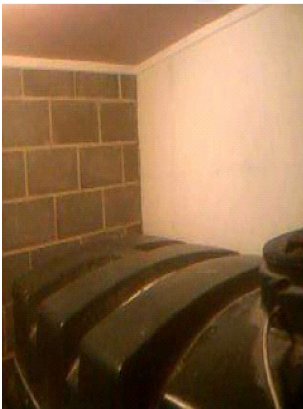
Room 16 (Fuel Store) was accessed and no suspect materials were found.

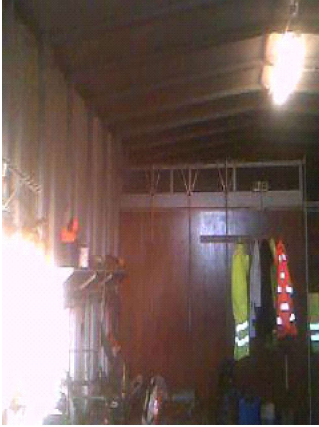
Room 17 (Container) was accessed and no suspect materials were found.

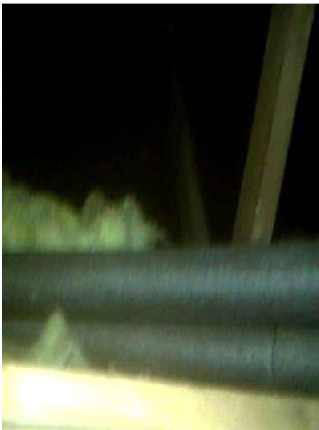
Room 1 (Roof void) was accessed and no suspect materials were found.

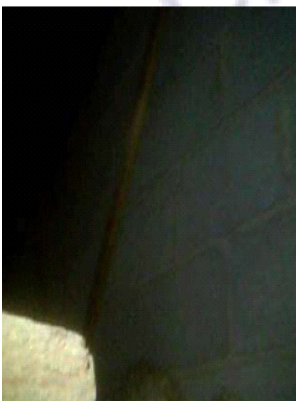
Room 2 (Roof void) was accessed and no suspect materials were found.

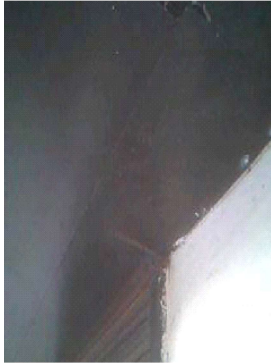
Item 11 Ref CB008850

The external canopy does not contain asbestos.

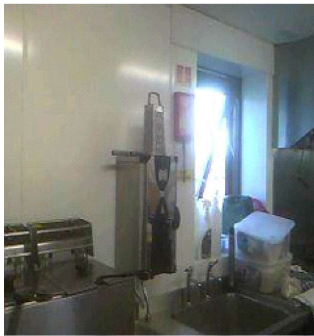
Room 1 (Kitchen) was accessed and no suspect materials were found.

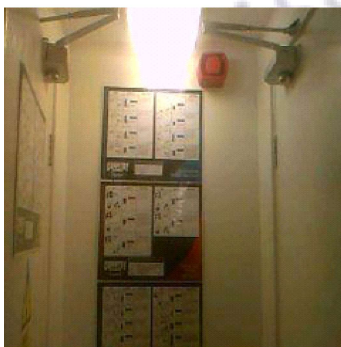
Room 2 (WC Lobby) was accessed and no suspect materials were found.

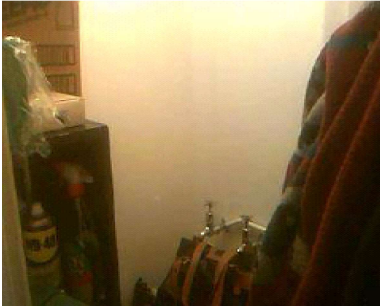
Room 3 (store) was accessed and no suspect materials were found.

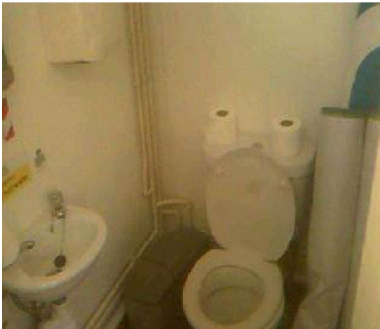
Room 4 (WC) was accessed and no suspect materials were found.

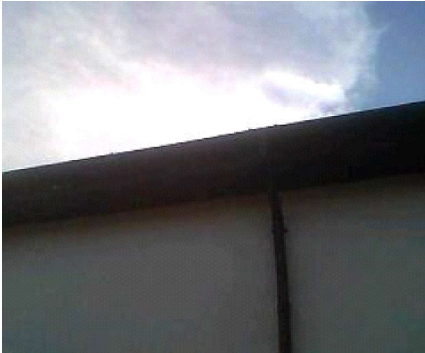
The external to the café was accessed and no suspect materials were found.

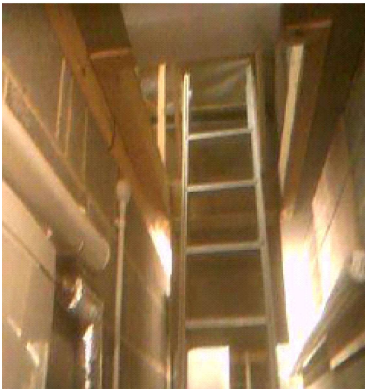
Item 12 Ref: CB008849

The ceiling and the loft hatch to the service hatch (Room 1) does not contain asbestos.

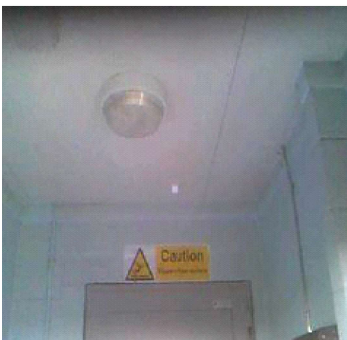
Item 13 As: CB008849

The ceiling to the WC lobby (Room 2) does not contain asbestos.

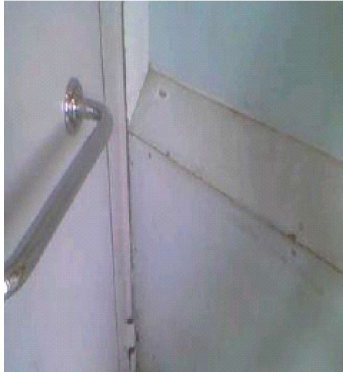
Item 14 As: CB008849

The boxing and wall panels to either side of the disabled WC (Room 2) does not contain asbestos.

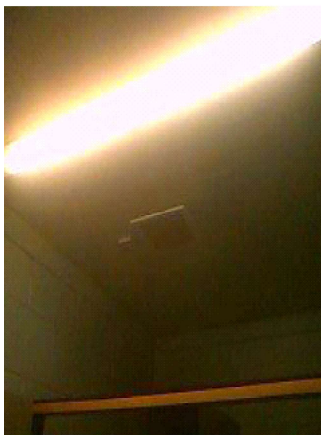
Item 15 As: CB008849

The ceiling to the female WC (Room 3) does not contain asbestos.

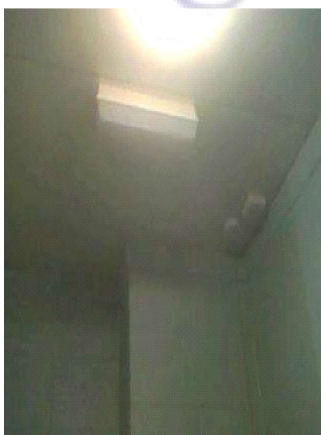
Item 16 As: CB008849

The ceiling to the disabled WC (Room 4) does not contain asbestos.

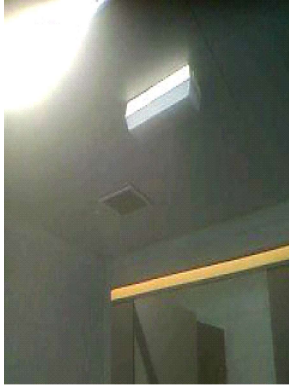
Item 17 As: CB008849

The ceiling to the male wc (Room 5) does not contain asbestos.

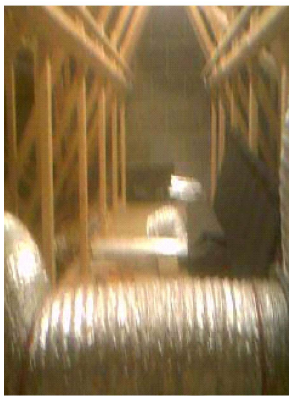
The roof void (Room 1) was accessed and no suspect materials were found.

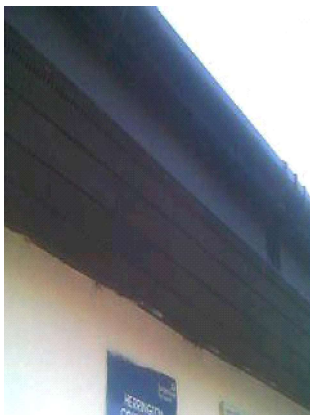
The external to the area was accessed and no suspect materials were found.

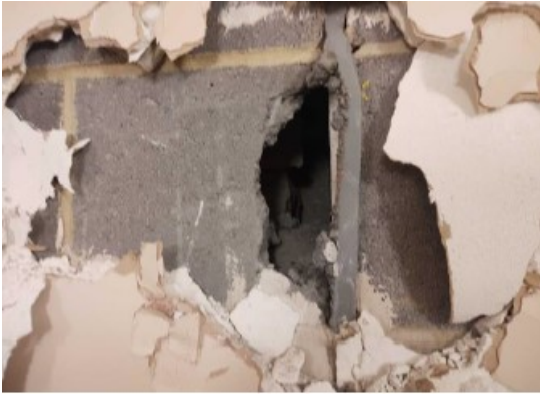
Item 18 Ref: 22-42145-1

The mastic within block wall in the Café Area (Area 4) does not contain asbestos.

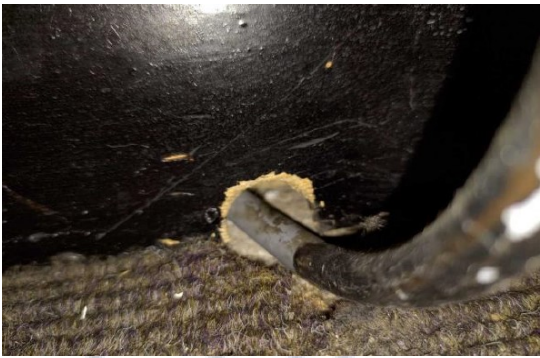
Item 19 Ref: 22-45451-1

The walls in the entrance lobby (Area 1) does not contain asbestos.

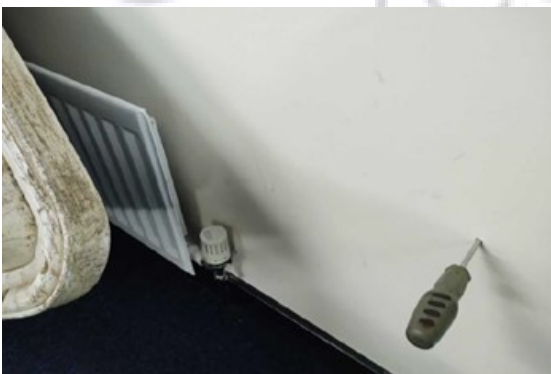
Item 20 Ref: 22-45451-1

The walls in the meeting room (Area 11) does not contain asbestos.
