### **ASBESTOS SURVEY REPORT FOR WASHINGTON SCHOOL – CARETAKERS HOUSE**

**Asbestos Register for  
WASHINGTON SCHOOL – CARETAKERS HOUSE**

**UPRN: - 1155/02**

**Premises Manager / Samo: - Tenant      Date: 23 November 2022**

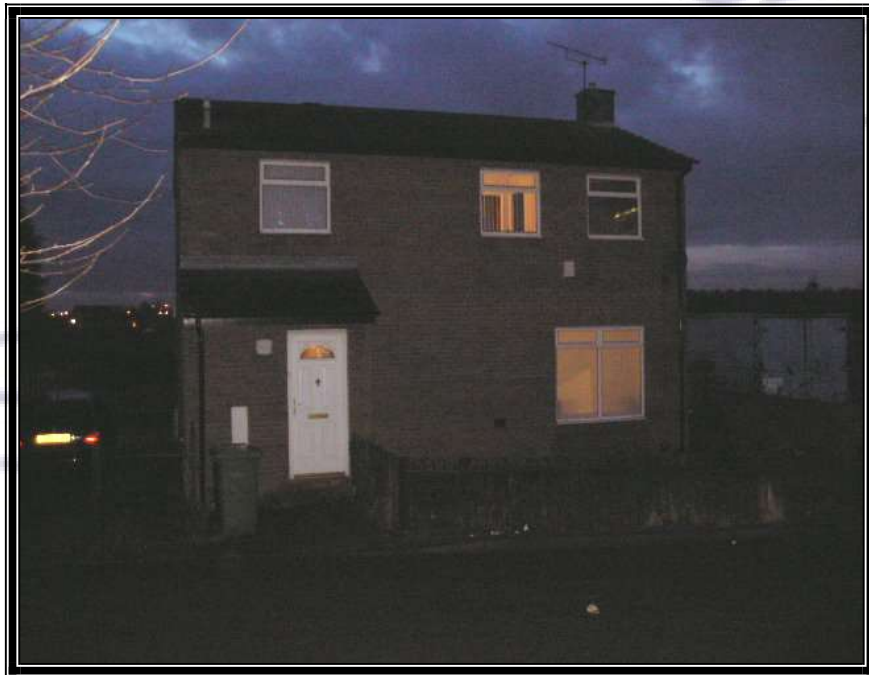
### **Plan of Building and Samples Location – CT House**

WSCT/001 – Textured coating - Kitchen (Item 1) No Risk  
WSCT/002 – Textured coating - Hallway (Item 2) No Risk  
As WSCT/002 – Textured coating – Front Porch (Item 3) No Risk  
WSCT/003 – Textured coating – Grnd floor WC (Item 4) No Risk  
WSCT/004 – Textured coating - Lounge (Item 5) Low Risk  
WSCT/005 – Textured coating – cupboard under stairs (Item 6) No Risk  
WSCT/006 – Textured coating – Bathroom (Item 7) Low Risk  
WSCT/007 – Textured coating – Large Bedroom (Item 8) Low Risk  
WSCT/008 – Textured coating – Middle Bedroom (Item 9) No Risk  
WSCT/009 – Textured coating – Smallest Bedroom (Item 10) No Risk  
WSCT/010 – Textured coating – Landing (Item 11) No Risk  
As WSCT/010 – Textured coating – Airing cupboard (Item 12) No Risk  
WSCT/011 – Roofing Felt (Item 13) No Risk  
WSCT/012 – Fillet to front porch (Item 14) No Risk

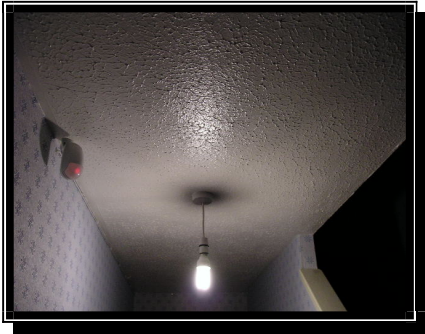
**Item 1 Ref: WSCT/001**

The textured coating to the ceiling in the kitchen does not contain asbestos.

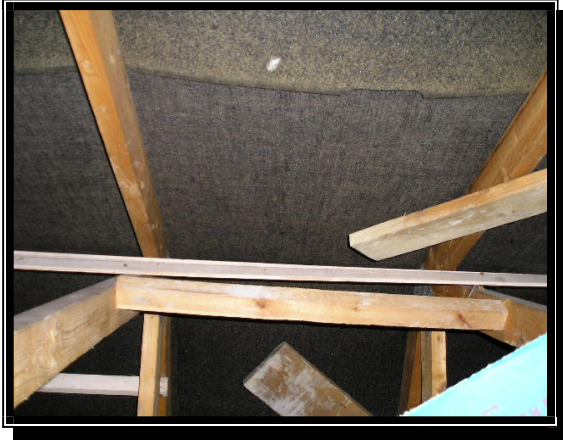
**Item 13- Ref: WSCT/011**

The roofing felt in the loft does not contain asbestos.

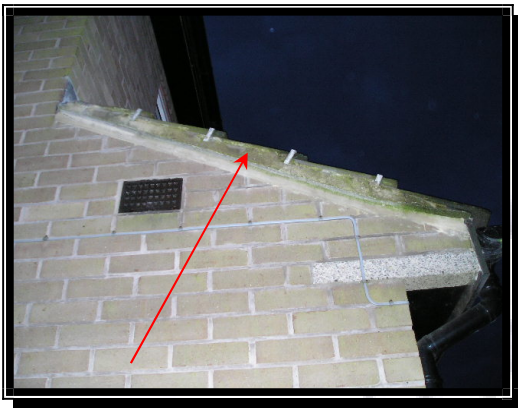
**Item 14- Ref: WSCT/012**

The cement fillet to the front porch roof does not contain asbestos.
