ASBESTOS SURVEY REPORT FOR CONNEXIONS CENTRE, THE GALLERIES, WASHINGTON.

Asbestos Register for

**Connexions Centre, The Galleries, Washington,
NE38 7RZ**

Premises Manager / Samo: - Tenant Date: 23 November 2023

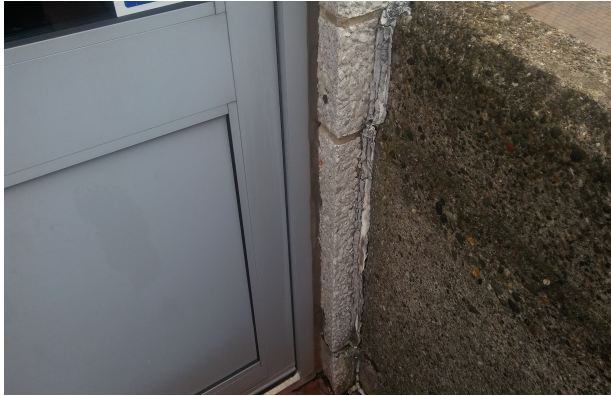
Item 1 Ref: 218435-1

218435-1 Mastic to door frame (External) (Item 1) – No Risk

The mastic around the door frame (External) does not contain asbestos.

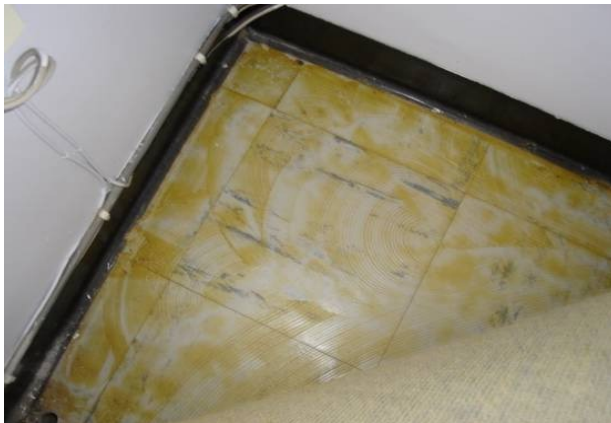
Item 2 Ref:As FP09-453-3

As FP09-453-3 – Floor tiles below carpet - Tiles removed bitumen remains (Interview Rm 9 / Rm 0/002) (Item 2) – Very Low Risk (*Pattinsons Survey ref 21-30945-1/Office 6/Interview Room 1*)

The floor tiles – below carpet in Interview Room 9 (Rm 0/002) do contain asbestos. Tiles removed bitumen remains.

Any change in its appearance should be recorded and passed to Property Services.

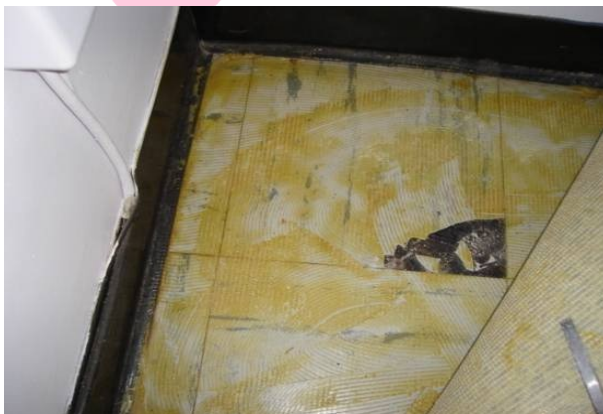
Item 3 Ref: FP09-453-3

FP09-453-3 – Floor tiles (Kitchen / Rm 0/003) (Item 3) – Very Low Risk (*Pattinsons Survey ref 21-30945-1/Kitchen*)

The floor tiles in the Kitchen (Rm 0/003) do contain asbestos.

Any change in its appearance should be recorded and passed to Property Services.

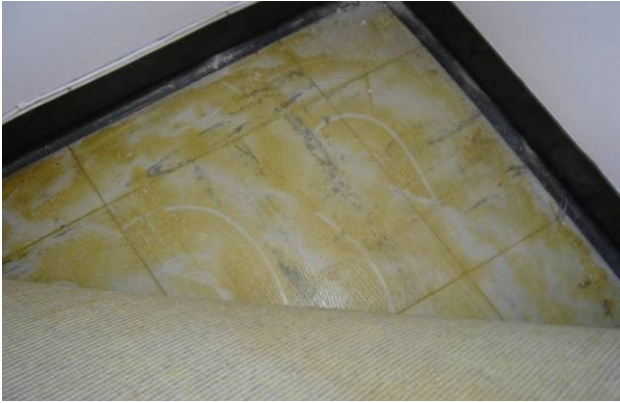
Item 4 Ref:As FP09-453-3

As FP09-453-3 – Floor tiles below carpet - Tiles removed bitumen remains (Interview Rm 3 & 4 / Rm 0/004) (Item 4) – Very Low Risk (*Pattinsons Survey ref 21-30945-1/Interview Room 2/3*)

The floor tiles – below carpet in Interview Rooms 3 & 4 (Rm 0/004) do contain asbestos.

- Tiles removed bitumen remains

Any change in its appearance should be recorded and passed to Property Services.

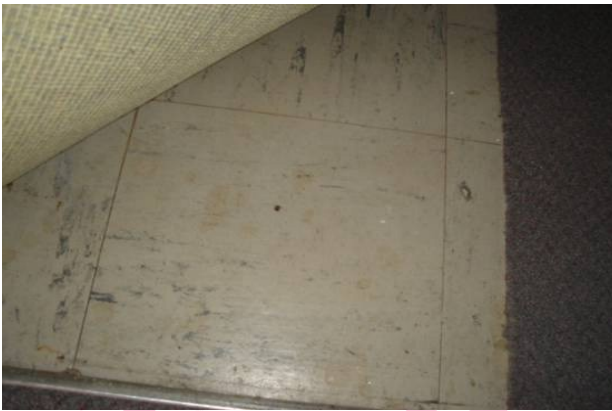
Item 5 Ref: FP09-453-5

FP09-453-5 – Floor tiles below carpet - Tiles removed bitumen remains (Cleaners Cupboard / Rm 0/005) (Item 5) – Very Low Risk (*Pattinsons Survey ref 21-30945-1/Cleaners Cupboard*)

The floor tiles – below carpet in the Cleaners Cupboard (Rm 0/005) do contain asbestos.

- Tiles removed bitumen remains

Any change in its appearance should be recorded and passed to Property Services.

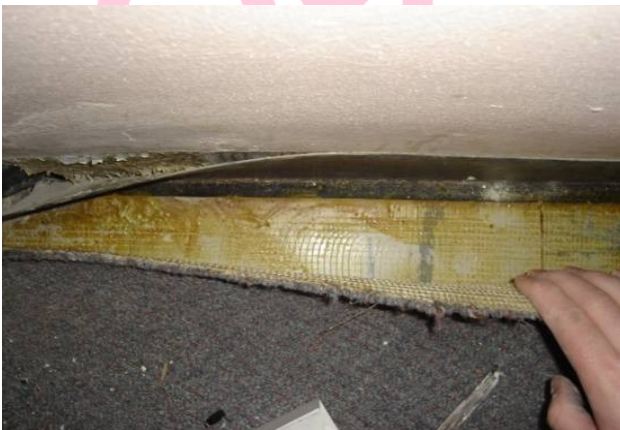
Item 6 Ref:As FP09-453-5

As FP09-453-5 – Floor tiles below carpet - Tiles removed bitumen remains (Store / Rm 0/006) (Item 6) – Very Low Risk (*Pattinsons Survey ref 21-30945-1/Server Room*)

The floor tiles – below carpet in the Store (Rm 0/006) do contain asbestos.

- Tiles removed bitumen remains

Any change in its appearance should be recorded and passed to Property Services.

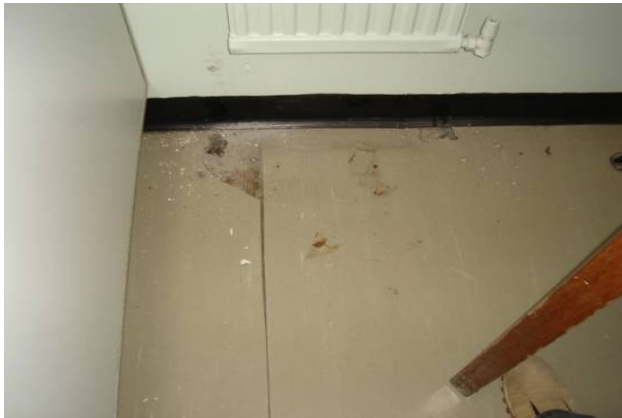
Item 7 Ref: FP09-453-7

FP09-453-7 – Floor covering (Female & Male WC / Rm 0/007) (Item 7) – Very Low Risk (*Pattinsons Survey ref 21-30945-1/Ladies and Gents Toilets*)

The floor tiles in the Female & Male WC (Rm 0/007) do contain asbestos.

Any change in its appearance should be recorded and passed to Property Services.

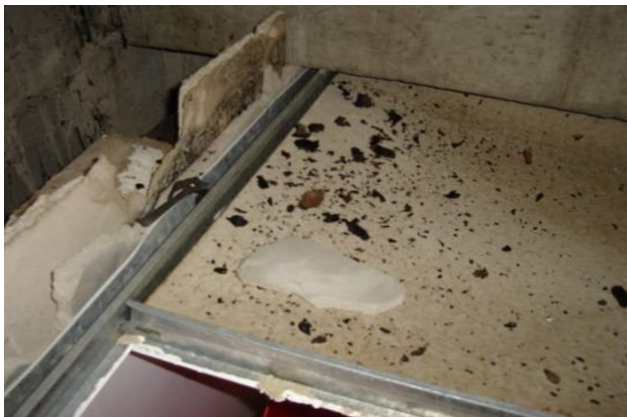
Item 8 Ref: FP09-453-1

FP09-453-1 – Debris (Interview Rms 9 & 10 – ceiling void / Rm 0/002) (Item 8) – No Risk

The roof debris in Interview Rooms 9 & 10 ceiling void (Rm 0/002) does not contain asbestos.

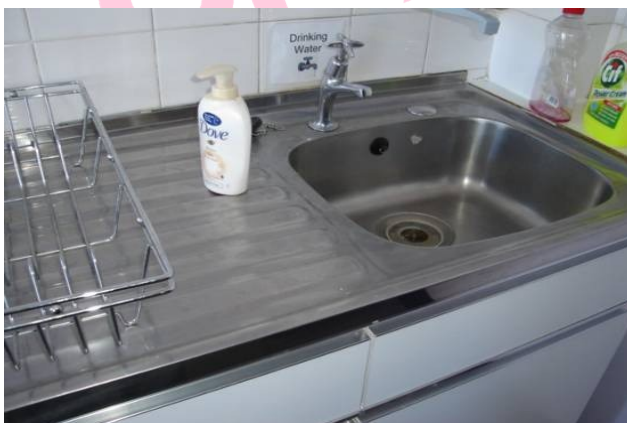
Item 9 Ref: FP09-453-2

FP09-453-2 – Sink Pad (Kitchen / Rm 0/003) (Item 9) – No Risk

The sink pad in the Kitchen (Rm 0/003) does not contain asbestos.

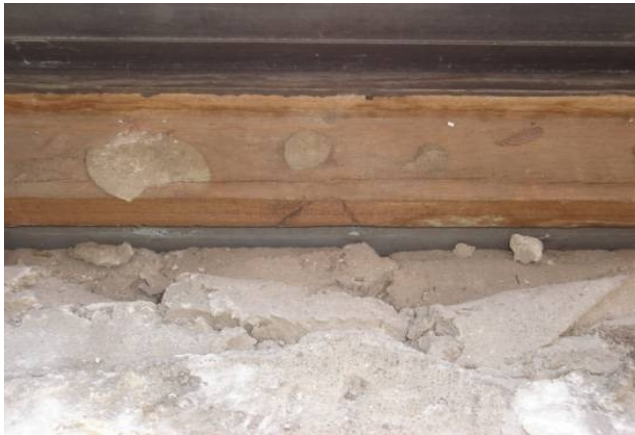
Item 10 Ref: FP09-453-4

FP09-453-4 – Panel below window – within cavity (Interview Rms 3 & 4 / Rm 0/004) (Item 10) – No Risk

The panel below window (within cavity) in the Interview Rooms 3 & 4 (Rm 0/004) does not contain asbestos.

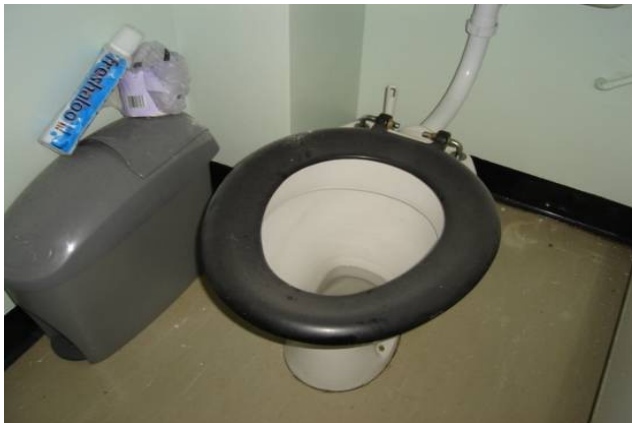
Item 11 Ref: FP09-453-6

FP09-453-6 – Toilet Seats (Female & Male WC / Rm 0/007) (Item 11) – No Risk

The toilet seats in the Female & Male WC (Rm 0/007) does not contain asbestos.

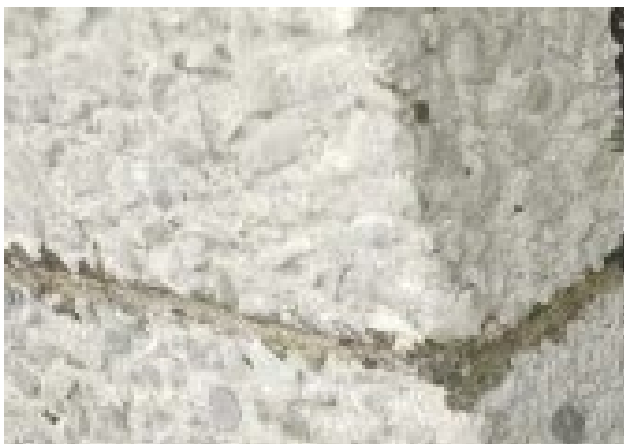
Item 12 Ref: 22-41634-3

22-41634-3 – Sealant around windows to connexions building (Area 1/External) (Item 12) – No Risk

The sealant around windows to connexions building (Area 1/External) does not contain asbestos.

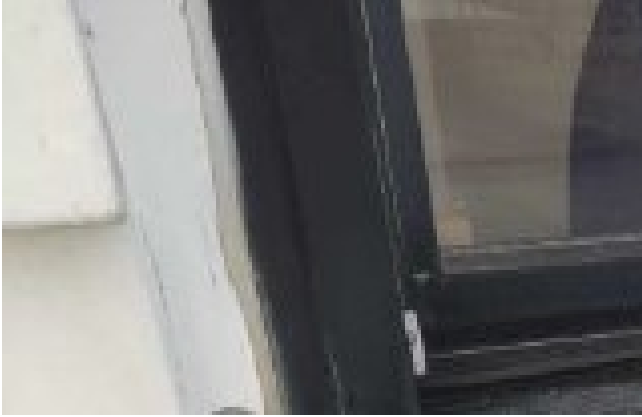
Item 13 Ref: 22-41634-4

22-41634-4 – Sills below windows to connexions building (Area 1/External) (Item 13) – No Risk

The sills below windows to connexions building (Area 1/External) does not contain asbestos.
