ASBESTOS SURVEY REPORT FOR 5 ELWIN TERRACE, SUNDERLAND, SR2 7JF

Asbestos Register for

5 Elwin Terrace, Sunderland, SR2 7JF

5 Elwin Terrace updated 29/05/2024 V.2.0

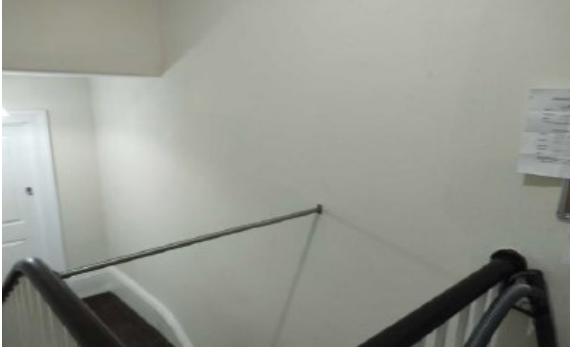
Item 1 Ref: 22-47975-1

The textured coating walls in Area 1 - Landing and Stairs does not contain asbestos.

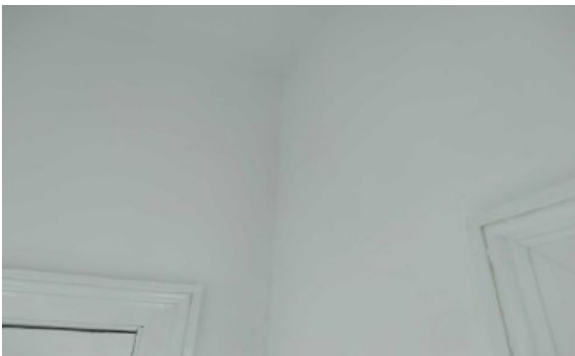
Item 2 Ref: 22-47975-1

The textured coating walls in Area 2 - Bedsit 5 does not contain asbestos.

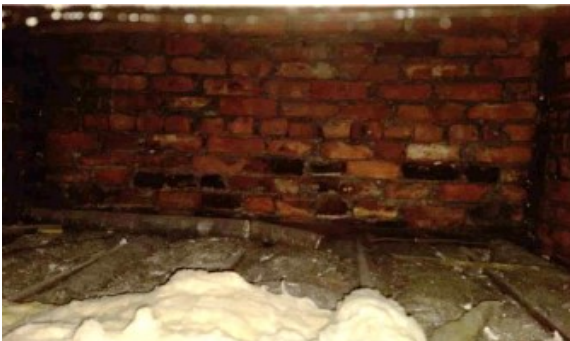
Item 3 Ref: Presumed

The redundant cement flue pipe in Area 6 – Loft 2 is strongly presumed to contain asbestos.

Any change in its appearance should be recorded and passed to Property Services.

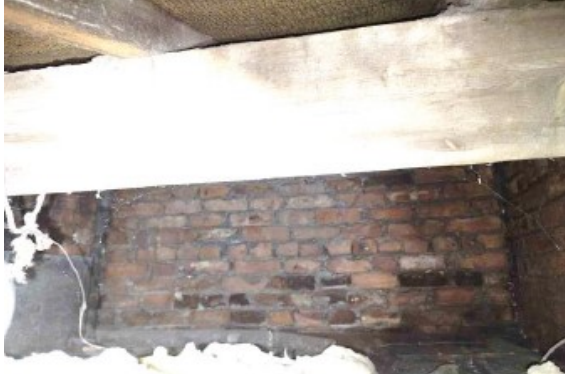
Item 4 Ref: Presumed

The redundant cement flue pipe in Area 6 – Loft 2 is strongly presumed to contain asbestos.

Any change in its appearance should be recorded and passed to Property Services.

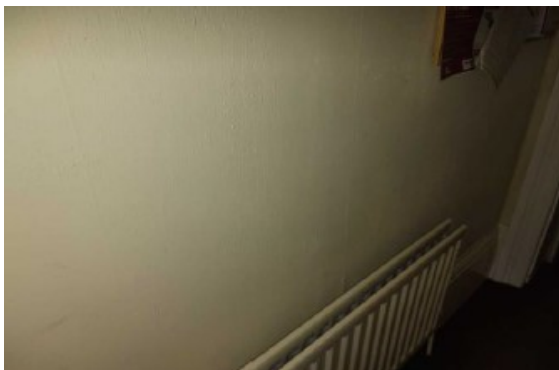
Item 5 Ref: 22-47975-1

The textured coating walls in Area 8 – Entrance Hall does not contain asbestos.

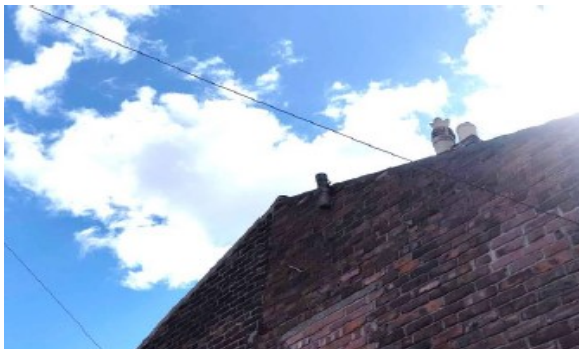
Item 6 Ref: Presumed

The redundant cement flue pipe External is strongly presumed to contain asbestos.

Any change in its appearance should be recorded and passed to Property Services.
