ASBESTOS SURVEY REPORT FOR PENSHAW HOUSE, STATION ROAD,
HOUGHTON LE SPRING, DH4 7LB.

Asbestos Register for

Penshaw House, Station Road, Houghton le Spring

Date: 23 November 2022

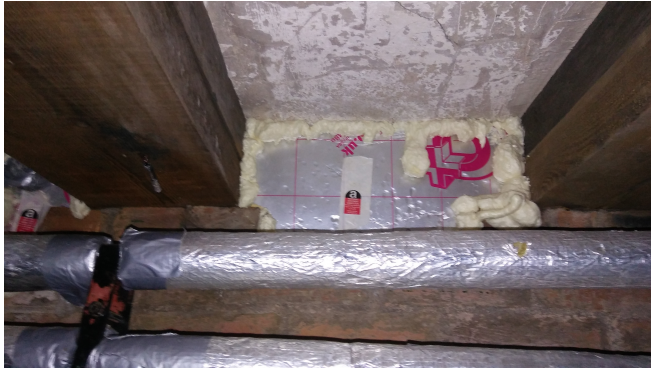
Item 1 Ref: 66981-3

The pipe lagging to high level wine store pipework (adj plasterboard ceiling) in the basement (Rm -1/001) does contain asbestos.

Any change in appearance should be reported to Property Services.

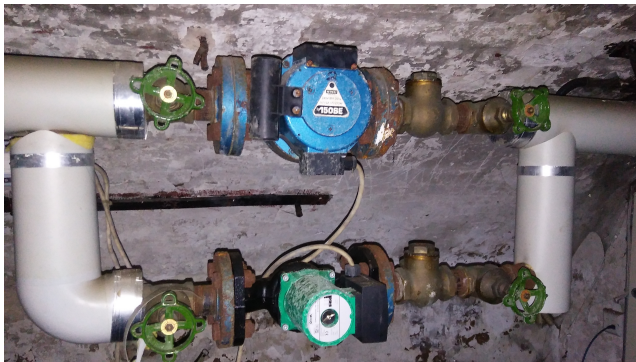
Item 2 Ref: 376431-1

The access within boiler in the basement (Rm -1/001) does not contain asbestos.

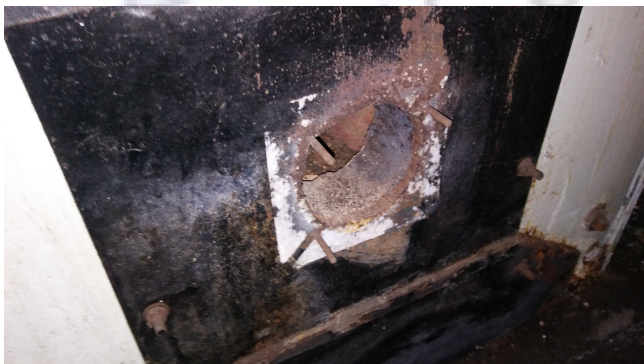
Item 3 Ref: DC0737/10

The pipework flange gaskets (inc boiler) in the basement (Rm -1/001) does not contain asbestos.

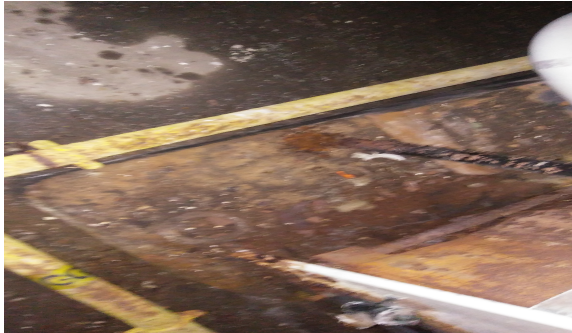
Item 4 Ref: 376431-3

The loose lying gaskets in the basement (Rm -1/001) does not contain asbestos.

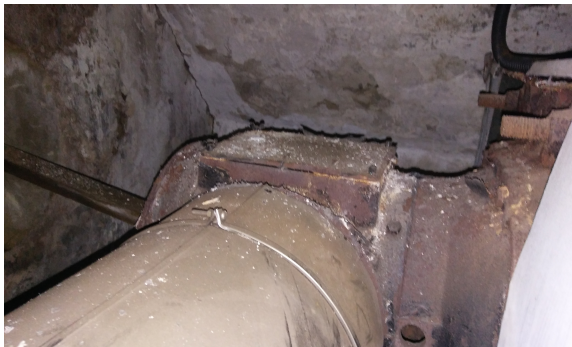
Item 5 Ref: 376431-4

The gaskets to rear of boiler (square) in the basement (Rm -1/001) does not contain asbestos.

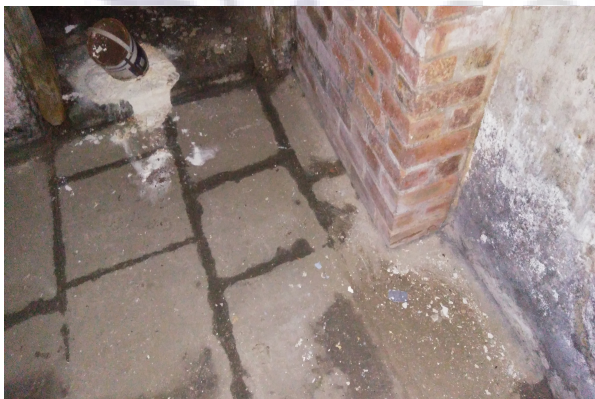
Item 6 Ref: 376431-5

The debris to the floor (adj wine store) in the basement (Rm -1/001) does not contain asbestos.

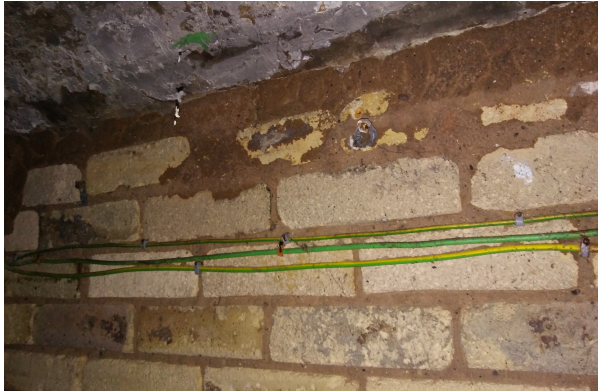
Item 7 Ref: 376431-6

The debris to wall and pipe hangers within boiler location in the basement (Rm -1/001) does not contain asbestos.

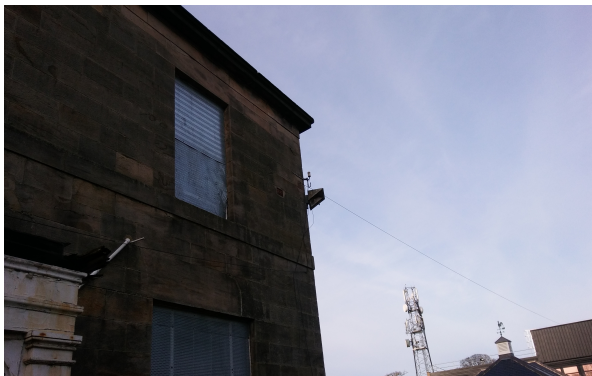
Item 8 Ref: Presumed

The telecommunications point (External) is presumed to contain asbestos.

Any change in appearance should be reported to Property Services.
