ASBESTOS SURVEY REPORT FOR 15 NILE STREET, SUNDERLAND, SR1 1EY.

Asbestos Register for

15 Nile Street, Sunderland, SR1 1EY

Date: 30 September 2024

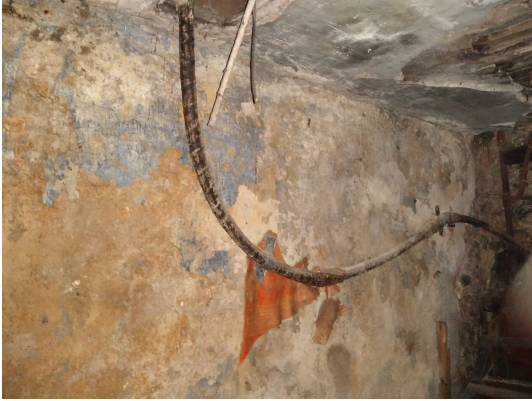
Item 1 Ref: 403295-1

- (Item 1) Ref: 403295-1 – Wrap to main incomer (Store/Rm -1/001) – No Risk
- (Item 2) Ref: As 403295-5 – Floor covering (Store/Rm -1/001) – No Risk
- (Item 3) Ref: 403295-2 – Cement panel to floor (Store/Rm -1/002) – Removed May 2020

The wrap to main incomer in the store (Rm -1/01) does not contain asbestos.

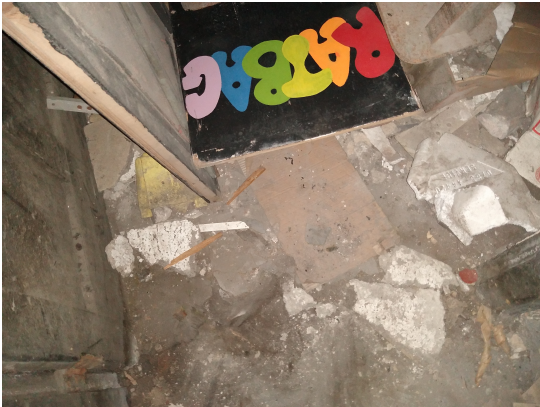
Item 2 Ref: As 403295-5

The floor covering in the store (Rm -1/01) does not contain asbestos.

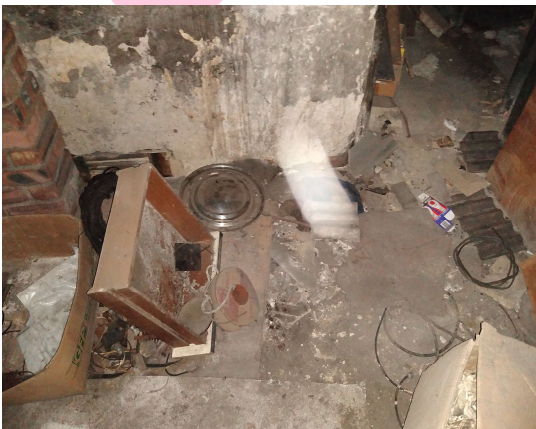
Item 3 Ref: 403295-2

The cement panel to floor in the store (Rm -1/02) contains asbestos.

| Picture | Location | Risk | Inspection Frequency | Date of return |
|---|---|---|---|---|
| Item 3 | Cement panel to floor (Store/Rm - 1/002) | Low Risk | 6 monthly | Removed May 2020 |

Removed May 2020.

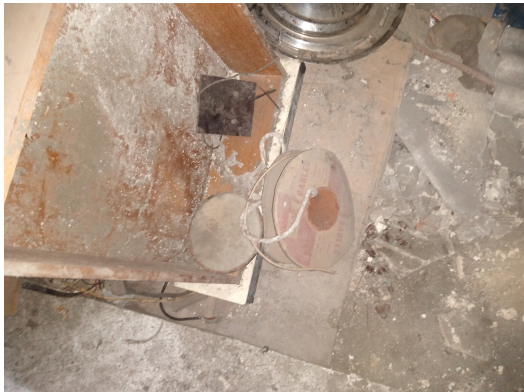
Item 4 Ref: 403295-3

The rope to cable reel in the store (Rm -1/002) does contain asbestos.

| Picture | Location | Risk | Inspection Frequency | Date of return |
|---|---|---|---|---|
| Item 4 | Rope to cable reel (Store/Rm - 1/002) | Low Risk | 6 monthly | Removed May 2020 |

Removed May 2020

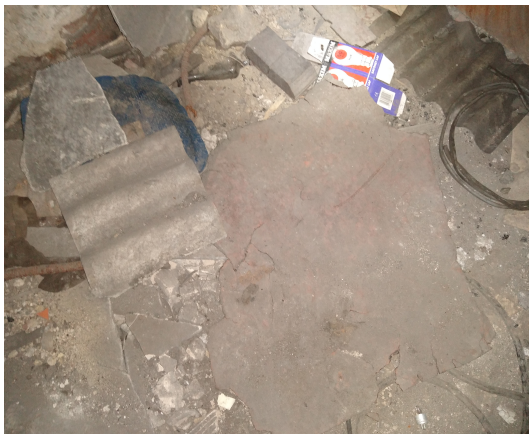
Item 5 Ref: 403295-4

The floor covering in the store (Rm -1/002) does not contain asbestos.

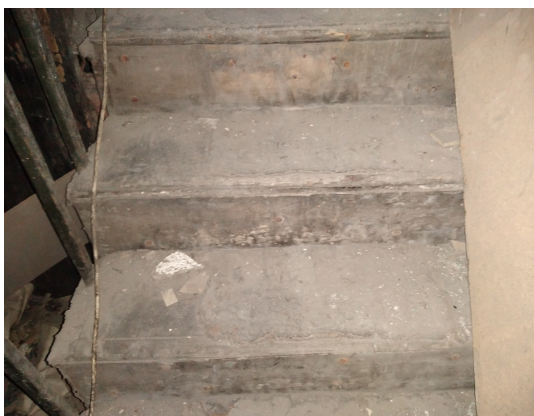
Item 6 Ref: 403295-5

The floor covering to stairs in the stairwell (Rm -1/004) does not contain asbestos.

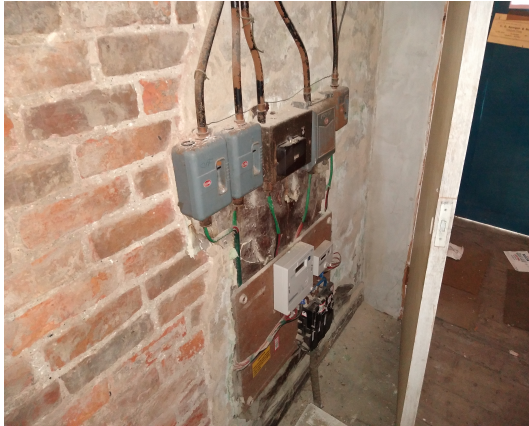
Item 7 Ref: Presumed

The Electrics in the entrance hallway (Rm 0/02) is presumed to contain asbestos.

| Picture | Location | Risk | Inspection Frequency | Date of return |
|---|---|---|---|---|
| Item 7 | Electrics flash protection (Entrance hallway/Rm 0/002) | Low Risk | 6 monthly | 11/03/2025 |

Further investigation is required before any works can commence.

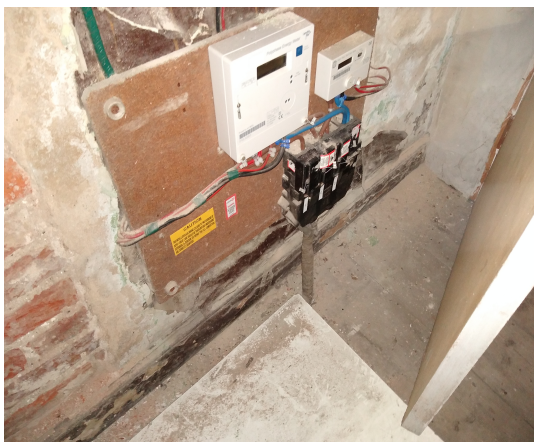
Item 8 Ref: As 403295-1

The wrap to main incomer in the entrance hallway (Rm 0/002) does not contain asbestos.

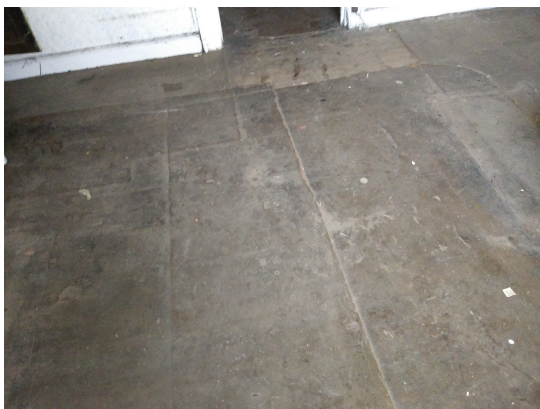
Item 9 Ref: 403295-6

The floor covering in the living room (Rm 0/003) does not contain asbestos.

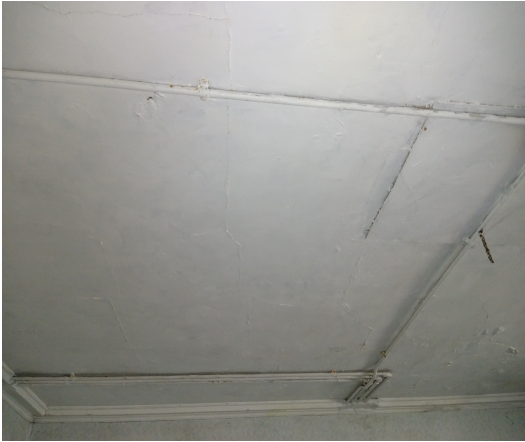
Item 10 Ref: 403295-7

The decorative finish to lath and plaster ceiling in the living room (Rm 0/003) does not contain asbestos.

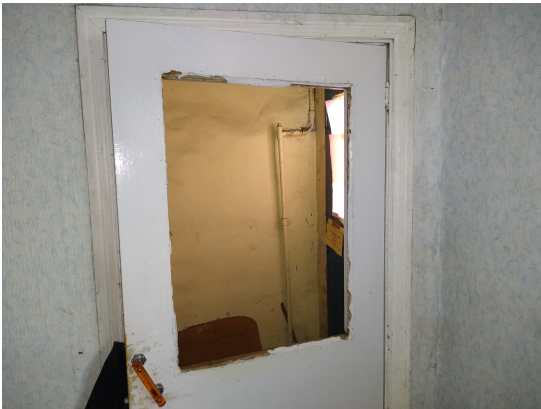
Item 11 Ref: 403295-11

The putty to door in the living room (Rm 0/003) does not contain asbestos.

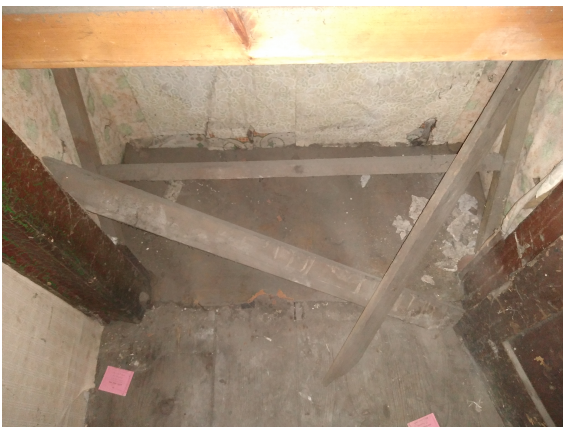
Item 12 Ref: 403295-8

The floor covering in the cupboard (Rm 0/004) does not contain asbestos.

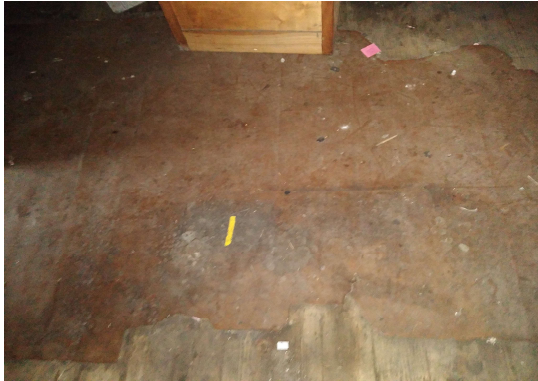
Item 13 Ref: As 403295-6

The floor covering to the workshop (Rm 0/005) does not contain asbestos.

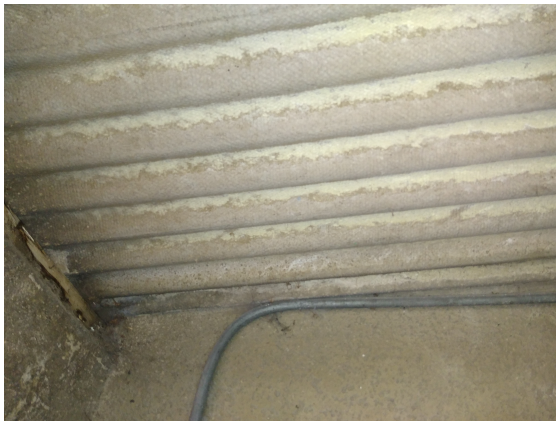
Item 14 Ref: 403295-9

The roof covering in the external wc (Rm 0/006) does contain asbestos.

| Picture | Location | Risk | Inspection Frequency | Date of return |
|---|---|---|---|---|
| Item 14 | Roof covering (External WC/Rm 0/006) | Very Low Risk | 12 monthly | Removed May 2020 |

Removed May 2020

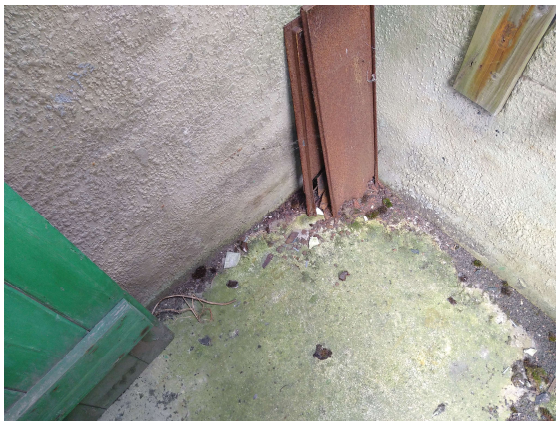
Item 15 Ref: As 403295-9

The cement debris to floor in the external wc (Rm 0/006) does contain asbestos.

| Picture | Location | Risk | Inspection Frequency | Date of return |
|---|---|---|---|---|
| Item 15 | Cement debris to floor (External WC/Rm 0/006) | Low Risk | 6 monthly | Removed May 2020 |

Removed May 2020

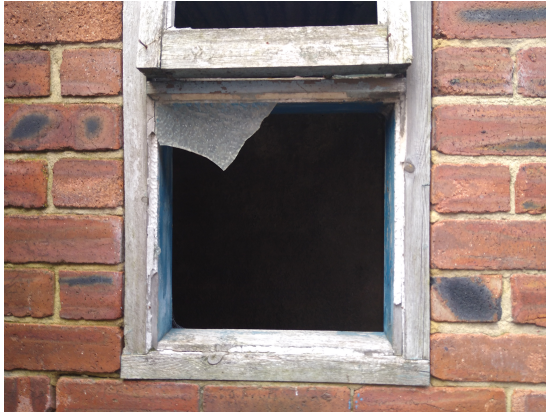
Item 16 Ref: 403295-10

The putty to the windows in the external wc (Rm 0/006) does not contain asbestos.

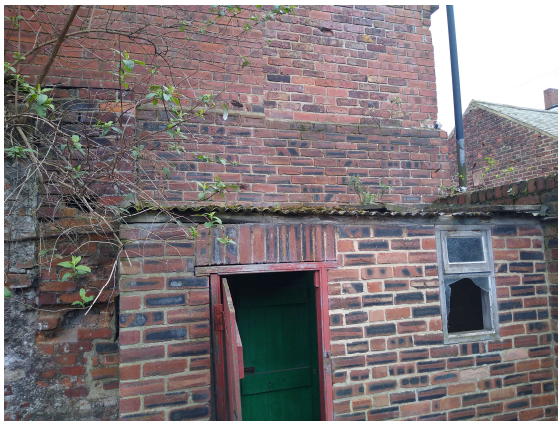
Item 17 Ref: As 403295-9

The roof covering in the external wc (Rm 0/007) does contain asbestos.

| Picture | Location | Risk | Inspection Frequency | Date of return |
|---|---|---|---|---|
| Item 17 | Roof covering (External WC/Rm 0/007) | Very Low Risk | 12 monthly | Removed May 2020 |

Removed May 2020

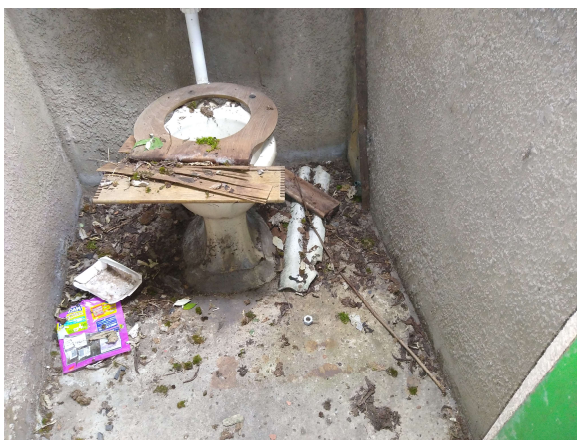
Item 18 Ref: As 403295-9

The cement debris to floor in the external wc (Rm 0/007) does contain asbestos.

| Picture | Location | Risk | Inspection Frequency | Date of return |
|---|---|---|---|---|
| Item 18 | Cement debris to floor (External WC/Rm 0/007) | Low Risk | 6 monthly | Removed May 2020 |

Removed May 2020.

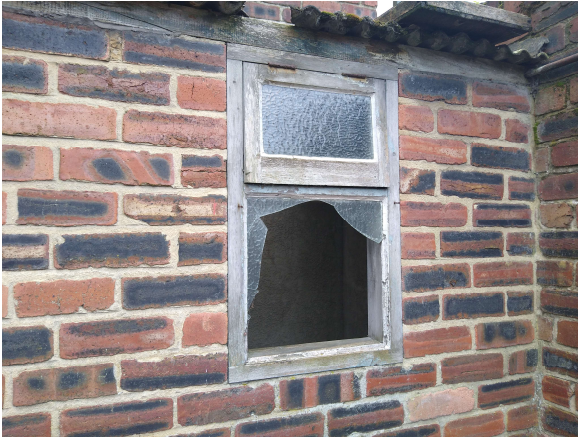
Item 19 Ref: As 403295-10

The putty to the windows in the external wc (Rm 0/007) does not contain asbestos.

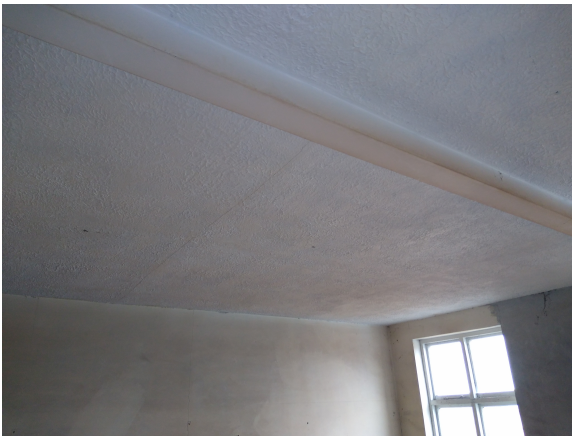
Item 20 Ref: 403295-12

The decorative finish to lath and plasterboard in the living area (Rm 1/001) does not contain asbestos.

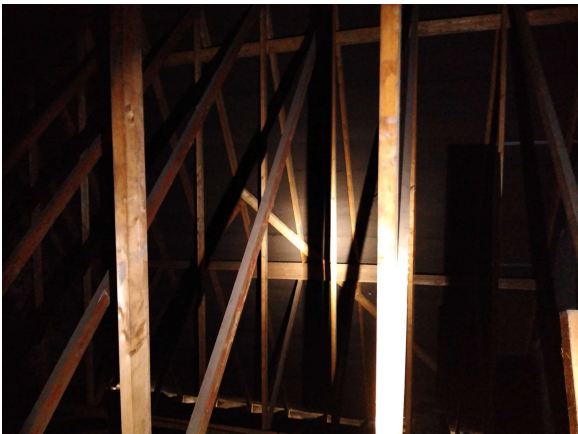
Item 21 Ref: 403295-13

The sarking in the loft void (Rm 2/001) does not contain asbestos.

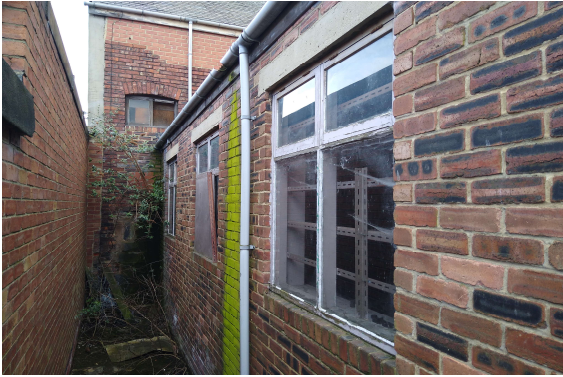
Item 22 Ref: 403295-14

The putty to the windows in the external does not contain asbestos.

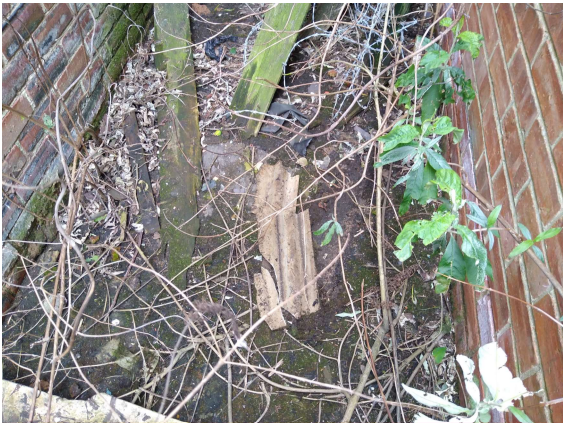
Item 23 Ref: 403295-15

The cement panels to path adjacent to workshop externally does contain asbestos.

| Picture | Location | Risk | Inspection Frequency | Date of return |
|---|---|---|---|---|
| Item 23 | Cement panels to path adjacent | Low Risk | 6 monthly | Removed May 2020 |

Removed May 2020
