ASBESTOS SURVEY REPORT FOR USWORTH RECREATION PARK,
MANOR PARK, USWORTH, WASHINGTON.

Asbestos Register for Usworth Recreation Park, Manor Park, Washington

Date: 09 December 2024

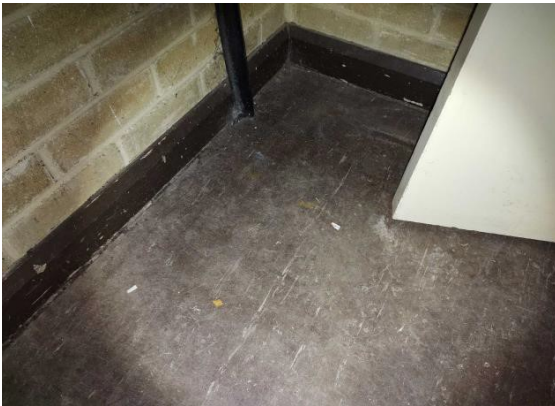
Item 19 Ref: 21-41504-2

The floor (Vinyl) (Room/Area: 3 Cupboard - Electric Meter) does not contain asbestos.
