ASBESTOS SURVEY REPORT FOR FARMBOROUGH COURT, BRENTFORD AVENUE, SUNDERLAND, SR5 4EU.

Asbestos Register for

Farmborough Court, Brentford Avenue, Sunderland

Date: 21 August 2024

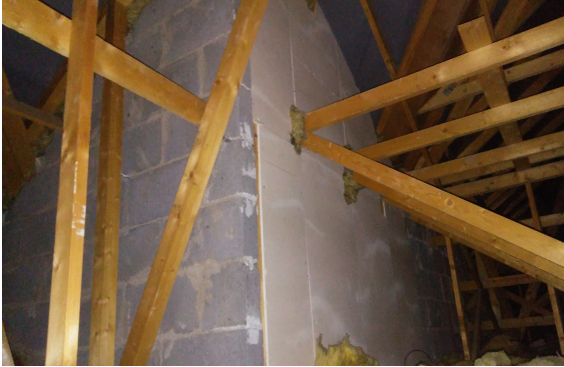
Item 1 Ref: As 416204-2

- (Item 1) Ref: As 416204-2 – Walls (2/001 Loft) – No Risk
- (Item 2) Ref: As 416204-3 – Rear of loft hatch (2/001 Loft) – No Risk
- (Item 3) Ref: As 416204-3 – Rear of loft hatch (2/002 Loft) – No Risk

The walls in Rm 2/001 Loft do not contain asbestos.

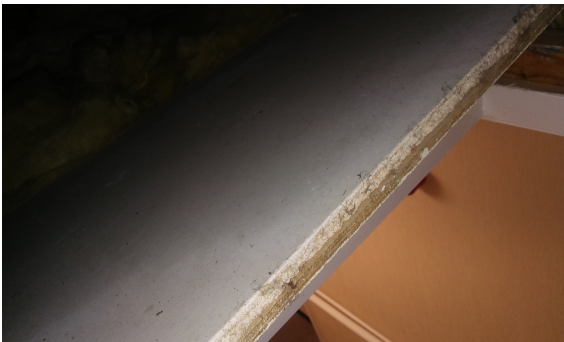
Item 2 Ref: As 416204-3

The rear of loft hatch in Rm 2/001 Loft does not contain asbestos.

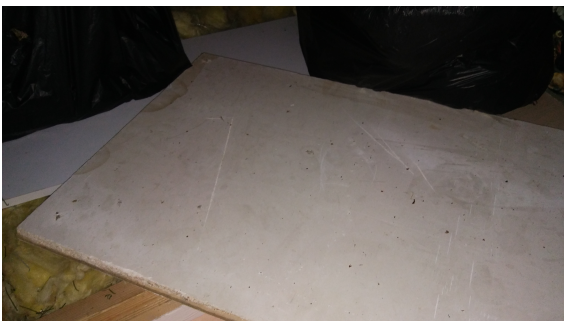
Item 3 Ref: As 416204-3

The rear of loft hatch in Rm 2/002 Loft does not contain asbestos.

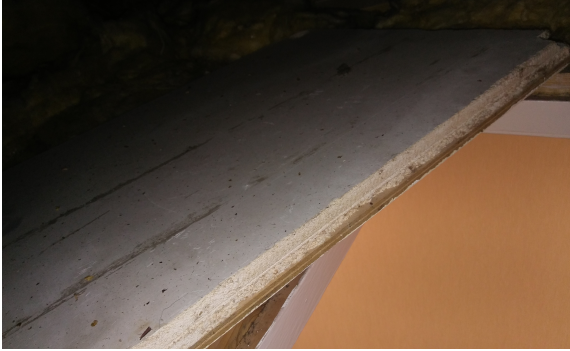
Item 4 Ref: As 416204-3

The rear of loft hatch in Rm 2/003 Loft does not contain asbestos.

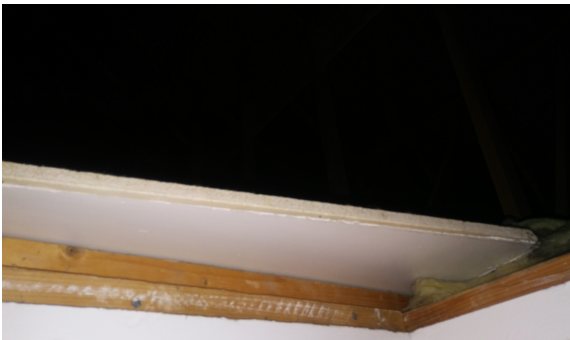
Item 5 Ref: As 416204-3

The loft hatch in Rm 2/004 Loft does not contain asbestos.

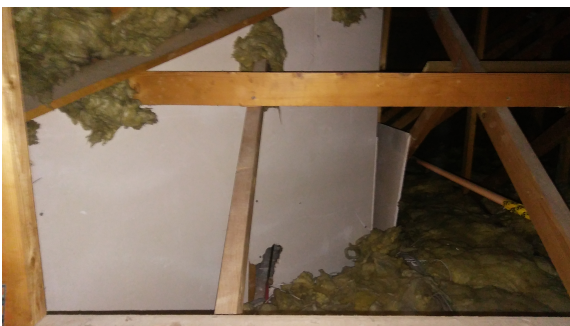
Item 6 Ref: 416204-2

The walls in Rm 2/005 Loft do not contain asbestos.

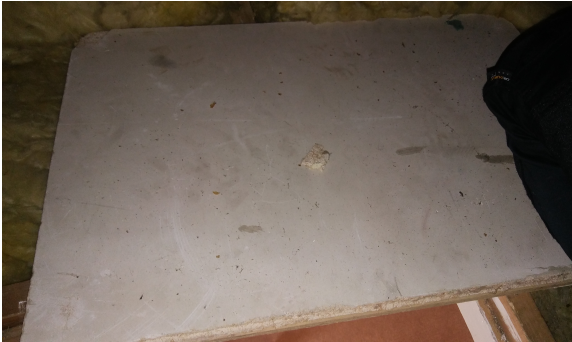
Item 7 Ref: 416204-3

The rear of loft hatch in Rm 2/005 Loft does not contain asbestos.

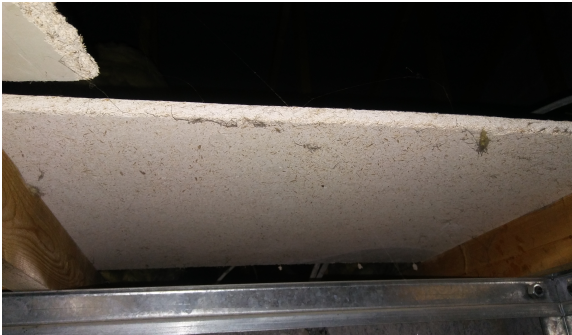
Item 8 Ref: As 416204-4

The ceiling to dumb waiter below in Rm 2/006 Loft does not contain asbestos.

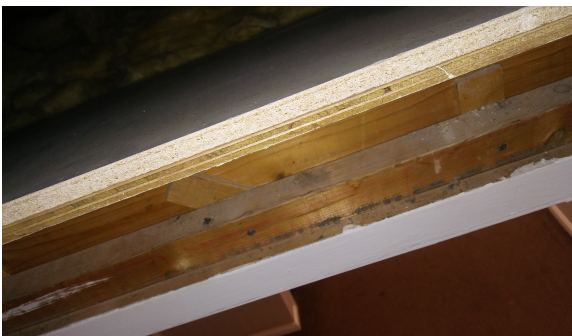
Item 9 Ref: As 416204-3

The rear of loft hatch in Rm 2/007 Loft does not contain asbestos.

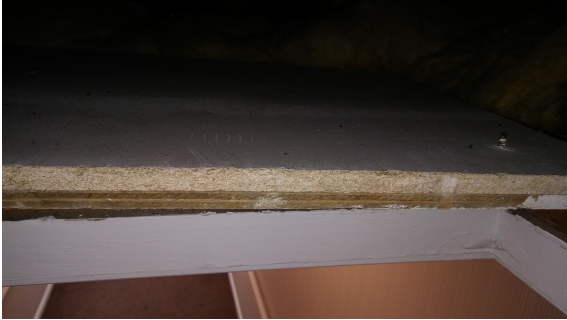
Item 10 Ref: 416204-3

The rear of loft hatch in Rm 2/008 Loft does not contain asbestos.

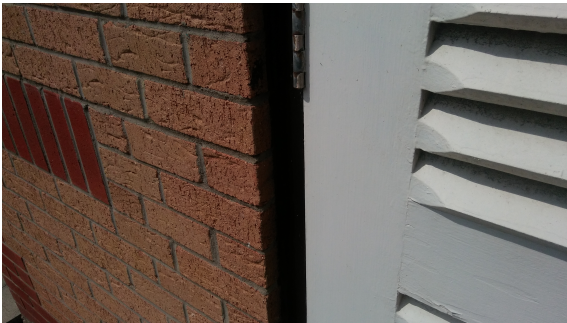
Item 11 Ref: 416204-11

The sealant to door frames (External) does not contain asbestos.

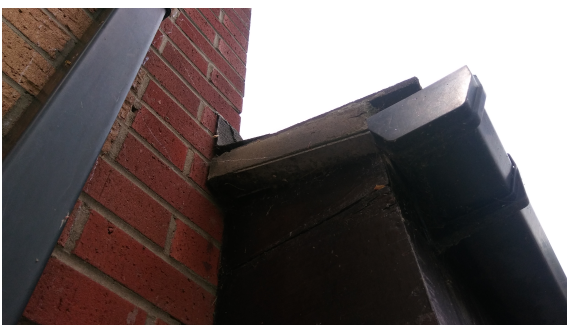
Item 12 Ref: As 416204-3

- (Item 10) Ref: As 416204-3 – Rear of loft hatch (2/008 Loft) – No Risk
- (Item 11) Ref: 416204-11 – Sealant to door frames (External) – No Risk
- (Item 12) Ref: 51416204-12 – Undercloak to lower level roofs (External) – Very Low Risk

The undercloak to lower level roofs (External) contain asbestos.

Any change in its appearance should be recorded and passed to Property Services.

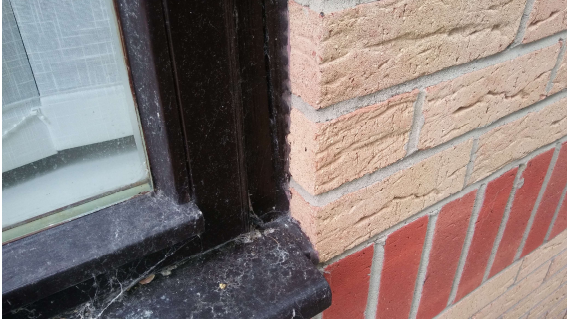
Item 13 Ref: 416204-13

The sealant to window frames (External) does not contain asbestos.

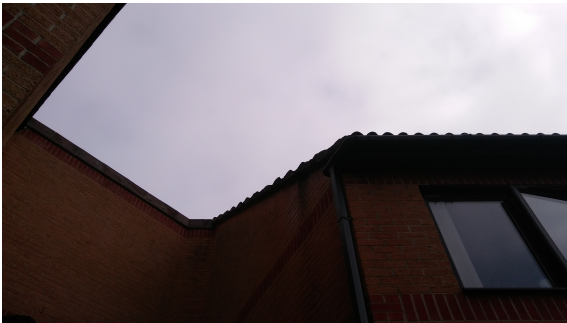
Item 14 Ref: 416204-14

The undercloak high level (above link 2 area/External) does not contain asbestos.

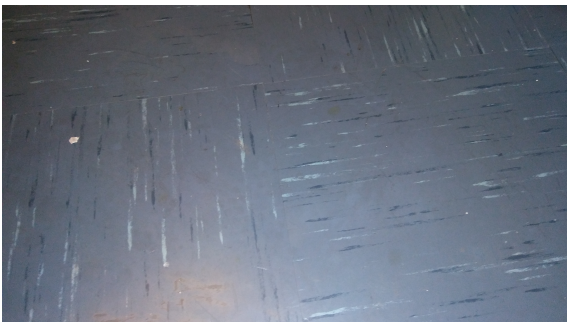
Item 15 Ref: As 416204-9

The floor covering in Rm 0/68 Store Balmoral Unit does not contain asbestos.

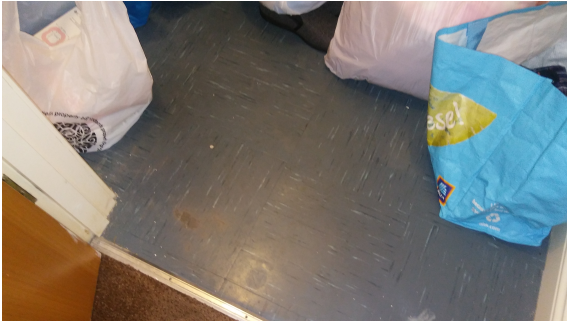
Item 16 Ref: 416204-9

The floor covering in Rm 0/69 Store Balmoral Unit does not contain asbestos.

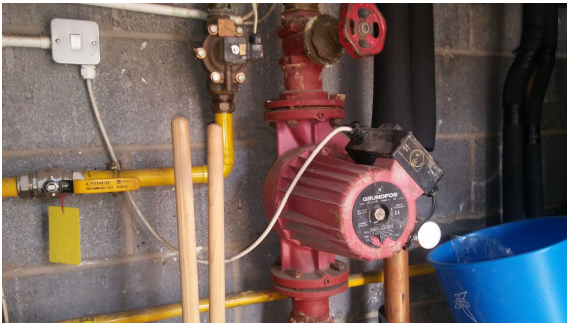
Item 17 Ref: 416204-10

The pipework flange gasket in Rm 0/79 Boiler house does not contain asbestos.

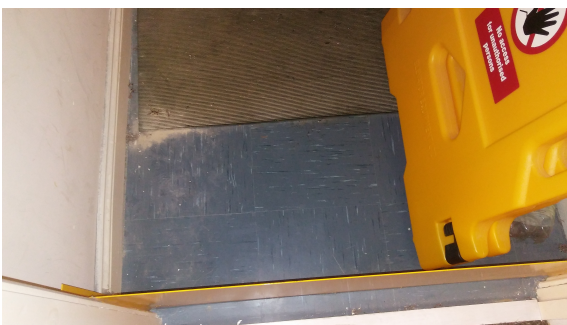
Item 18 Ref: As 416204-5

The floor covering in Rm 1/043 Lift machinery room Buckingham unit does not contain asbestos.

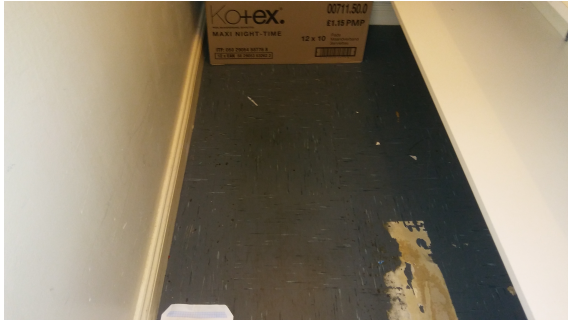
Item 19 Ref: As 416204-5

The floor covering in Rm 1/044 Store Buckingham unit does not contain asbestos.

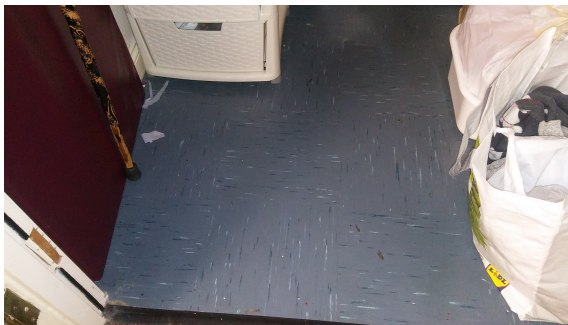
Item 20 Ref: 416204-5

The floor covering in Rm 1/048 Store Buckingham unit does not contain asbestos.

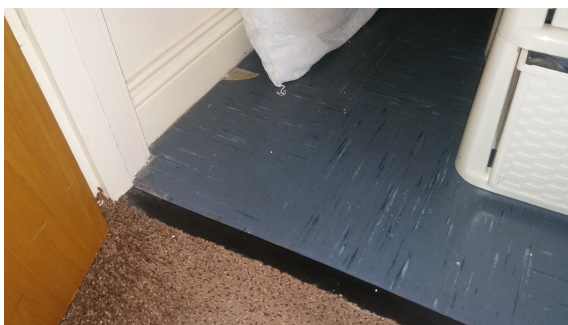
Item 21 Ref: 416204-1

The floor covering in Rm 1/014 Store Clarence unit does not contain asbestos.

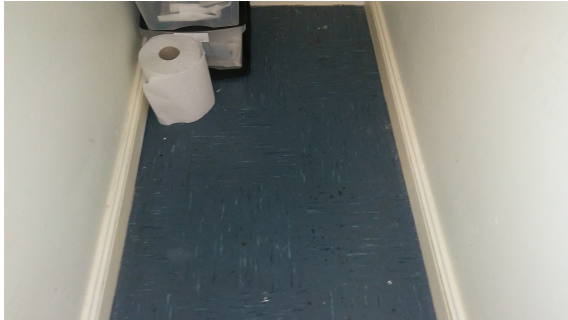
Item 22 Ref: As 416204-1

The floor covering in Rm 1/016 Store Clarence unit does not contain asbestos.

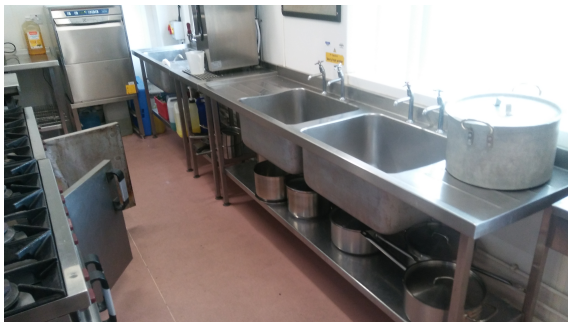
Item 23 Ref: 416204-7

The sink paint in Rm 0/043 kitchen Link 1 does not contain asbestos.

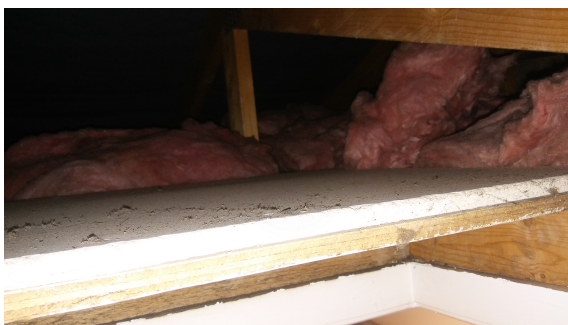
Item 24 Ref: 416204-8

The rear of access hatch in Rm 0/034a Cold store void above Link 1 does not contain asbestos.

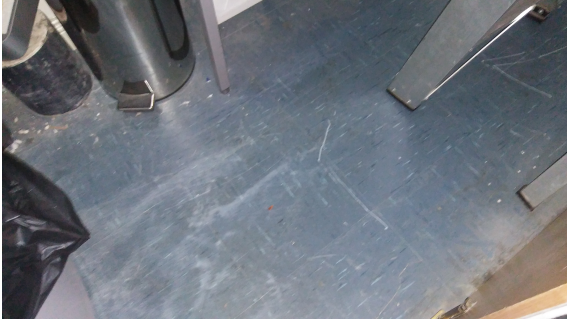
Item 25 Ref: As 416204-1

The floor covering in Rm 0/037 Switchroom Link 1 does not contain asbestos.

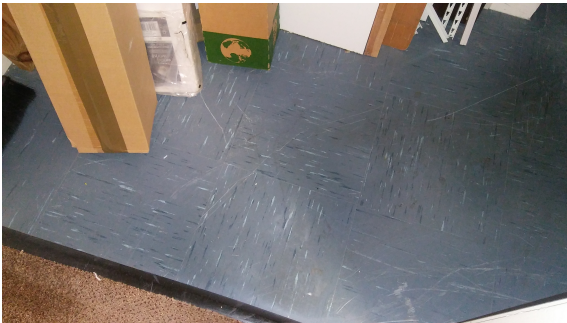
Item 26 Ref: As 416204-1

The floor covering in Rm 1/028 Office Link 2 does not contain asbestos.

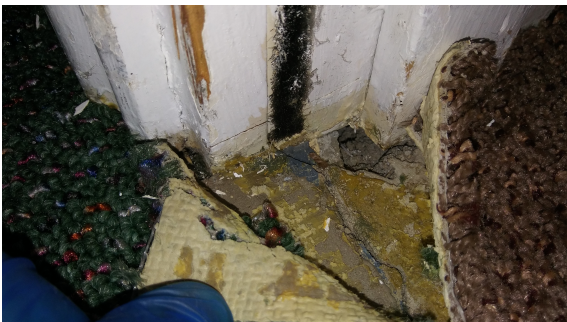
Item 27 Ref: As 416204-1

The floor covering in Rm 1/033 Store Link 2 does not contain asbestos.

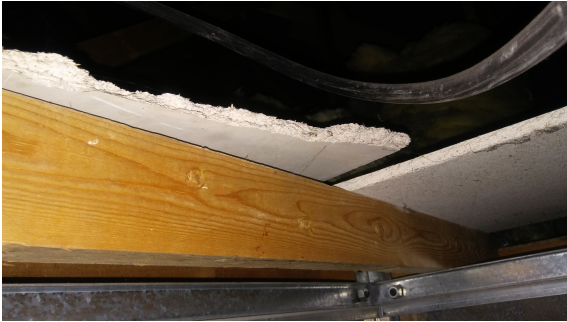
Item 28 Ref: 416204-4

The ceiling in Rm 1/068
Corridor dub waiter Link 2
does not contain asbestos.

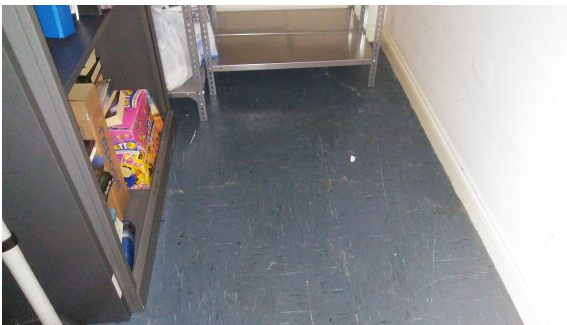
Item 29 Ref: As 416204-6

The floor covering in Rm
0/066 Store Windsor unit does
not contain asbestos.

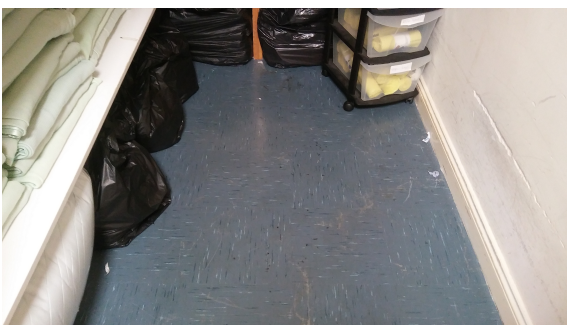
Item 30 Ref: 416204-6

The floor covering in Rm
0/007 Store Windsor unit does
not contain asbestos.

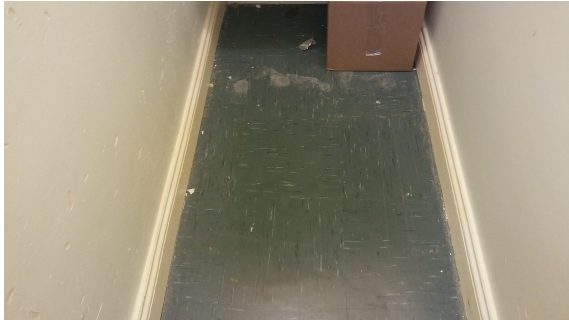
Item 31 Ref: As 416204-6

The floor covering in Rm 0/13b Store Windsor unit does not contain asbestos.

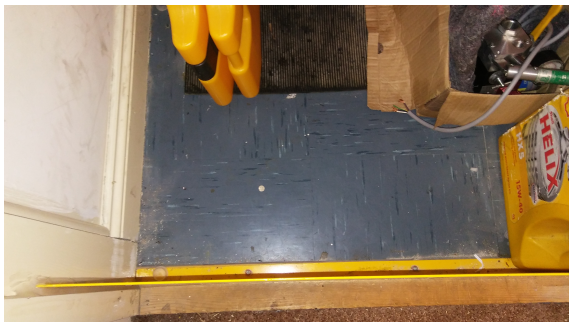
Item 32 Ref: As 416204-6

The floor covering in Rm 0/016 Lift machinery room Windsor unit does not contain asbestos.

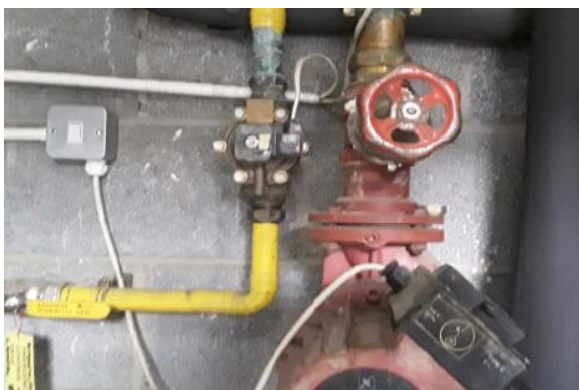
Item 33 Ref: 21-41127-1

The flange gaskets to the pipes in the Plant Room (Area 1) does not contain asbestos.

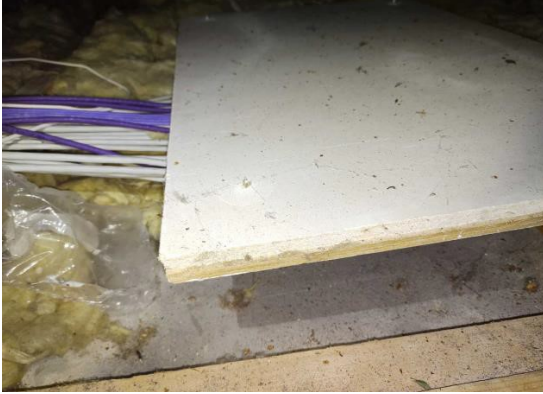
Item 34 Ref: 22-46328-1

The insulating board to access hatch (Loft Space 1/Area 2.001) does not contain asbestos.

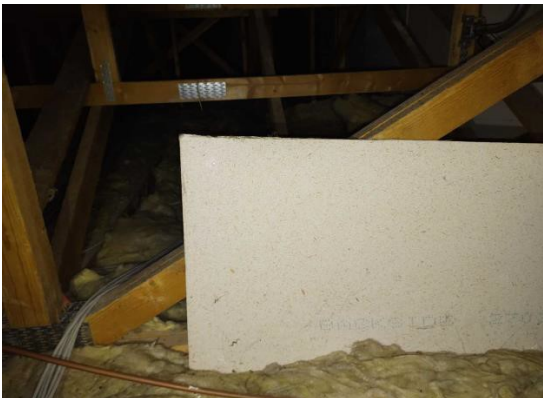
Item 35 Ref: 22-46328-1

The loose panel (Loft Space 1/Area 2.001) does not contain asbestos.

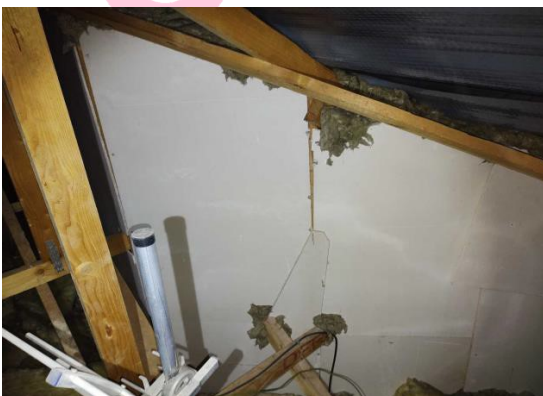
Item 36 Ref: 22-46328-1

The partition wall (Loft Space 1/Area 2.001) does not contain asbestos.

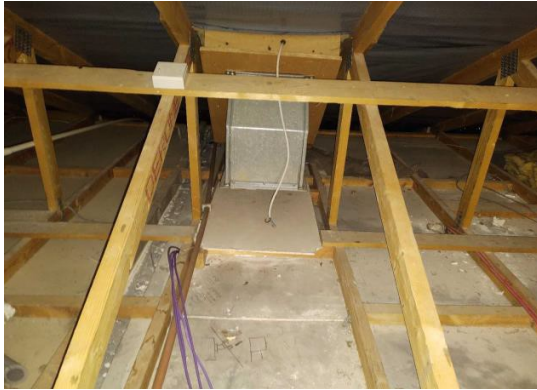
Item 37 Ref: 22-46328-1

The floor panel beneath duct work to roof (Loft Space 2/Area 2.002) does not contain asbestos.

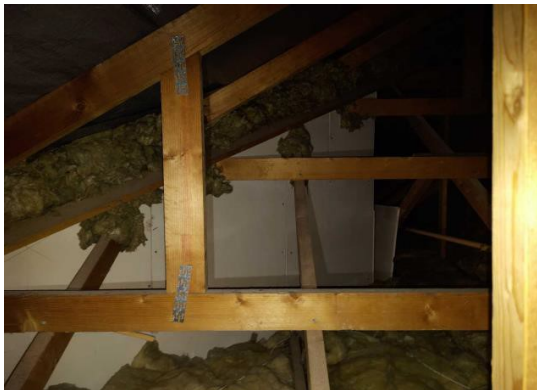
Item 38 Ref: 22-46328-1

The partition wall (Loft Space 3/Area 2.003) does not contain asbestos.

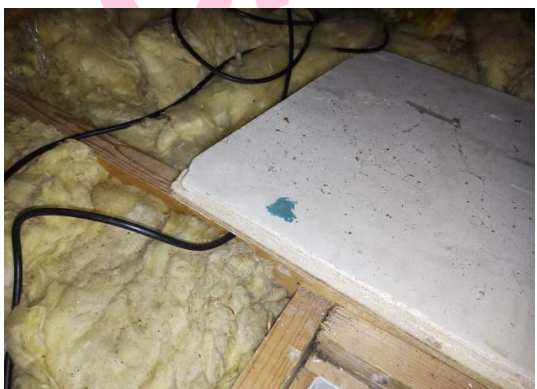
Item 39 Ref: 22-46328-1

The door (Loft Space 3/Area 2.003) does not contain asbestos.

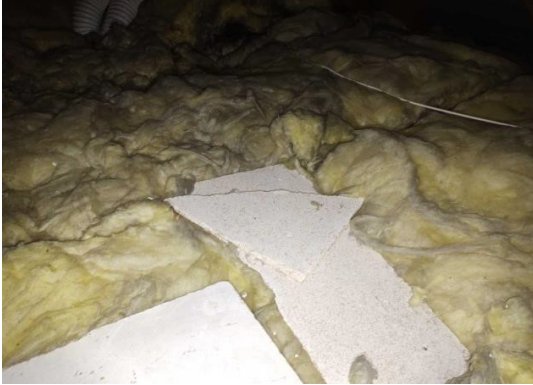
Item 40 Ref: 22-46328-1

The loose lying panels surrounding hatch (Loft Space 3/Area 2.003) does not contain asbestos.

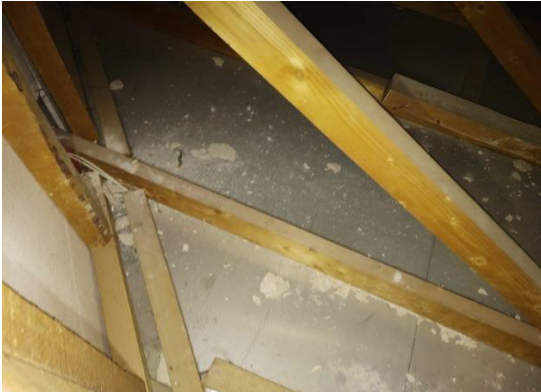
Item 41 Ref: 22-46328-2

The Insulating board debris to top side of ceiling (Stairwell/ Area 1.024a) does not contain asbestos.

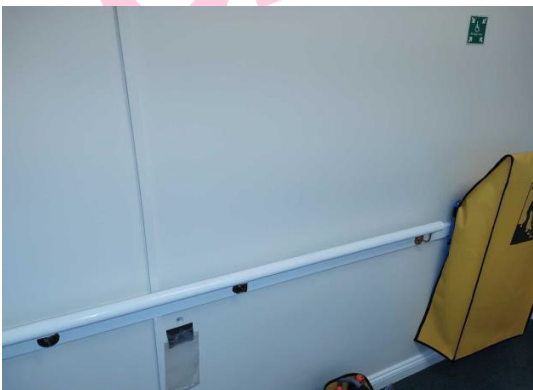
Item 42 Ref: 22-46328-3

The walls (Stairwell/Area 1.024a) does not contain asbestos.

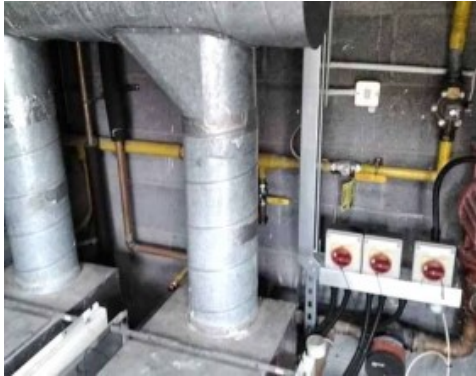
Item 43 Ref: SY000007

The flue pipe – sealant to flue/boiler in the boiler house (E/001) does not contain asbestos.

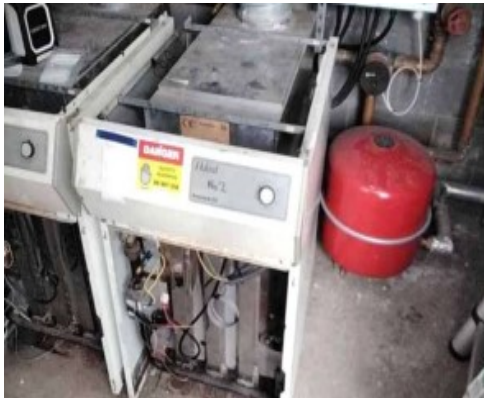
Item 44 Ref: SY000008

The boiler -seal gasket in the boiler house (E/001) does not contain asbestos.

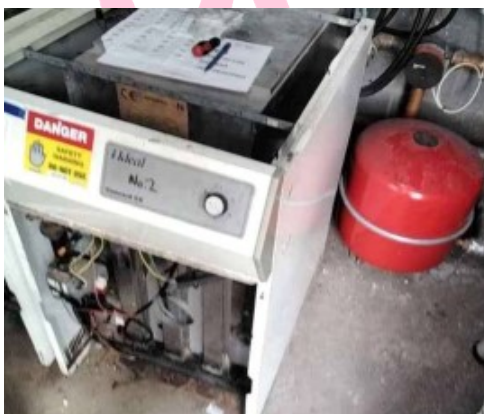
Item 45 Ref: SY000010

The boiler – lining/casing in the boiler house (E/001) does not contain asbestos.

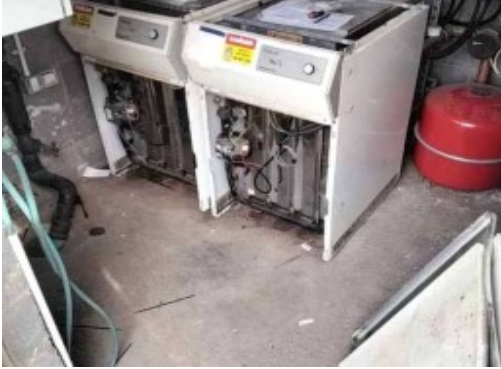
Item 46 Ref: SY000011

The debris/residue to the floor in the boiler house (E/001) does not contain asbestos.

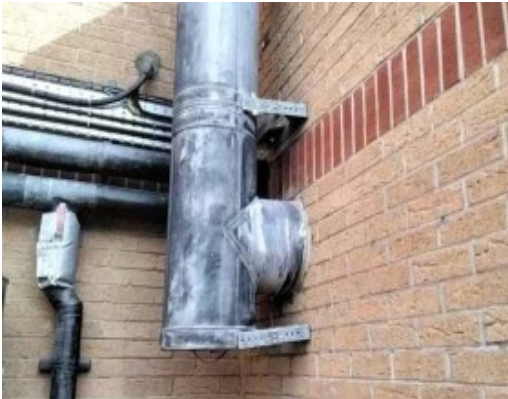
Item 47 Ref: SY000012

The flue pipe – sealant to flue/wall in the boiler house (E/001) does not contain asbestos.
