ASBESTOS SURVEY REPORT FOR 16 NILE STREET, SUNDERLAND, SR1 1EY.

## Asbestos Register for

**16 Nile Street, Sunderland, SR1 1EY**

**Date: 30 September 2024**

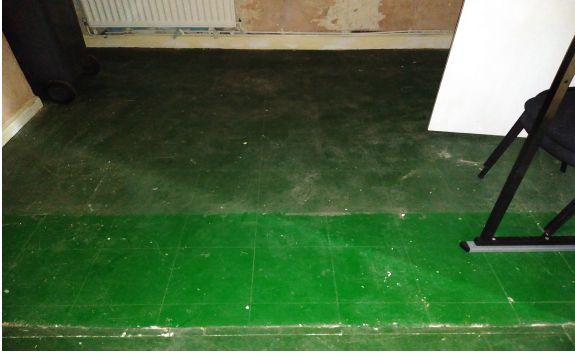
### **Item 1 Ref: 418624-1**

The floor tile with bitumen adhesive in the Office (Rm 0/002) does not contain asbestos.

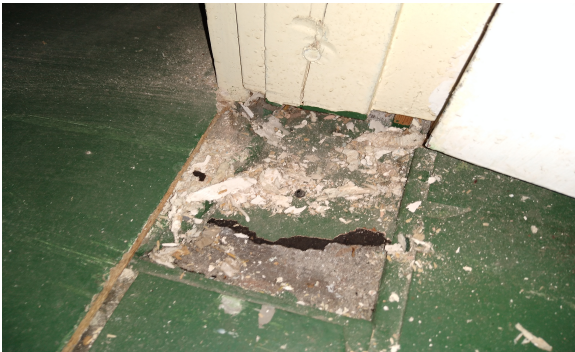
### **Item 2 Ref: 418624-2**

The subfloor covering in the Office (Rm 0/002) does not contain asbestos.

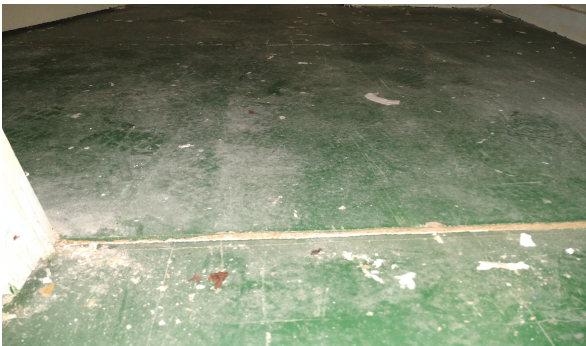
### **Item 3 Ref: As 418624-1**

The floor tile with bitumen adhesive in the Office Lobby (Rm 0/003) does not contain asbestos.

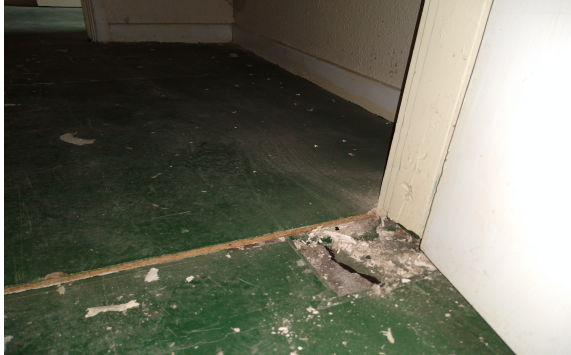
**Item 4 Ref: As 418624-2**

The subfloor covering in the Office Lobby (Rm 0/003) does not contain asbestos.

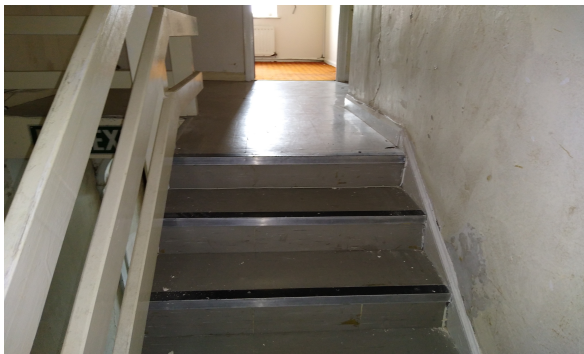
**Item 5 Ref: 418624-3**

The stairs and floor covering in the Stairwell & Landing (Rm 1/001) does not contain asbestos.

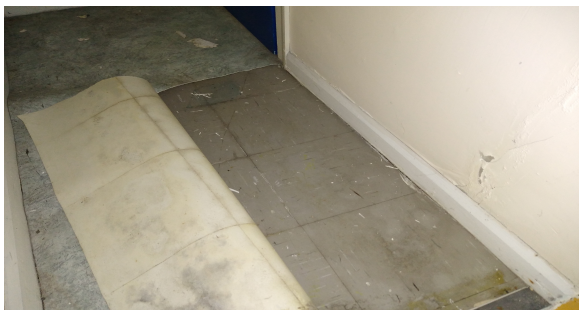
**Item 6 Ref: As 418624-3**

The floor covering to the corridor (Rm 1/005) does not contain asbestos.

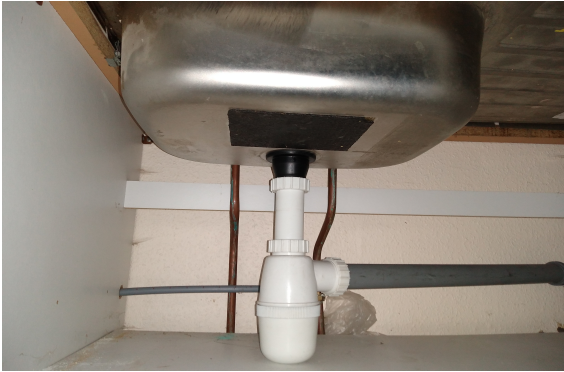
**Item 7 Ref: 418624-4**

The sink pad in the kitchen (Rm 1/008) does not contain asbestos.

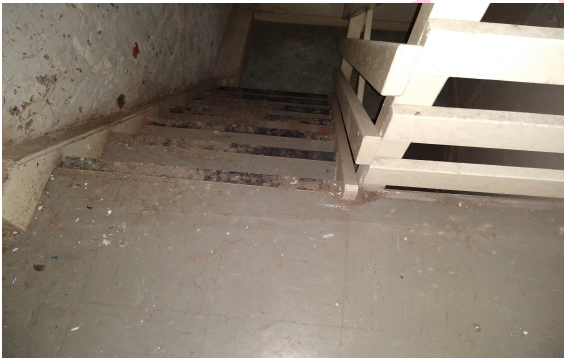
**Item 8 Ref: As 418624-3**

The floor and stair covering in the Rear Stairwell & Landing (Rm 1/009) does not contain asbestos.

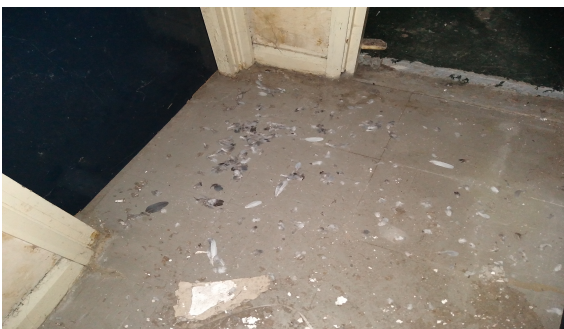
**Item 9 Ref: As 418624-3**

The floor covering in the WC Lobby (Rm 1/010) does not contain asbestos.

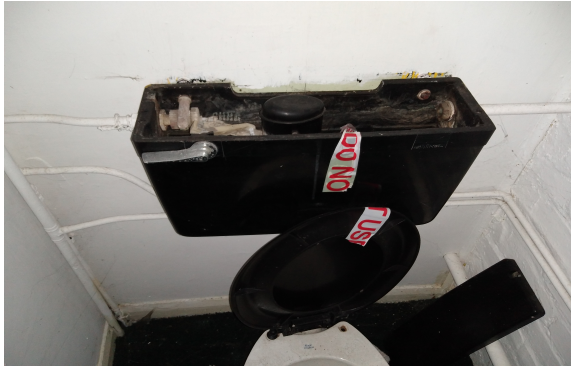
**Item 10 Ref: 418624-5**

The toilet cistern in the Female WC (Rm 1/011) contains asbestos.

Any change in its appearance should be recorded and reported to Property Services.

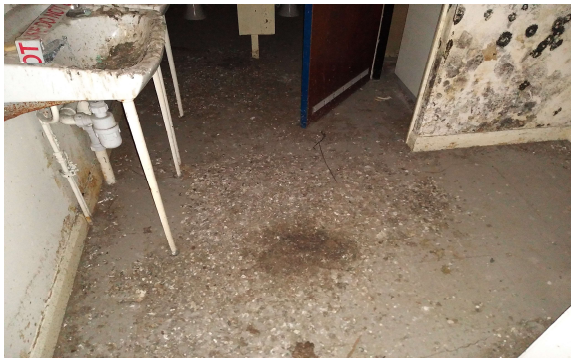
**Item 11 Ref: As 418624-3**

The floor covering in the Male WC (Rm 1/012) does not contain asbestos.
