### **ASBESTOS SURVEY REPORT FOR HOUGHTON LE SPRING CEMETERY LODGE, HOUGHTON LE SPRING**

## **Asbestos Register for Houghton Cemetery Lodge, Houghton**

**UPRN: - 21-35406**

**Date: 02 August 2024**

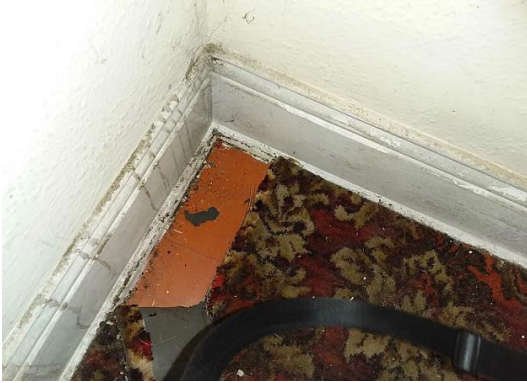
**Item 1 Ref: 21-35406-1**

The floor beneath carpet (Tiles & Adhesive) (Lodge - Room/Area: 1 - Front Entrance) does not contain asbestos.

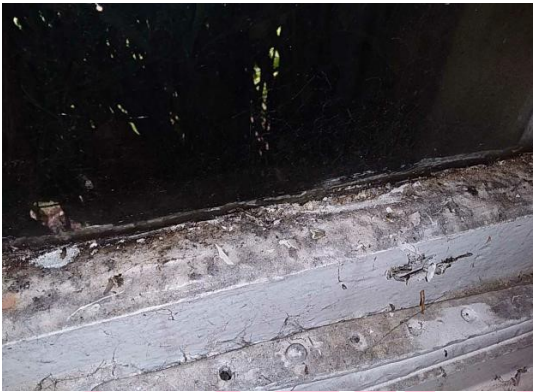
**Item 2 Ref: 21-35406-2**

The putty around windows (Lodge - Room/Area: 1 Front Entrance) does not contain asbestos.

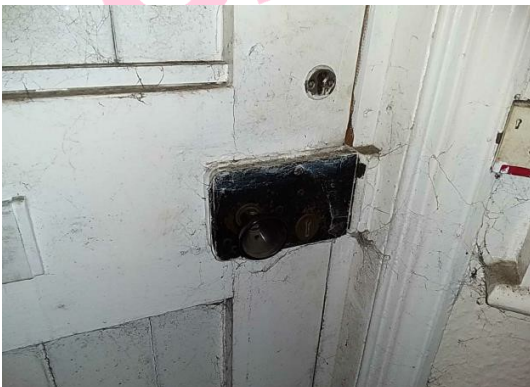
**Item 3 Ref: 21-35406-3**

The door handle (Composite) (Lodge - Room/Area: 1 Front Entrance) does not contain asbestos.

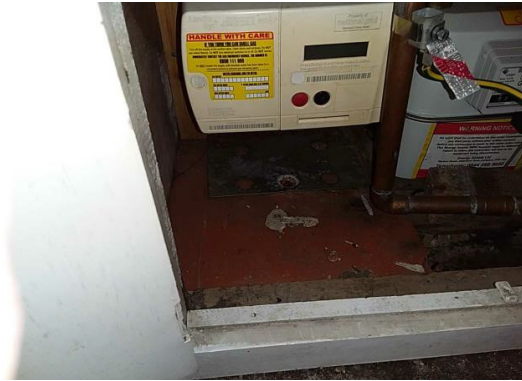
**Item 4 Ref: 21-35406-1**

The floor beneath carpet and gas meter (Tiles & Adhesive) (Lodge - Room/Area: 2 - Lounge 1 and cupboard) does not contain asbestos.

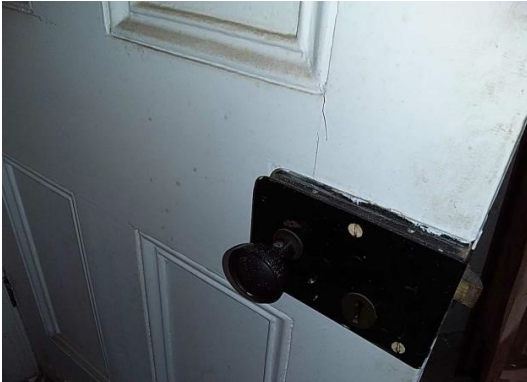
**Item 5 Ref: 21-35406-4**

The plastic composite door handles (Composite) (Lodge - Room/Area: 2 - Lounge 1 and cupboard) does not contain asbestos.

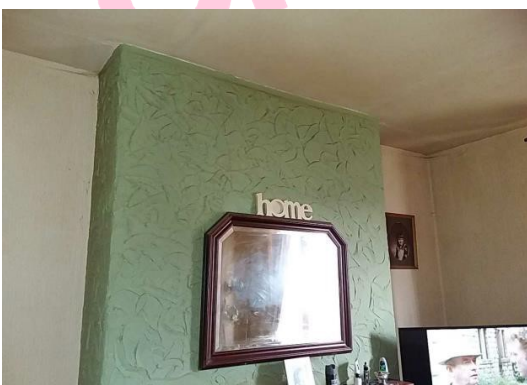
**Item 6 Ref: 21-35406-5**

The textured coating on chimney breast (Lodge - Room/Area: 4 - Lounge 2) does not contain asbestos.

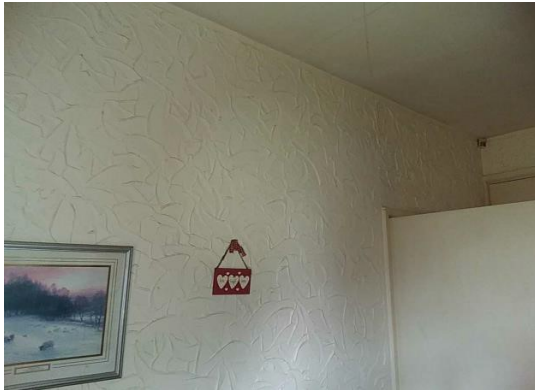
**Item 7 Ref: 21-35406-5**

The walls (Textured Coating)  
(Lodge - Room/Area: 5 -  
Dining Room and Cupboard)  
do not contain asbestos.

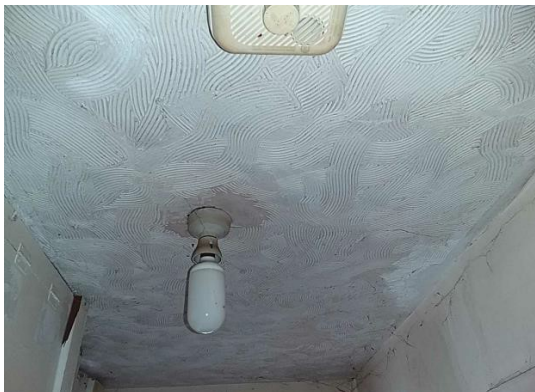
**Item 8 Ref: 21-35406-6**

The ceiling (Textured Coating)  
(Lodge - Room/Area: 6 - Rear  
Entrance) contains asbestos.

Item 5	No asbestos	Is present		
Item 6	No asbestos	Is present		
Item 7	No asbestos	Is present		
<b>Item 8</b>	<b>Ceiling (Lodge - Room/Area: 6 - Rear Entrance)</b>	<b>Very Low</b>	<b>12 monthly</b>	<b>07/07/2025</b>

Any change in its appearance  
should be recorded and  
passed to Property Services.

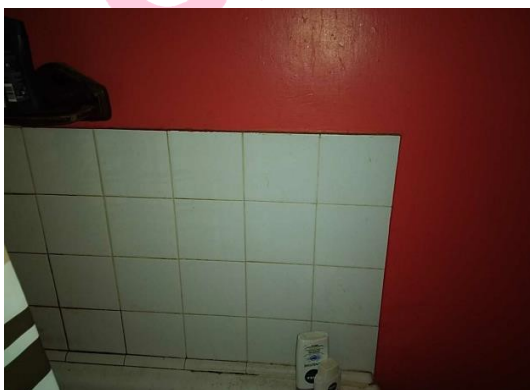
**Item 9 Ref: 21-35406-7**

The ceramic tiles adhesive  
(Lodge - Room/Area: 7 -  
Bathroom) does not contain  
asbestos.

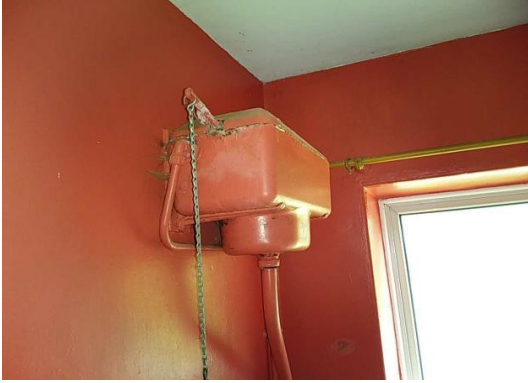
**Item 10 Ref: 21-35406-8**

The toilet cistern (Composite)  
(Lodge - Room/Area: 7 -  
Bathroom) contains asbestos.

Item 9	No asbestos	Is present		
<b>Item 10</b>	<b>Toilet cistern (Lodge - Room/Area: 7 - Bathroom)</b>	<b>Very Low</b>	<b>12 monthly</b>	<b>07/07/2025</b>

Any change in its appearance  
should be recorded and  
passed to Property Services.

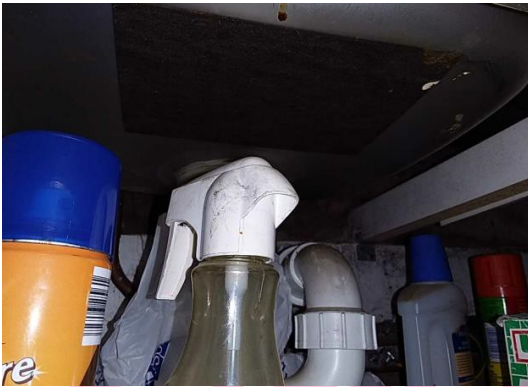
**Item 11 Ref: 21-35406-10**

The sink pad (Bitumen)  
(Lodge - Room/Area: 8 -  
Kitchen) does not contain  
asbestos.

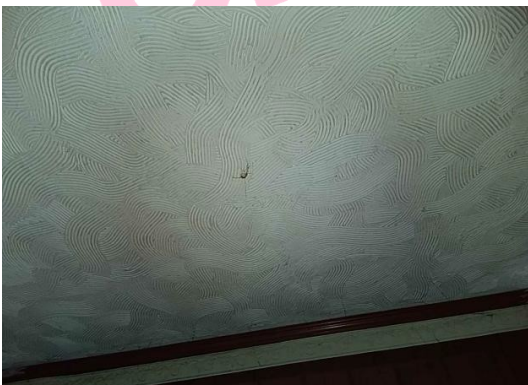
**Item 12 Ref: 21-35406-7**

The ceiling (Textured Coating)  
(Lodge - Room/Area: 8 -  
Kitchen) contains asbestos.

Item 11	No asbestos	Is present		
<b>Item 12</b>	<b>Ceiling (Lodge - Room/Area: 8 - Kitchen)</b>	<b>Very Low</b>	<b>12 monthly</b>	<b>07/07/2025</b>
Item 13	No asbestos	Is present

Any change in its appearance  
should be recorded and  
passed to Property Services.

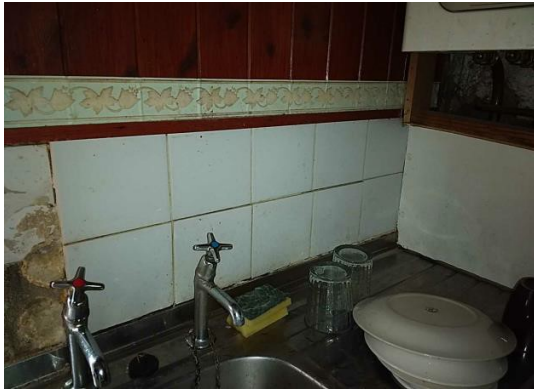
**Item 13 Ref: 21-35406-9**

The ceramic tiles (Tiles & Adhesive) (Lodge - Room/Area: 8 - Kitchen) do not contain asbestos.

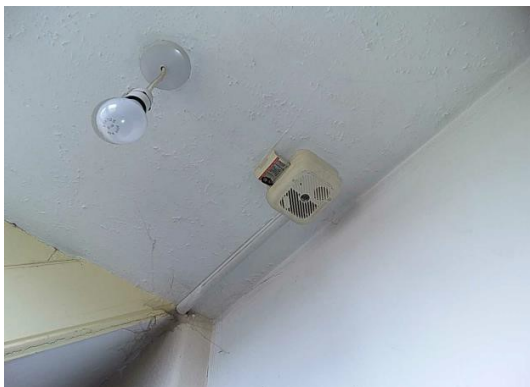
**Item 14 Ref: 21-35406-11**

The ceiling (Textured Coating) (Lodge - Room/Area: 9 - Landing and Stairs) does not contain asbestos.

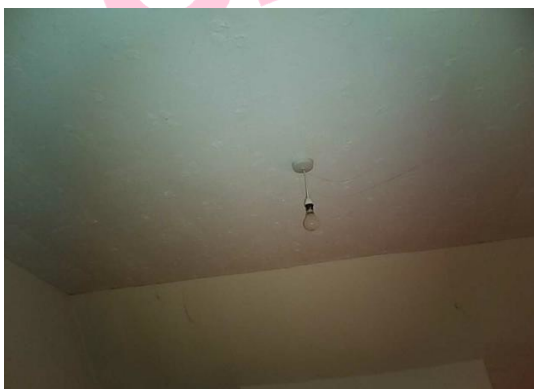
**Item 15 Ref: 21-35406-11**

The ceiling (Textured Coating) (Lodge - Room/Area: 10 - Bedroom 1) does not contain asbestos.

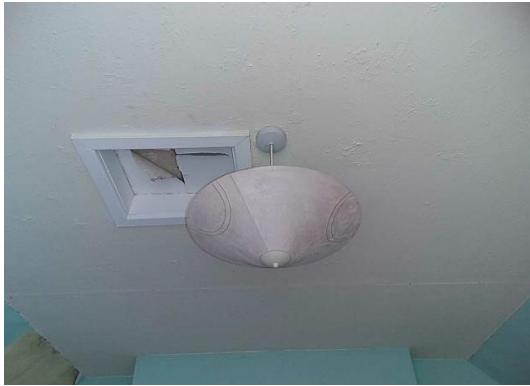
**Item 16 Ref: 21-35406-9**

The ceiling (Textured Coating) (Lodge - Room/Area: 11 - Bedroom 2) does not contain asbestos.

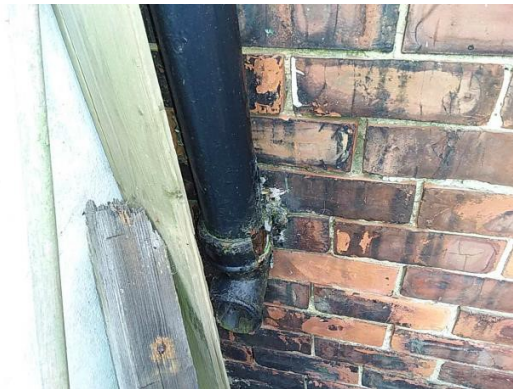
**Item 17 Ref: 21-35406-12**

The downpipes - joint capping (Cement) (Lodge - Room/Area: 15 - External) do not contain asbestos.

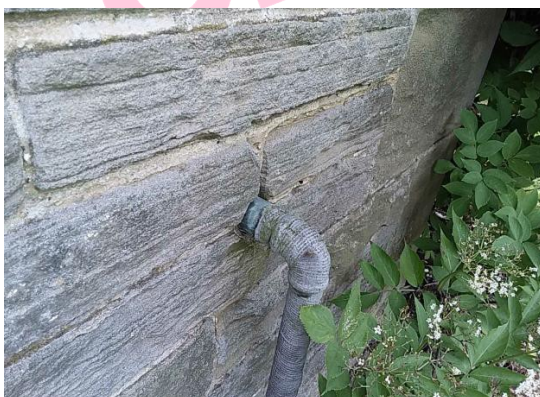
**Item 18 Ref: 21-35406-13**

The bitumen wrap on pipe (Lodge - Room/Area: 15 - External) does not contain asbestos.

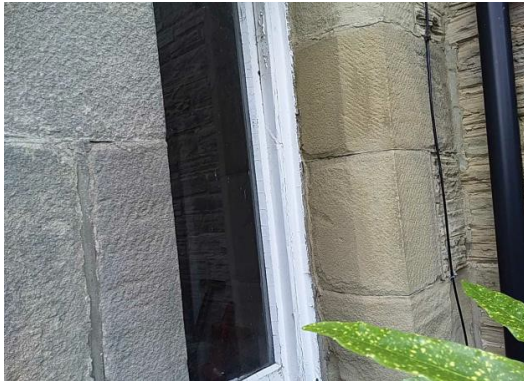
**Item 19 Ref: 21-35406-14**

The putty around windows (Lodge - Room/Area: 15 - External) does not contain asbestos.

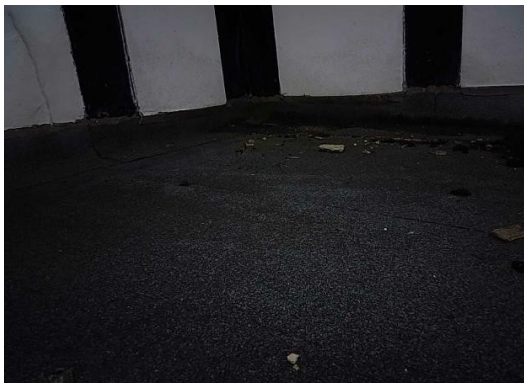
**Item 20 Ref: 21-35406-15**

The felt on front entrance roof (Bitumen) (Lodge - Room/Area: 15 - External) does not contain asbestos.

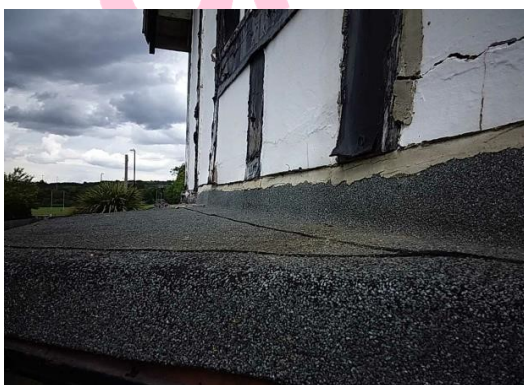
**Item 21 Ref: 21-35406-16**

The felt on bay window roof (Bitumen) (Lodge - Room/Area: 15 - External) does not contain asbestos.

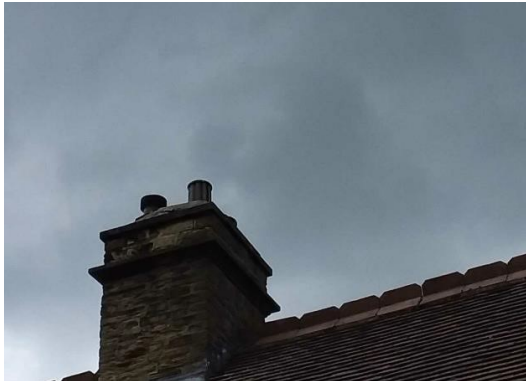
**Item 22 Ref: PRESUMED**

The flues on chimney stack (Cement) (Lodge - Room/Area: 15 - External) are presumed to contain asbestos.

Item 19	No asbestos	Is present		
Item 20	No asbestos	Is present		
Item 21	No asbestos	Is present		
<b>Item 22</b>	<b>PRESUMED – Flues on chimney stack (Lodge - Room/Area: 15 - External)</b>	<b>Very Low</b>	<b>12 monthly</b>	<b>07/07/2025</b>

Any change in its appearance should be recorded and passed to Property Services.

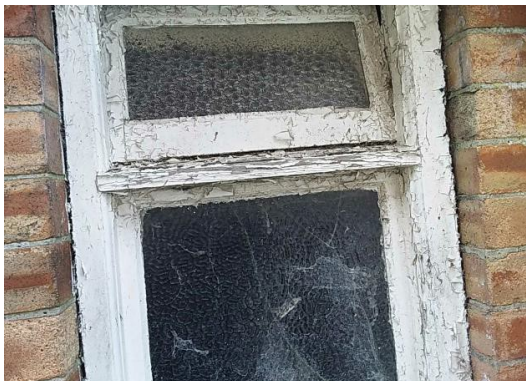
**Item 23 Ref: 21-35406-18**

The putty around window (Room/Area: 16 - Outhouse and Stores) does not contain asbestos.

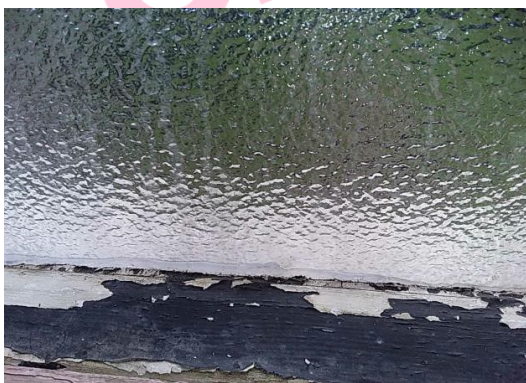
**Item 24 Ref: 21-35406-19**

The putty around window (Room/Area: 17 - Outside toilet) does not contain asbestos.

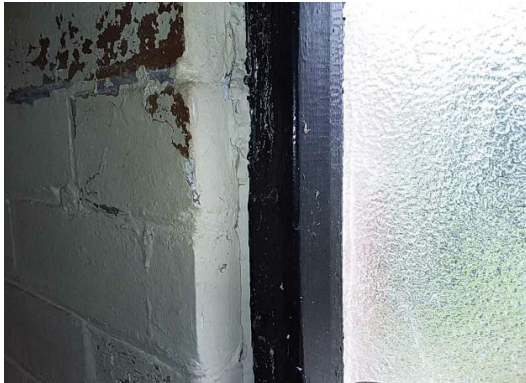
**Item 25 Ref: 21-35406-20**

The residual frame sealant around window (Putty) (Room/Area: 17 - Outside toilet) does not contain asbestos.

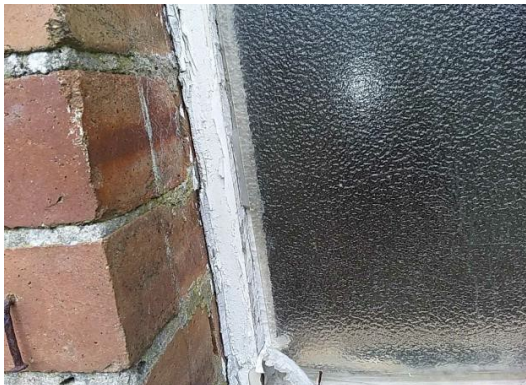
**Item 26 Ref: 21-35406-21**

The residual frame sealant around external part of window (Putty) (Room/Area: 17 - Outside toilet) does not contain asbestos.

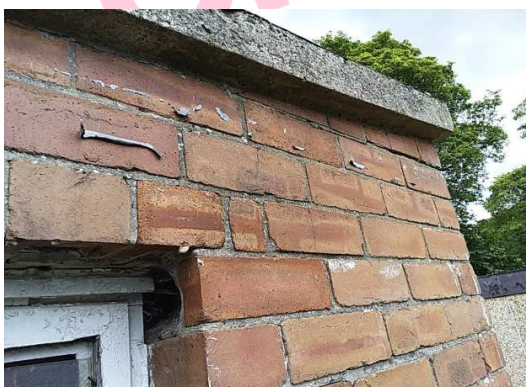
**Item 27 Ref: 21-35406-22**

The residual frame sealant on walls (Putty) (Room/Area: 17 - Outside toilet) contains asbestos.

Item 25	No asbestos	Is present		
Item 26	No asbestos	Is present		
<b>Item 27</b>	<b>Residual frame sealant on walls (Room/Area: 17 - Outside toilet)</b>	<b>Very Low</b>	<b>12 monthly</b>	<b>07/07/2025</b>
Item 28	No asbestos	Is present		
Item 29	No asbestos	Is present		
Item 30	No asbestos	Is present		
Item 31	No asbestos	Is present		
Item 32	No asbestos	Is present

Any change in its appearance should be recorded and passed to Property Services.

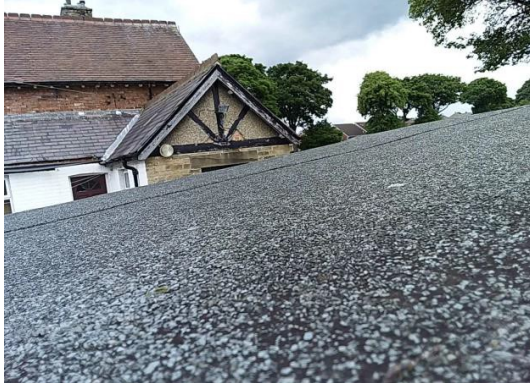
**Item 28 Ref: 21-35406-23**

The felt on roof (Bitumen)  
(Room/Area: 17 - Outside  
toilet) does not contain  
asbestos.

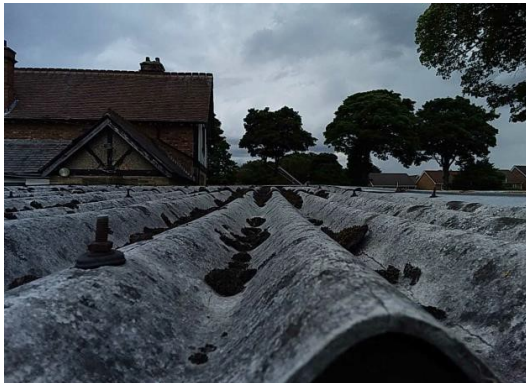
**Item 29 Ref: 21-35406-24**

The roof (Cement)  
(Room/Area: 18 - Garage)  
does not contain asbestos.

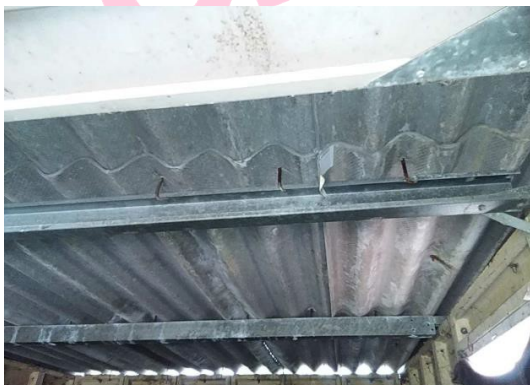
**Item 30 Ref: 21-35406-22**

The ceiling (Cement)  
(Room/Area: 18 - Garage)  
does not contain asbestos.

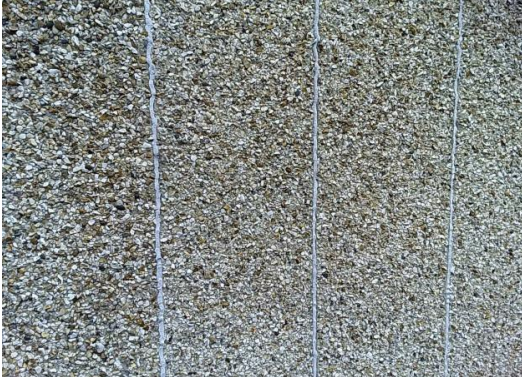
**Item 31 Ref: 21-35406-25**

The walls - residual frame sealant between concrete (Putty) (Room/Area: 18 - Garage) does not contain asbestos.

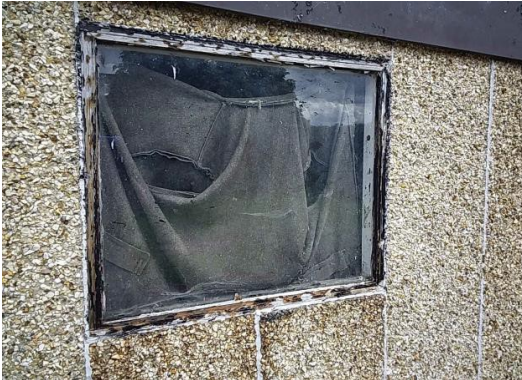
**Item 32 Ref: 21-35406-25**

The residual frame sealant around window (Putty) (Room/Area: 18 - Garage) does not contain asbestos.
