ASBESTOS SURVEY REPORT FOR YOUTH OFFENDING SERVICE,
LAMBTON HOUSE, 145 HIGH STREET WEST, SUNDERLAND

**Asbestos Register for
YOUTH OFFENDING SERVICE, 145 HIGH STREET WEST**

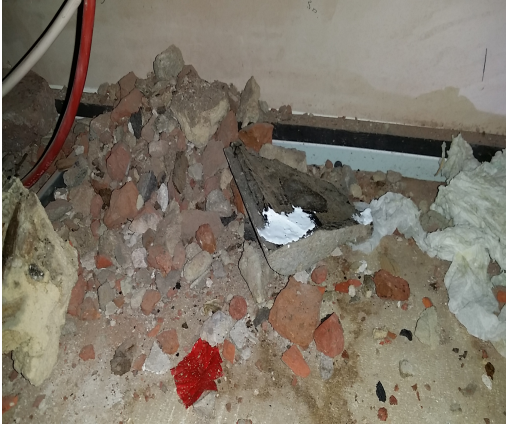
Item 1: Ref 318529-2

- (Item 1) Ref: 318529-2 – Bitumen to rumble above door (Rm 003/wc-void above) – Very Low Risk
- (Item 2) Ref: 318529-1 – Debris to main wood beam (Rm 009a/office-void above) – No Risk
- (Item 3) Presumed – Debris to ledge (Rm 009a/office-void above) – Removed August 2019

The Bitumen to rubble above the door in the void above Room 003 WC does contain asbestos.

This area should not be inspected. Any works planned in this area will require liaising with Property Services and the asbestos to be removed.

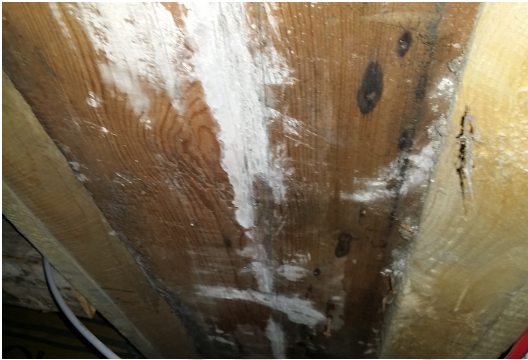
Item 2: Ref 318529-1

The debris to main wood beam in the void above Room 009a office does not contain asbestos.

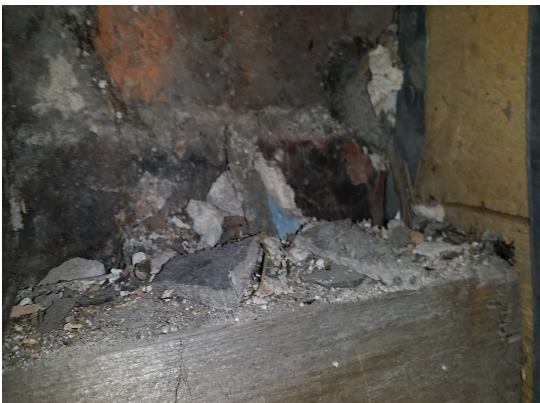
Item 3: Ref Presumed

The debris to the ledge in the void above Room 009a Office is presumed to contain asbestos.

Removed August 2019

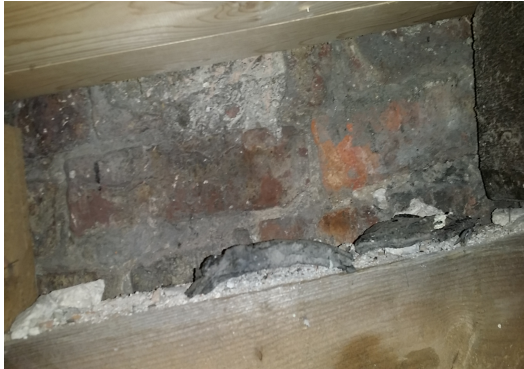
Item 4: Ref Presumed

The debris to the ledge in the void above Room 009a Office is presumed to contain asbestos.

Removed August 2019

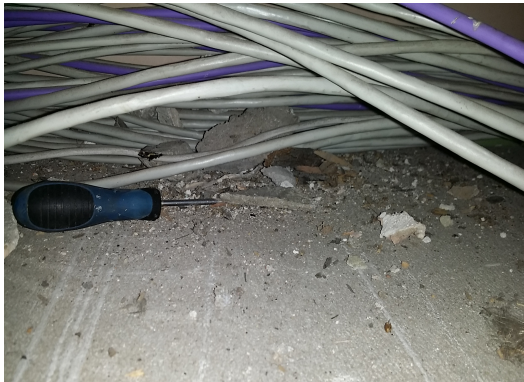
Item 5: Ref 318529-5

The cement debris to the topside of suspended ceiling in the void above Room 009a Office does contain asbestos.

Removed August 2019

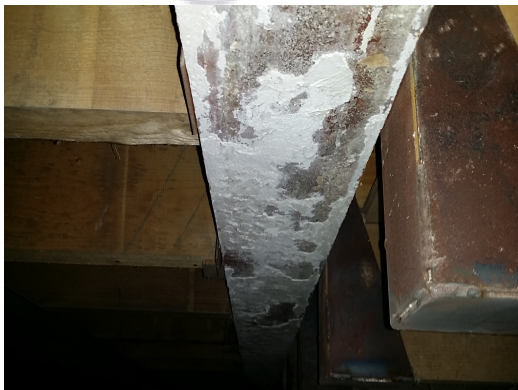
Item 6: Ref 318529-3

The remnant board to metal beam in the void above Room 001 Office does contain asbestos.

Removed August 2019

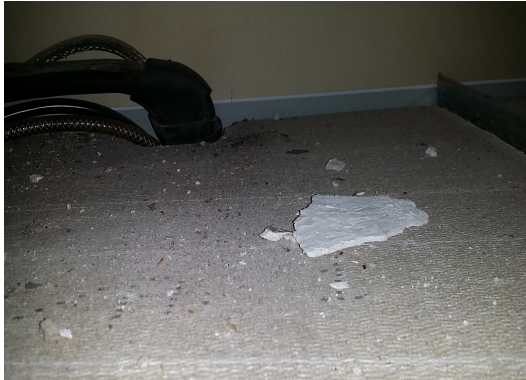
Item 7: Ref 318529-4

The boarding debris to topside suspended ceiling in the void above Room 001 Office does contain asbestos.

Removed August 2019

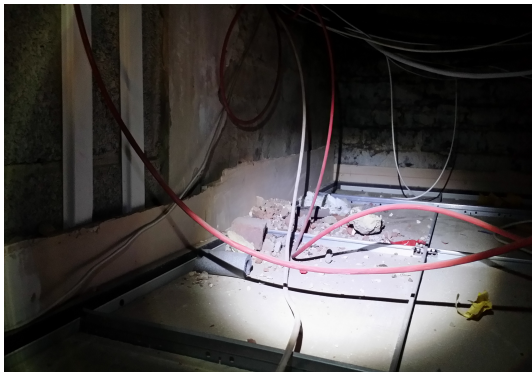
Item 8: Ref Presumed

The bitumen to rumble above door in the void above Room 007 Disabled WC is presumed to contain asbestos.

Removed August 2019

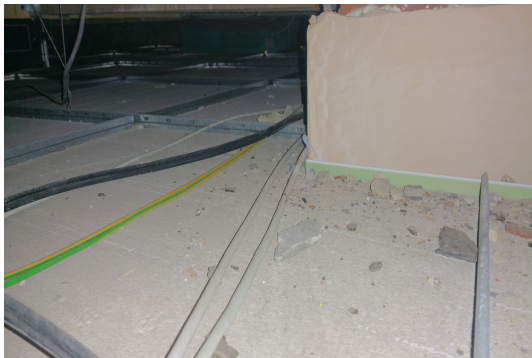
Item 9: Ref 324294-3

The cement debris to topside of suspended ceiling in the void above Room 009 meeting room does contain asbestos.

Removed August 2019

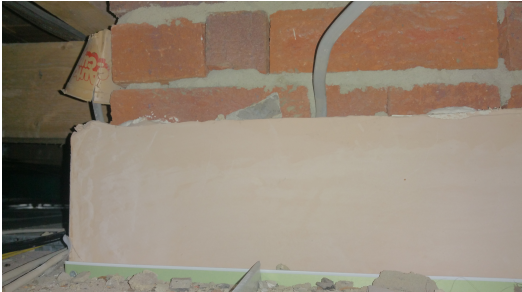
Item 10: Ref 324294-4

The debris to ledges of perimeter in the void above Room 009 meeting room does contain asbestos.

Removed August 2019

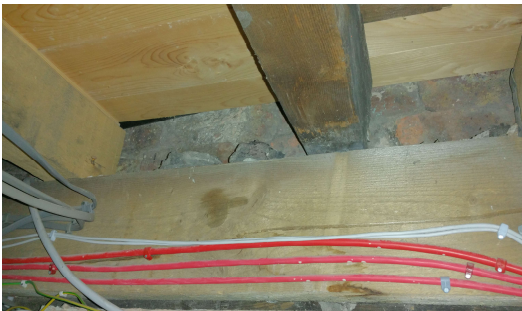
Item 11: Ref 324294-5

The debris to ledge of window wall in the void above Room 009 meeting room does contain asbestos.

Removed August 2019

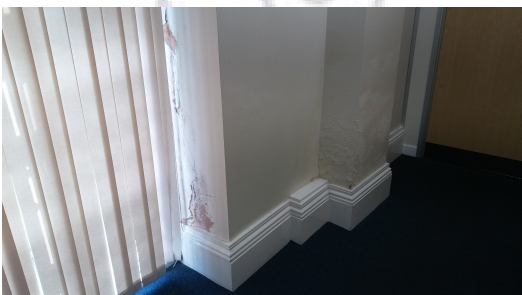
Item 12: Ref 404056-6

The walls in Rm 001/Corridor do not contain asbestos.

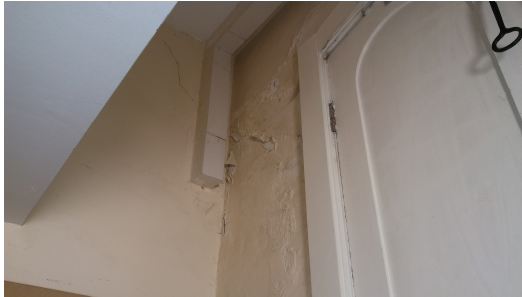
Item 13: Ref 404056-4

The walls to rear exit in Rm 011/Rear lobby and Stairwell do not contain asbestos.

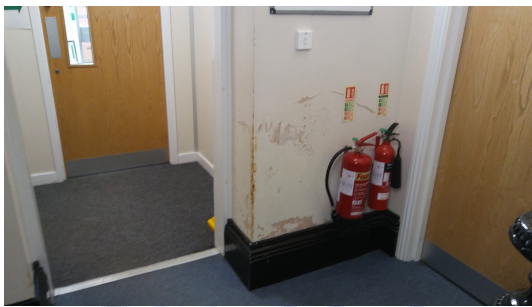
Item 14: Ref 404056-5

The walls adjacent to front lobby in Rm 011/Rear lobby and Stairwell do not contain asbestos.

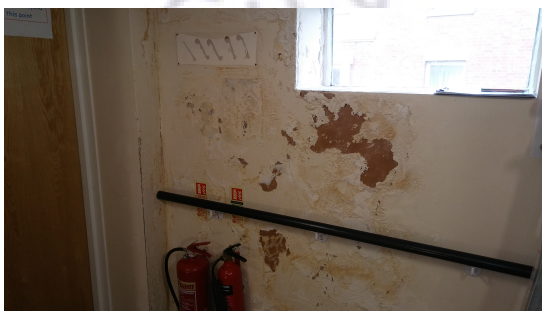
Item 15: Ref 404056-2

The walls in Rm 2/005/ Stairwell & Landing do not contain asbestos.

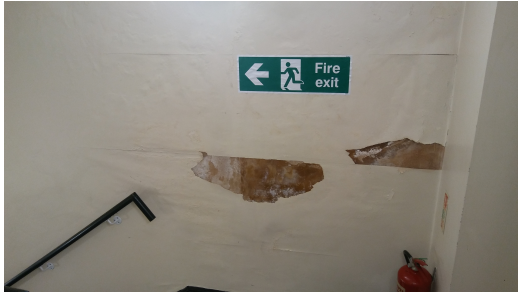
Item 16: Ref 404056-1

The walls in Rm 3/005/Landing do not contain asbestos.

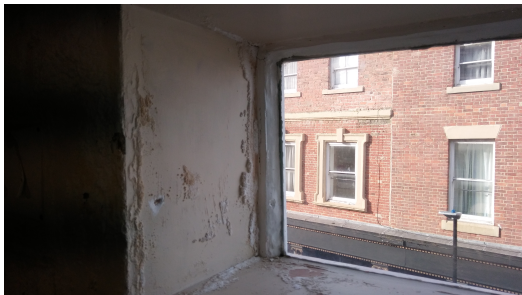
Item 17: Ref 404056-3

The sealant to window frame in Rm 3/005/Landing does not contain asbestos.
