ASBESTOS SURVEY REPORT FOR CAPSTAN HOUSE, GREENWELLS QUAY, SUNDERLAND PORT, HENDON, SR1 2BU

Asbestos Register for

**CAPSTAN HOUSE, GREENWELLS QUAY, SUNDERLAND PORT,
HENDON, SR1 2BU**

Date: 07 December 2022

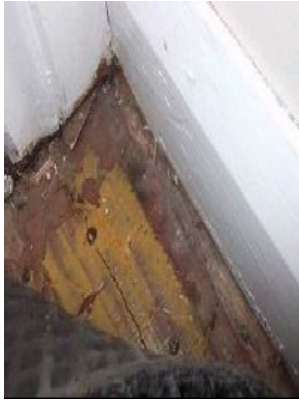
Item 1 Ref: VP002050

The red screed to floor in Room 1 (Reception Lobby) does not contain asbestos.

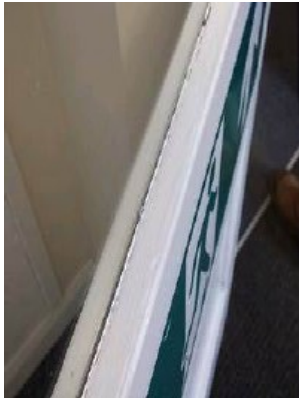
Item 2 - Ref: VP002051

The putty round door frame to glass Room 1 (Reception Lobby) does not contain asbestos.

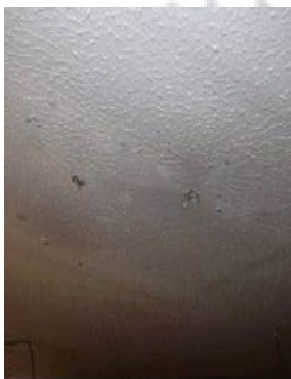
Item 3 - Ref: VP002052

The textured coating to the ceiling in the entrance does not contain asbestos.

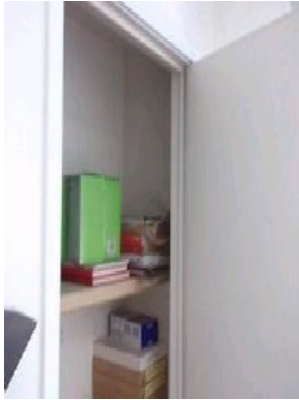
Room 2 (Reception stationery cupboard) was accessed and no suspect materials were found.

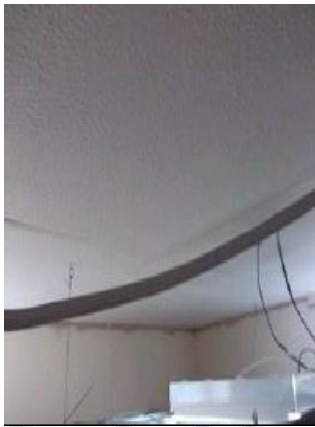
Item 4 - Ref: As VP002052

Textured coating to ceiling in Room 3 (Reception waiting room) does not contain asbestos.

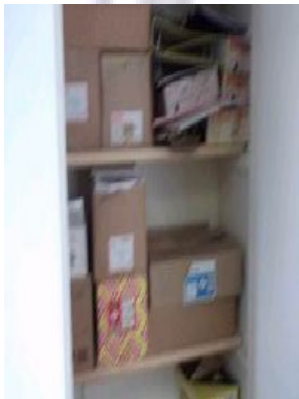
Room 4 (Waiting Room stationery cupboard) was accessed and no suspect materials were found.

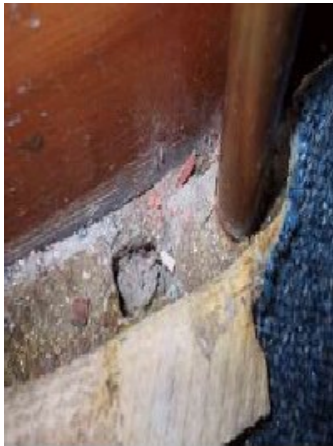
Item 5 - Ref: VP002050

Red screed floor in Room 5 (Corridor) does not contain asbestos.

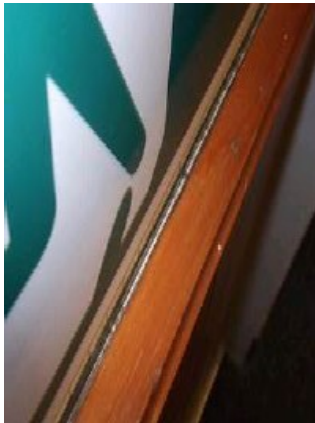
Item 6 - Ref: VP002053

Putty around door frame to glass at rear of corridor in Room 5 does not contain asbestos.

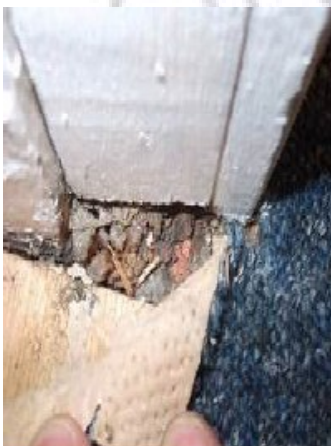
Item 7 - Ref: VP002050

Red screed floor in Room 6 (Shipping Office) does not contain asbestos.

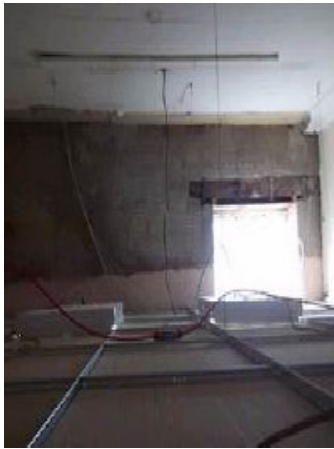
Room 7 (Harbour masters Office) was accessed no suspect materials were found.

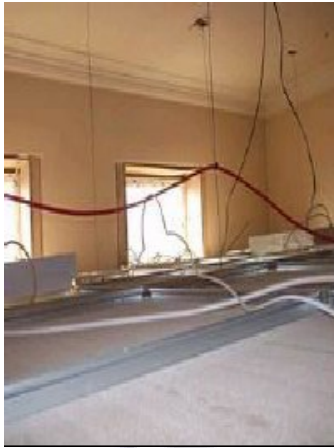
Room 8 (Port Directors Office) was accessed no suspect materials were found.

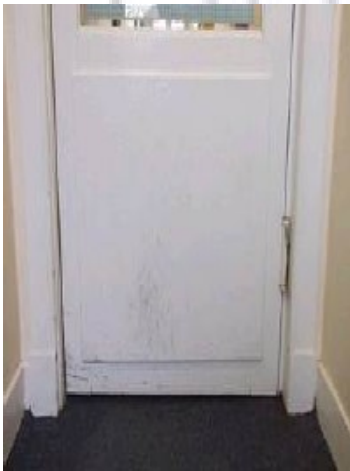
Item 8 - Ref: VP002054

Board Panel on door Room 9 does no contain asbestos.

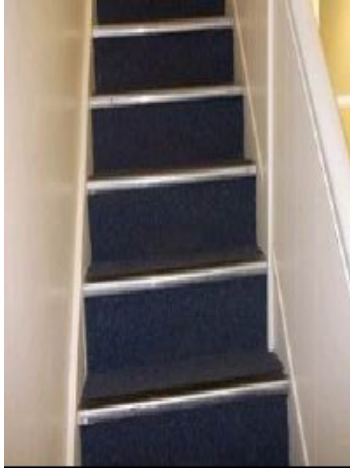
Item 9 - Ref: VP002055

The Stairtread to Room 9 does not contain asbestos.

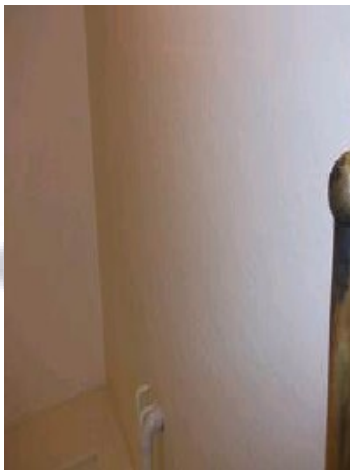
Item 10 – VP002056

Board to walls at top of stairs in Room 9 (Circulation/stairwell) does not contain asbestos.

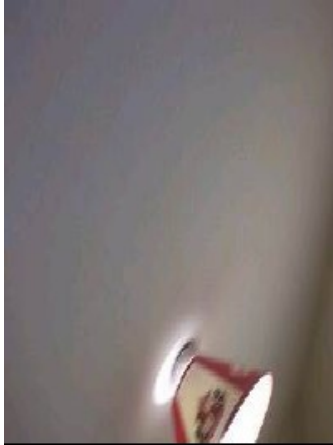
Item 11 – VP002057

Board to ceiling at top of stairs
in Room 9
(Circulation/stairwell) does not
contain asbestos.

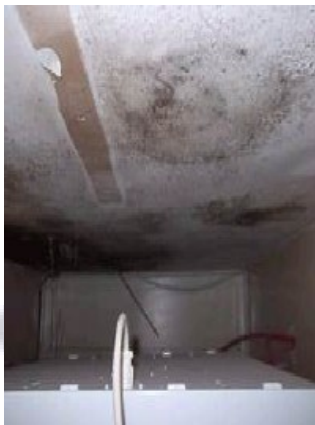
Room 10 was accessed no
suspect materials were found.

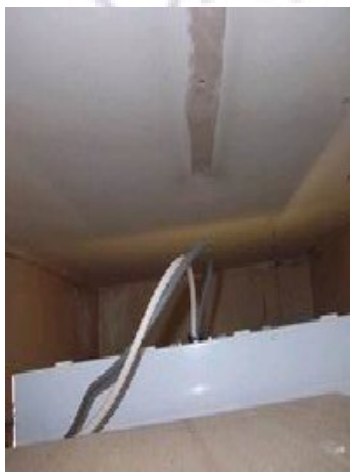
Room 11 (Store) was
accessed no suspect
materials were found.

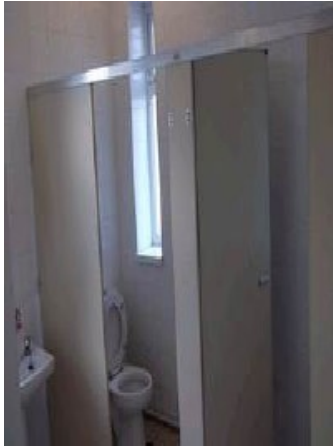
Room 12 (Male WC) was accessed no suspect materials were found.

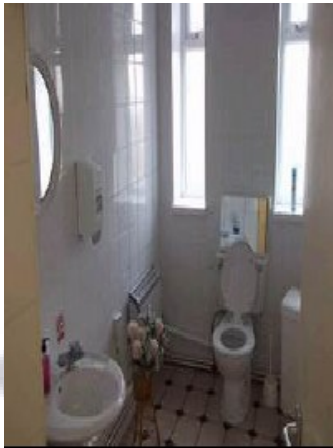
Room 13 (Female WC) was accessed no suspect materials were found.

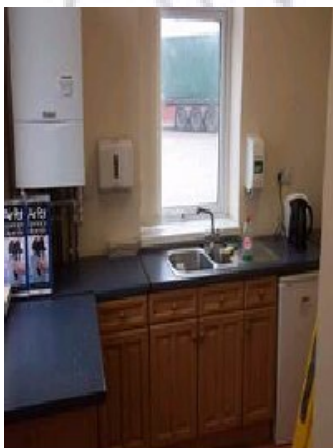
Room 14 (Kitchen) was accessed no suspect materials were found.

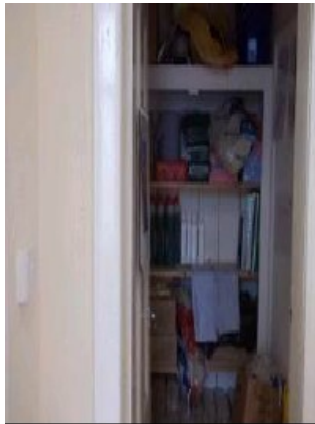
Room 15 (Cleaners Cupboard) was accessed no suspect materials were found.

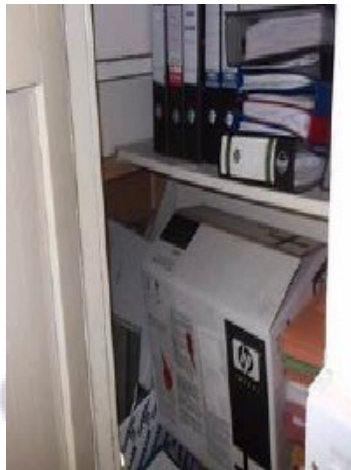
Room 16 (Under stairs cupboard) was accessed no suspect materials were found.

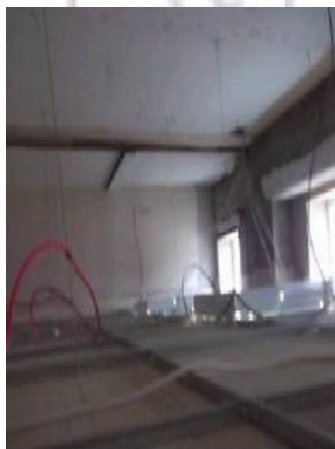
Room 17 (Conference Room) was accessed no suspect materials were found.

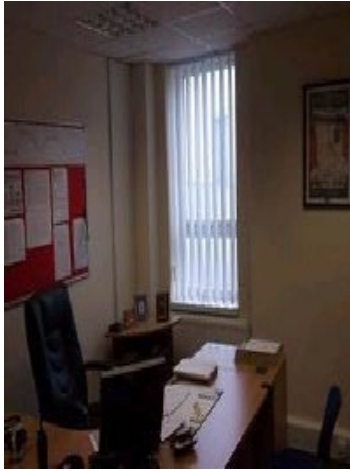
Room 18 (Cargo Managers Office) was accessed no suspect materials were found.

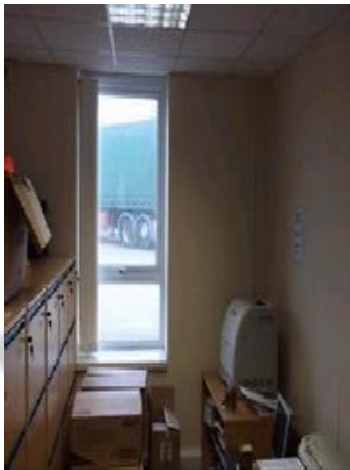
Room 19 (Photocopier Room) was accessed no suspect materials were found.

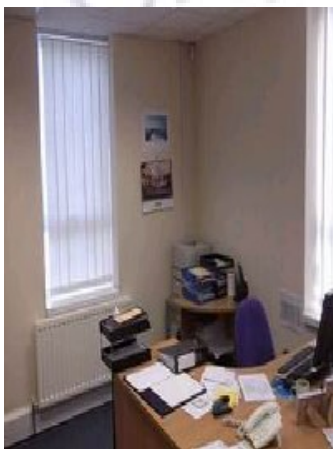
Room 20 (Finance Office) was accessed no suspect materials were found.

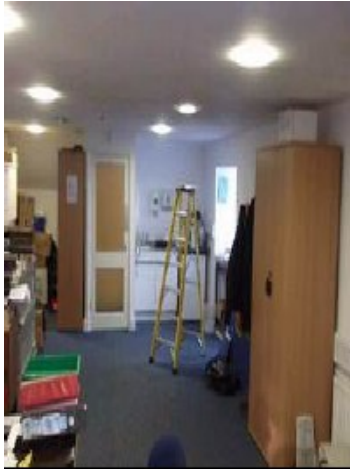
Room 1 (Engineering department) was accessed no suspect materials were found.

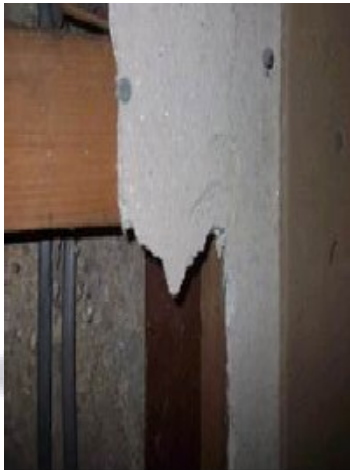
Item 12 – VP002058

Board firebreak in Room 2 (Attic) does not contain asbestos.

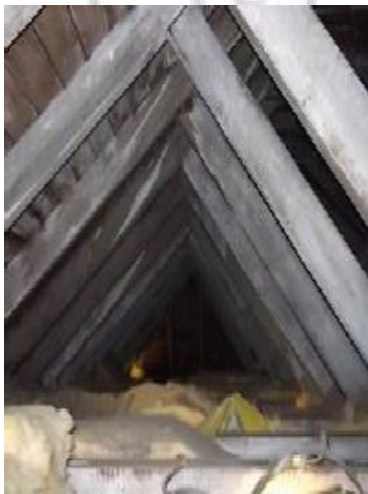
Room 1 (Loft area) was accessed no suspect materials were found.

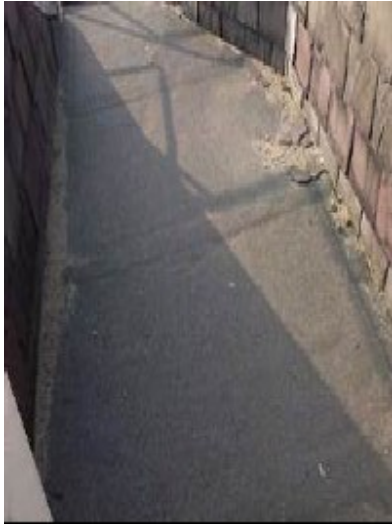
Item 13 – VP002059

Bitumen to felt to flat roof section at fire escape stairs Room 1 (External) does not contain asbestos.
