ASBESTOS SURVEY REPORT FOR HM BOAT GARAGE, W.SIDE 1/2 TIDE BASIN, HENDON, SUNDERLAND

Asbestos Register for

HM BOAT GARAGE, W.SIDE 1/2 TIDE BASIN, HENDON, SUNDERLAND

Date: 07 December 2022

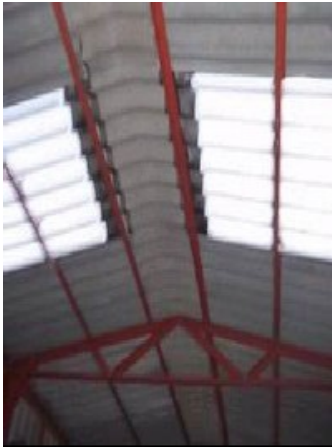
Item 1 Ref: VP002282

VP002282 – Cement roof (Room 1) (Garage) (Item 1) - No Risk

The cement roof to the ground floor (Room 1) (Garage) does not contain asbestos.

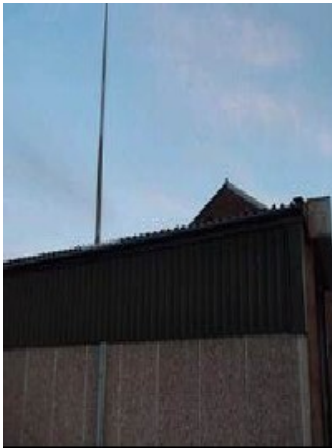
Item 2 – As VP002282

As VP002282 – Cement roof (Room 1) (External) (Item 2) - No Risk

The external cement roof to (Room 1) does not contain asbestos.

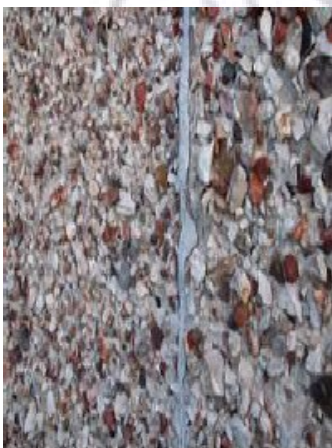
Item 3 Ref: VP002283

VP002283 – Putty between concrete wall slabs (Room 1) (External) (Item 3) - No Risk

The putty between concrete wall slabs to the external of the building does not contain asbestos.
